# PORT TALBOT HARBOURSIDE

## Remediation Verification Report

**PROJECT NO. 70057278**

**DATE: APRIL 2022**

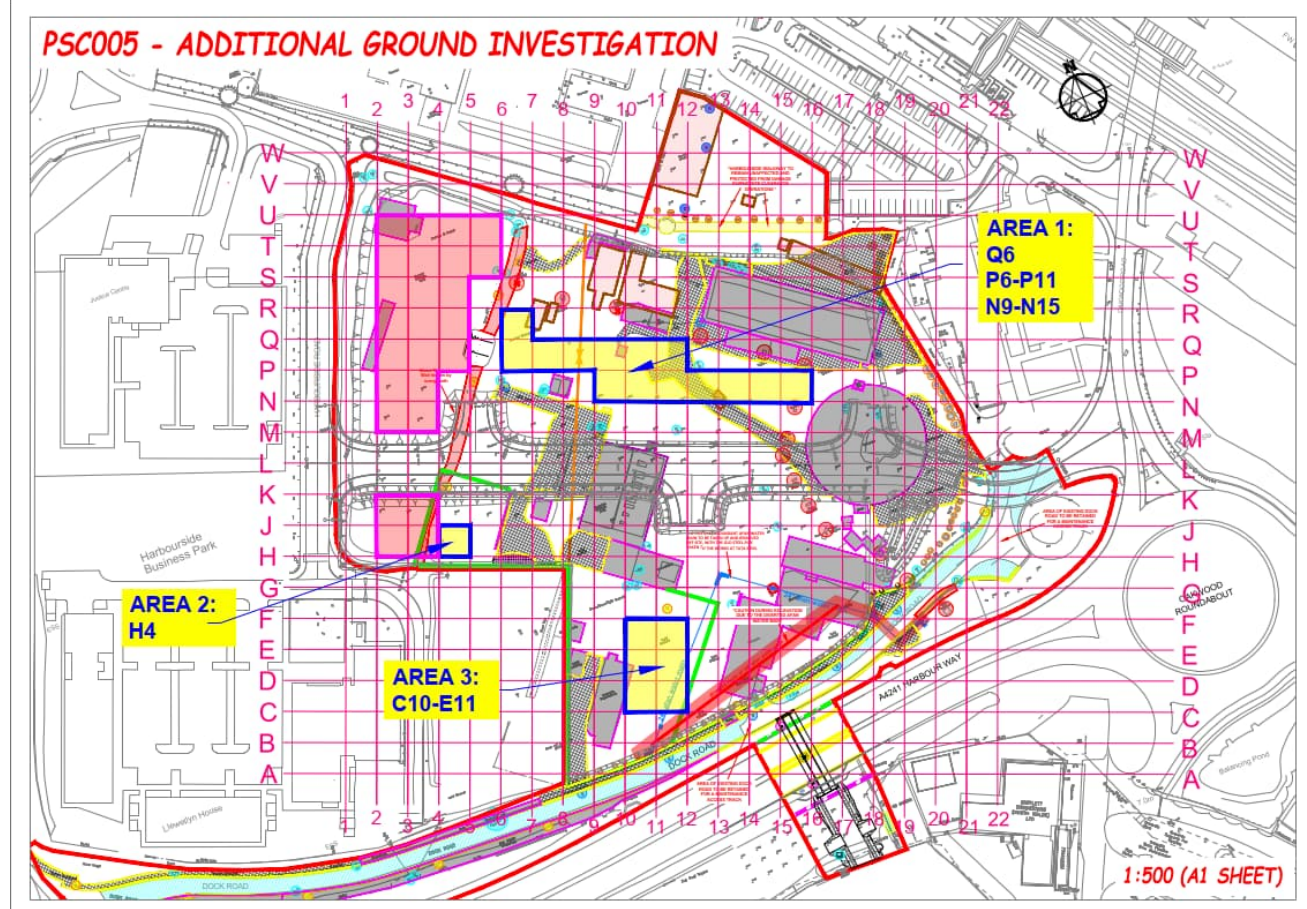
**Image 3-1 - Buried Obstruction Ground Investigation**

- Grey shaded areas – known areas of hardstanding / below ground obstructions requiring removal;
- Pink shaded areas – Upper plateau area with suspected below ground obstructions; and
- Yellow shaded areas – Areas of proposed future development requiring clearance.

These works completed by ASL, with part time site attendance by WSP validated the areas of known LNAPL presence were spatially limited to the southwestern area as identified in the Remediation Strategy (WSP, 2020).

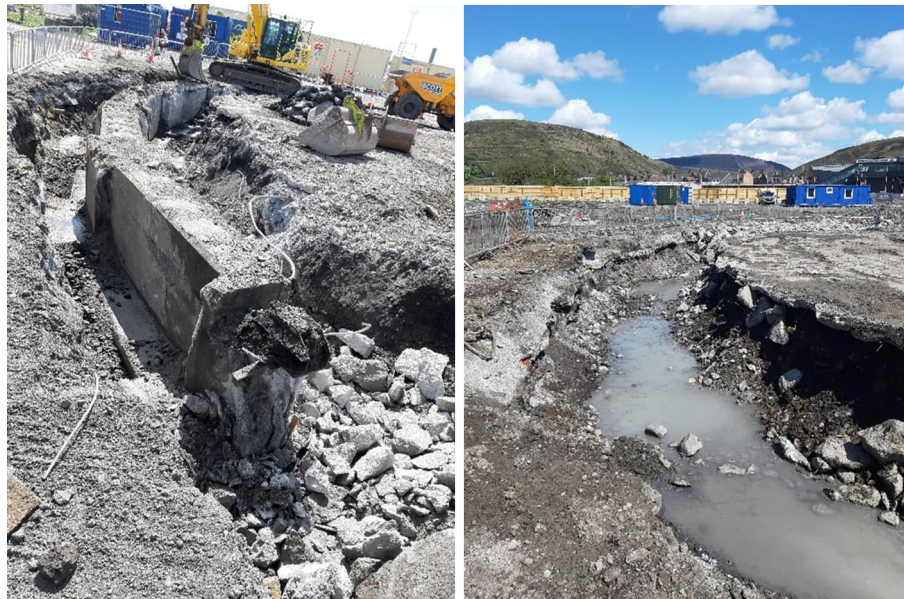
The ground conditions and construction of the gasholder foundation encountered were as expected, based on the typical construction of a Klönne gasholder. A reinforced concrete ring-beam encircled the gasholder foundation, with these foundations reaching a depth of approximately 1.5 m bgl around

**Left - Reinforced concrete ring-beam encircling gasholder.**  
**Right – Excavation following removal of ring beam.**

WSP observed no signs of visual or olfactory evidence of contamination in the exposed soils, and none had been noted by the on-site ASL supervisor during the works. The WSP engineer collected four soil samples (GH1 – GH4) from the excavation extents (soil surrounding the ring-beam) with the locations presented in Figure 5 (Appendix A). Samples were taken from approximately 1.5 m bgl.

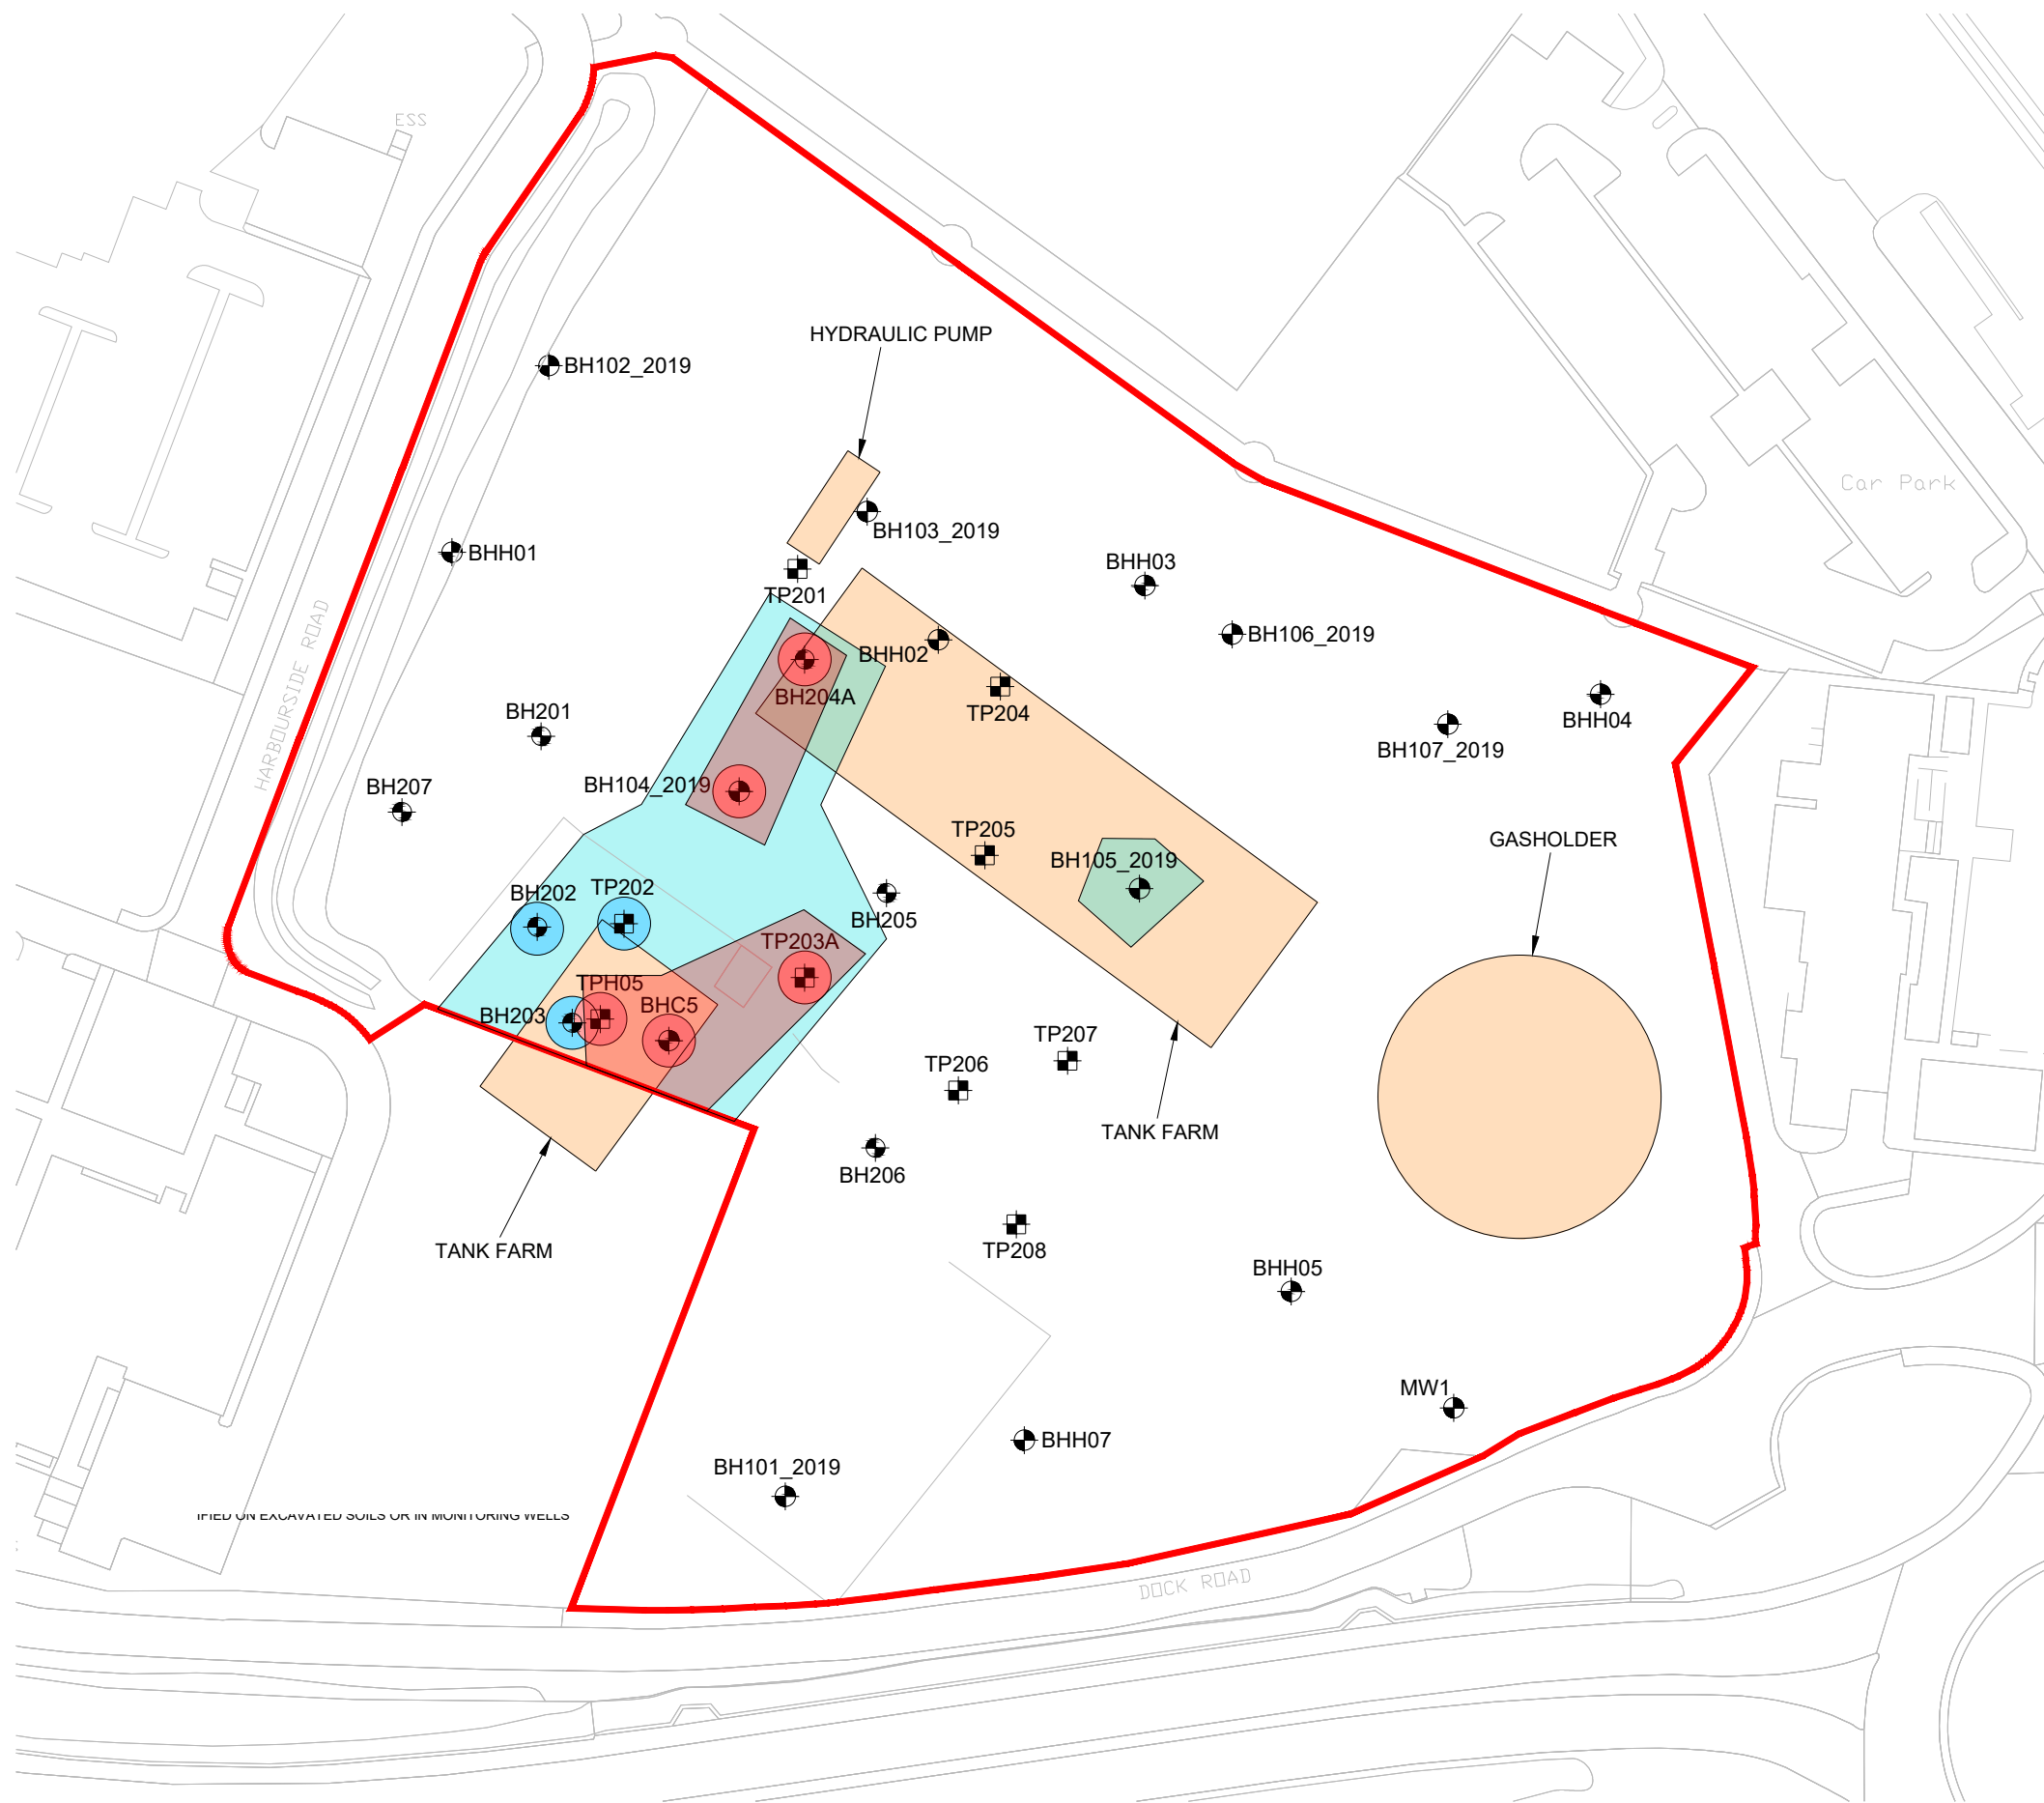
Elevated petroleum hydrocarbons and observed NAPL were identified within BH104, BH204A, BHC5, TP203 and TPH05 as presented on Figure 4 (Appendix A).

- SITE BOUNDARY
- BOREHOLE
- TRIAL PIT
- POTENTIAL HISTORICAL SOURCE AREAS
- FREE PHASE LNAPL
- HYDROCARBON IMPACTED SOILS
- ELEVATED CONCENTRATIONS OF HYDROCARBONS OBSERVED IN SOILS AND/OR GROUNDWATER
- FREE PHASE PRODUCT IDENTIFIED ON EXCAVATED SOILS OR IN MONITORING WELLS
