**Proposed Redevelopment at**

**121 Heol Cae Gurnen**

**Bat Survey**

**October 2022**

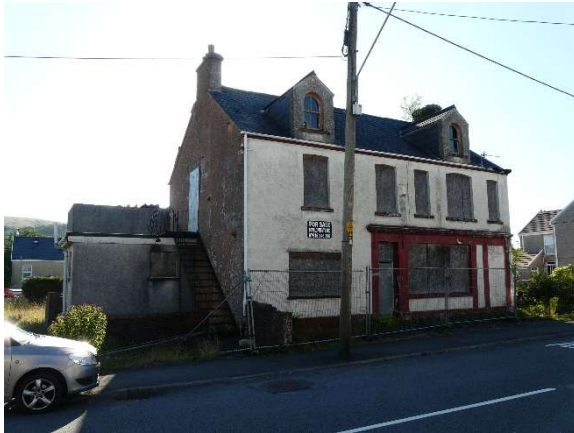
*Image 1: Front (east) and south facing elevations of building*

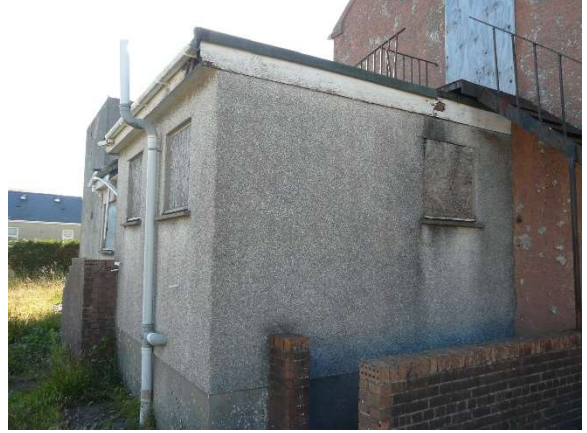
- 4.21 The southern elevation comprised a series of roof elevations and extensions. The majority of the main roof was open, and large gaps were noted around soffits on the single-storey extensions.

*Image 4: Single storey extensions to south - gaps around soffits*

- 7.1 As a precaution, building features with potential suitability for bat roosting (such as roof slates, wall tops, fascias, flashing, and spaces around the wall frame) shall be dismantled carefully and checked for bats before discarding.
- 7.2 Construction personnel shall be informed of what to do in the unlikely event that a bat is encountered:
- If a bat is found, works in the vicinity shall halt and a bat licensed ecologist shall be called for advice on bat welfare and licensing considerations.
  - The bat must not be handled or moved unless there is an immediate threat to its life (in which case it may be moved to a place of safety - the handler must wear gloves for protection against bites).

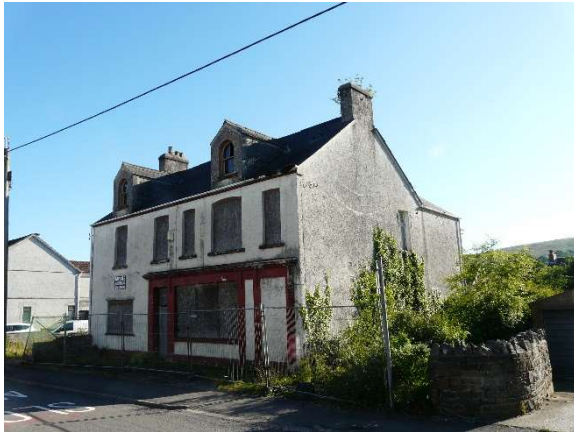
- 4.20 The front (east) elevation was generally well sealed, with rendered wall and boarded doors and windows. Gaps were noted at the corners of the fascia, and beneath flashing where dormer windows joined the main roof.

*Image 2: Front (east) and north elevations of building*

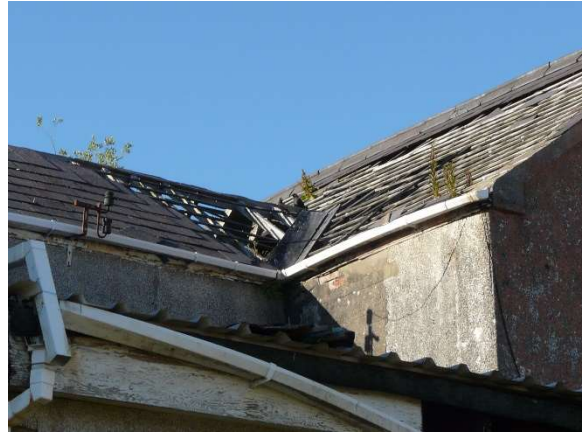
*Image 5: Roof - viewed from south - large gaps*

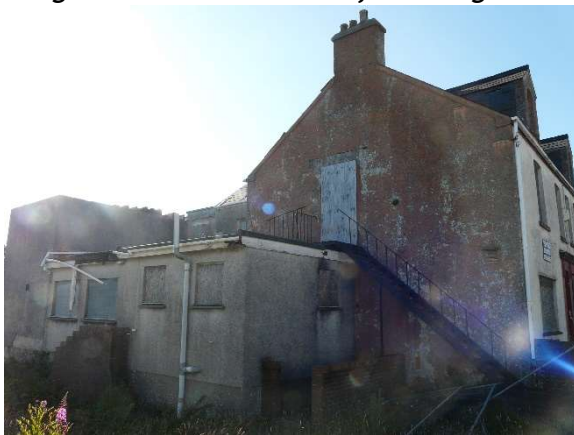
*Image 3: South elevation of building*

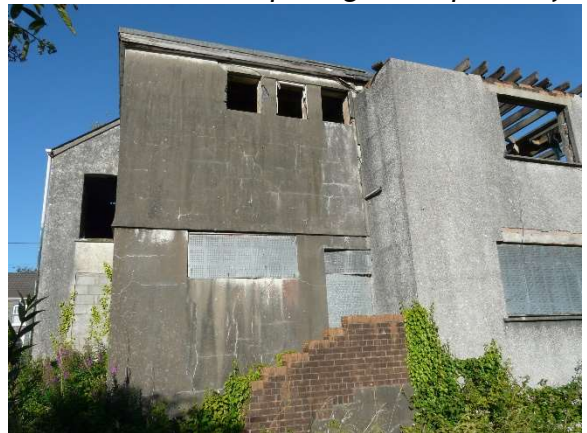
- 4.22 The rear (west) extension comprised two storey extensions with missing roofs and doorway/ window openings. Occasional gaps were noted in rotting timber fascias and in soffits.

*Image 6: Rear (west) elevations - numerous window openings and open roof*

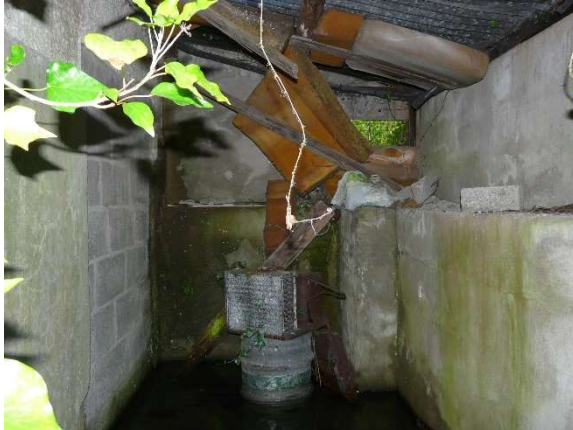
- 4.23 The north elevation was generally well sealed, with no potential bat access points and cement sealed wall tops. A small outbuilding / external cellar occurred on the northern elevation with a doorway opening and corrugated metal roof. The feature was overgrown with dense vegetation and was flooded internally. No potential bat roost features were noted in this area.

*Image 7: Flooded basement / cellar*

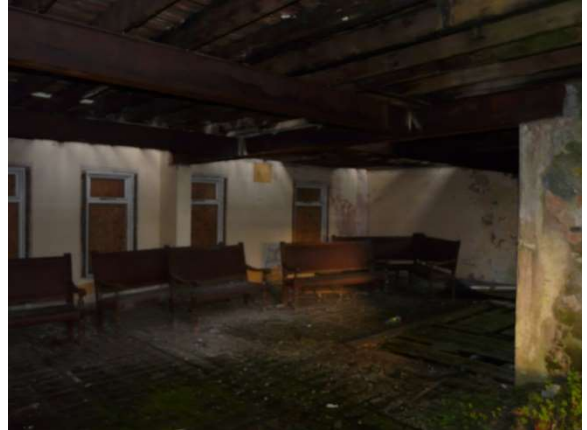
- 4.24 The main internal space of the building was derelict and damp. The lower floors were unused with rendered walls and timber ceilings. Upper floors were in poor condition with roofs partially or completely open. Occasional small gaps were noted in the roof frame and between roof timbers and walls.
- 4.25 A small, flooded basement occurred on the southern elevation. No potential crevice roost features were noted in this area.
- 4.26 No evidence of bats was noted in any part of the building

*Image 10: First floor room to rear of building*

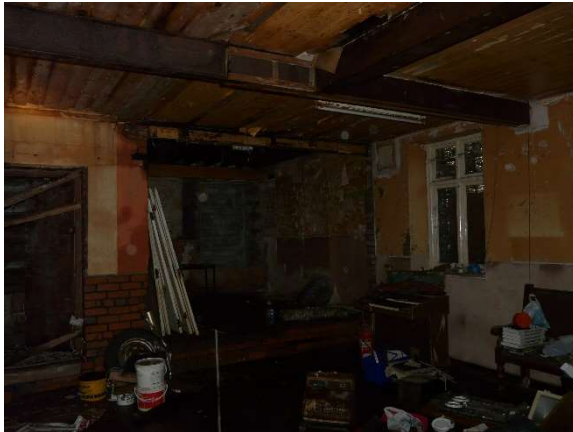
*Image 8: Ground floor of building - northern area*

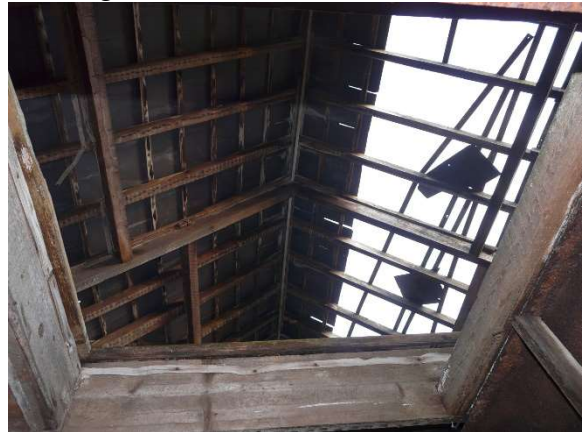
- 4.19 The roof of the main building was of slate, but only the front (eastern) elevation had a complete roof, with slates missing from the majority of the rear sections.

*Image 11: View of roof - main section of building*

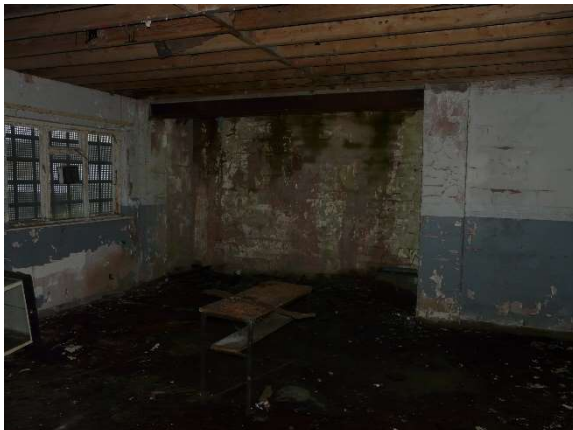
*Image 9: Ground floor - southern and rear areas*

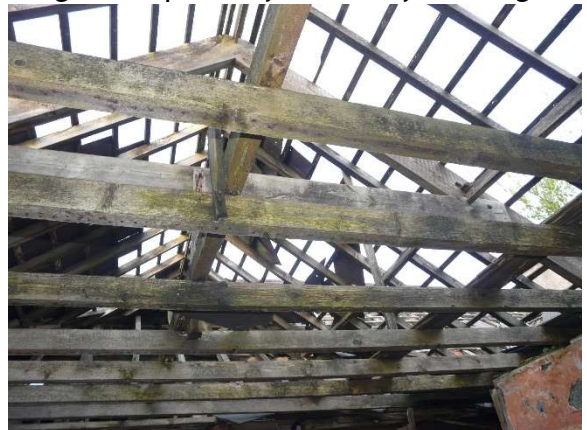
*Image 12: Open roof to rear of building*

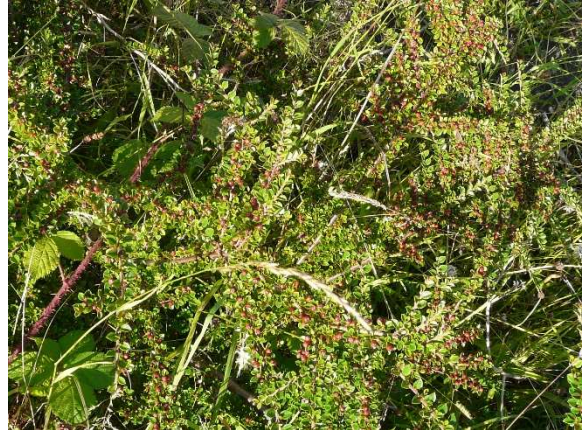
- 4.50 Several small specimens of Wall Cotoneaster (an invasive cotoneaster species, listed on Schedule 9 of the Wildlife and Countryside Act) were noted throughout the plot.
- 4.51 No other invasive species were recorded at the site.

*Image 16: Example of cotoneaster frequently occurring within the site*

- 7.14 Prior to commencing excavation works, the cotoneaster growing within the plot shall be removed and chipped or burnt on site. Alternatively, the plant may be transported to a licensed landfill as controlled waste.
- 7.15 The plant is spread by seeds contained within the berries. Therefore, all topsoil within the plot could potentially contain seeds of the plant. Topsoil should be retained on site or transported off site as controlled waste.

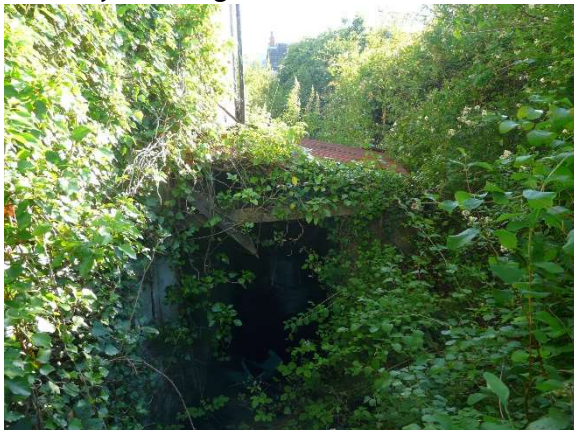
*Image 14: Flooded shed / basement to north of building*

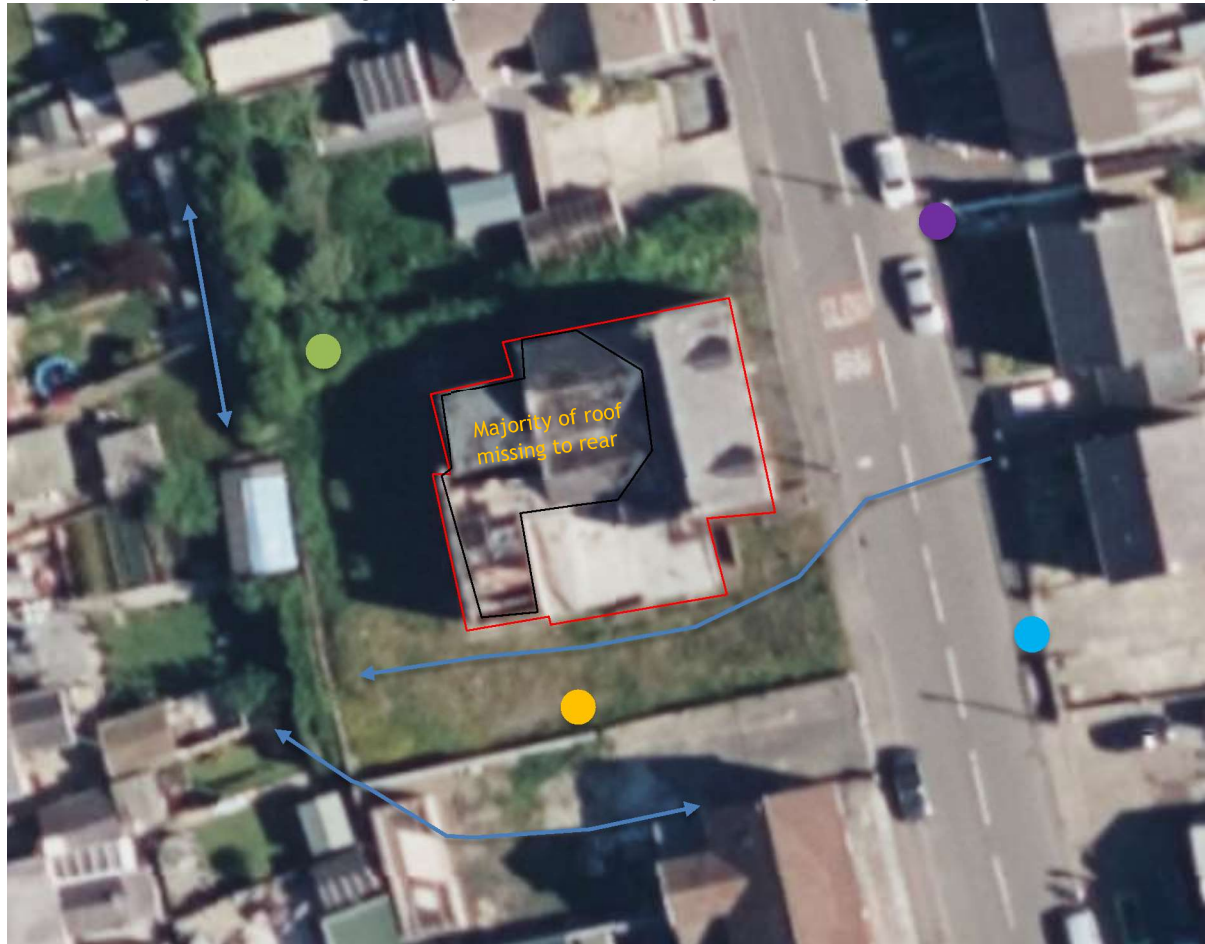
**Dusk Survey 1 - Plan Showing Surveyor Locations and Key Bat Activity**

Bat activity generally low - occasional passes and brief bouts of foraging from individual common pipistrelle and soprano pipistrelle bats.

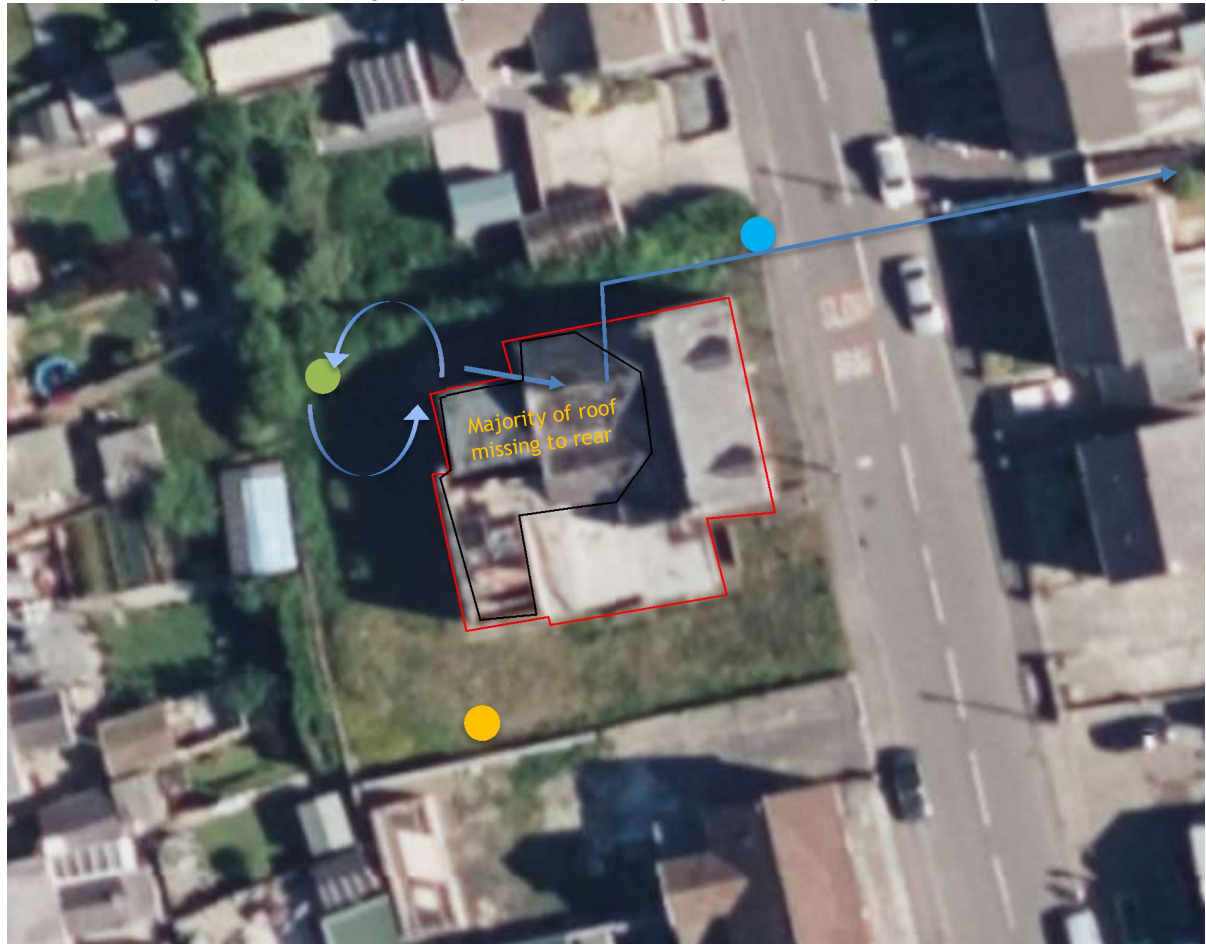
**Dawn Survey 2 - Plan Showing Surveyor Locations and Key Bat Activity**

Bat activity relatively low. 1 x common pipistrelle bat entered the building during foraging, before exiting and flying towards the east

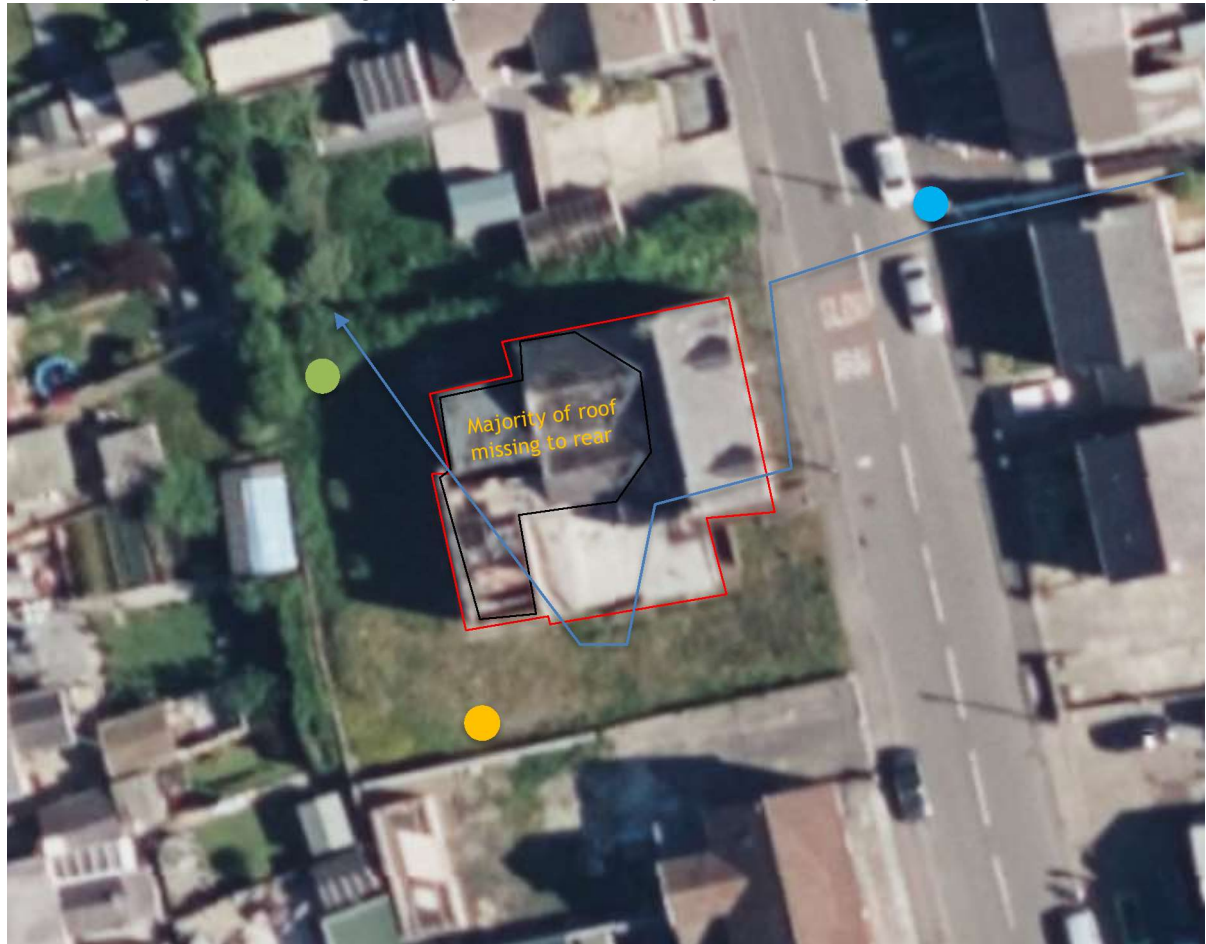
**Dusk Survey 3 - Plan Showing Surveyor Locations and Key Bat Activity**

1 x common pipistrelle bat flew from the east and over the site early in the survey period.  
Bat activity generally low
