| 22131/R1 | September 2022 |
| Project | <b>NPT HOSPITAL – WAC TESTING</b> |

Spectrum Geo Services (SGS) were requested by TRJ to undertake soil testing at a site at NPT Hospital, Aberafon.

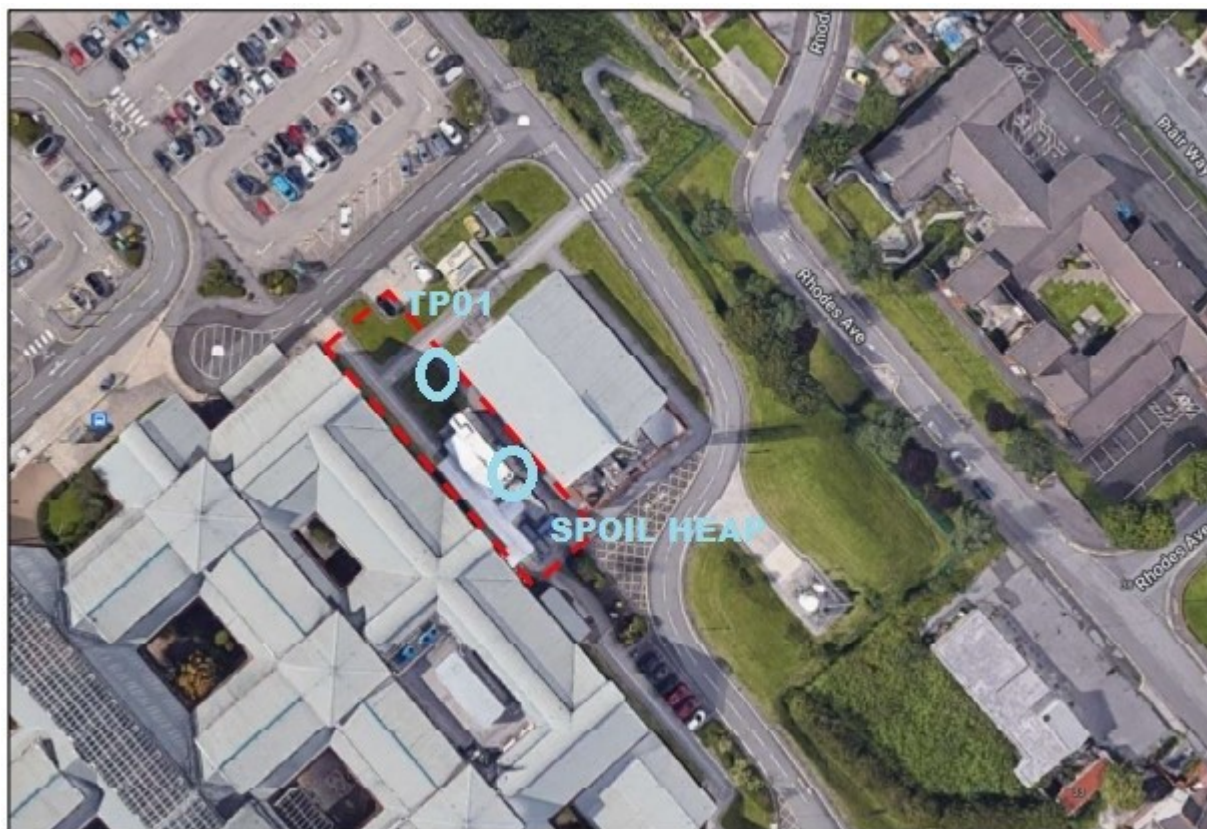
SGS/22131/02

Site works were undertaken on 25 August 2022 and comprised 1 Trial Pits and sampling of a spoil heap. Conditions during the fieldwork were dry and sunny. The positions are shown on Drawing SGS/22131/02.

Exploratory Hole Locations
