**Tyn-y-Caeau, Margam Road, Margam,  
Port Talbot, Neath Port Talbot, SA13 2NW**

**Bat Survey Report for Recycling Plant & Machinery Ltd**

| <b>Report type</b> | Bat Survey Report |

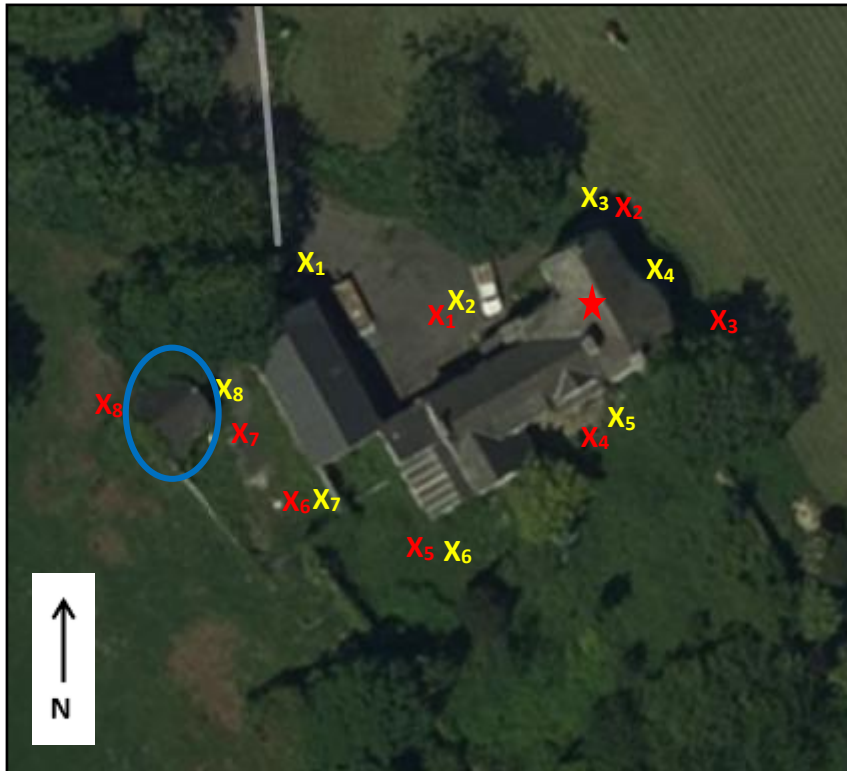
**Figure 4:** Surveyor positions during the activity surveys.  
(from Apple® Maps)

3.1.7 Figure 4 shows the position of surveyors during the surveys. Those in yellow are the positions on the first dusk and the dawn activity surveys while those in red are the second dusk survey when the focus was on the original house and the outbuilding (as the proposed mitigation in blue circle). Each surveyor had a Magenta 5 or an Elekon Batscanner bat detector to assist in identification and detection of bats and their behaviour. The location of the Anabat is indicated by a red star.

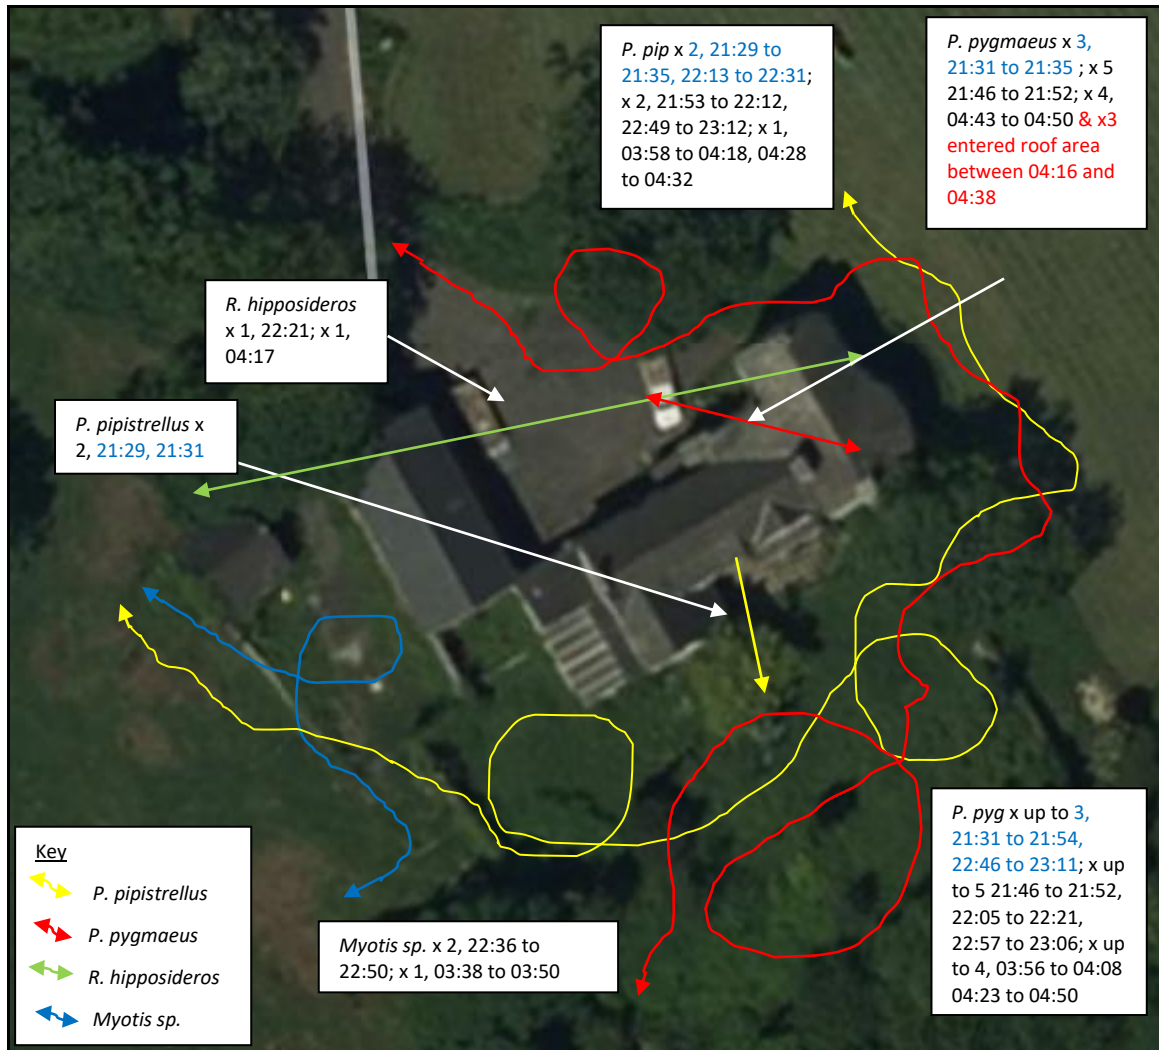
**Figure 5:** Aerial map (from Apple® Maps) showing the flight lines of bats detected on the surveys

3.2.3 Figure 5 shows the flight lines of bats detected and includes the species seen/detected and the times they were detected. Flight activity follows:

- ***P. pygmaeus*:** Three bats were seen to emerge from loose lead flashing around the chimney pot to the left of the front elevation (east facing) on the first dusk survey, five bats were seen to leave on the second dusk survey and four bats were seen to enter on the dawn survey. On all surveys, bats were detected foraging and commuting to the north-east, south-east and south-west of the buildings. The earliest activity on the first survey was an emergence at 10 minutes after sunset, the earliest activity on the second dusk survey was an emergence 13 minutes after sunset, and the latest activity on the dawn survey was a re-entry nine minutes before sunrise (with some swarming activity detected). In addition, bats were detected foraging, commuting and socialising to the north-west, north-east and south-east.

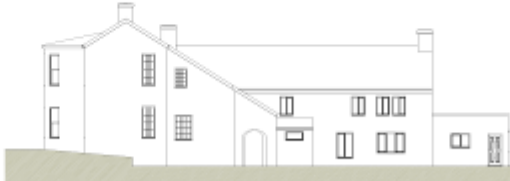
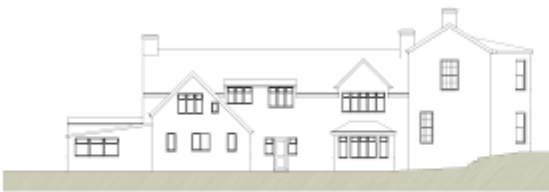
| <p><b>1 North East</b><br/>1:150</p> | | <p><b>2 North West</b><br/>1:150</p> | |
| <p><b>3 South East</b><br/>1:100</p> | | <p><b>4 South West</b><br/>1:100</p> | |

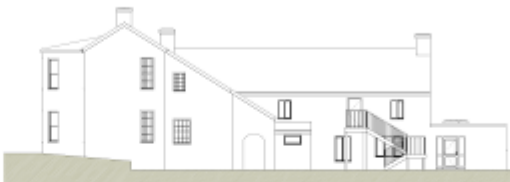
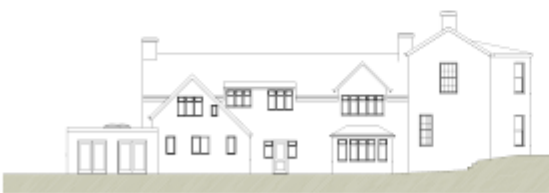
Existing (above) and proposed (below) elevations for the house.

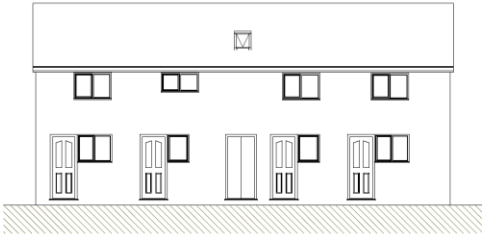
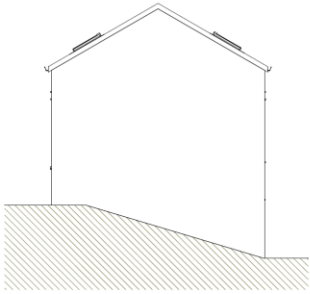
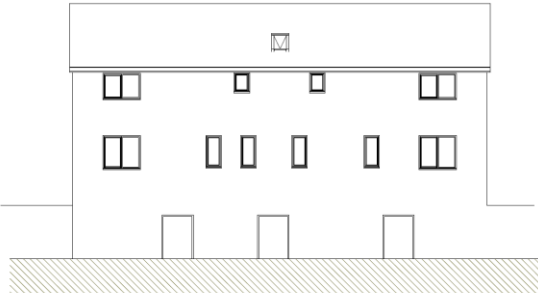
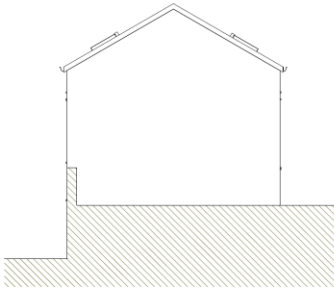
Existing (above) and proposed (below) plans for the annexe

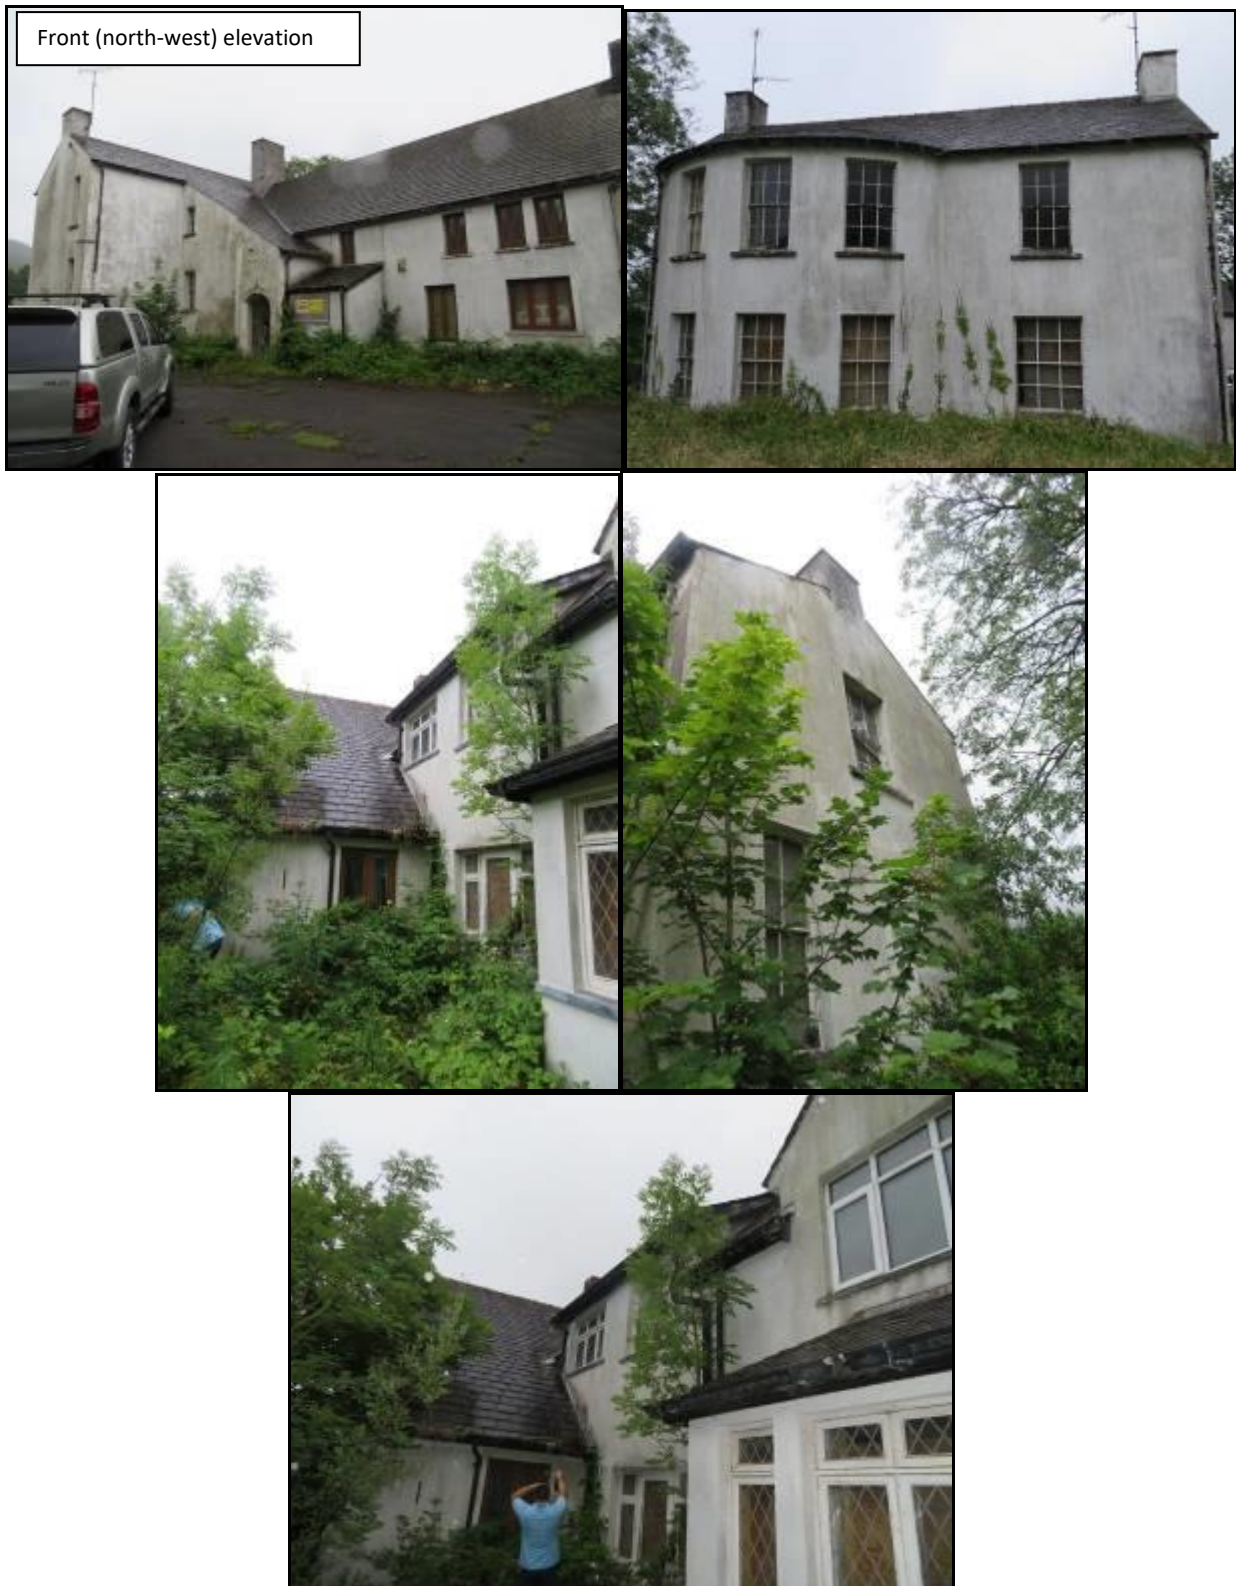
Images showing the construction and condition of the original period dwelling. It is a large north-west facing predominantly two storey detached building which is subject to proposed plans for conversion to a mixed (residential and commercial) development. It is constructed of rendered and painted walls and has natural slate roofs with lead flashing around the chimneys, a mix of uPVC and timber framed windows and doors, and where present the soffits/fascias/weatherboards are painted timber.

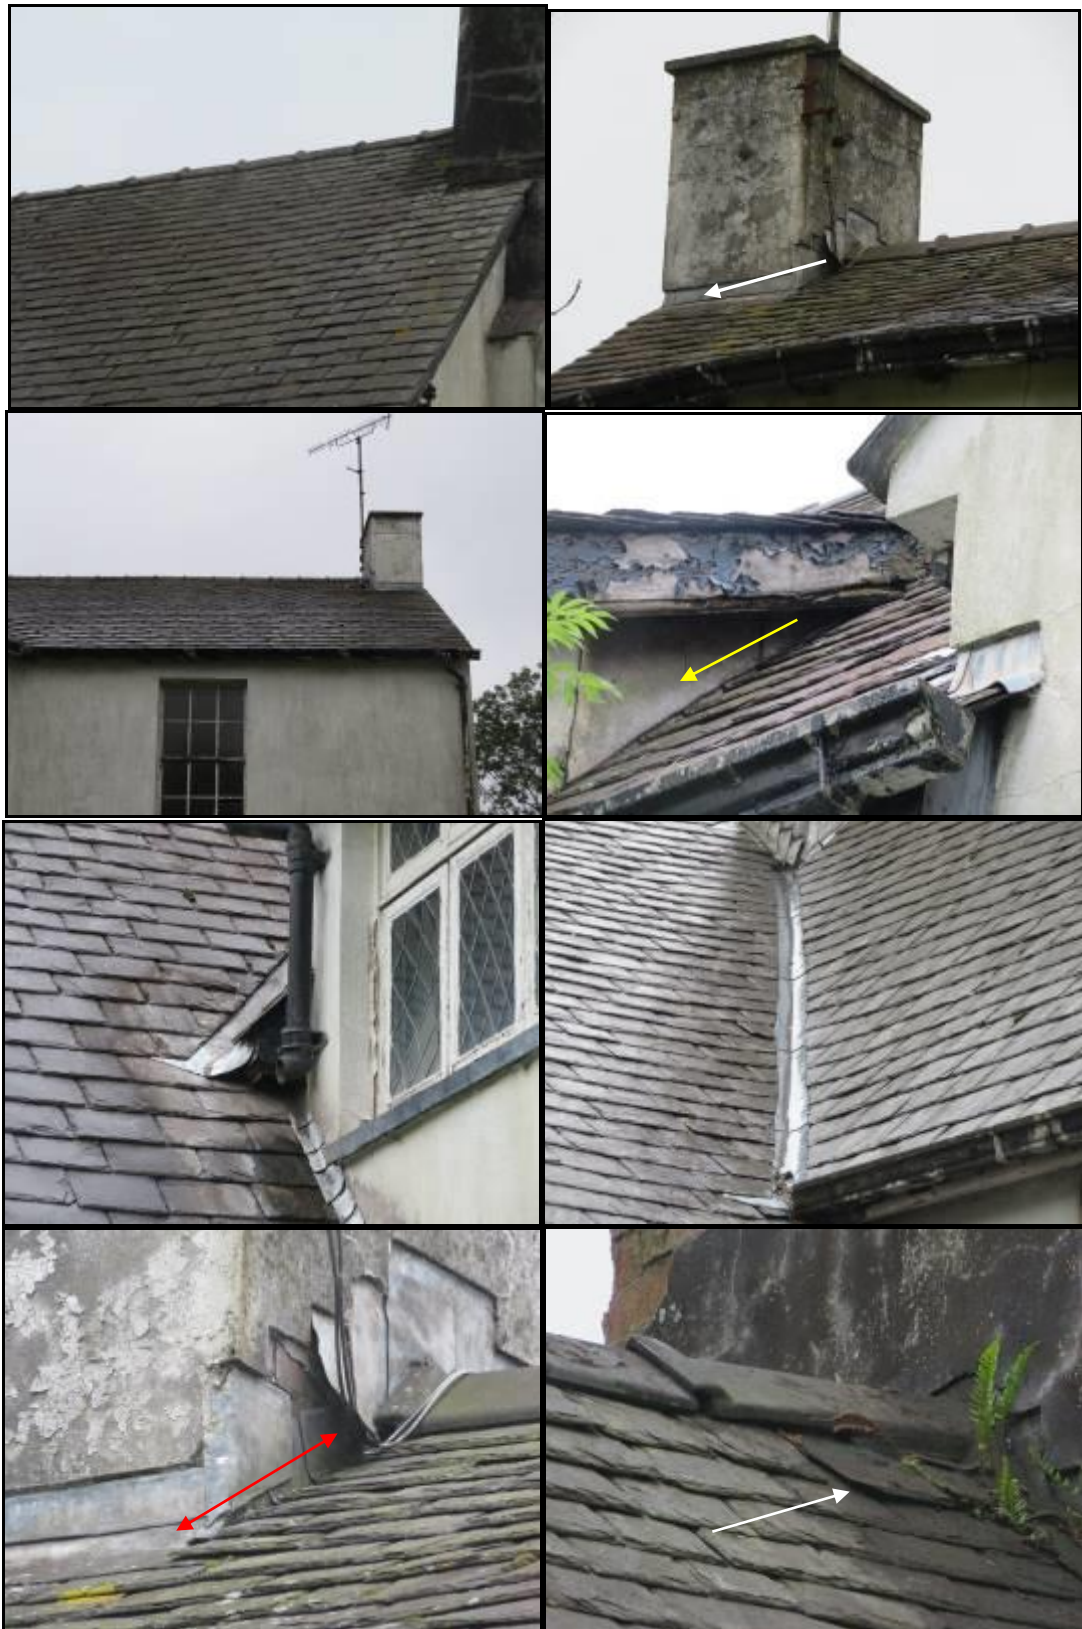
Images of the natural slate roofs on the original dwelling along with some of the windows. The white arrow in image three shows the slipped glass pane where the *R. hipposideros* bat is presently entering and exiting the building. The slates themselves are predominantly in good condition with no missing or damaged slates, but there were one or two areas where they may have slipped, thus creating potentially exploitable gaps e.g., image eight. As can be seen in images two and seven, there is also some loose lead flashing around the chimney pot to the left of the front elevation, and this is where **three *P. pygmaeus*** bats were seen to leave on the first dusk survey, **five *P. pygmaeus*** bats were seen to leave on the second dusk survey and **four *P. pygmaeus*** bats were seen to enter on the dawn survey. Image four shows the area where the roof steps down to the rear of the dwelling where **two *P. pipistrellus*** bats were seen to leave on the first dusk survey.

3.2.5 **Flight activity summary for the Original Dwelling**: During the second dusk survey, **one Lesser horseshoe was detected entering the building via a slipped glass pane to the front, and during the dawn survey, one bat of the same species was seen to leave the same area**. In addition, **three *P. pygmaeus*** bats were seen to leave loose lead flashing around the chimney pot to the left of the front elevation on the first dusk survey, **five *P. pygmaeus*** bats were seen to leave on the second dusk survey **and four *P. pygmaeus*** bats were seen to enter on the dawn survey. There is also an area where the roof steps down to the rear of the dwelling where **two *P. pipistrellus*** bats were seen to leave on the first dusk survey. **3x *P. pygmaeus* were seen to enter around the chimney on the second dawn (2022)**. These and a further one species (***Myotis* species**) were seen/detected by the surveyors utilising the immediate surroundings for foraging and commuting.

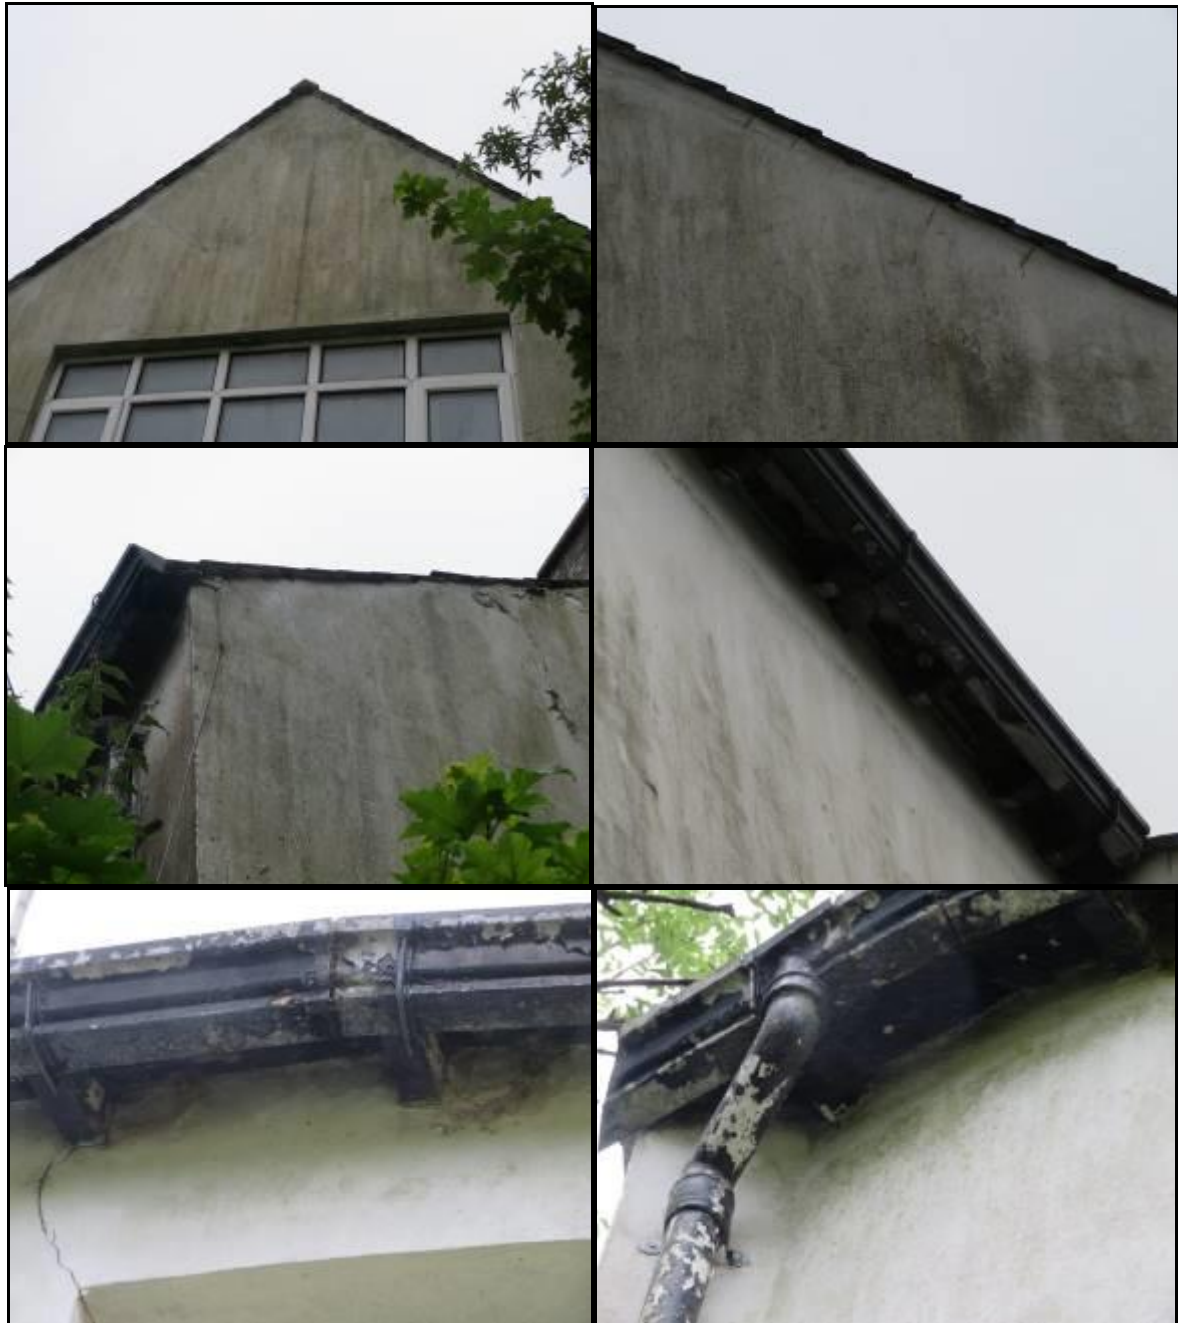
The walls of the original house are intact and generally in good condition with only some small (non-exploitable) cracks while the timber soffits/facias/weatherboards are predominantly tight to the walls with only a small number of potentially exploitable gaps (including where *P. pipistrellus* bats were seen to leave, as shown on the previous page). The windows and doors are generally intact (the main door having been boarded up after being damaged leading to the house being open) with only one pane of glass in the original timber framed windows at the front having slipped.

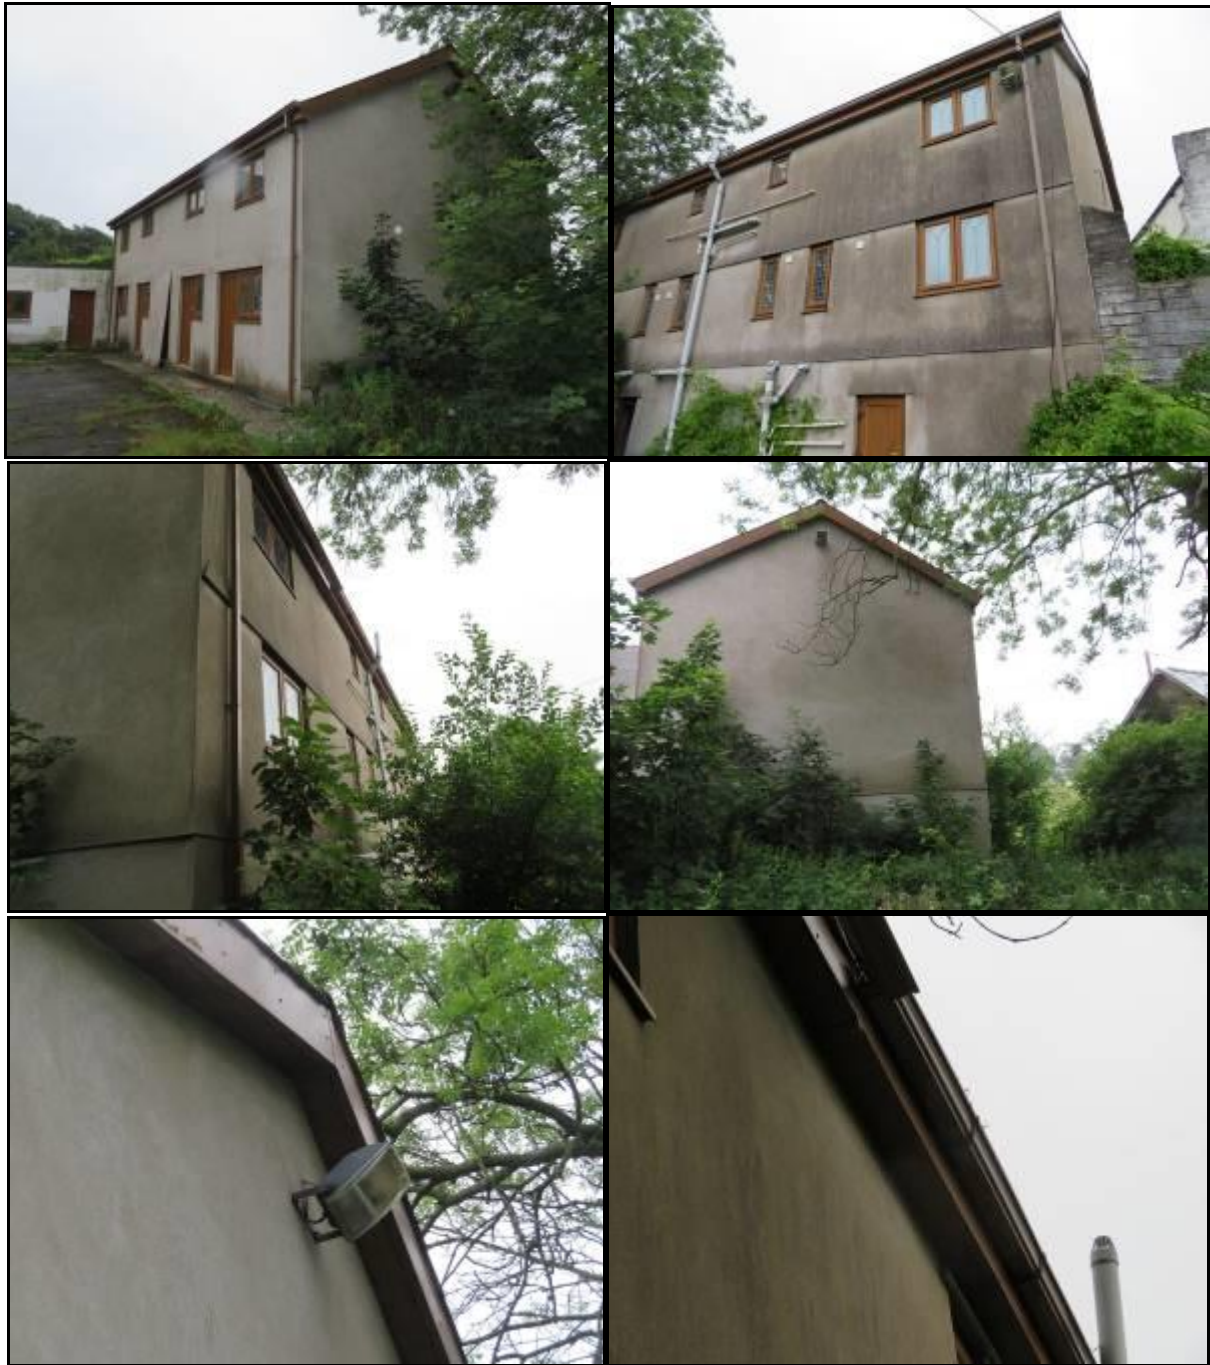
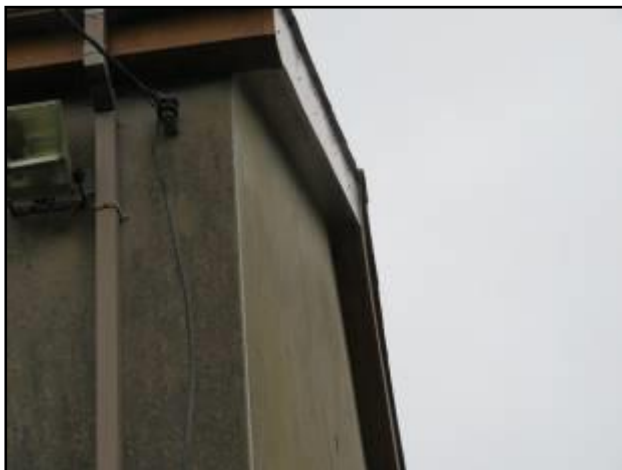
Images showing the north east facing two storey (with subterranean rooms to the rear so this aspect is three storey) annexe at the property. It is constructed of smooth rendered walls with a slate roof, brown uPVC framed windows and doors, and brown uPVC soffits/fascias/weatherboards and rainwater goods. The building is in very good condition with no observable exploitable gaps and no damage to either the walls or roof.

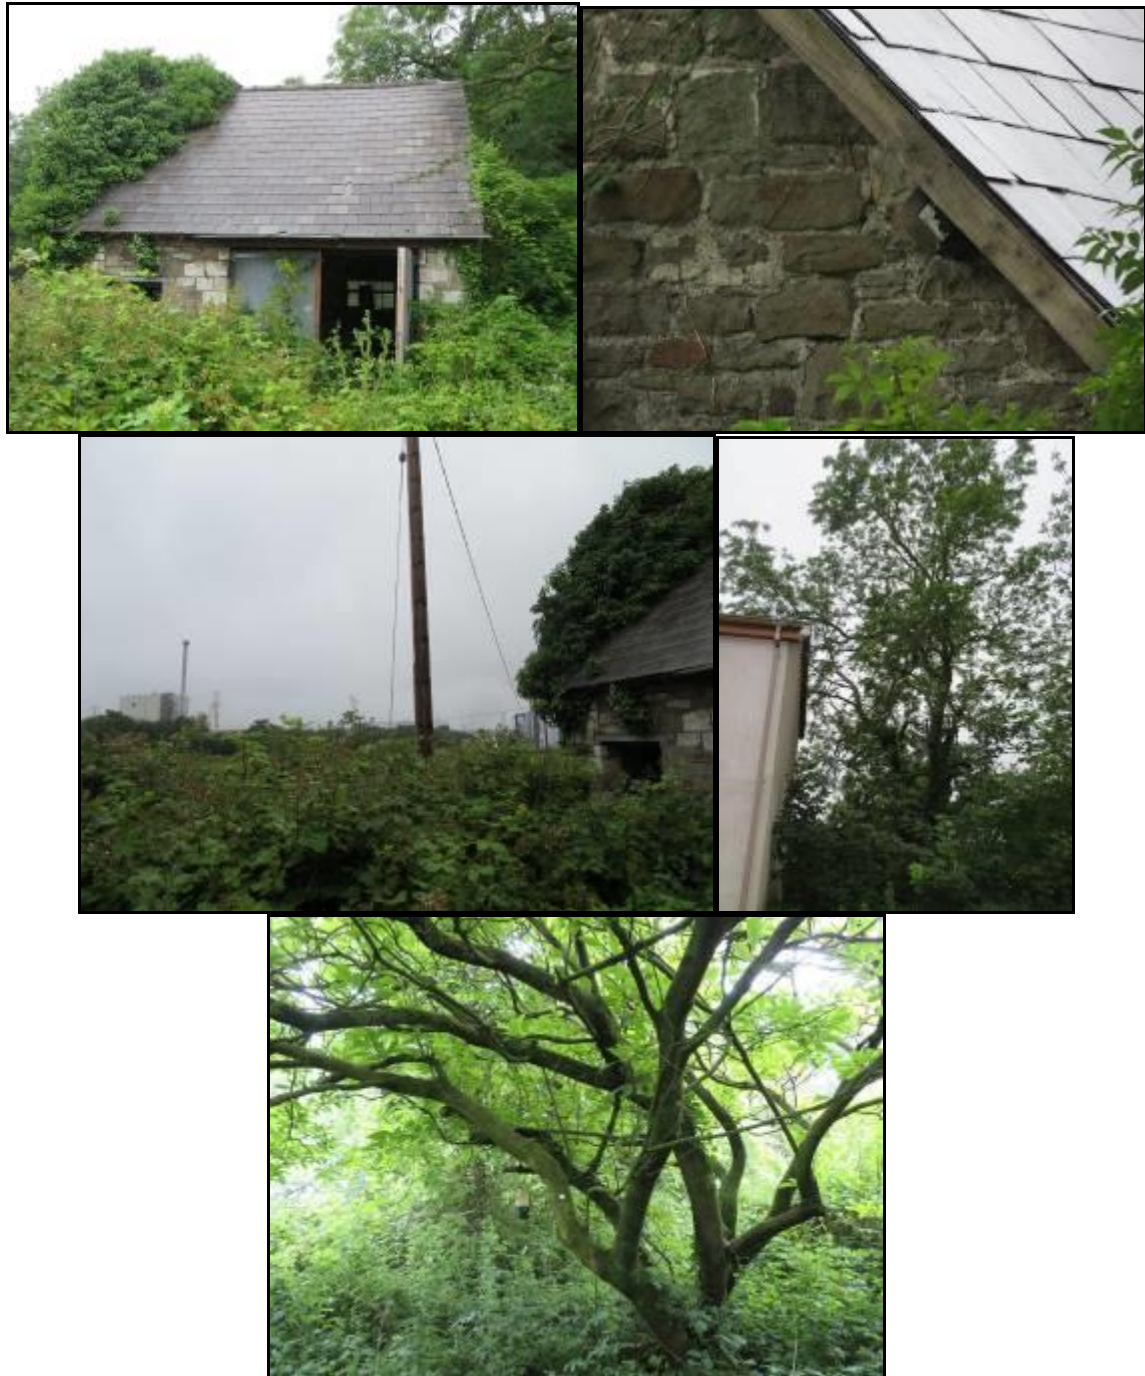
Images one to three show the outbuilding which is to be used as bat mitigation at the site. The proximity to the Margam Steelworks can be seen in image three. Image 4 shows one of the Ash trees on site which may require felling as disease is present. The final image is of a mature magnolia tree which could be retained for its decorative value.

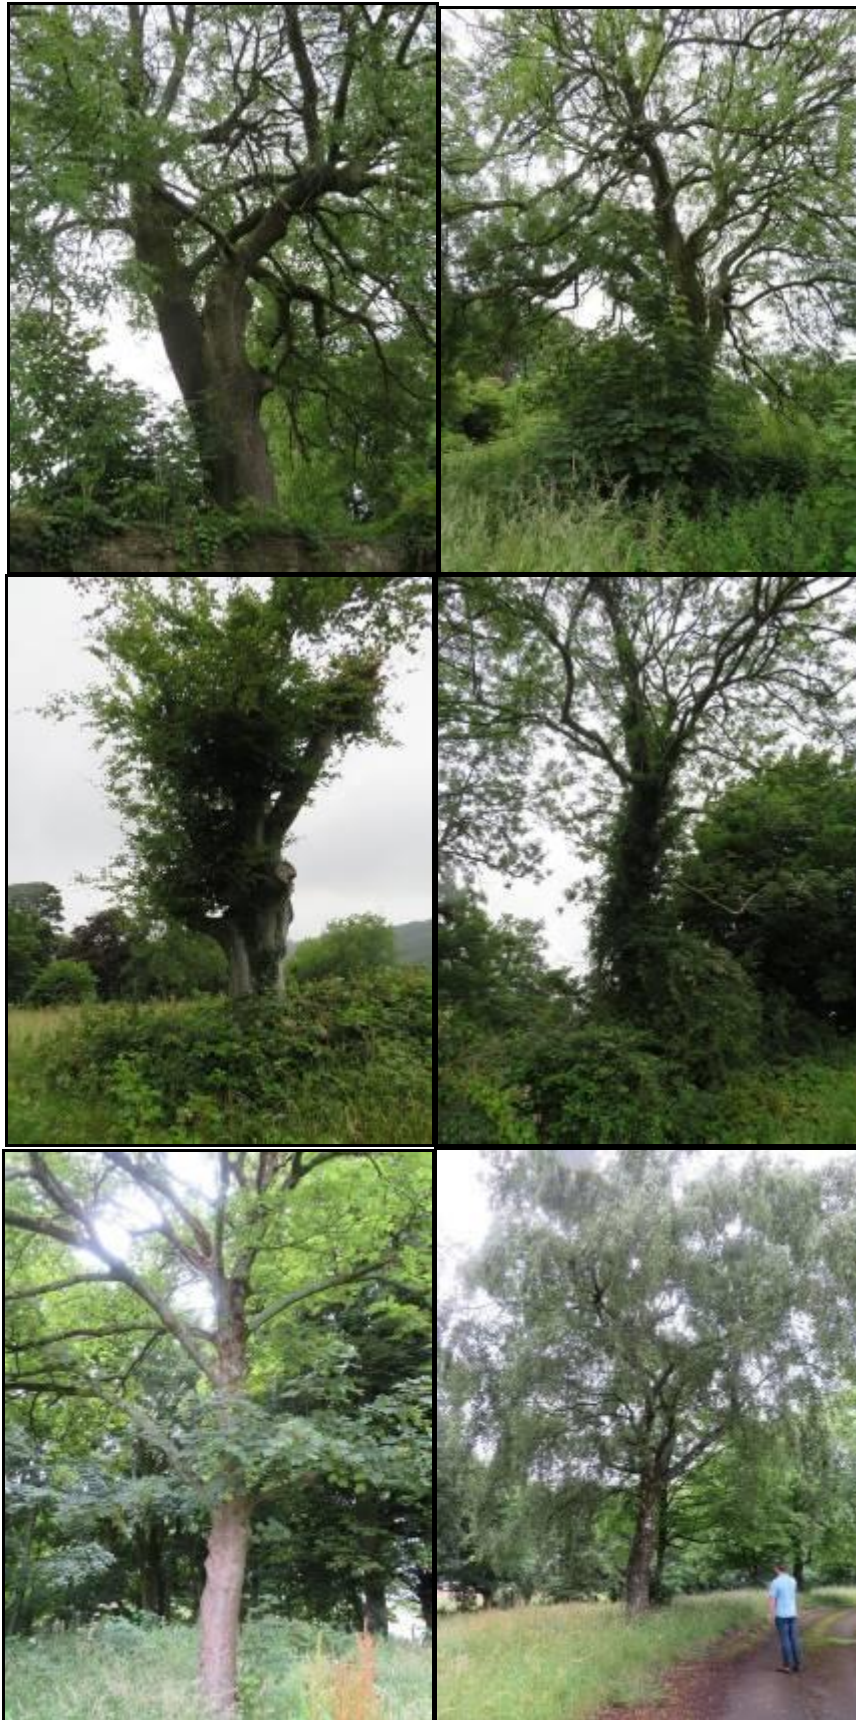
Additional images showing the mature trees within the grounds of the property which extends to around 4 acres. Some of the Ash trees show signs of Ash dieback (caused by the fungus *Hymenoscyphus fraxineus*) and may need felling before works can safely commence. Some specimen trees on site should remain where possible.

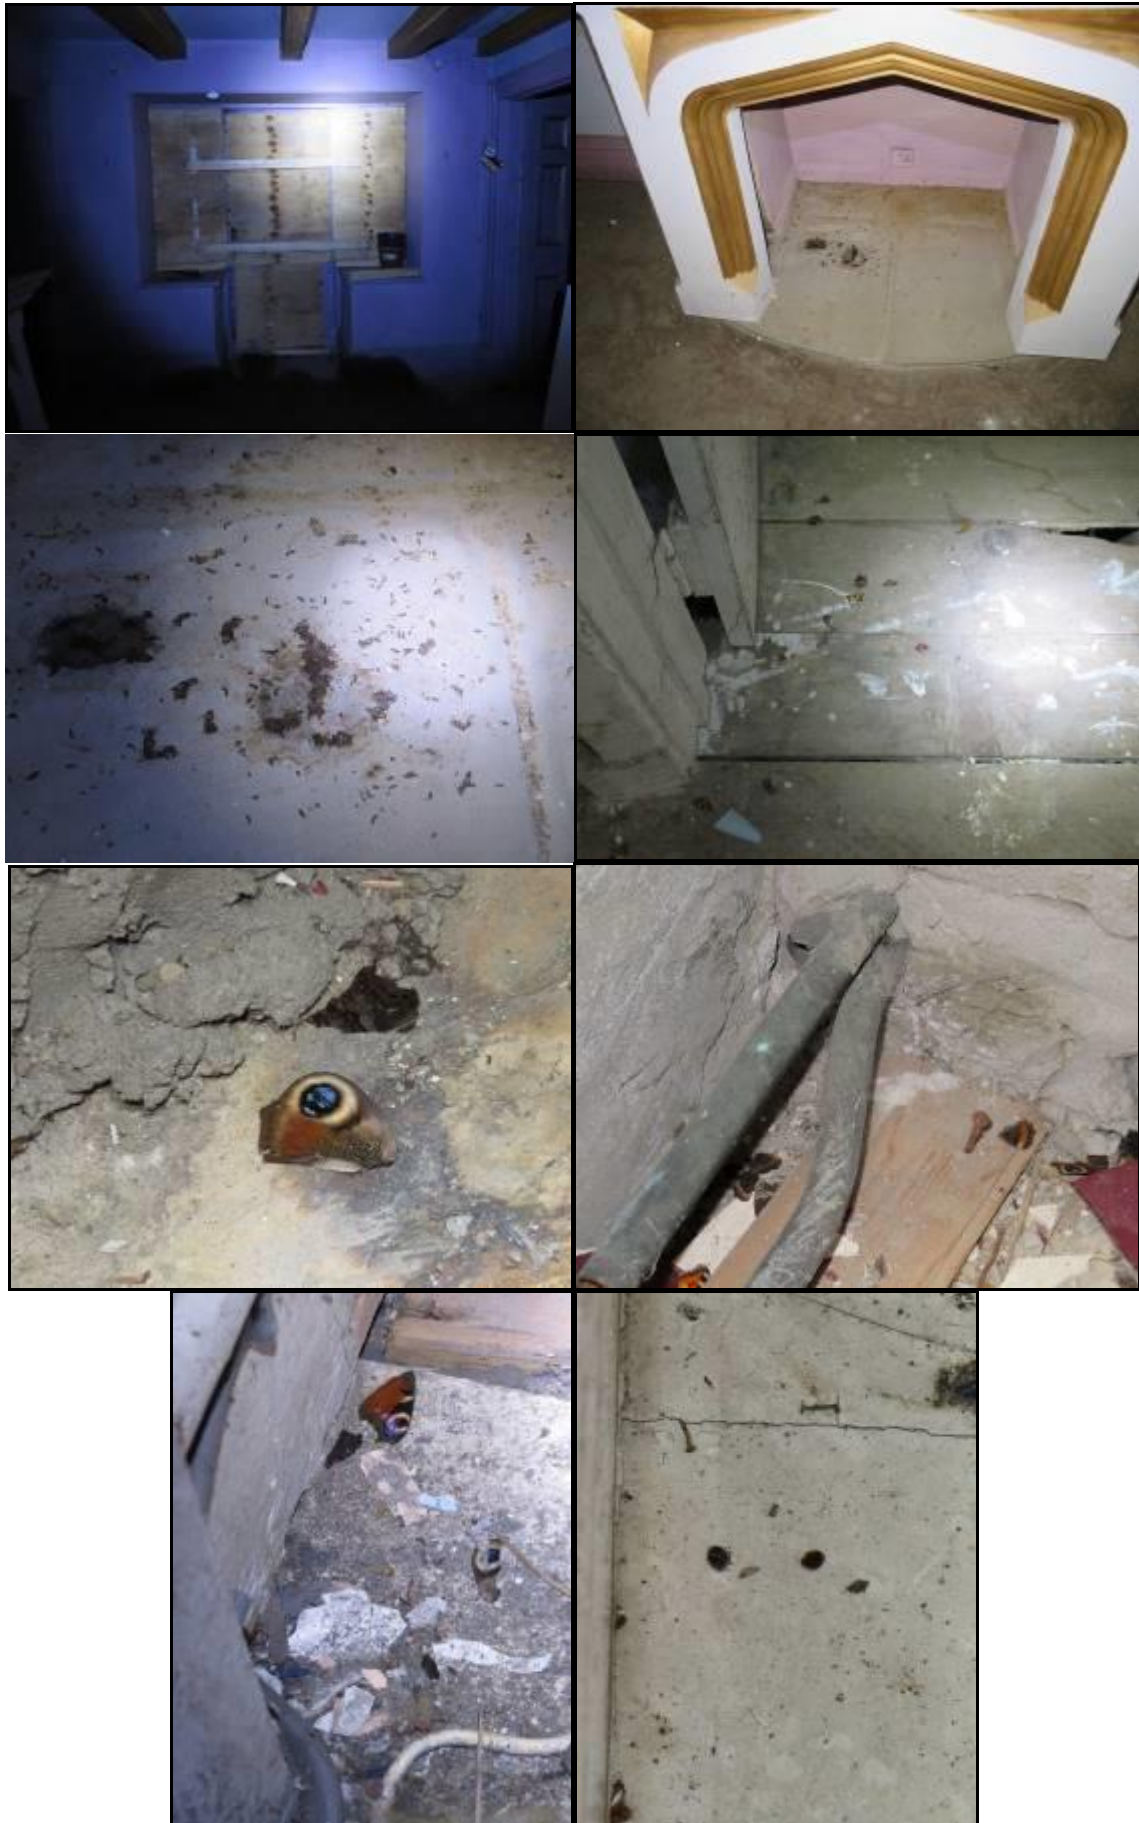
Images in and around the fireplace within the hall area and fireplace close to the front door where both droppings and feeding signs (peacock butterfly wings) were found. DNA analysis confirmed that the droppings were from *R. hipposideros*. Image one shows the boarded up front door which was where the bat was likely to have previously accessed the building before it was boarded up.

- ✦ During the scoping survey of the **Original (Period) Dwelling**, no bats were found, but droppings and feeding signs (peacock butterfly wings) were found within the hall fireplace area, which DNA analysis confirmed were from **Lesser horseshoe bats**. The Anabat recorded only **Lesser horseshoe** calls while during the second dusk survey, **one Lesser horseshoe was detected entering the building via a slipped glass pane to the front, and during the dawn survey, one bat of the same species was seen to leave the same area.** In addition, **three P. pygmaeus** bats were seen to leave loose lead flashing around the chimney pot to the left of the front elevation on the first dusk survey, **five P. pygmaeus** bats were seen to leave on the second dusk survey and **four P. pygmaeus** bats were seen to enter on the dawn survey. **3x P.pygmaeus were seen to enter the same area on the 2<sup>nd</sup> dawn survey, and a solitary lesser horseshoe bat was heard and not seen commuting and foraging over the site.** There is also an area where the roof steps down to the rear of the dwelling where **two P. pipistrellus bats** were seen to leave on the first dusk survey. These and a further one species (**Myotis species**) was seen/detected by the surveyors utilising the immediate surroundings for foraging and commuting.

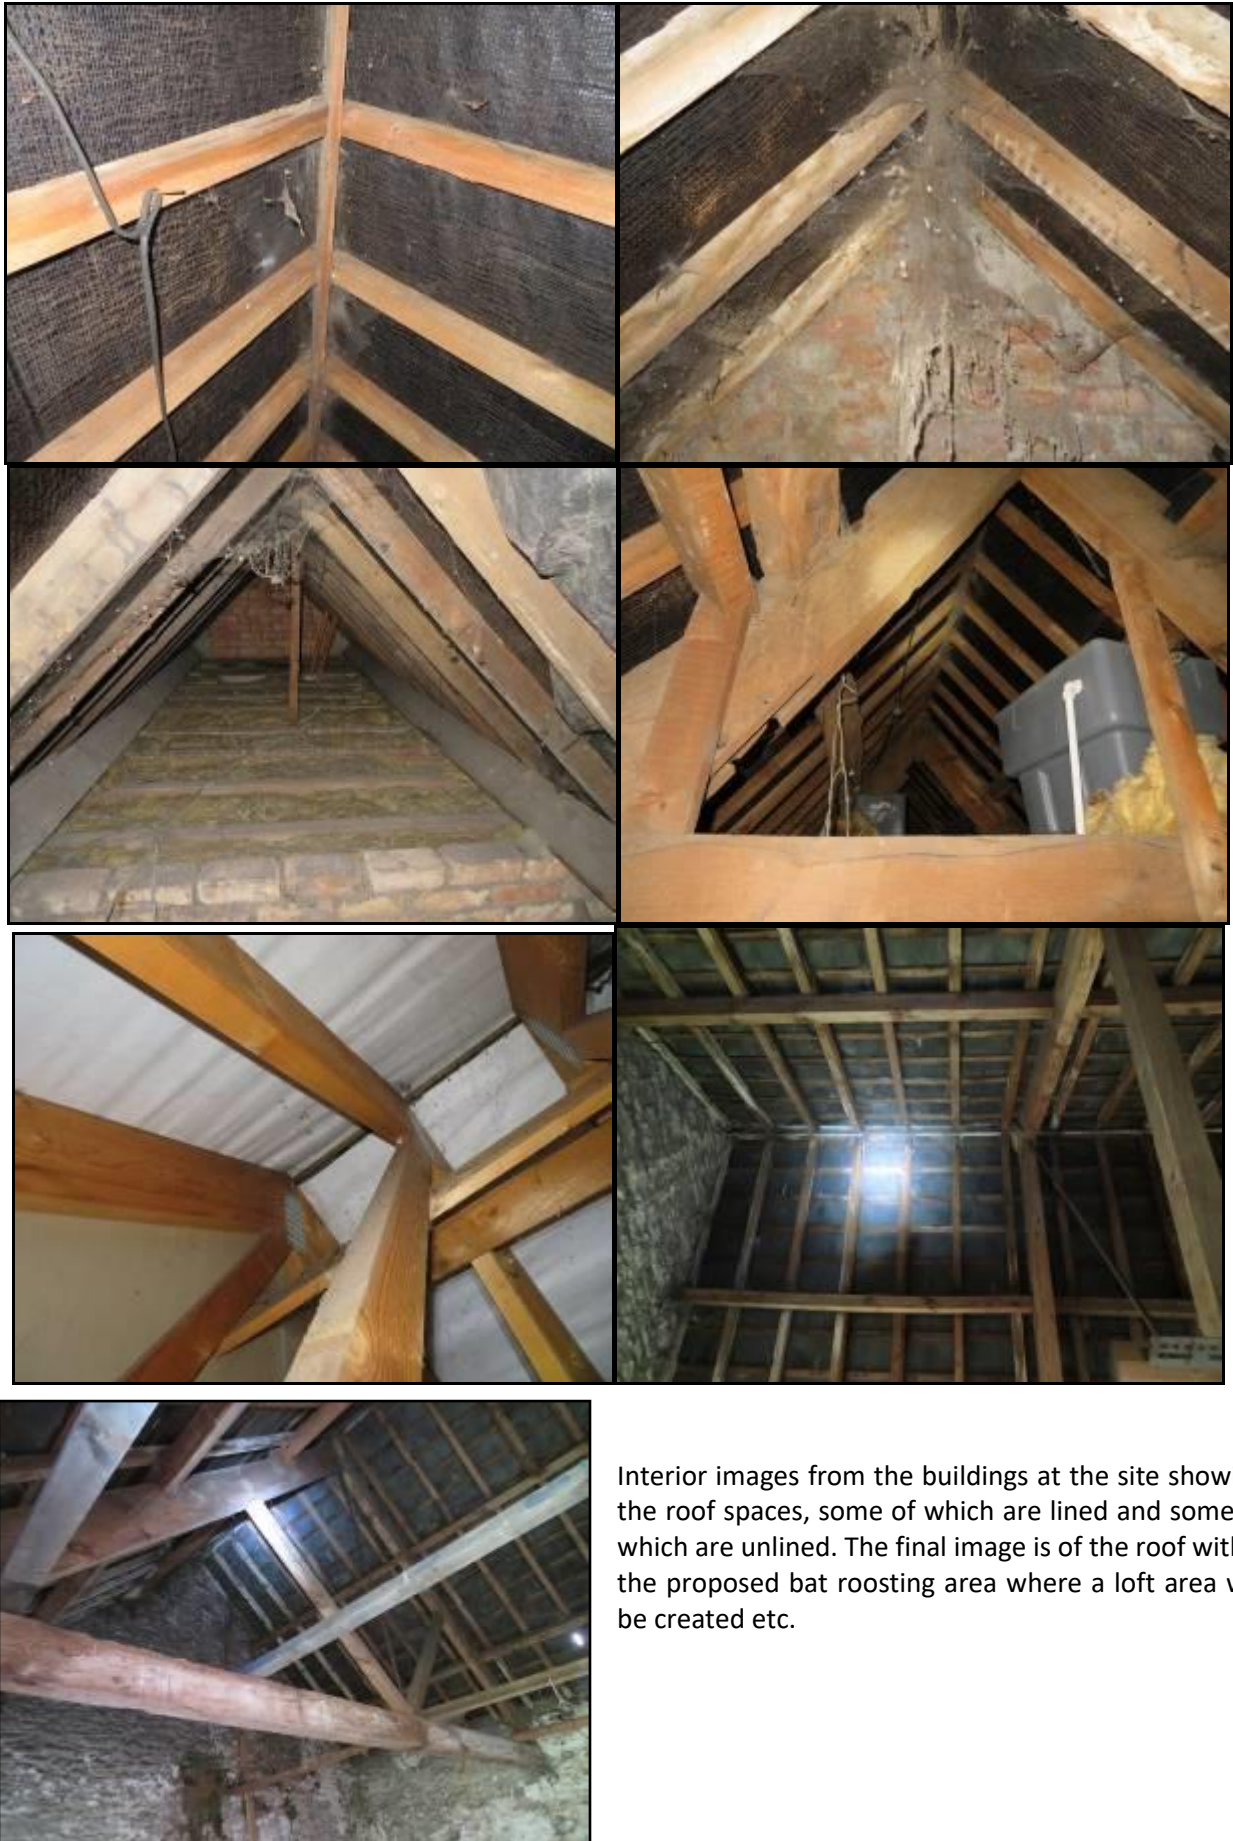
Interior images from the buildings at the site showing the roof spaces, some of which are lined and some of which are unlined. The final image is of the roof within the proposed bat roosting area where a loft area will be created etc.

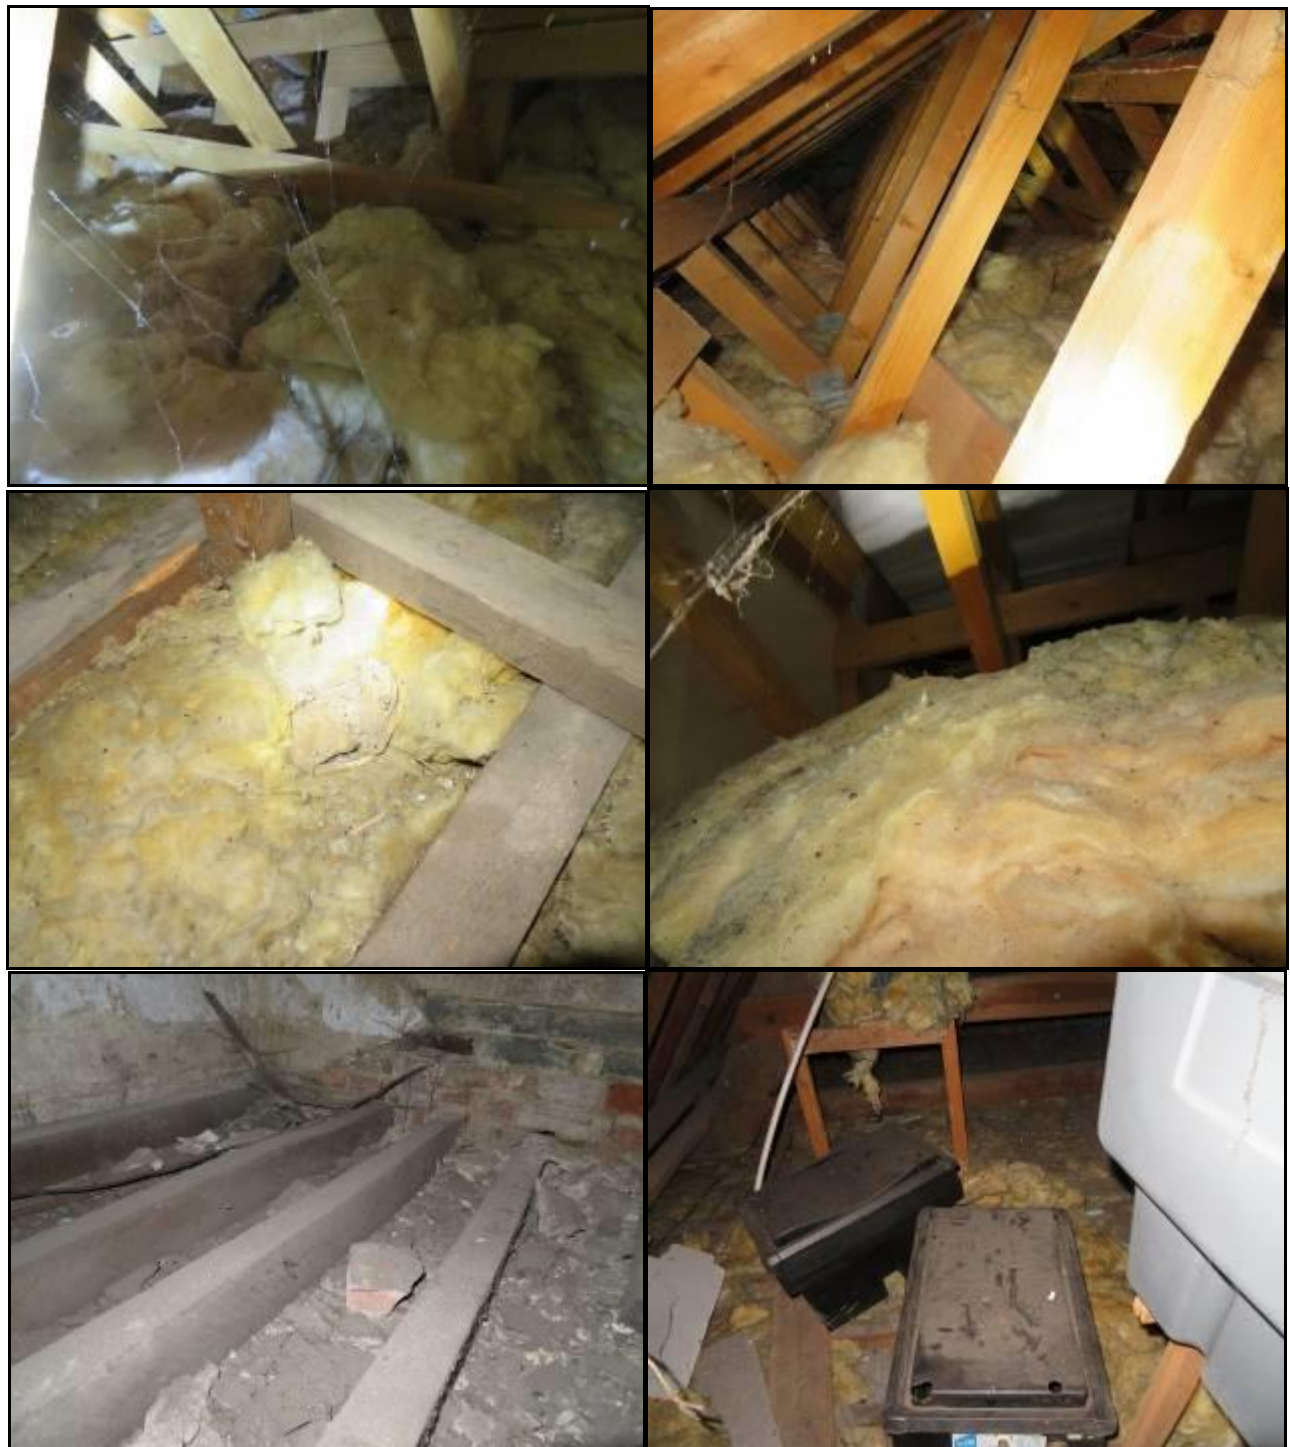
Additional interior images of the loft spaces at the annex property. There were many undisturbed cobwebs, a lot of dust, and some signs of rodent use but no bats or their signs were found.
