**Tyn-y-Caeau, Margam Road, Margam,  
Port Talbot, Neath Port Talbot, SA13 2NW**

**Bat Survey Report for Recycling Plant & Machinery Ltd**

| <b>Report type</b> | Bat Survey Report |

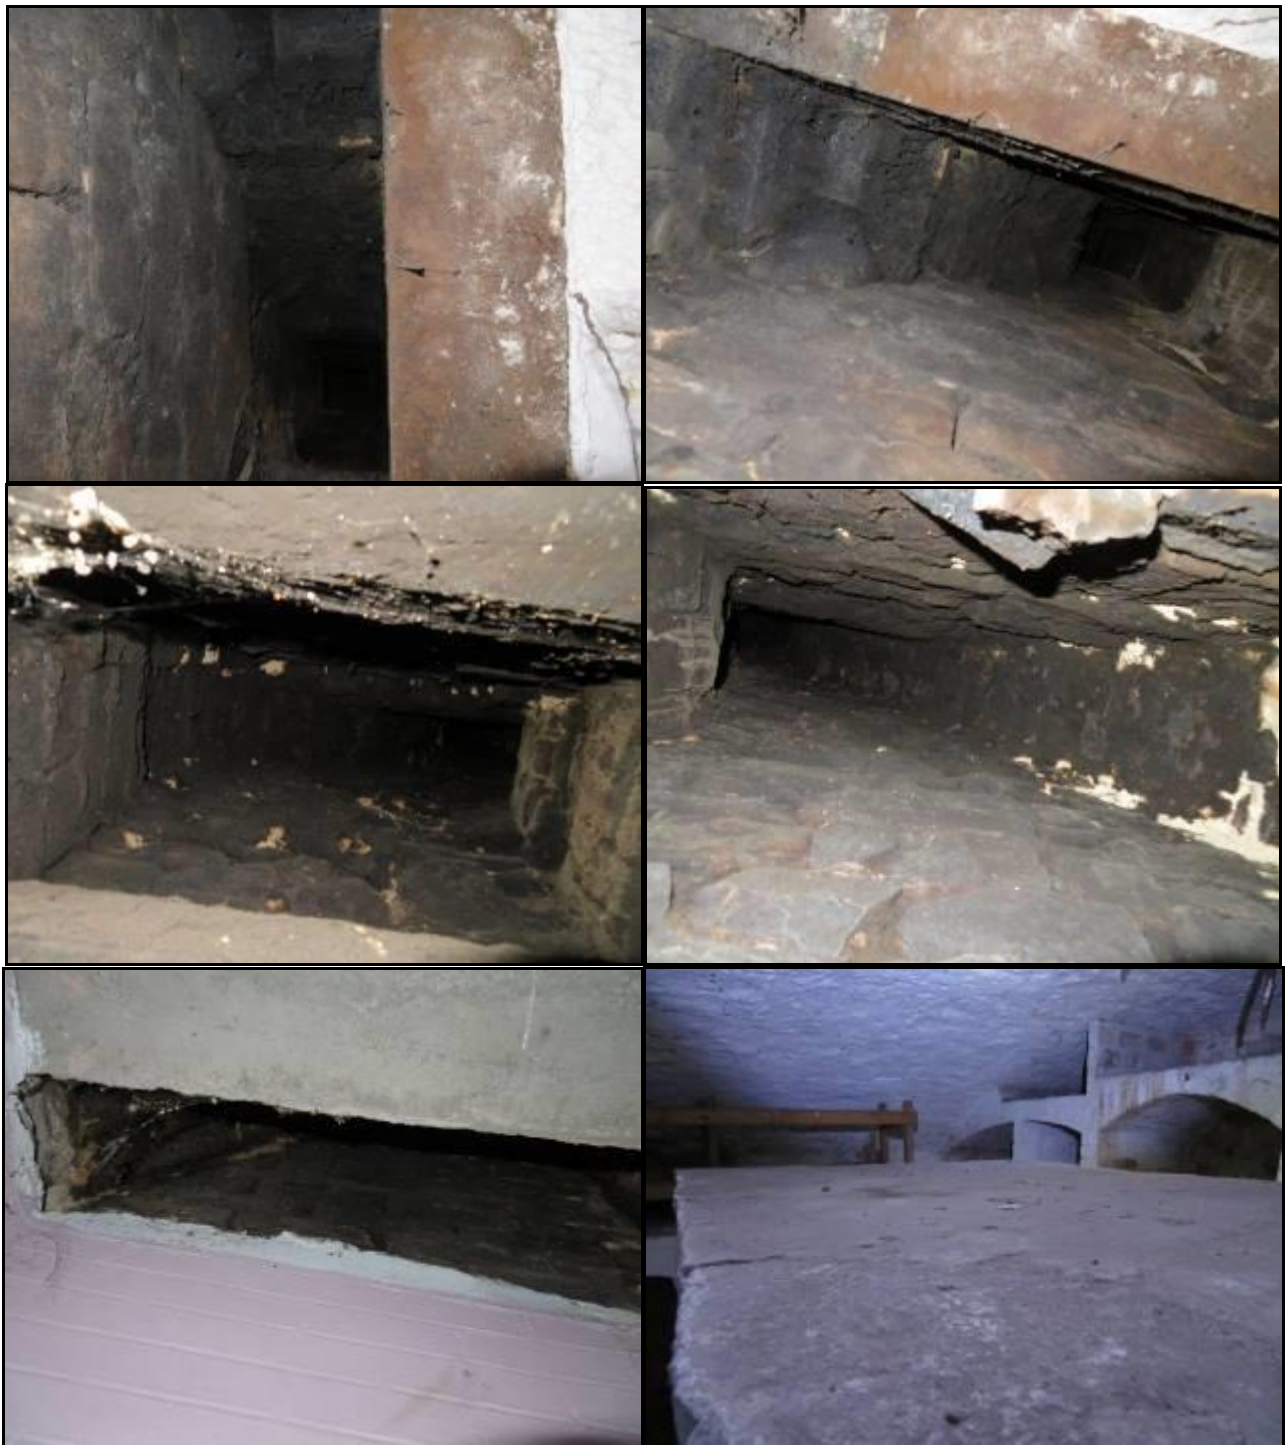
All potentially exploitable internal crevices were endoscoped and explored and no bats or their signs were found.

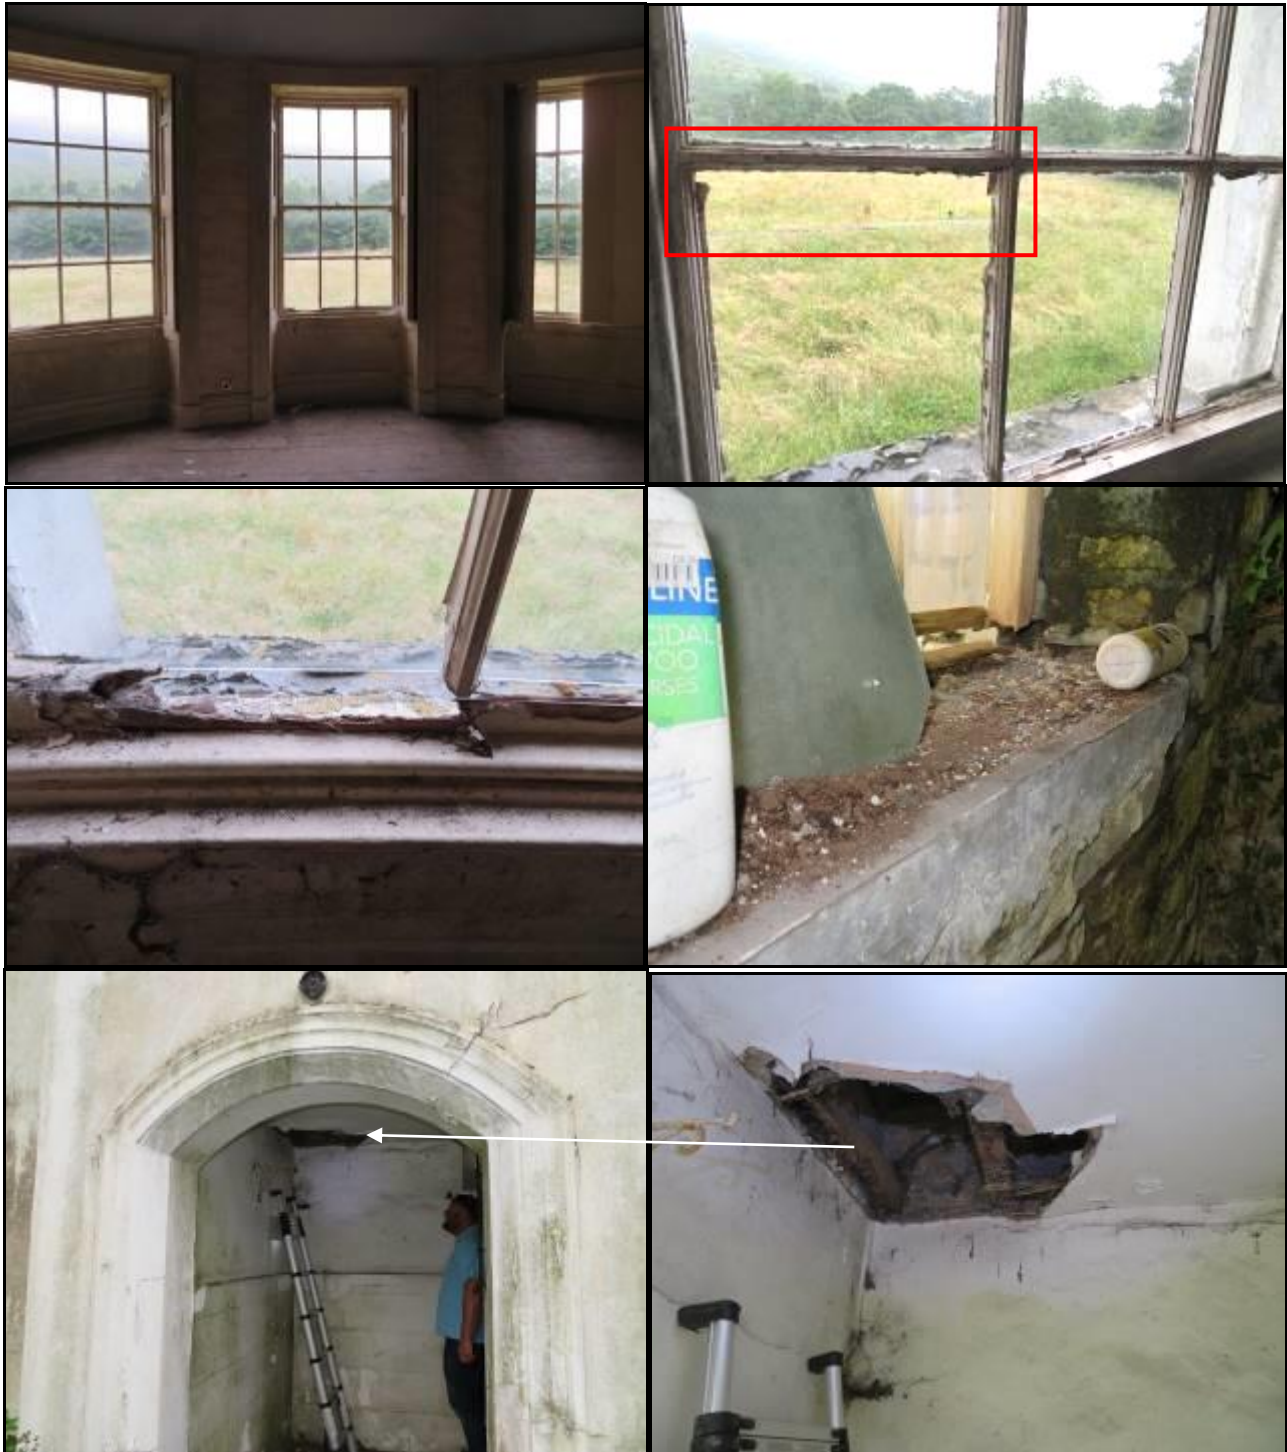
Additional interior images from the property. Image one shows the large windows of the original house which allow a lot of light internally; thus reducing the potential for day roosting in these areas. Image two shows the only viable access and egress point for the *R. hipposideros* bat, which is through a slipped pane of glass in the upper floor window. Images five and six show one area (inside the main porch) where there is damage to the ceiling, no bats or signs were found here either.

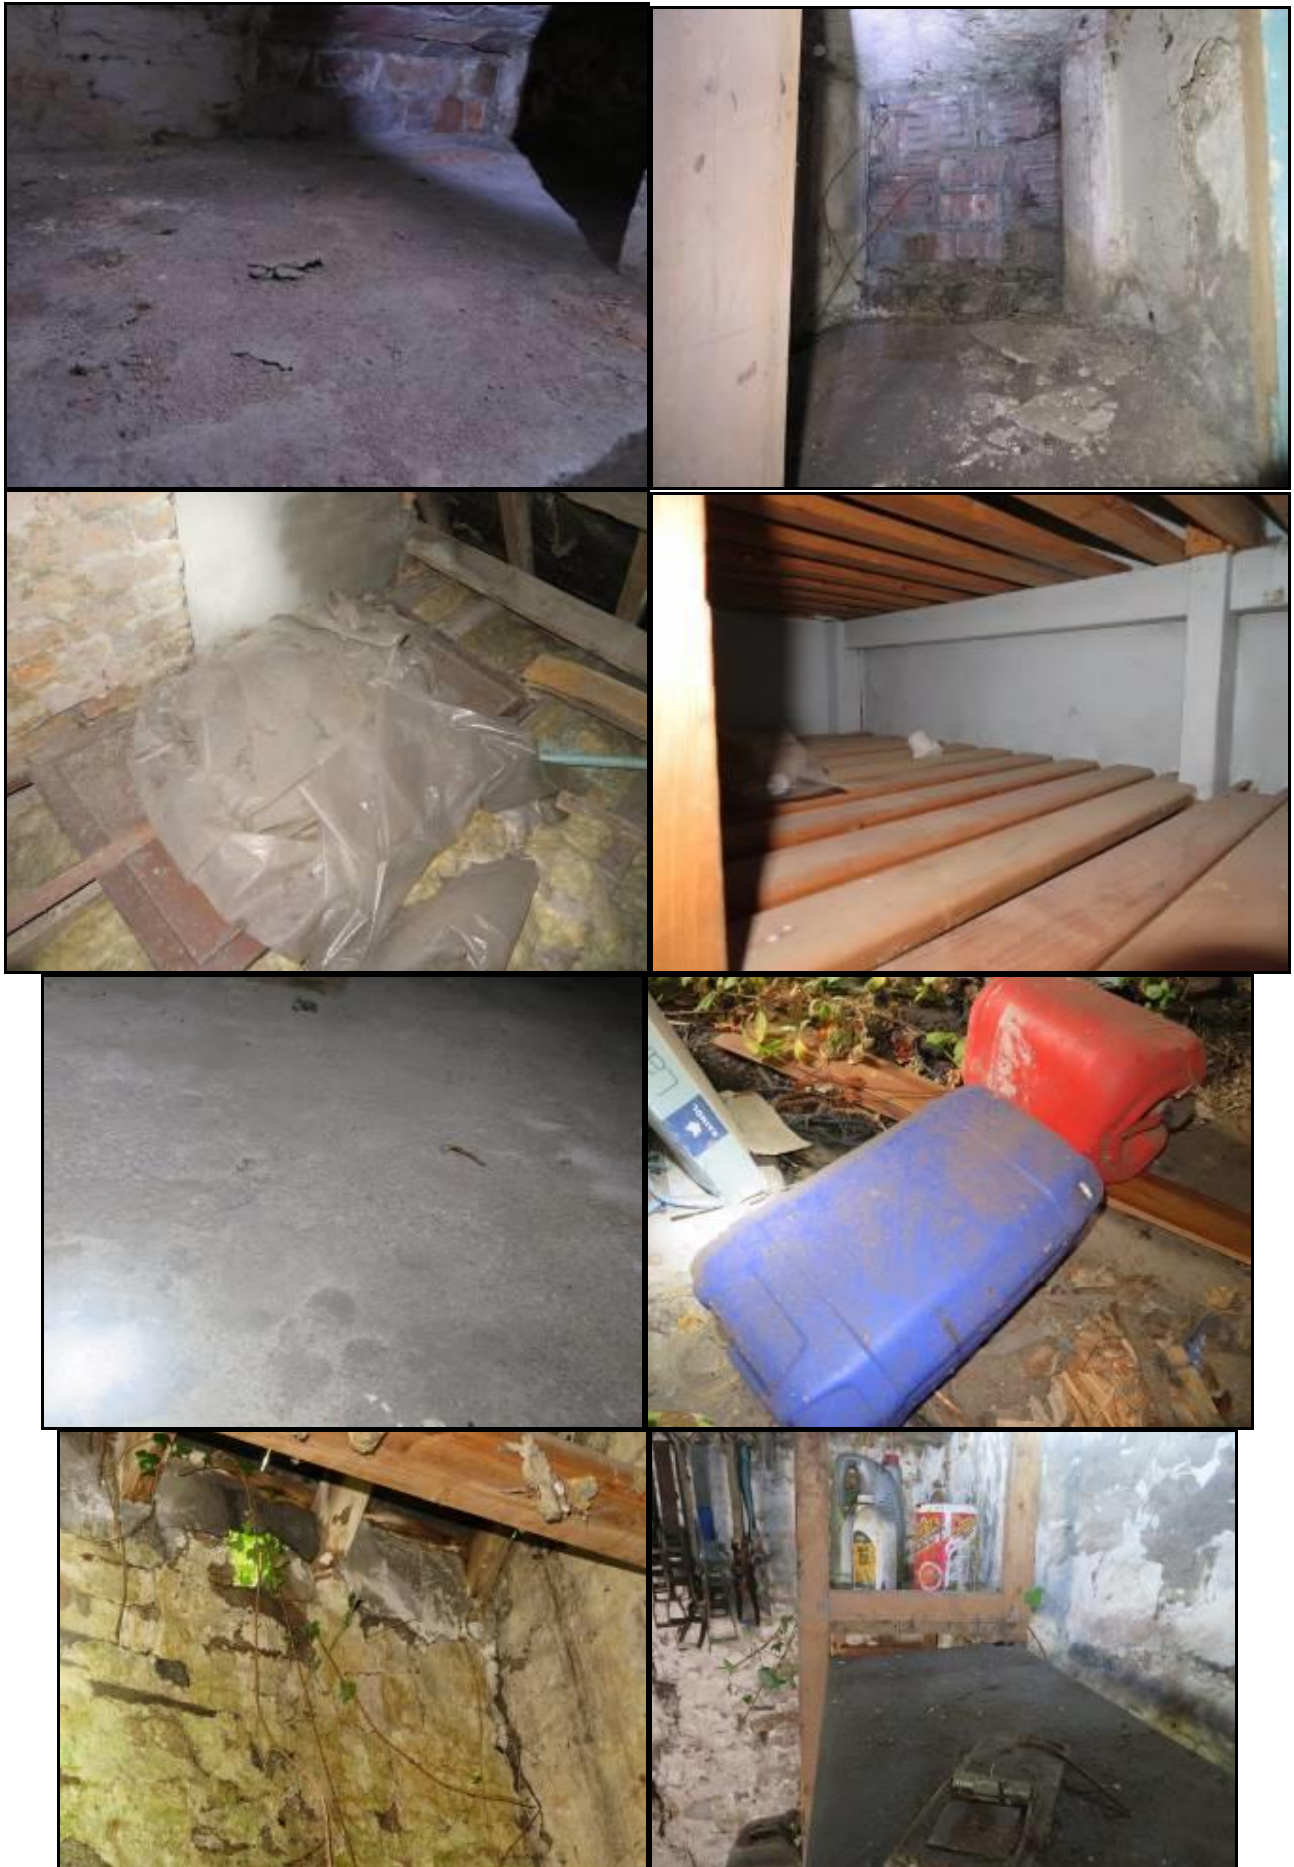
Additional images showing the items and surfaces within the outbuilding (proposed bat roost) at the property.

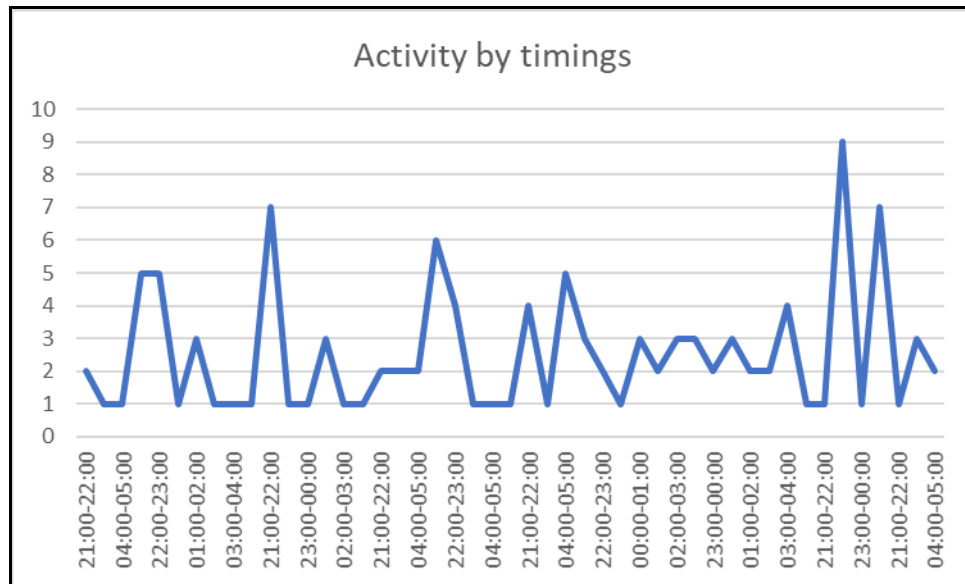
### Sonogram Interpretation of Activity & Building Usage

The Anabat machine was deployed within the loft area of the original (period) house on the 26th June 2020 and was removed on the 7th July 2020. The machine was in working order throughout and this was confirmed by the anabat log files. The machine was triggered by only one species of bat, The Lesser horseshoe. No bat calls were recorded during the daytime hours. During the daytime inspections, a small number of droppings were discovered within the downstairs fireplace, and DNA analysis of the guano confirmed that they were produced by Lesser horseshoe bats.

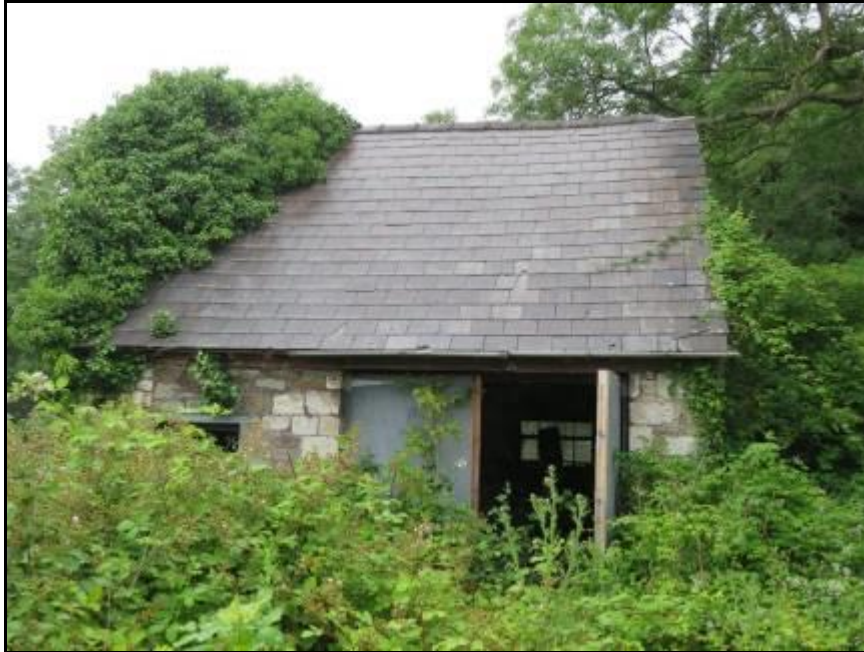
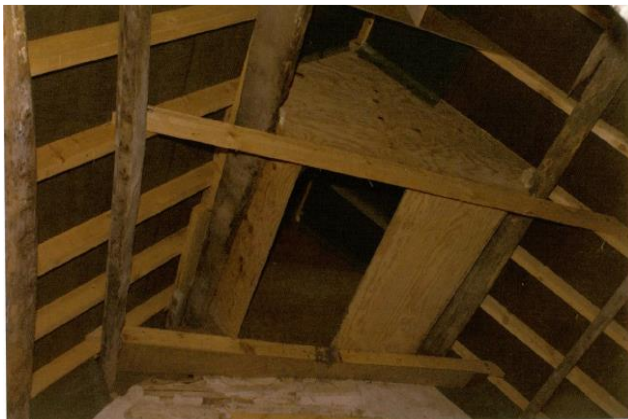
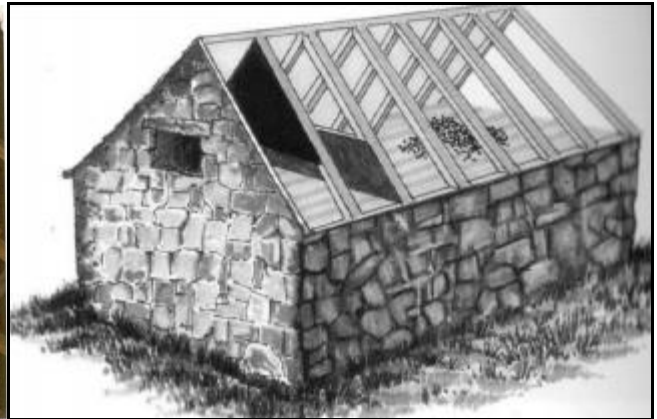
**Top:** The south-east facing outbuilding on site which is to be converted – prior to works commencing – to provide a dedicated roost space for *R. hipposideros*, *P. pygmaeus* and *P. pipistrelles* (as well as all crevice-dwelling and roof-void dwelling species). The final plans for the bat mitigation house to be submitted to the LPA are to include all exterior and interior dimensions and material. They are also to indicate the location on the north-east elevation of the letterbox access and crevice access and to confirm confirm the blocking up of the existing windows confirm that no external lighting will be included and that no light spill from the house or annexe will occur

**Bottom left:** Hot boxes incorporate a floor, which has an access space for bats cut into it. These features ensure that the roost provides a range of microclimates, cooler areas for when summer temperatures get too high, and warmer areas during cooler weather. This is essential to meet the varying needs of the colony. The warmest areas are most critical for the pregnant and lactating females (noting that the roost currently present is not a maternity roost).

5.2.6 As per **recommendation 1**: prior to works commencing, a dedicated roost space is to be created within the detached stone building on site (35m west of the loft space of the house and some 30m from the site where horseshoe droppings were found) for the species confirmed to be present. Letterbox access (at least 300mm long x 400mm high to provide for both Rhinolophidae) will be provided as well as wall top gaps, and one in eight crevices are to be retained in the stonework. In addition, as per **recommendation 2**: x 1 Beaumaris (or similar) and x 1 Kent style (or similar) bat box to be affixed internally within the dedicated roost space. To be affixed in an elevated position (2m or >). See appendix 10 for further details.

**Mitigation and enhancement recommendations:** *Recommendation 1:* Prior to works commencing, a dedicated roost space is to be created within the detached stone building on site for the species confirmed to be present. Letterbox access will be provided as well as x 4 wall top gaps, and one in eight crevices are to be retained in the stonework. *Recommendation 2:* x 1 Beaumaris (or similar) and x 1 Kent style (or similar) bat box to be affixed internally within the dedicated roost space. To be affixed in an elevated position (2m or >).

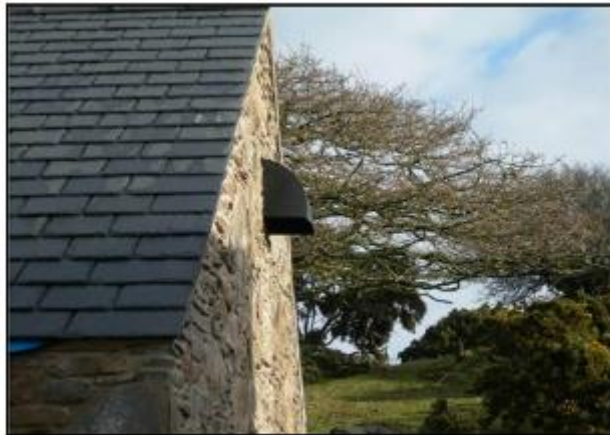
*Crevice-dwelling bats* (such as Soprano pipistrelles) can crawl into roosts via small gaps in the range of 15–20mm high by 20–50mm wide to be created at the wall tops. The roost area should maintain a crevice of this approximate size gap that the bats can roost between. Gaps will also be created/retained in the walls to provide additional roosting opportunities. *Horseshoe bats* need a larger access so that they can fly (instead of crawl) directly into the roost. Lesser horseshoe bats need an access of 300mm (w) x 200mm (h). The roosting area should not be trussed, to allow flight. The letterbox access is to be installed as low as practically possible but at least 0.4m above

ground level of. This ensures that bats are away from clutter during access and will not be impeded by any potential bird's nests. The entrance is to be sloped downwards and outwards with waterproofing (e.g. lead lining) below to minimise ingress by rain. An optional canopy above can be used. Additional draught reducing and light deflecting baffles could be used in conjunction with this access feature. Any weather shielding must not restrict roost access. **NO BREATHABLE ROOFING MEMBRANE IS TO BE USED WITHIN THE ROOST AREA. ONLY TYPE 1F BITUMASTIC FELT IS TO BE USED IF FELTING BECOMES NECESSARY.**

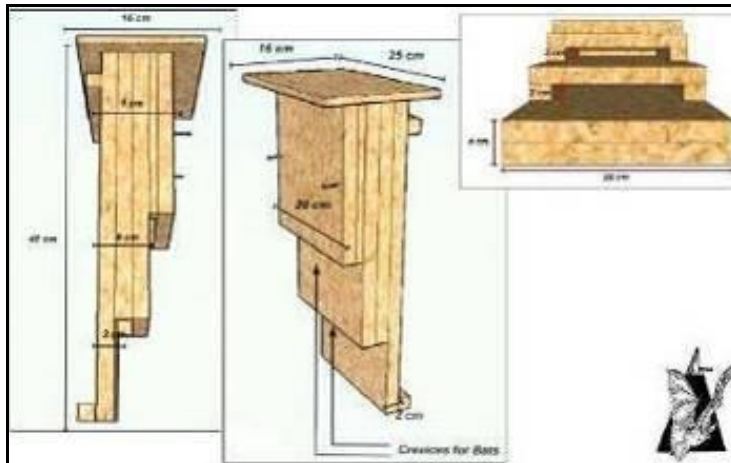
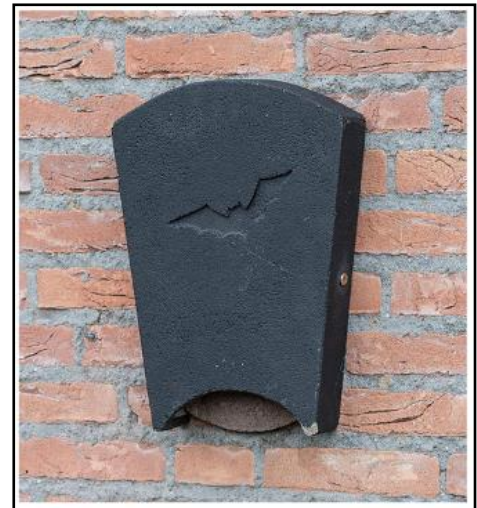
**Above:** The Kent style bat box. **Right:** The Beaumaris bat box.

**Recommendation 2:** x 1 Beaumaris (or similar) and x 1 Kent style (or similar) bat box to be affixed internally within the dedicated roost space.

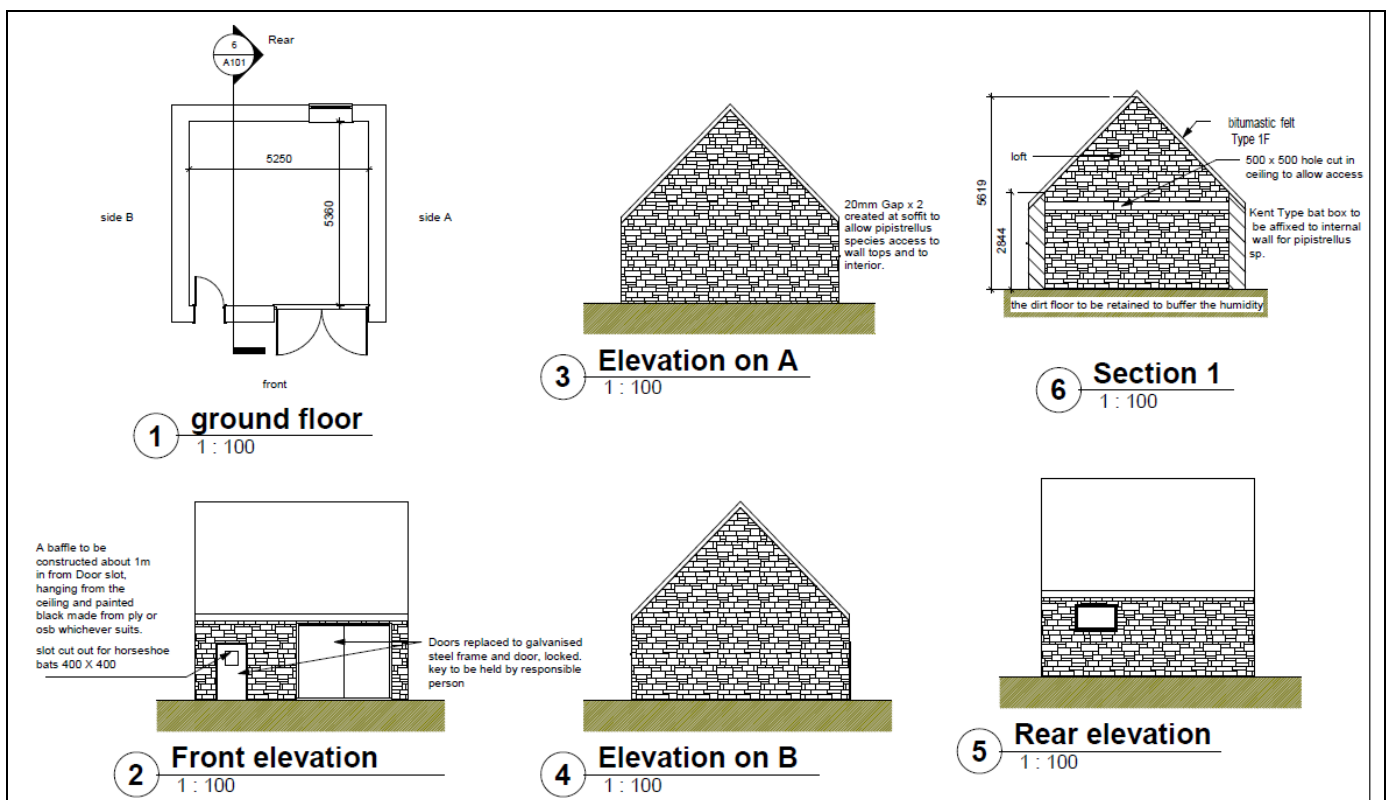
**Above:** The bat roost mitigation. The 400x400 Or 400x300mm slot in the door should be cowled to reduce chances of bird and squirrel access.

**Recommendation 1:** Prior to works commencing, a dedicated roost space is to be created within the detached stone building on site for the species confirmed to be present. Letterbox access will be provided as well as x 4 wall top gaps, and one in eight crevices are to be retained in the stonework. In addition, as per
