**Bat and Nesting Bird Survey Report**  
**Glen View, 9 Primrose Lane, Pontardawe,**  
**Rhos, Neath Port Talbot, SA8 3ES.**  
Surveys conducted July - September 2022

**Lee Gwyther - Grounded Trees and Ecology Ltd**

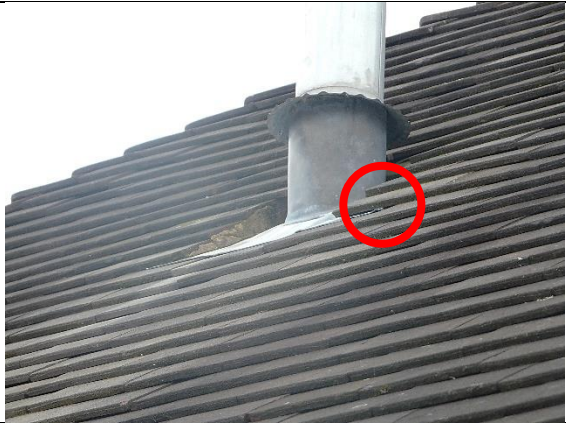
| A close-up photograph of a roof with dark grey concrete tiles. A white flue pipe protrudes from the roofline. A red circle highlights a gap between the tiles directly beneath the flue pipe. | A photograph of a roof with dark grey concrete tiles. Two red circles highlight gaps between the tiles, one near the top ridge and one further down the slope. |

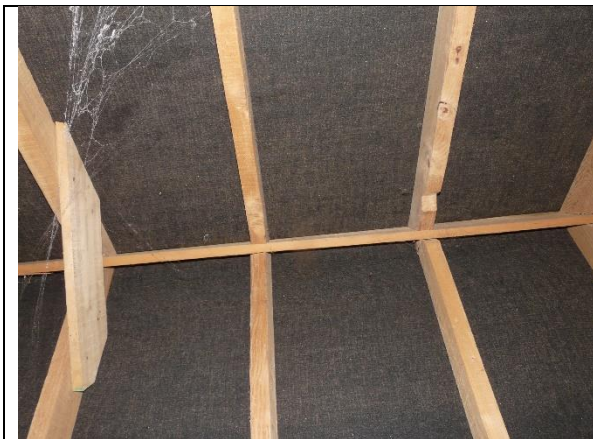
Photo 19: The concrete tile roof is lined with black bitumen roofing felt

**Using ‘Bat Friendly’ Roofing Materials:** 1F black bitumen roofing felt only will be used in the new clay tile roof areas of the building. Breathable membranes will not be used as they may due to wear and tear by the little bat claws can give rise to dislodged fibres which can cause bats to become tangled and strangled. A PhD study by Stacey Waring under Reading University proving the negative effect of breathable membranes to endangered species was published in 2013.

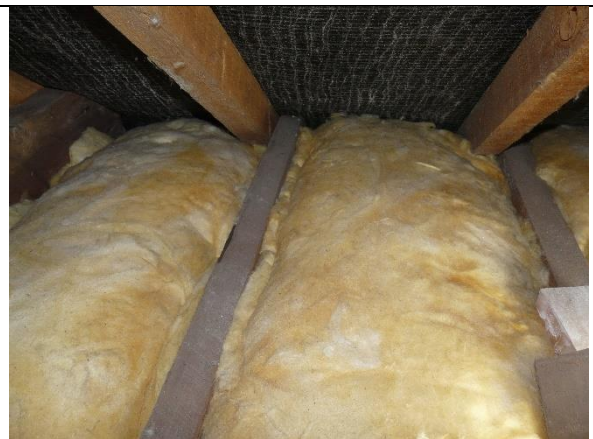
Photo 20: The loft floor is insulated with yellow fibreglass material at floor level

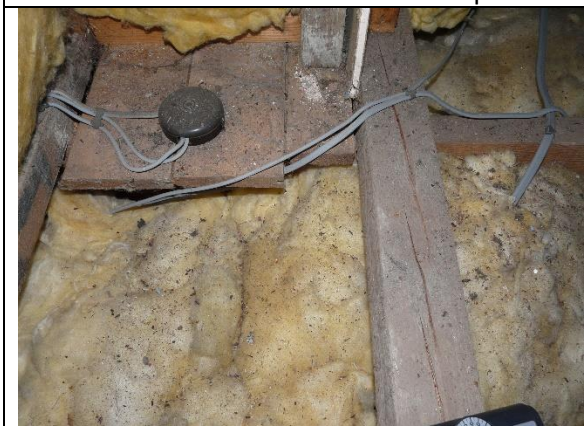
**Evidence of Bats:** Approximately 20 bat droppings typical in shape, size and location of pipistrelle bats were found inside the loft space (on the southern eaves side). The bat droppings are likely to have fallen inside the loft space from the concrete roof areas via gaps in the black bitumen roofing felt.

Photo 25: Location of bat droppings found

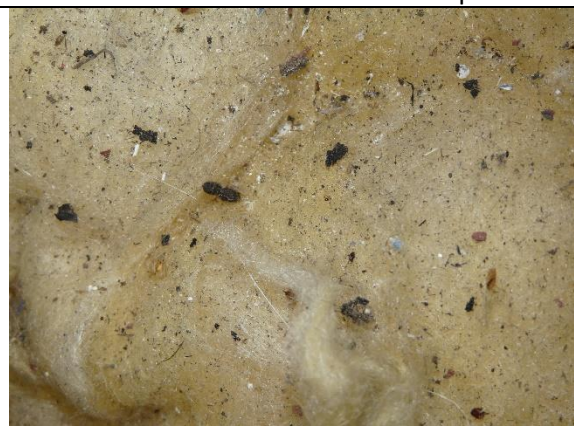
Photo 26: Close up view of bat droppings

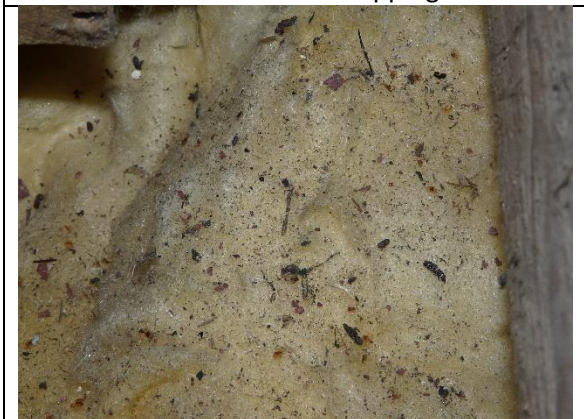
Photo 27: Close up view of bat droppings

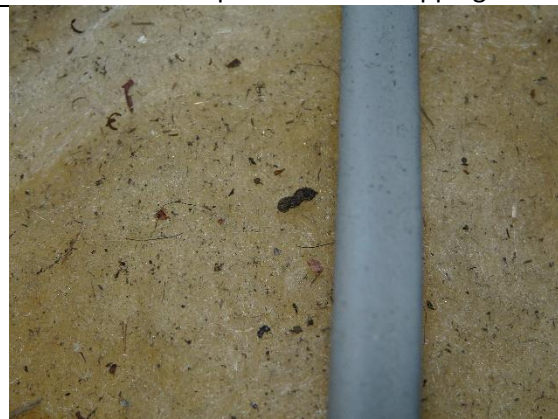
Photo 28: Close up view of bat droppings
