**Quantitative Risk Assessment for Contamination  
Land adjacent to A4067, Pontardawe  
for  
ANTHONY HUNT ASSOCIATES**

**APPENDICES**

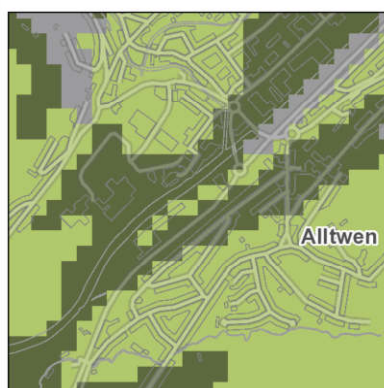
### Is ground instability likely to be a problem?

Increased infiltration is very unlikely to result in ground instability.
-

Ground instability problems may be present or anticipated, but increased infiltration is unlikely to result in ground instability.
-

Ground instability problems are probably present.  
Increased infiltration may result in ground instability.
-

There is a very significant potential for one or more geohazards associated with infiltration.

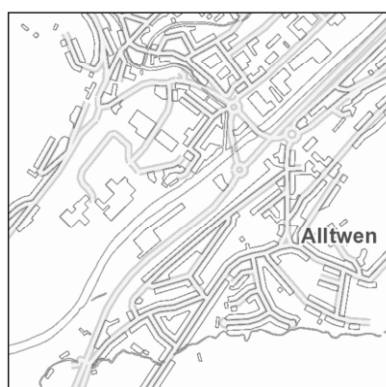
#### Soluble rock hazard

☒ Very significant soluble rock hazard.  
Soluble rocks are present with a very significant possibility of localised subsidence that could be initiated or made worse by infiltration. The site investigation should consider whether the potential for or the consequences of subsidence as a result of infiltration are significant.

☐ Very significant soluble rock hazards are not present; however this hazard may still need to be considered. See Part 3.

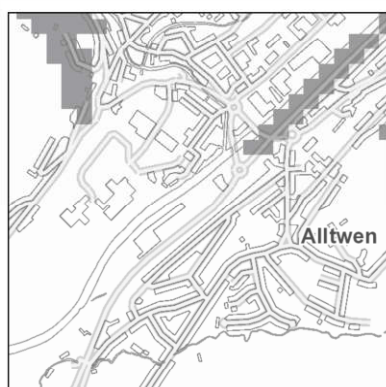
#### Landslide hazard

☒ Very significant landslide hazard.  
Slope instability problems are almost certainly present and may be active. An increase in moisture content as a result of infiltration may cause the slope to fail. The site investigation should consider whether the potential for or the consequences of landslide as a result of infiltration are significant.

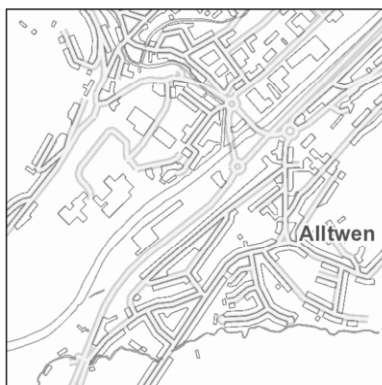
## Shallow mining hazard

Very significant mining hazard.

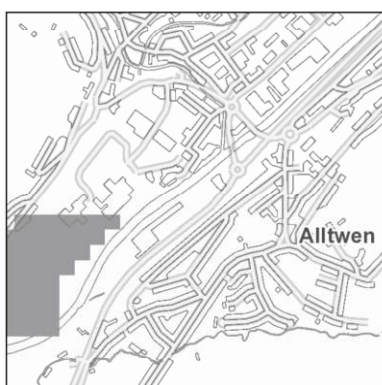
## Made ground

Made ground is present at the surface. Infiltration may affect ground stability or increase the possibility of remobilising pollutants. The site investigation should consider whether the potential for or consequences of ground instability and/or pollutant leaching as a result of infiltration are significant.

Made ground is present at the surface. Infiltration may increase the possibility of remobilising pollutants.

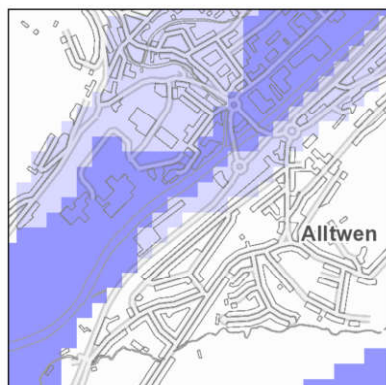
## Superficial deposit permeability

The superficial deposit permeability is **spatially variable**, but likely to permit moderate infiltration.

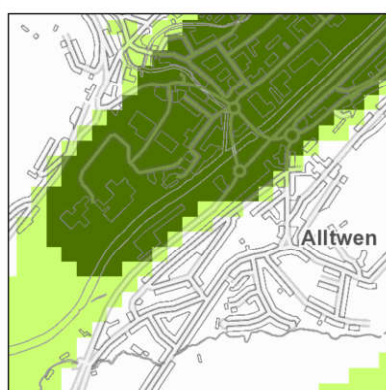
## Superficial deposit thickness

The thickness of superficial deposits is **> 3 m** and hence the permeability of the superficial deposits is likely to determine the permeability of the ground.

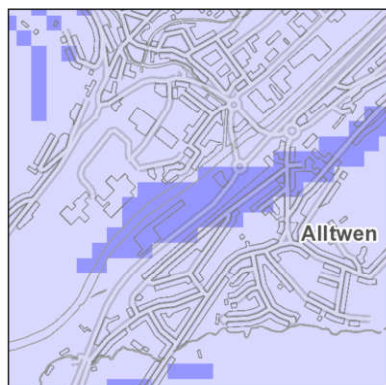
## Bedrock permeability

The bedrock permeability is **spatially variable**, but likely to permit moderate infiltration.

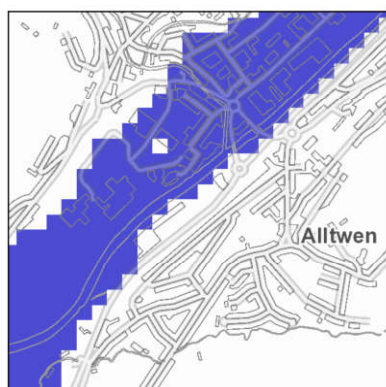
## Geological indicators of flooding

Superficial floodplain deposits or low-lying coastal areas have been identified. Groundwater levels may rise in response to high river or tide levels, potentially causing inundation of subsurface infiltration SuDS.

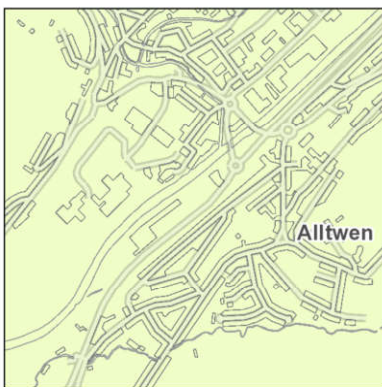
| Soluble rocks | |
|---|---|
| <p>Contains OS data © Crown Copyright and database right 2020</p> | <p> Increased infiltration is unlikely to result in subsidence.</p> |
| | <p> Increased infiltration is unlikely to cause localised subsidence, but potential impacts should be considered.</p> |
| | <p> Increased infiltration may result in localised subsidence. The potential for or the consequences of subsidence associated with soluble rocks should be considered.</p> |

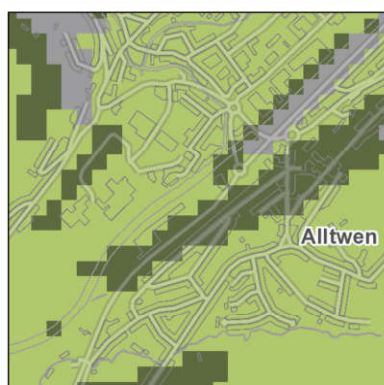
## Landslides

Increased infiltration is unlikely to lead to slope instability.
-

Slope instability problems may be present or anticipated, but increased infiltration is unlikely to cause instability
-

Slope instability problems are probably present or have occurred in the past, and increased infiltration may result in slope instability.
-

Slope instability problems are almost certainly present and may be active. An increase in moisture content as a result of infiltration may cause the slope to fail.

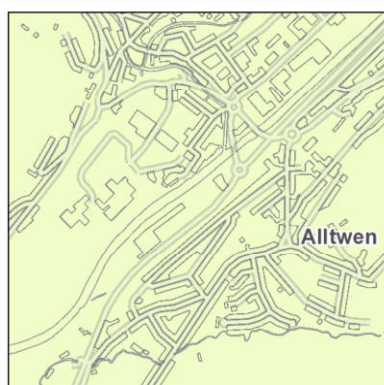
## Shallow mining

Increased infiltration is unlikely to lead to subsidence.
-

Shallow mining is possibly present. Increased infiltration is unlikely to cause a geohazard, but potential impacts should be considered.
-

Shallow mining could be present with a significant possibility that localised subsidence could be initiated or made worse by increased infiltration.
-

Shallow mining is likely to be present, with a very significant possibility that localised subsidence may be initiated or made worse by increased infiltration.

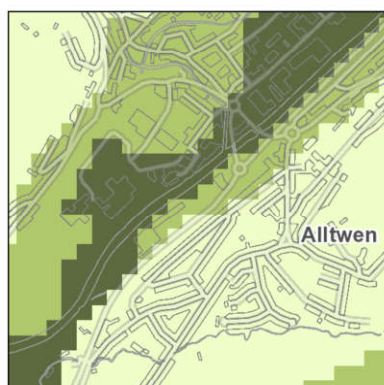
## Running sand

Increased infiltration is unlikely to cause ground collapse associated with running sands.
-

Running sand is possibly present. Increased infiltration is unlikely to cause a geohazard, but potential impacts should be considered.
-

Significant possibility for running sand problems. Increased infiltration may result in a geohazard.

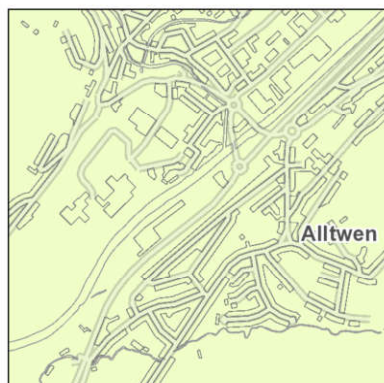
## Swelling clays

- Increased infiltration is unlikely to cause shrink-swell ground movement.
- Ground is susceptible to shrink-swell ground movement. Increased infiltration is unlikely to cause a geohazard, but potential impacts should be considered.
- Ground is susceptible to shrink-swell ground movement. Increased infiltration may result in a geohazard.

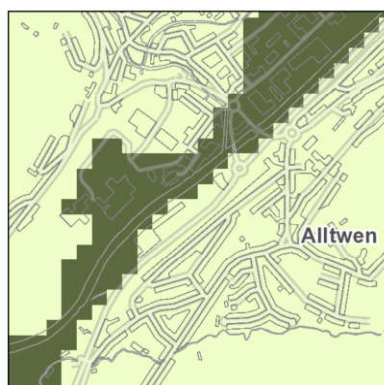
## Compressible ground

- Increased infiltration is unlikely to lead to ground compression.
- Compressibility and uneven settlement hazards are probably present. Increased infiltration may result in a geohazard.

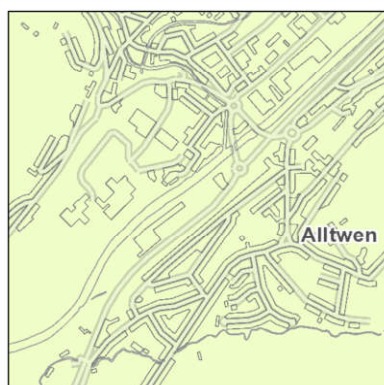
## Collapsible ground

- Increased infiltration is unlikely to result in subsidence.
- Deposits with potential to collapse when loaded and saturated are possibly present in places. Increased infiltration is unlikely to cause a geohazard, but potential impacts should be considered.
- Deposits with potential to collapse when loaded and saturated are probably present in places. Increased infiltration may result in a geohazard.
