**PANT GLAS FARM**

**UPDATED BAT BUILDING INSPECTION AND ACTIVITY REPORT**

17 January 2023

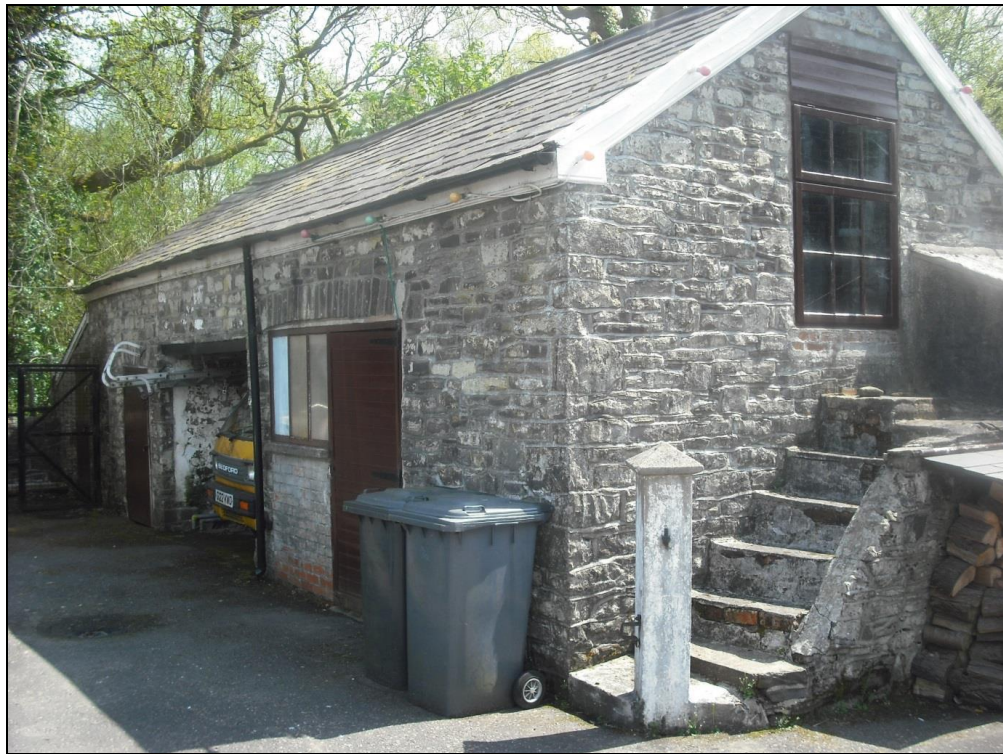
- 3.3 The southern historic stone barn possessed a pitched slate roof with a combination of wooden and uPVC fascias (Photo 1). The barn had a slate tile roof lean-to on its eastern gable end as well as a corrugated metal lean-to located on the western gable end with historic steps that used to lead to the first floor (now not present) (Photo 2). The barn was being utilised for storage and possessed exposed wooden beams and roof slates internally with wooden doors and window frames evident. During the survey an old bat dropping indicative of Pipistrelle sp. was identified internally at the western extent of the barn. Potential bat roosting features were also associated with the gaps beneath the fascias around the barn's elevations.

***Photo 1: Southern barn (view looking east).***

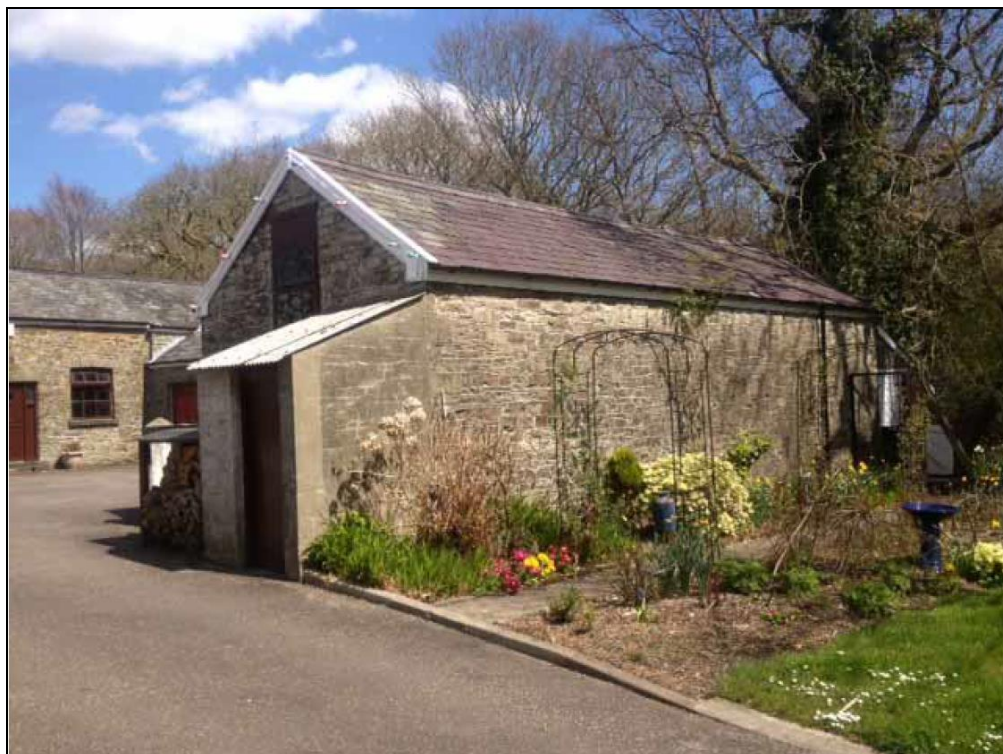
***Photo 2: Western gable end and southern elevation of southern barn (view looking north).***

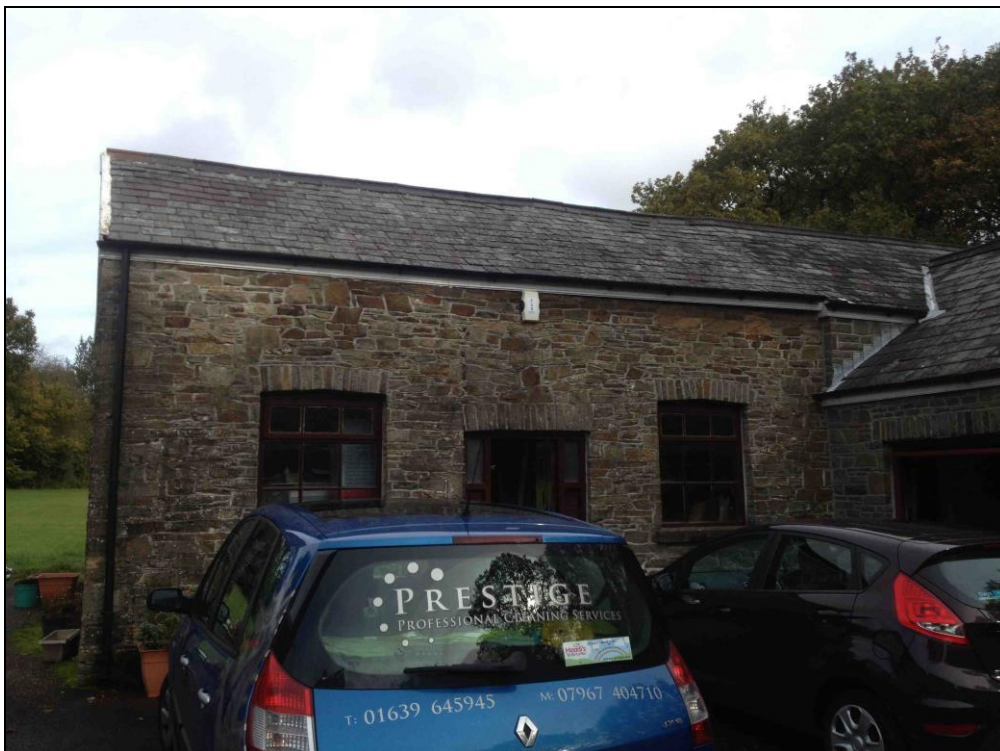
- 3.4 The western extent of the northern stone barn was the original historic structure (Photo 3) with a 'slit window' located on the western gable end. Metal roller garage doors had been installed on the northern elevation of the barn (Photo 4), and the western extent was being utilised for storage and possessed exposed wooden beams and slate roof tiles. In general the barn possessed wooden window frames and doors with a combination of uPVC and wooden fascias. During the inspection a bat dropping indicative in size and shape of *Pipistrelle* sp. was identified on the western metal roller door located on the northern elevation.

***Photo 3: Original western extent of northern stone barn (view looking north).***

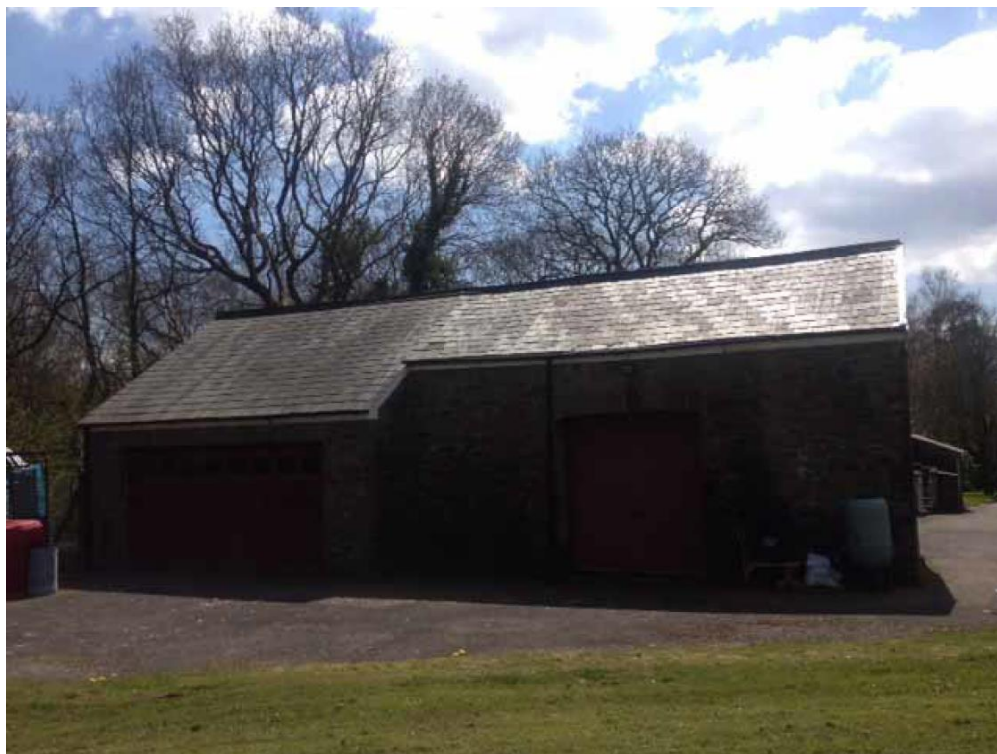
- 3.5 A modern extension had been constructed on the eastern extent of the barn (Photo 4 & 5) and was constructed from breeze block with cut stone facing located on the northern and western and southern elevations, whilst the extension was rendered on the rear eastern elevation. The garage possessed to large metal doors located on the western elevation. Potential bat roosting features were also associated with the gaps beneath the fascias around the barn's elevations. The internal inspection of the extension identified multiple loft spaces that exposed wooden trusses and bitumastic roof felting evident throughout. The extension was currently being utilised as a garage at its southern extent and as a store room at its northern extent. During the inspection an accumulation of droppings within the loft space beneath the southern gable end of the garage. The droppings were indicative in size and shape of *Pipistrelle* sp..

***Photo 4: Northern elevation of northern barn.***

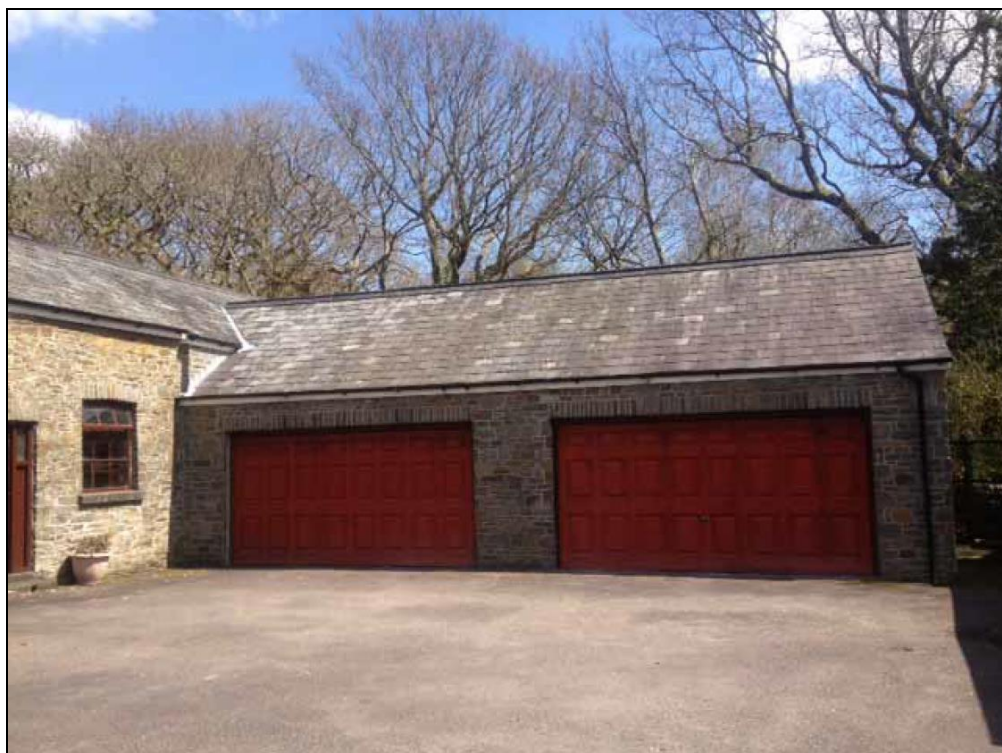
***Photo 5: Eastern extent of northern barn (view looking east).***

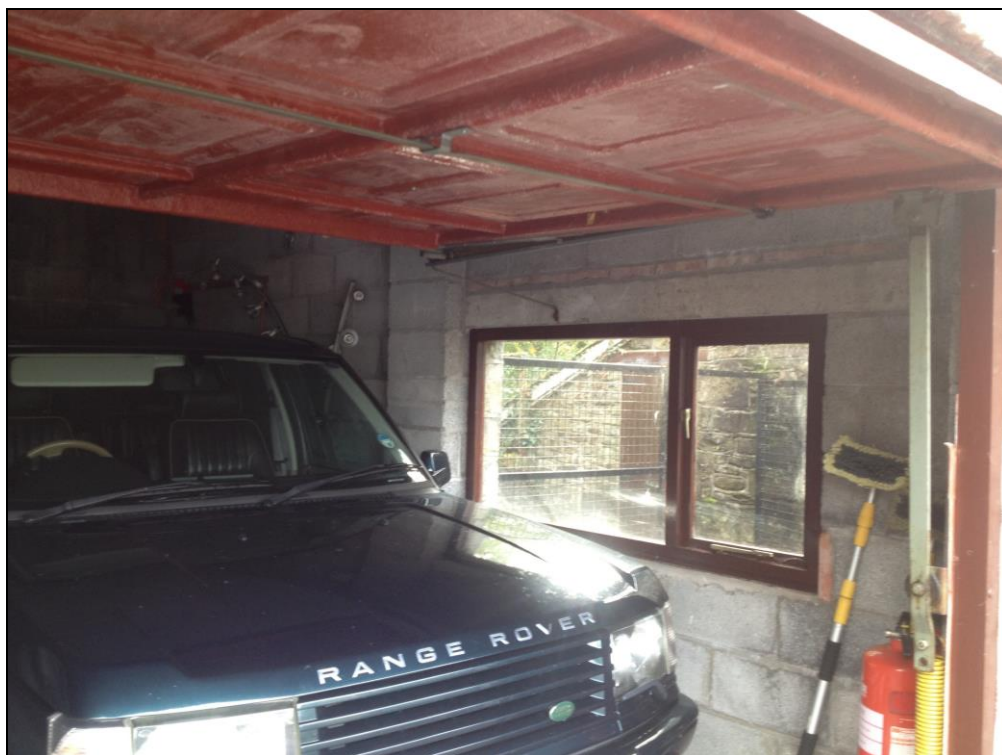
**Photo 6: Interior of modern eastern garage.**

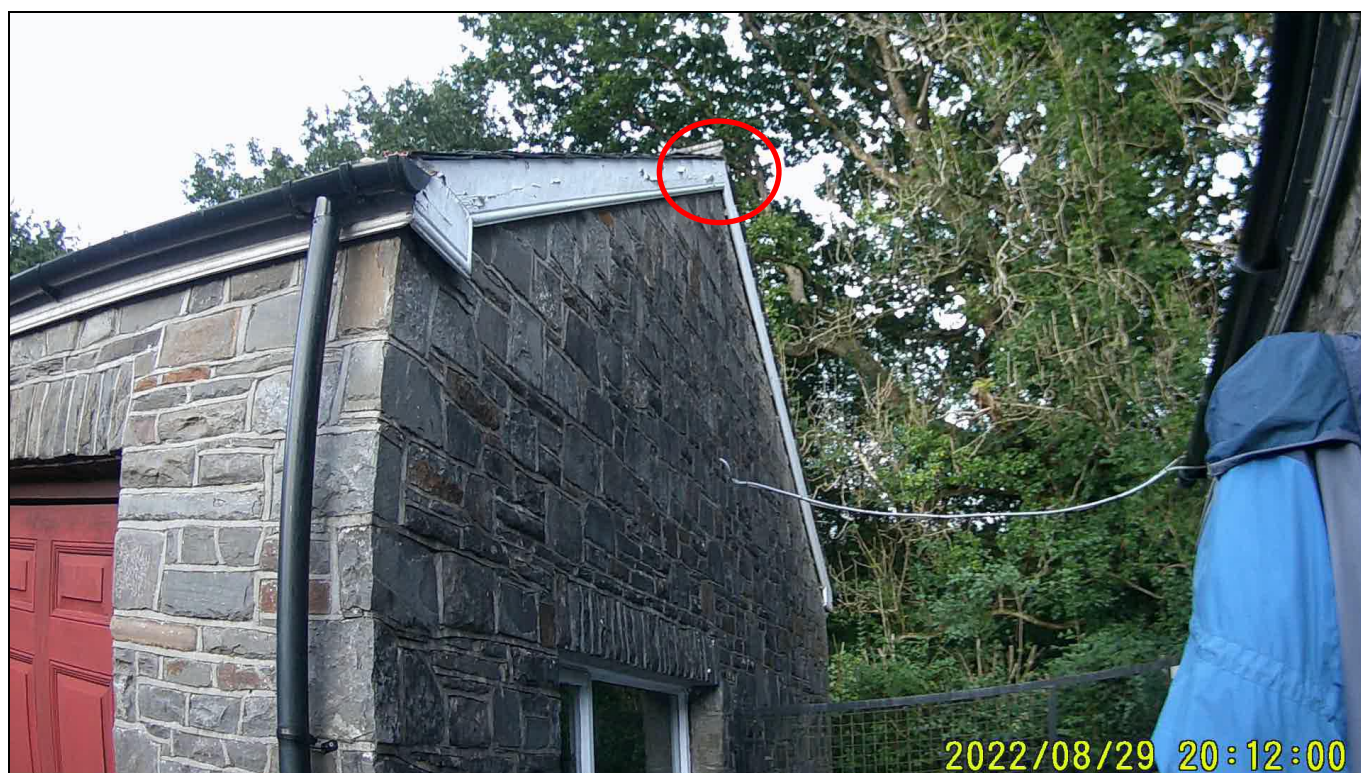
- 3.5 During the evening emergence survey a single Soprano Pipistrelle was identified emerging from beneath the fascia on the southern gable end of the northern barn's eastern garage (Photo 7 & Appendix I) at 20.15h (6mins post sunset 20.09h); whilst an unidentified Pipistrelle (not echolocating) was identified emerging at the same time from beneath the fascia of the southern elevation of the northern barn (Photo 8 & Appendix I). A further Soprano Pipistrelle was identified emerging from beneath the fascia of the southern elevation of the southern barn (Photo 9 & Appendix I) at 20.45h (36mins post sunset 20.09h). In general moderate levels of bat activity was recorded across the site, which were generally attributed to individual Soprano and Common Pipistrelle bats foraging and commuting along the eastern woodland boundary. Individual Brown Long-eared bats were also recorded during the survey.

- 3.6 During the second evening emergence only a single Pipistrelle (not echolocating) was identified emerging from beneath the fascia on the southern gable end of the northern barn's eastern garage (Photo 7 & Appendix I) at 19.29h (24mins post sunset 19.05h) as recorded during the August survey. In general moderate levels of bat activity was recorded across the site, which were generally attributed to individual Soprano and Common Pipistrelle bats foraging and commuting along the eastern woodland boundary, with Individual Brown Long-eared and Noctule bats also recorded during the survey.
- 3.7 During the survey a Blue Tit was identified roosting within the northern barn beneath the fascia on the norther elevation.

***Photo 7: Location of Soprano Pipistrelle on southern gable end of garage.***

- 5.3 On this basis, it is considered that the proposed conversion works will damage and destroy the fascia roosting location and will require European Protected Species (EPS) derogation licence. Any EPS licence application will require an accompanying bat method statement that will include details timings of works, required watching briefs, sensitive working methodologies, required mitigation and monitoring.

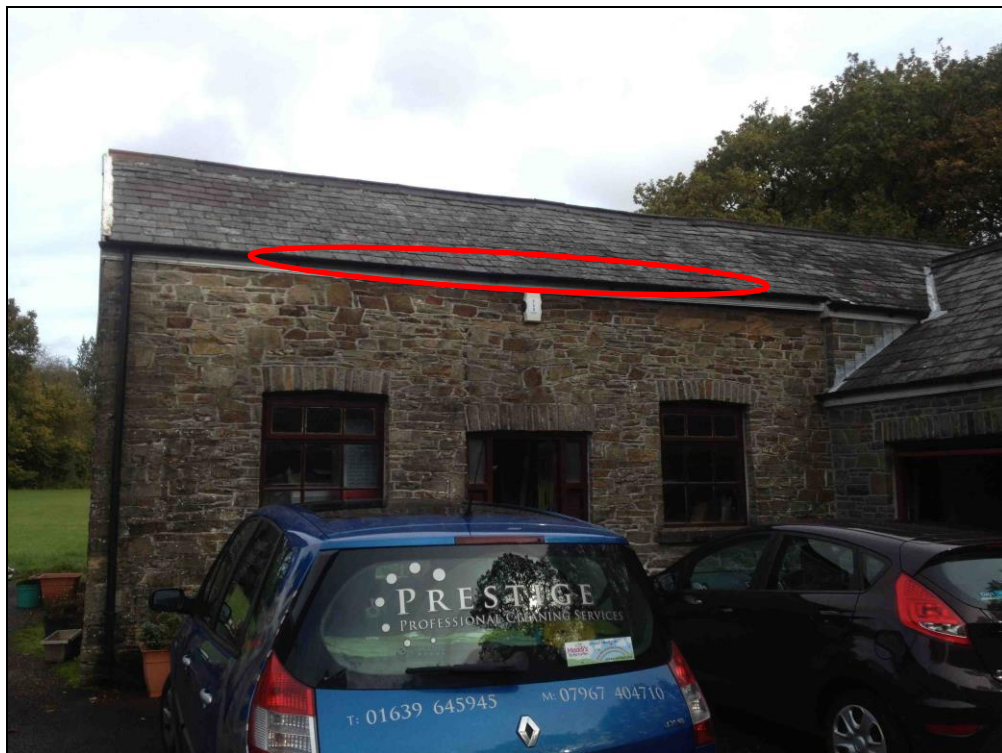
**Photo 8: Approximate location of roosting Pipistrelle on southern elevation of northern barn (view looking north).**

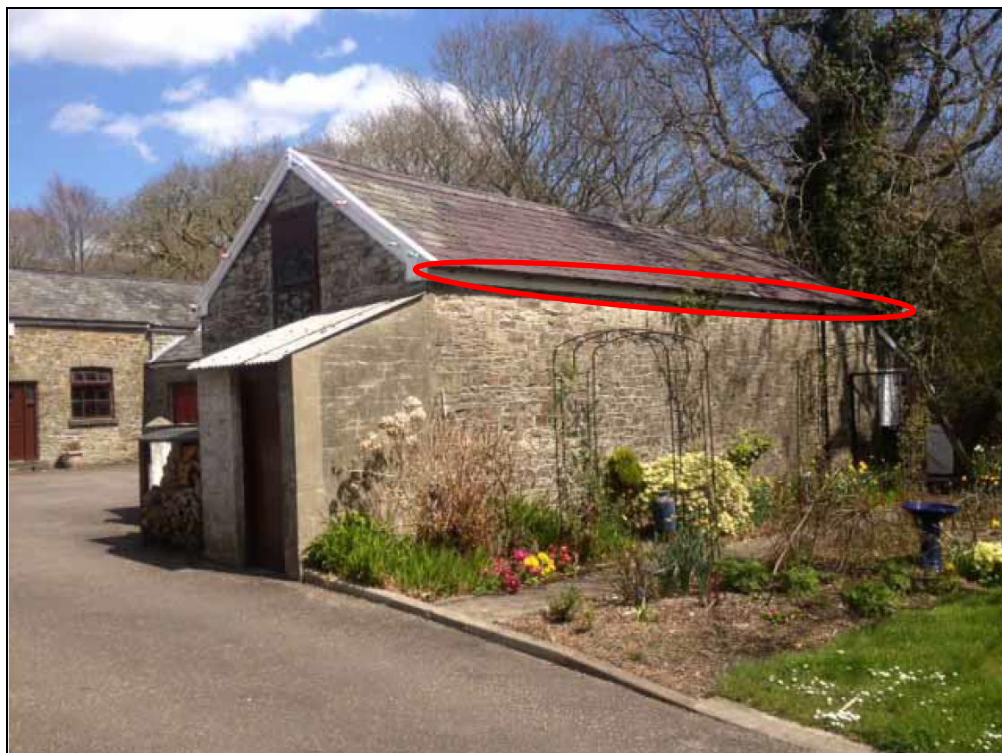
**Photo 9: Approximate location of roosting Soprano Pipistrelle beneath wooden fascia on southern elevation of southern barn.**
