| Site/Building: | Semi-detached house | Date of survey: | 07/02/2023 |
| Site Address | Peacehaven Cottage, 5 Queens Street, Glyncorrwg, SA13 3BL | | |
| Reason for Survey | <p>Planning permission is sought to demolish the semi-detached property in its entirety. Bats are a European Protected Species (EPS) and their presence or potential presence must be considered as a material part of any planning application; i.e. prior to the decision-making process.</p> <p>Initially, to determine likelihood of roosting bat presence at Peacehaven Cottage, the suitability of the structure and its surrounding habitat was ranked according to the Bat Survey Guidelines (2016), shown in Table 1 below.</p> | | |

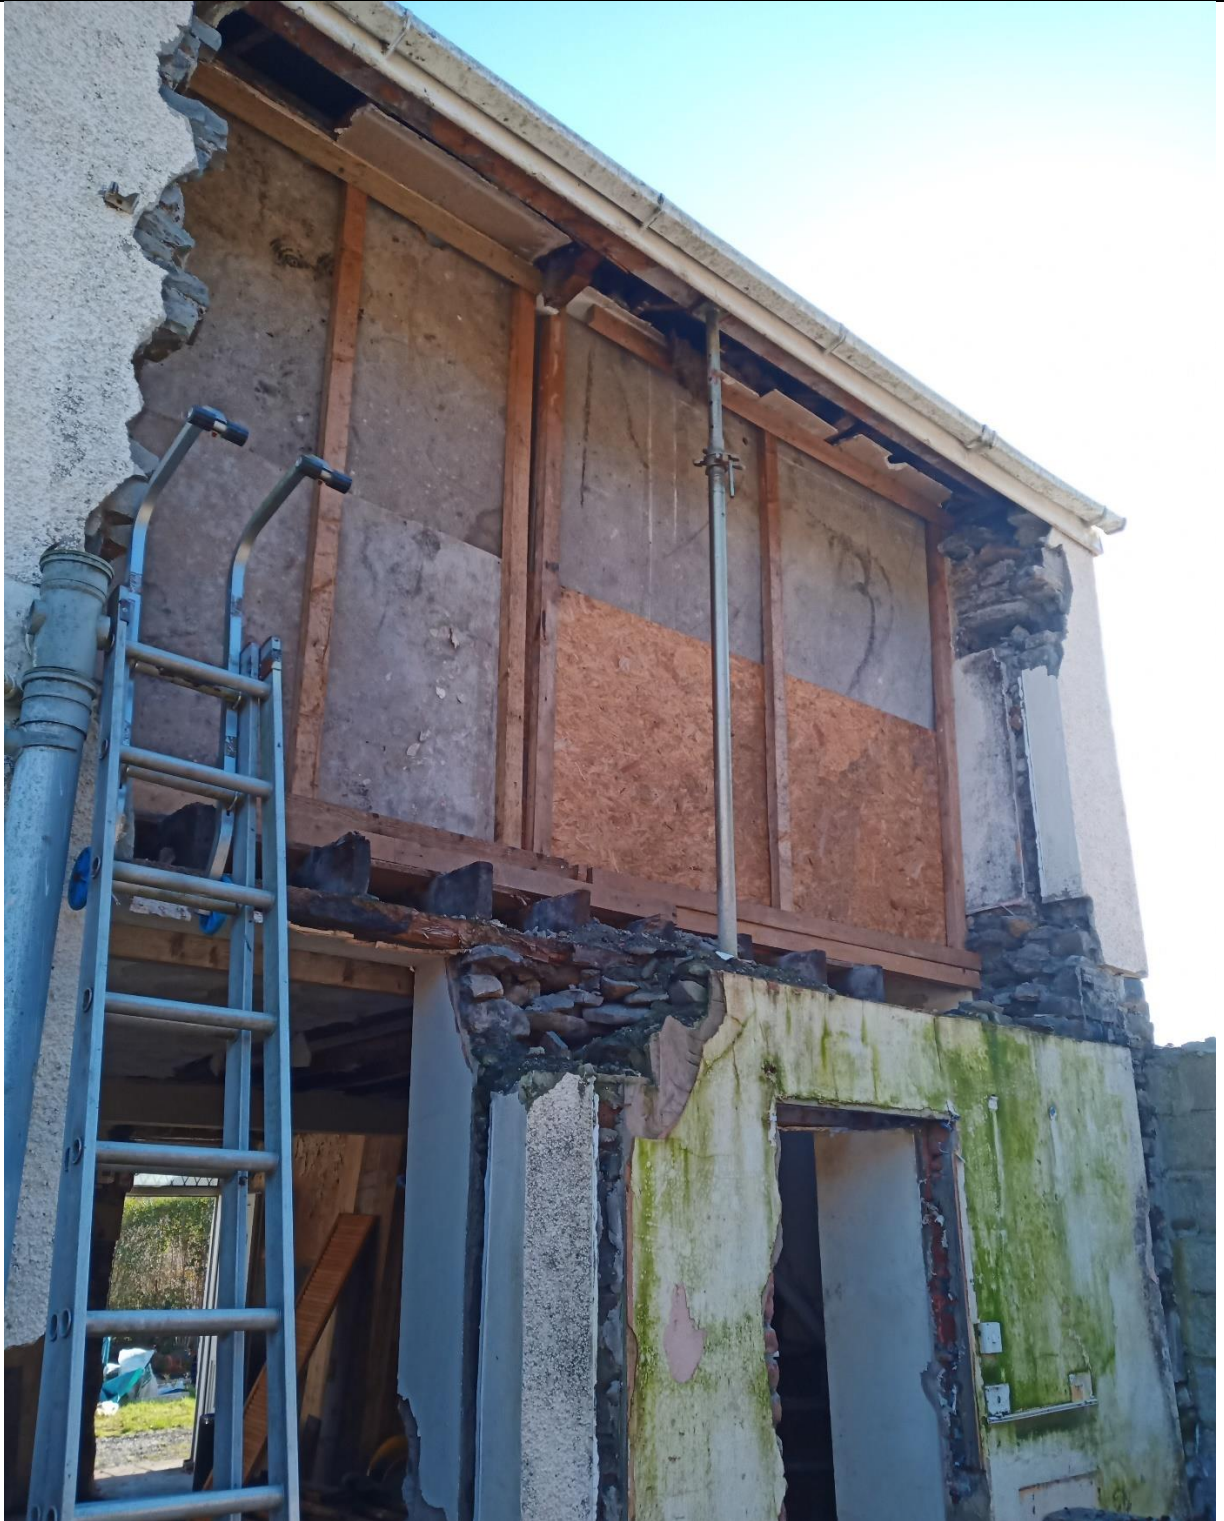
| <b>External Assessment (inc. presence/evidence of breeding birds):</b><br>Peacehaven Cottage is a semi-detached two-storey building currently in the process of being demolished. The house is a stone block build and finished in a rough render on the west and south elevation, with dressed stone at the front of the property (east elevation). The entire back of the house (west elevation) has been removed and boarded up over the winter months (2022/2023) (Figure 2). The ground floor is open to the elements and there are large gaps around the boarding on the first floor. The roof has been partially stripped of ridge and slate tiles creating large gaps with access to the loft space (Figure 3). The building has no soffits, facias made of timber and barge boards of uPVC plastic. Rainwater goods are plastic but in the process of being removed. The remaining windows and doors are double-glazed set in uPVC plastic frames. | | | |

Figure 2: West elevation from the ground floor showing boards and exposed stonework

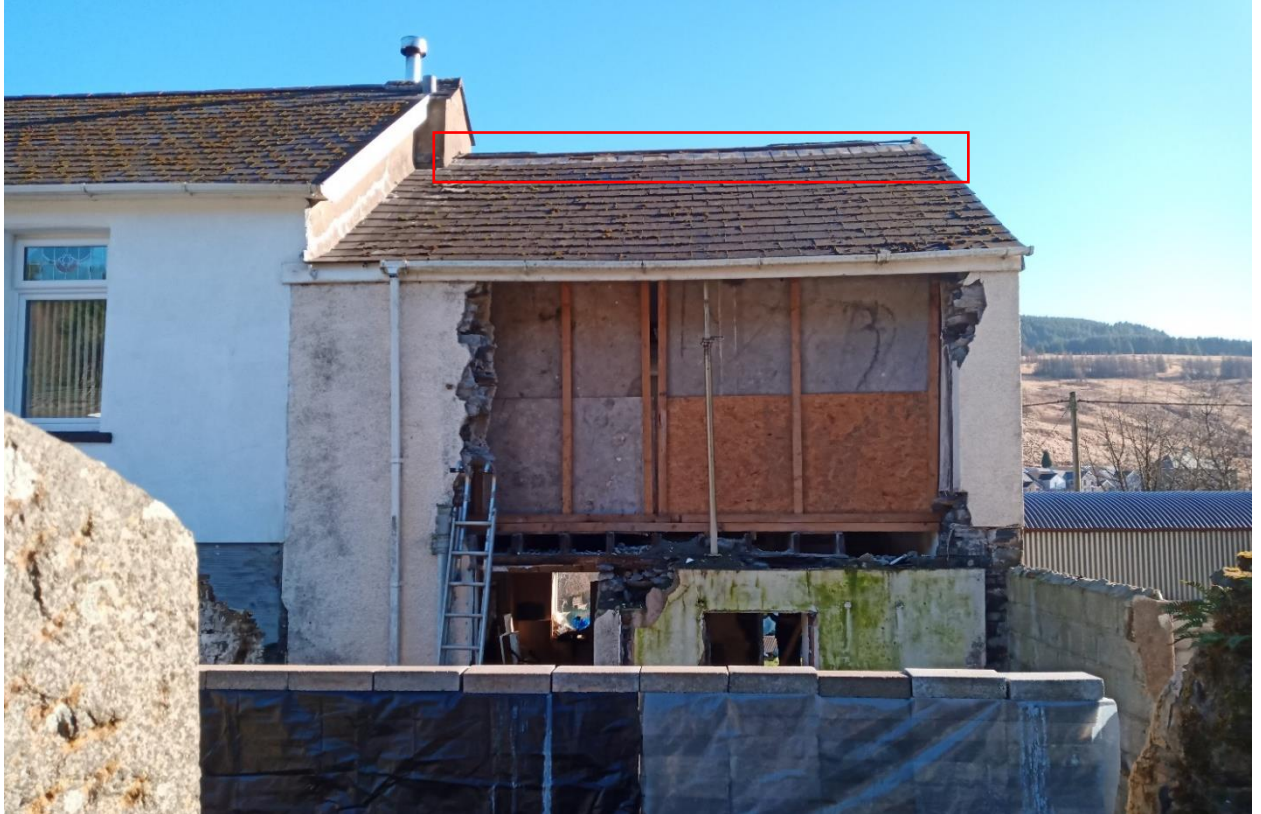
As the building is in the process of being demolished, very large gaps were noted that may afford access to a roost. However, it is unlikely that bats would occupy the building in its current state due to the amount of construction noise, natural light, and wind entering the property.

Figure 3: West elevation showing the removed ridge tiles highlighted in red

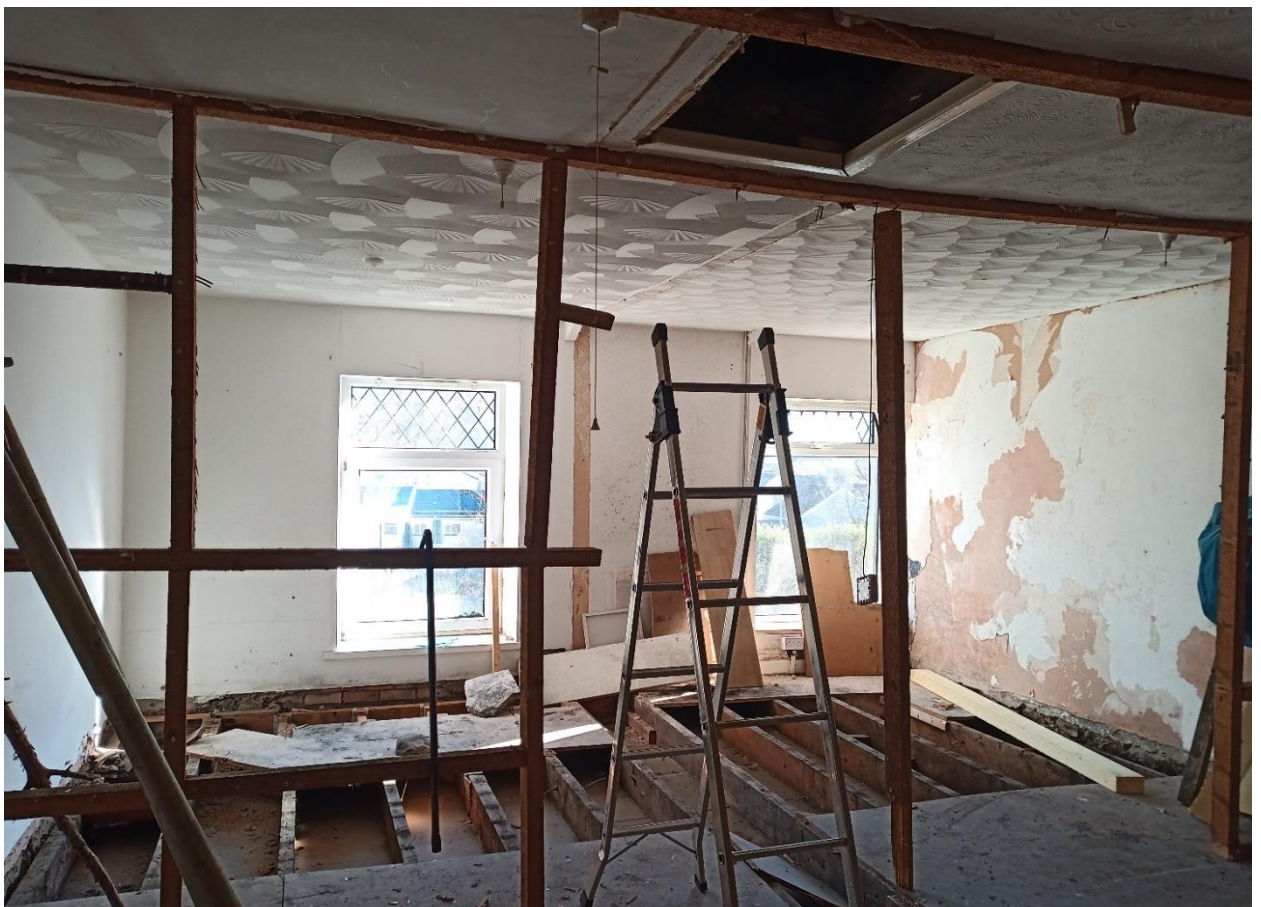
| <b>Internal Inspection (inc. presence/evidence of breeding birds):</b><br>The cottage is currently in the process of being demolished and as such is open to the elements at the west elevation. The property has been gutted of all internal fixtures and fittings including non-load-bearing walls and part of the ground floor ceiling (Figure 4). The roof has also been partially removed resulting in light and wind entering the attic space (Figure 5). | | | |

Figure 4: First floor interior facing eastward

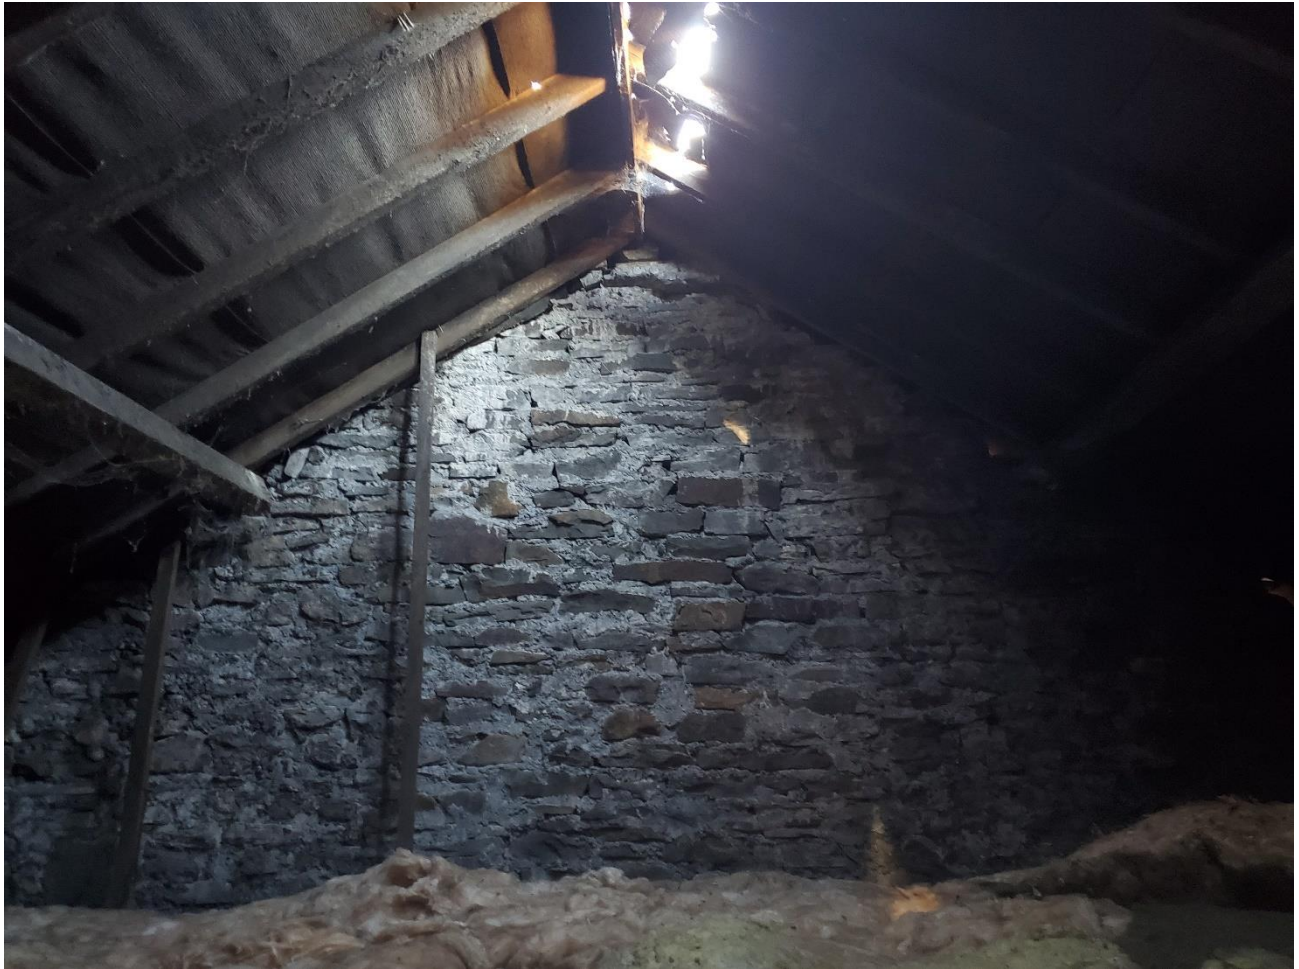
**Figure 5: View from loft interior showing light spill from removed ridge tiles**
