**Lonlas Boys Club, Lonlas Avenue,  
Skewen, Neath Port Talbot, SA10 6RT**

**Bat Survey Report for Lonlas Boys Club**

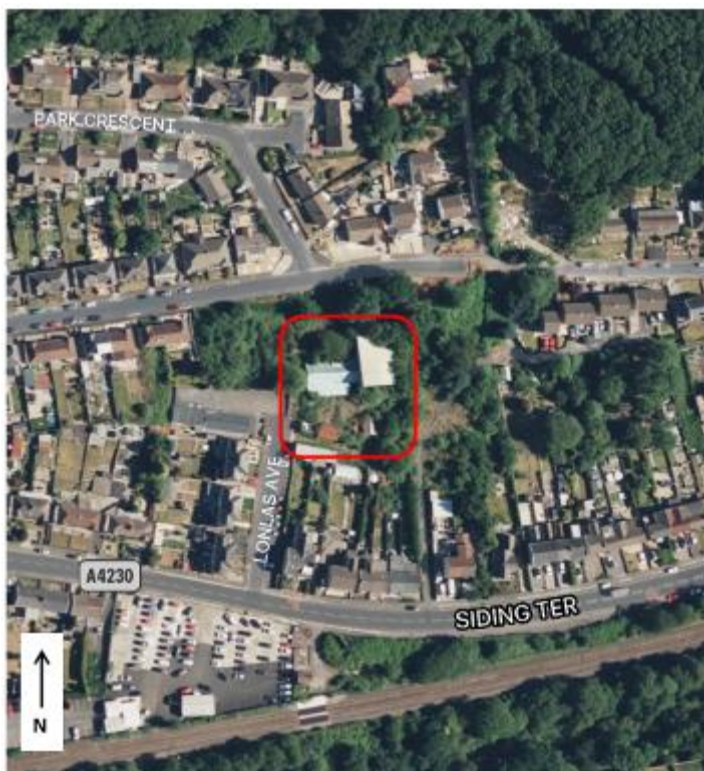
**Figure 1:** Aerial view of the property which is outlined in red (from Apple® Maps)

1.2.2 The property is subject to proposed plans for demolition to create space for a small residential development. Figure 1 is an aerial view of the property, figure 2 on the following page is of the wider environment around the property, and figure 3 is a site location and block plan. Additional plans are included in Appendix 5.

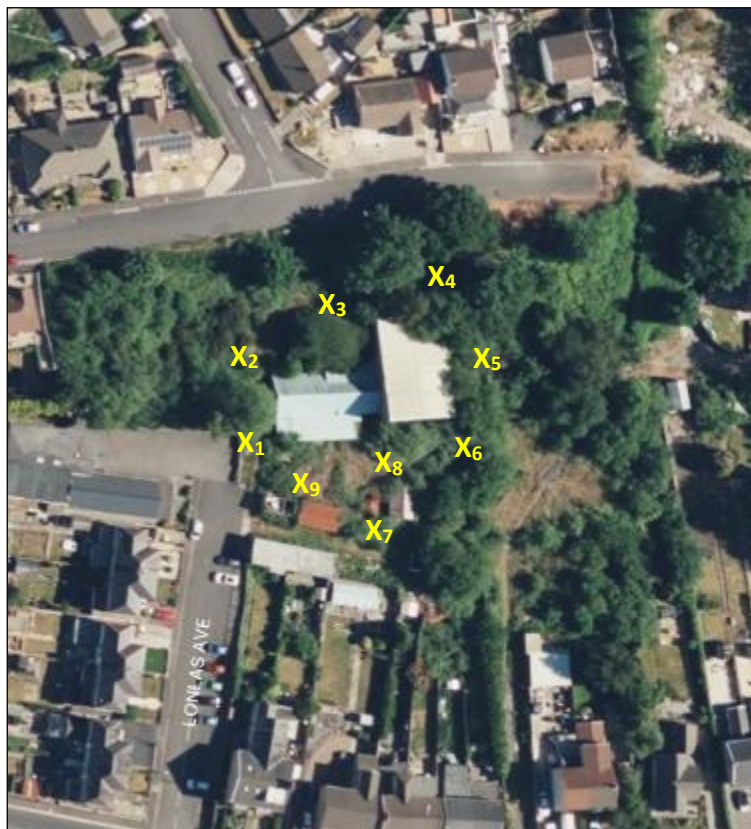
**Figure 4:** Surveyor positions during the activity surveys (from Apple® Maps)

3.1.7 Figure 4 shows the position of surveyors during the activity surveys. Each surveyor had a Magenta 5 or an Elekon Batscanner bat detector to assist in identification and detection of bats and their behaviour. **Surveyors X<sub>8</sub> and X<sub>9</sub> were only present on the dawn surveys.**

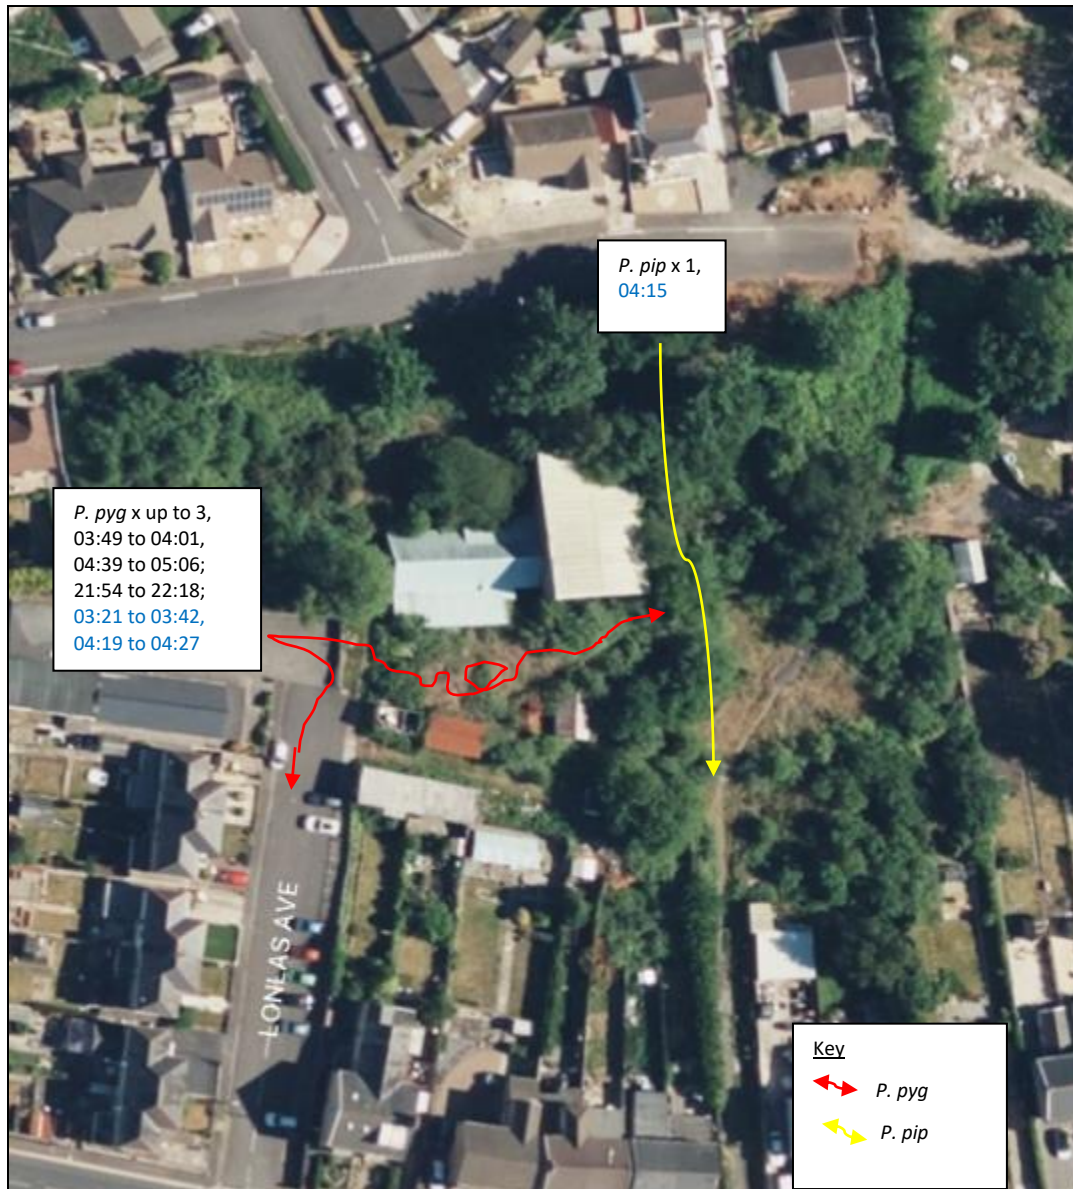
**Figure 5:** Aerial map showing the flight lines of bats detected (from Apple® Maps)

sporadic calls were heard to the north on the first dawn survey from 25 minutes after the start of the survey until 41 minutes before sunrise. In addition, during the second dawn survey, sporadic calls were heard to the north from 22 minutes after the start of the survey until 55 minutes before sunrise with an individual bat being detected commuting from the north to the south along the eastern boundary at 46 minutes before sunrise.

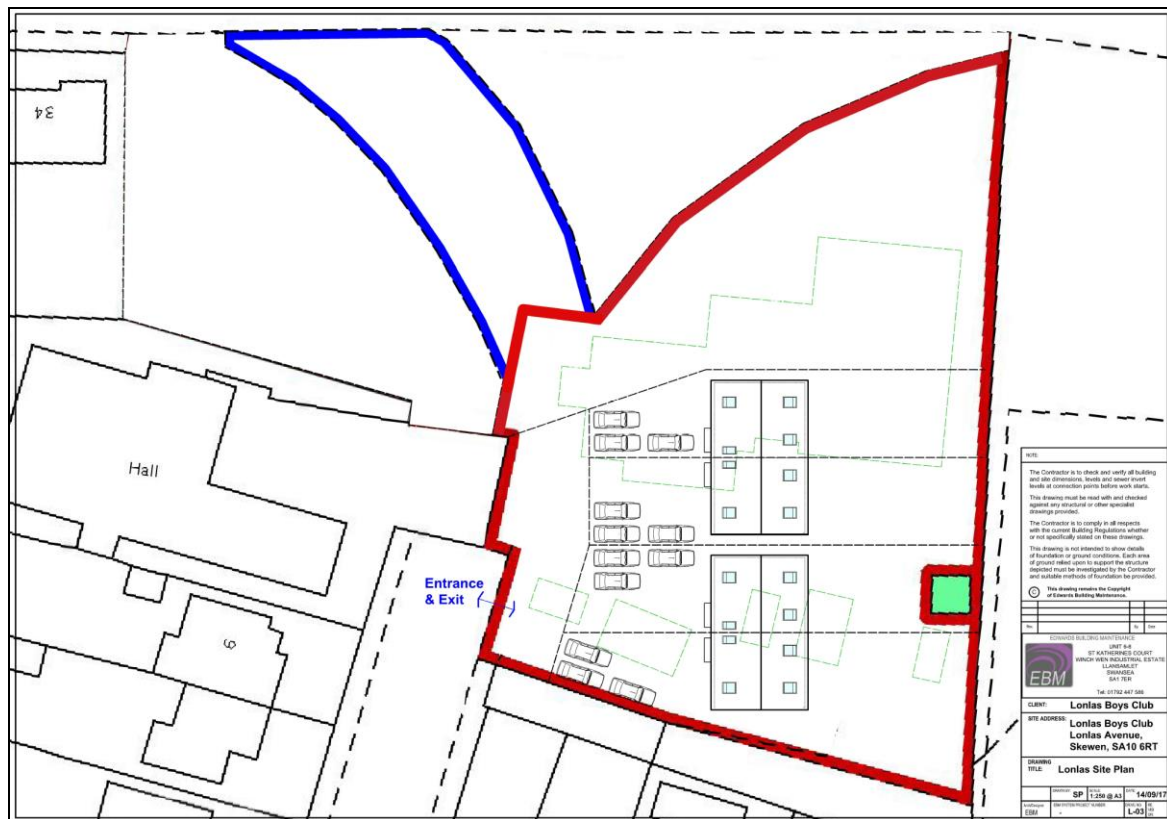
**Above:** Proposed site plans. **Below:** Proposed side elevations. **Biodiversity Enhancements** – the proposed locations for the bat tubes (Vivara pro) on the north and south elevations are shown by red arrows.

- ✦ **Recommendation 2 (Enhancement):** 1 x Vivara Pro Build-in bat box (or similar) to be embedded at the apex of the southern and northern walls of each pair of semi-detached dwellings. See appendix 5 for proposed locations.

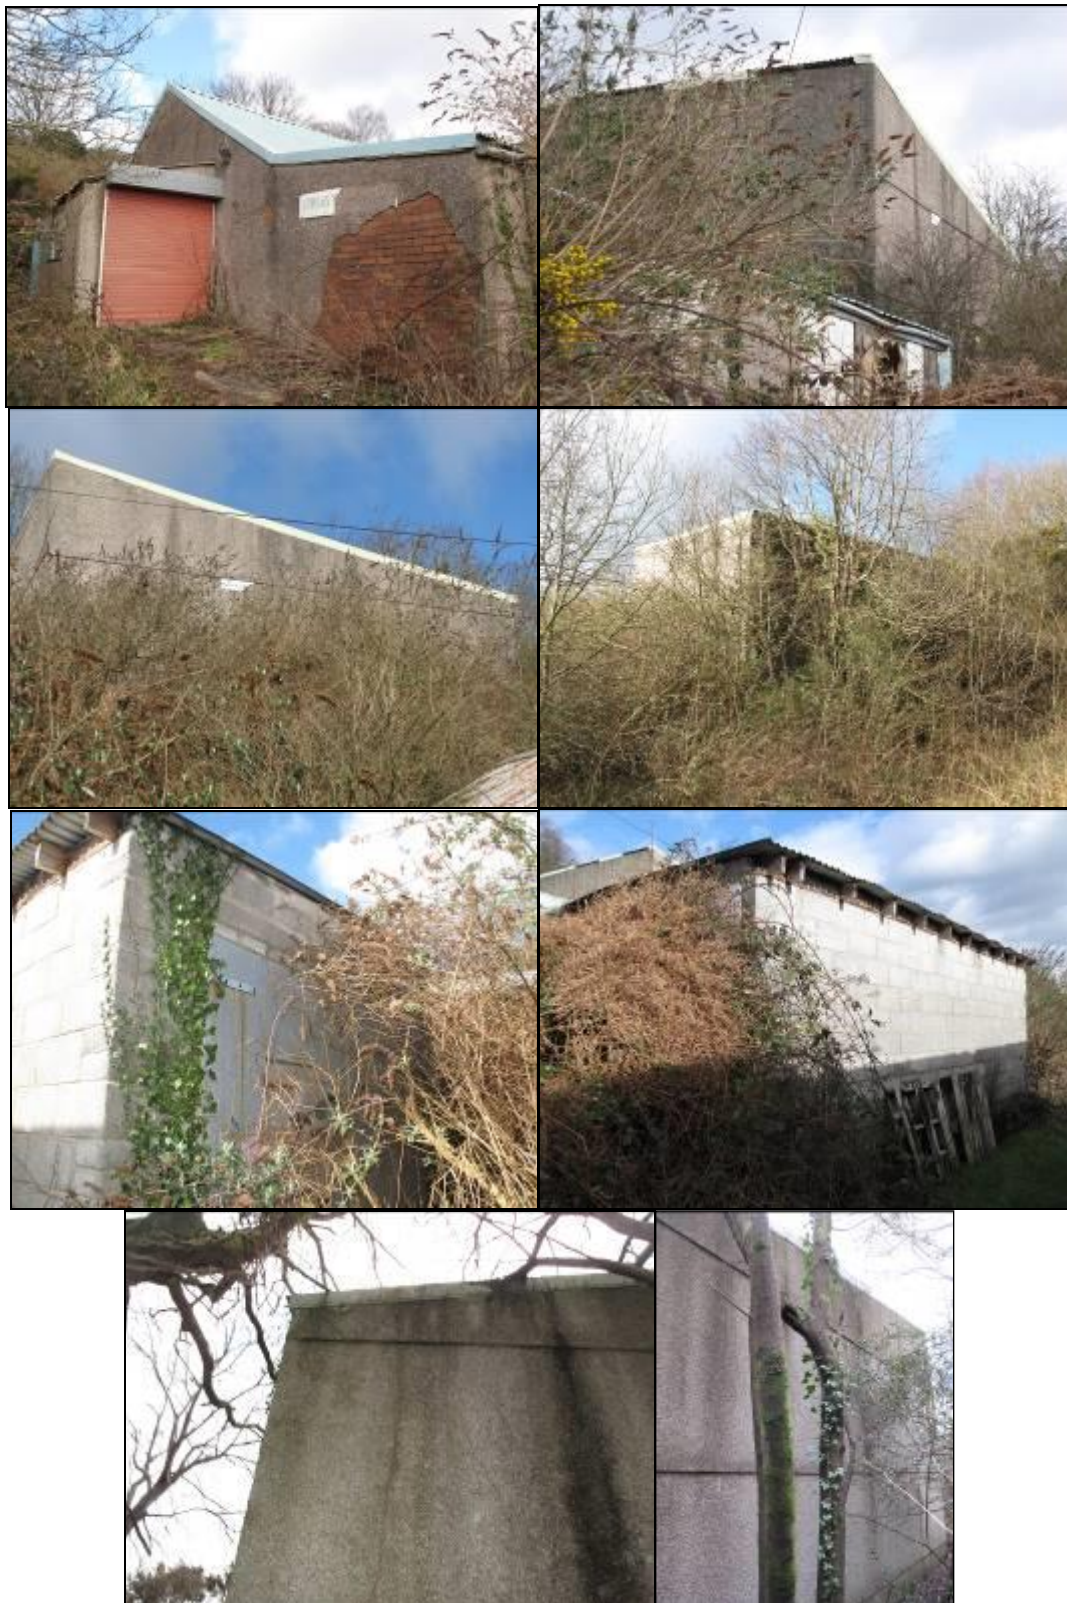
The property comprises a main L-shaped building (one part aligned west/east and the other north-south) and several small outbuildings (to the south of the main building) and is subject to proposed plans for demolition to create space for a small residential development.

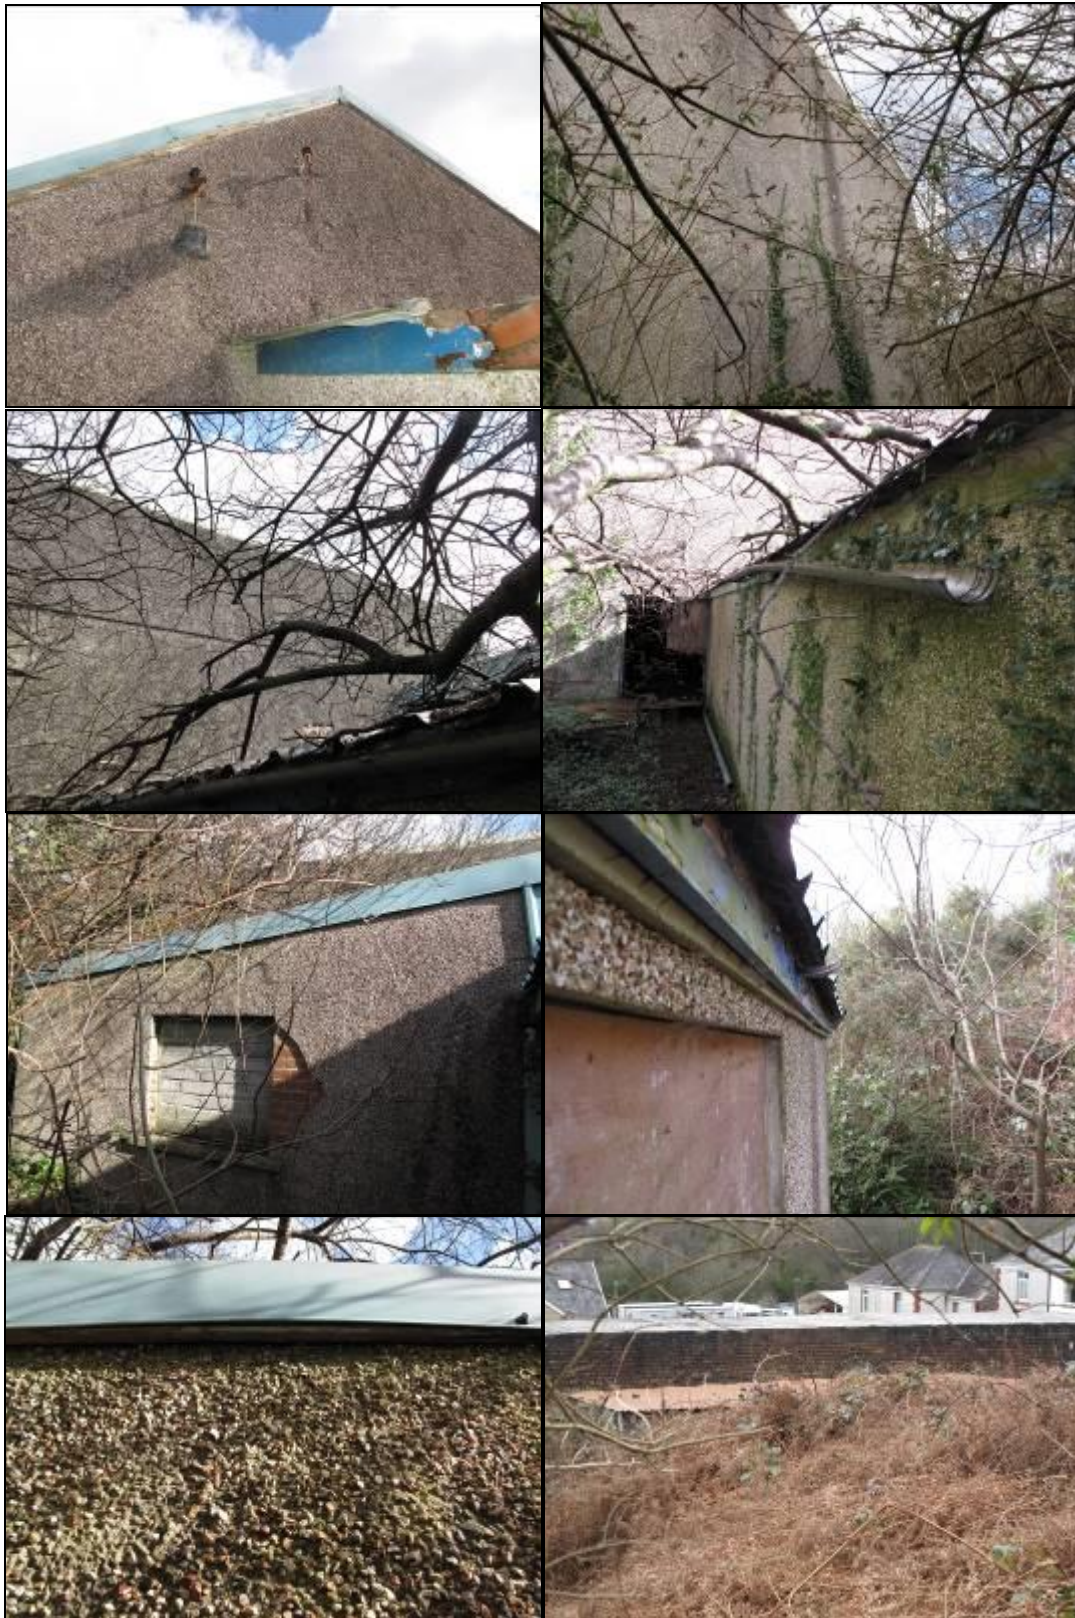
It is constructed of a mix of rendered and dashed brick, block, and corrugated sheet (with some timber boarding) with metal flashing and some timber fascia boards while the roofs are a mix of box profile and corrugated metal sheet. Generally, it is in poor condition having been subject to fire damage but it is surprisingly well sealed. The walls are predominantly intact with only a few areas where the render has come away and exposed the brickwork, but this has not created any potentially exploitable gaps. However, there are some wall top areas where the flashing has come away as well as some gaps under the timber fascia boards that have created some potentially exploitable gaps.

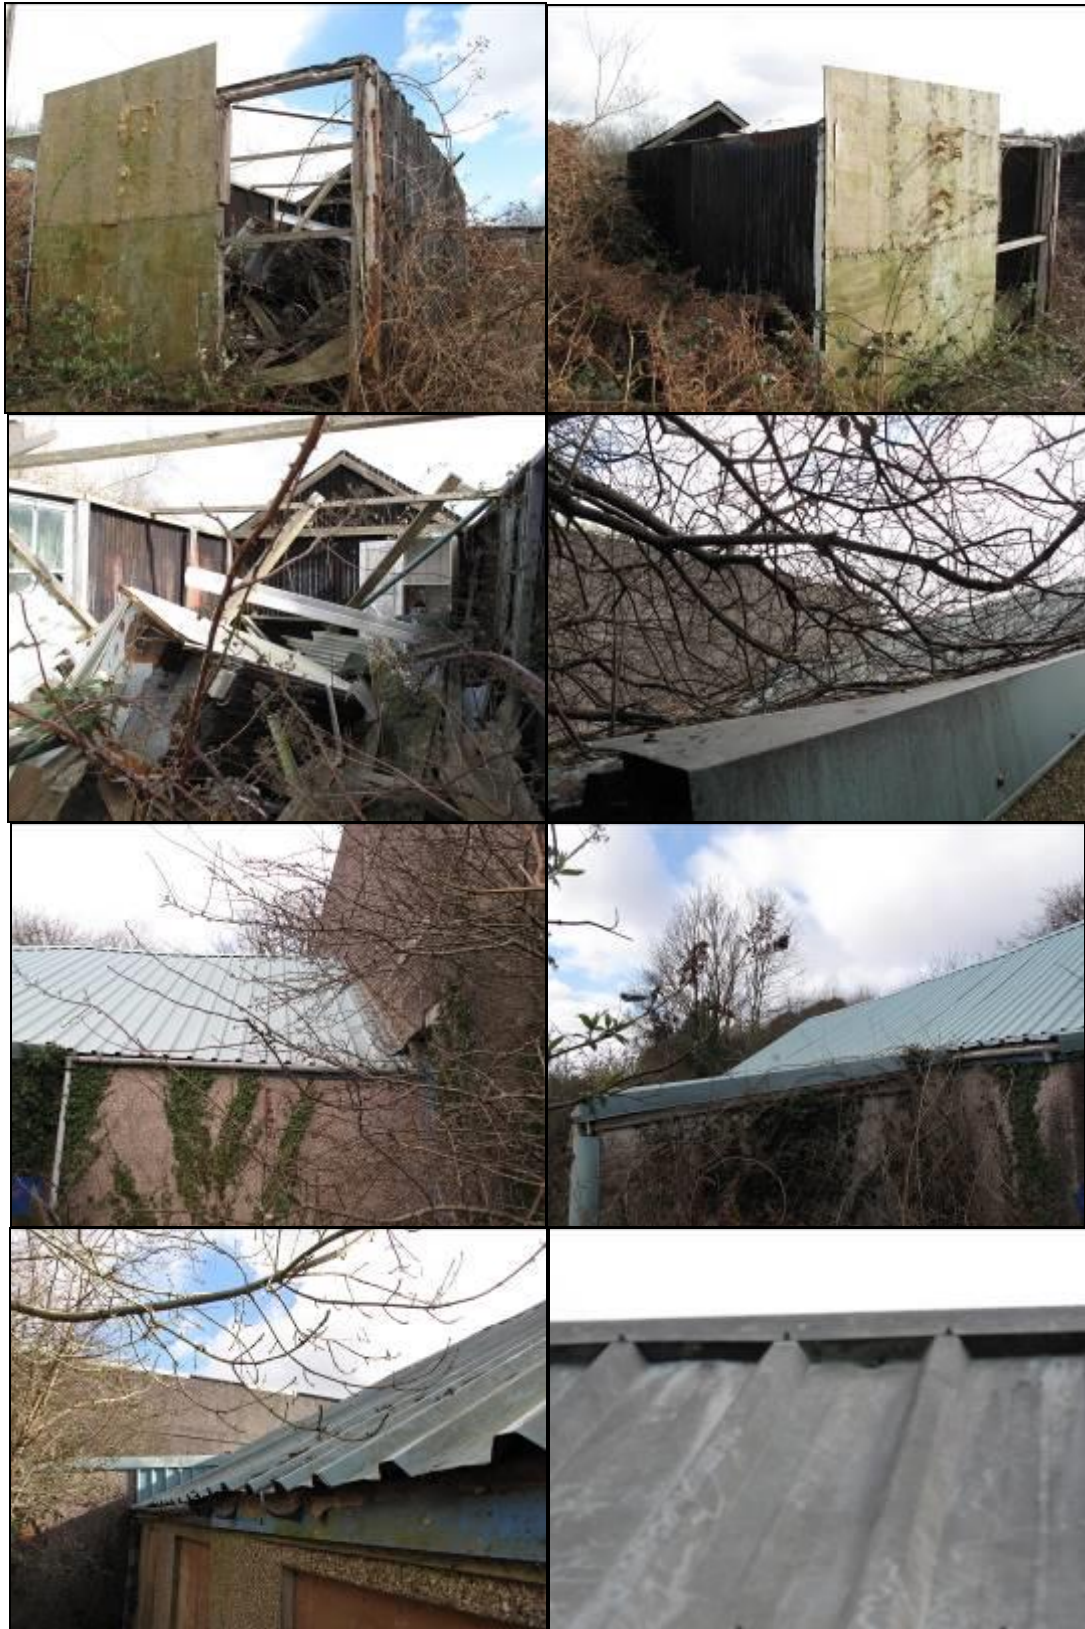
The roofs of the main building are in good condition with no missing sheets but some of the roofs of the outbuildings are missing, with one being mainly collapsed with no roof and another being used to store a car. The property has rollersheet and metal doors with windows being mainly boarded over with only one or two still glazed, but there are some gaps under the boards and around the frames, the latter enabling interior access for those bats which do not require fly-in access.

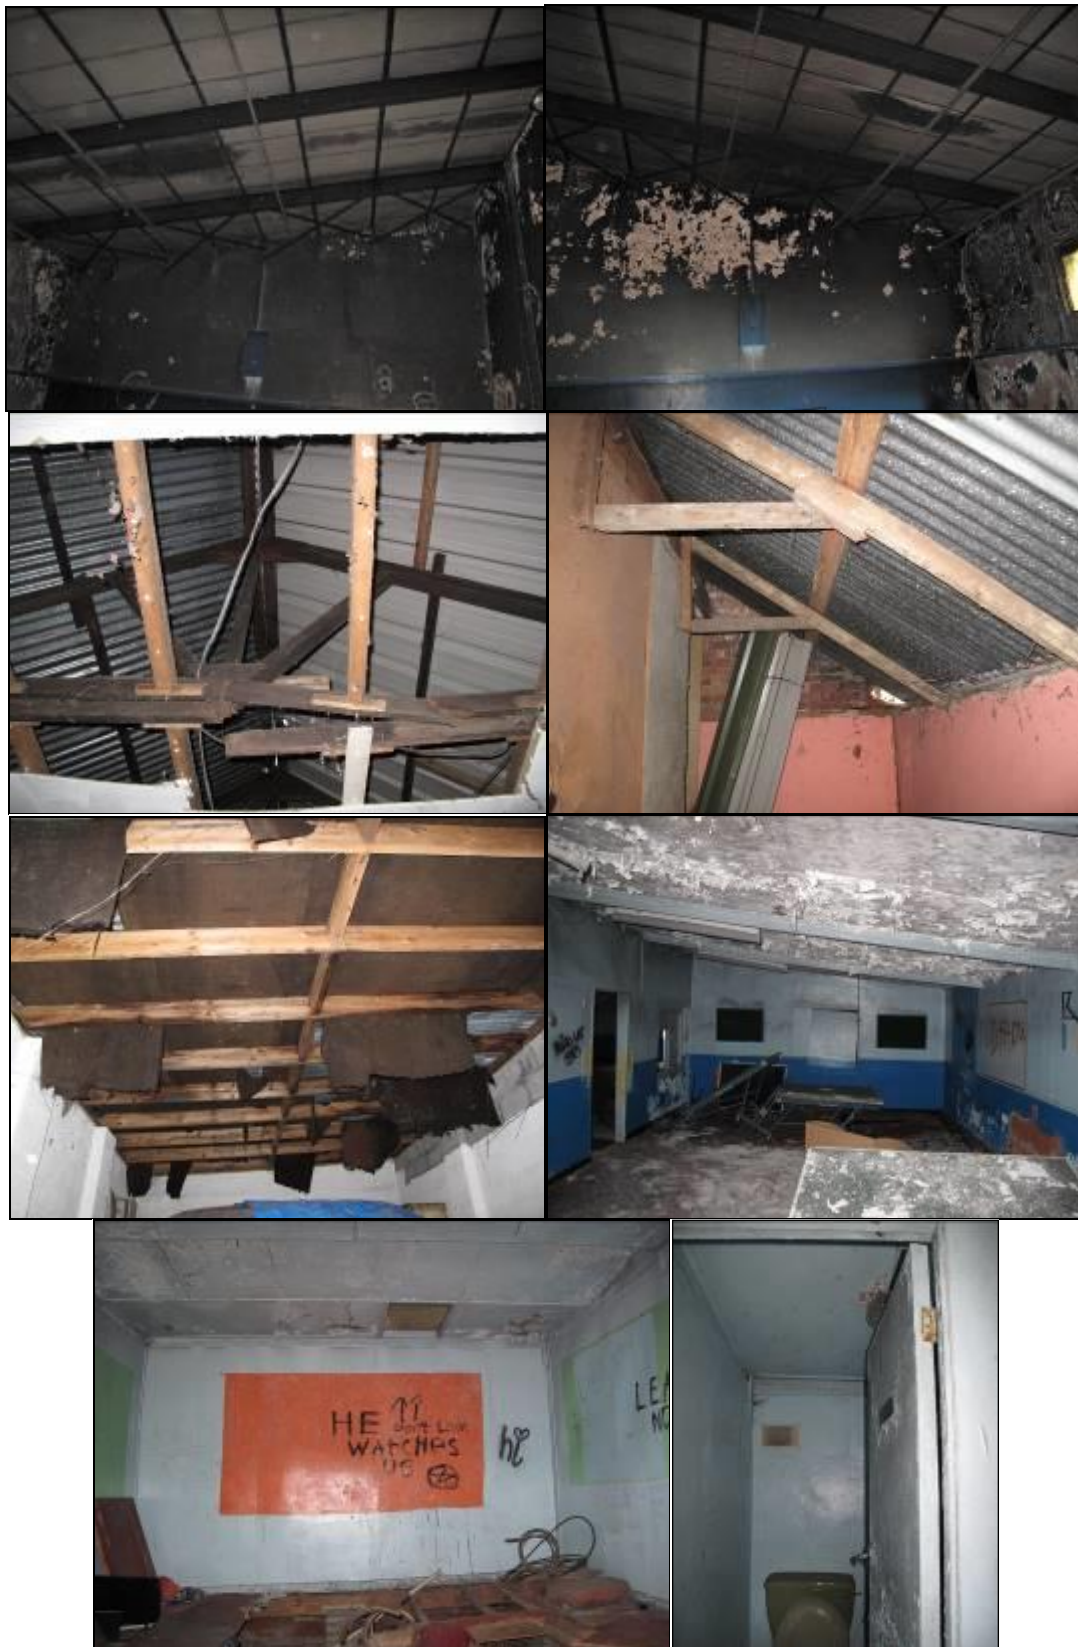
Internally, the main building has been subject to significant fire damage and vandalism, there is a lot of debris within, and it is dark inside while the outbuildings are much lighter; thus reducing any potential for day roosting. There are some areas which could be suitable for crevice-dwelling and roof void dwelling bats, such as wall top gaps, crevices in timber joists, and boarding on the windows, but these were all examined carefully with no live or dead bats or their signs (e.g., droppings, urine stains, smells) found anywhere either externally or internally.

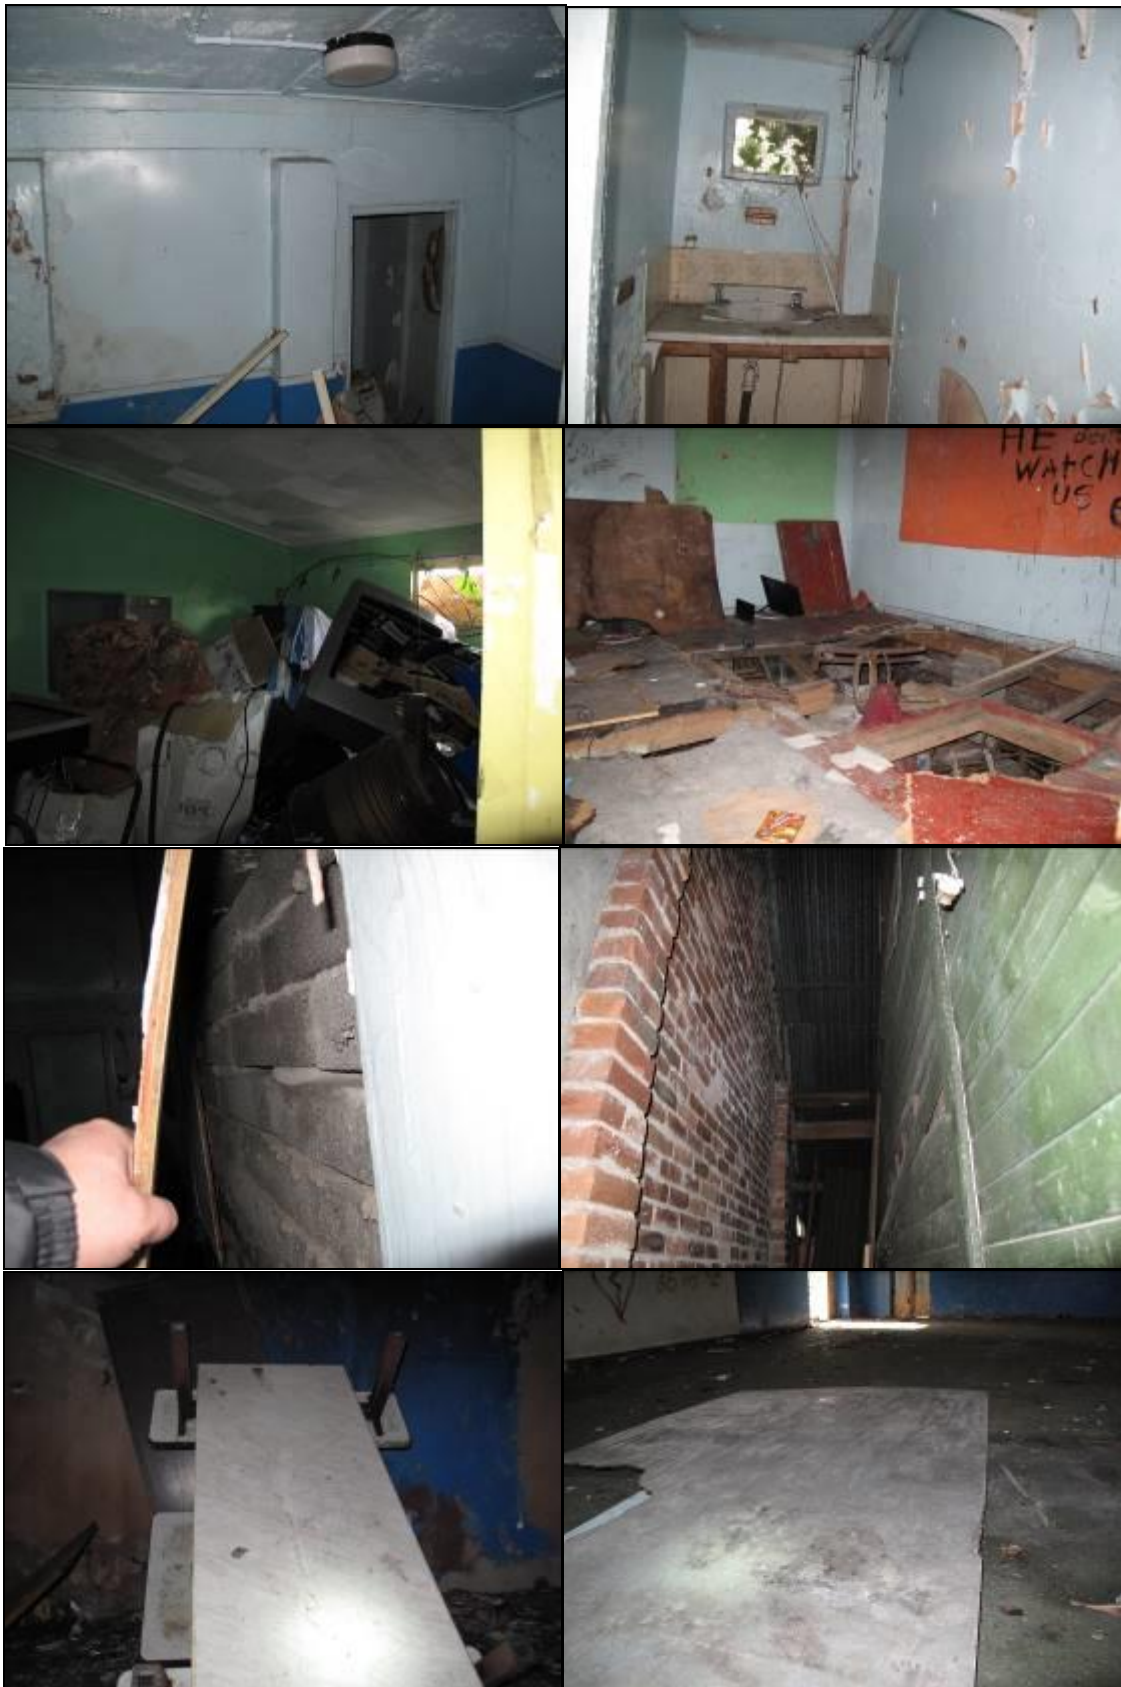
Additional interior images showing the absence of any bats or signs of their presence – gaps behind boards as well as other areas were all checked thoroughly.

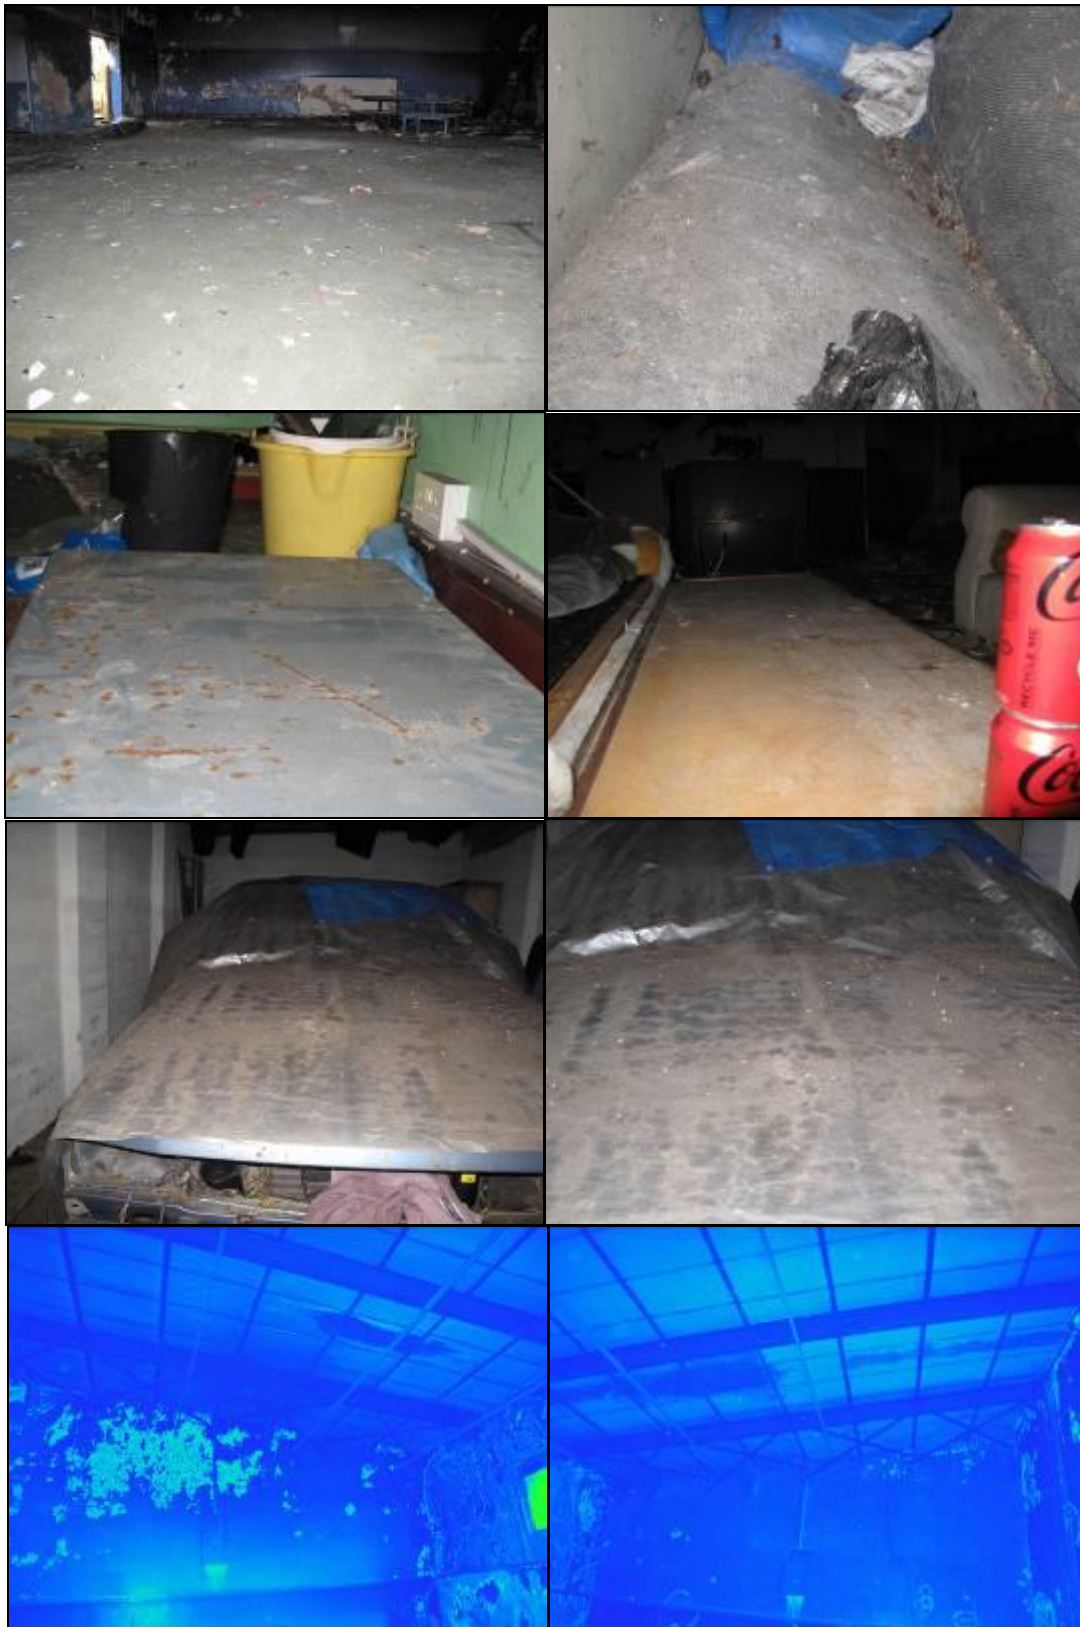
Additional interior images, including thermal images taken from within the main building. No 'hot spots' (which [in this case] would be in red) were found that may indicate the presence of cryptic bat species.

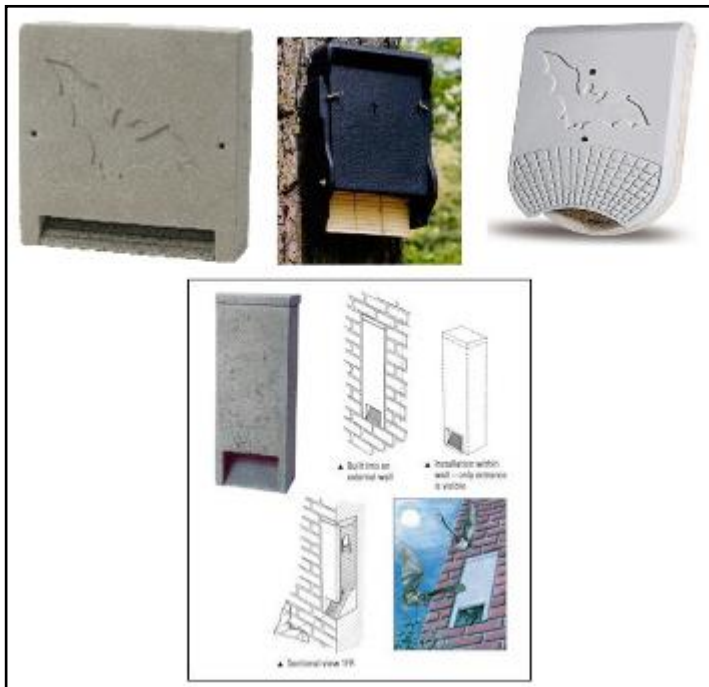
**Top:** From left to right, the in-wall Schwegler 1FE, the tree mounted 1FF and the multi season 1WQ. The bottom image shows the 1FR in situ.

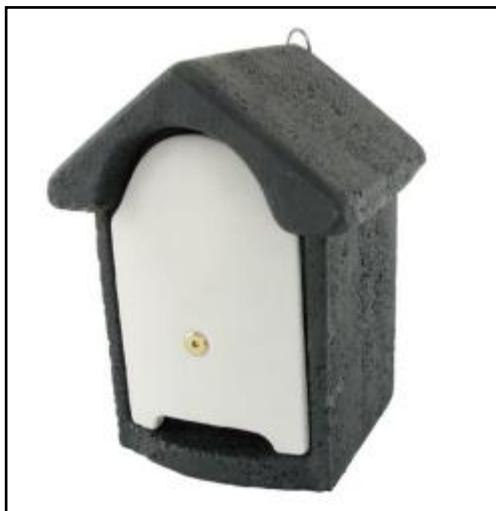
**Left:** The Harlech WoodStone bat box offers excellent insulation with a minimum of condensation for roosting bats. WoodStone® is a mixture of sawdust from FSC wood sources and concrete, and it is designed to last for years. It is breathable so there will be no problems with condensation and Woodstone maintains a consistent temperature inside, providing excellent insulation for roosting bats. Height 24cm x width 19cm x depth 18cm; Weight 4.4kg; Colour: Black with White front panel; Hook for hanging; Removable front panel for inspection/cleaning; and 10 Year Manufacturers Guarantee. **Bottom:** The Vivara Pro Build-in bat box has been specifically designed to fit into the cavity of house walls. It features a slim sized entrance hole which can sit

- ✦ **Recommendation 1 (Enhancement):** 2 x Harlech Woodstone (or similar) bat boxes to be affixed to mature trees within the curtilage of the property. To be affixed in an elevated position (2–7m and ideally 4m) away from artificial light and potential predation and ideally facing different directions to provide a variety of roosting opportunities. See [Putting up your box - Bat Boxes - Bat Conservation Trust \(bats.org.uk\)](https://bats.org.uk/putting-up-your-box-bat-boxes-bat-conservation-trust/) for siting advice.

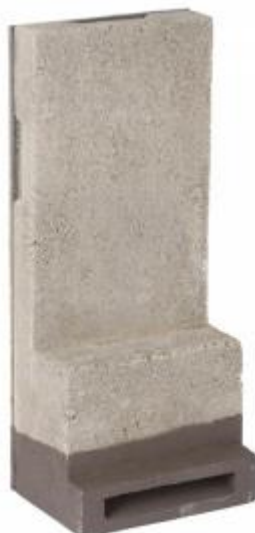
flush in a course of bricks to provide a discreet entry way for bats. It is manufactured from hard-

wearing WoodStone and plywood with removable side panels so that several boxes can be placed side by side. Position the box at least 2m above ground level away from artificial light sources. WoodStone is a mixture of sawdust from FSC wood sources and concrete, and it is designed to last for years. It is breathable so there will be no problems with condensation and Woodstone maintains a consistent temperature inside, providing excellent insulation for roosting bats.

- ✦ **Recommendation 1 (Enhancement):** Prior to works commencing, 2 x Harlech Woodstone (or similar) bat boxes to be affixed to mature trees within the curtilage of the property.

- ✦ **Recommendation 2 (Enhancement):** 1 x Vivara Pro Build-in bat box (or similar) to be embedded at the apex of the southern and northern walls of each pair of semi-detached dwellings.

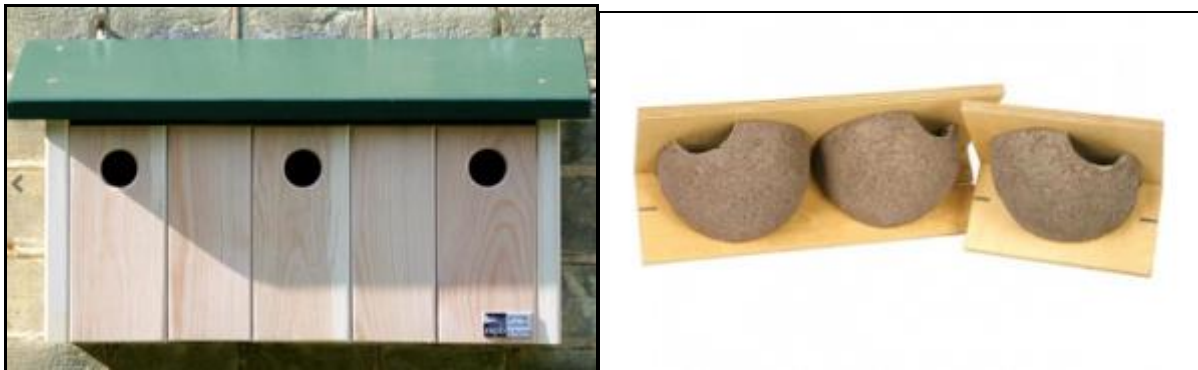
Examples of sparrow terraces and House martin nest cups. Siting advice can be found at [Where To Put A Bird Box | Nestboxes - The RSPB](#)

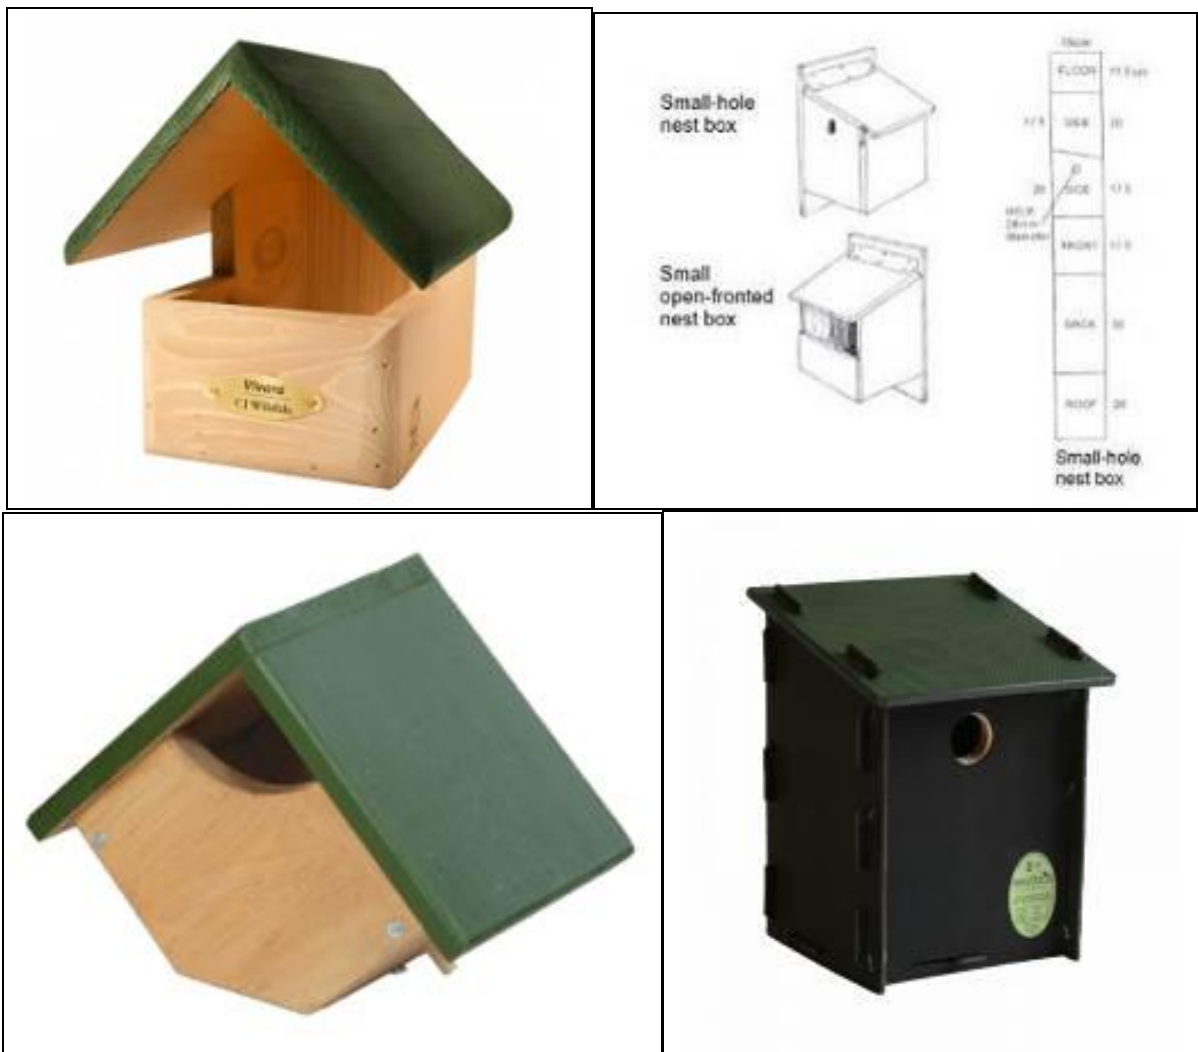
**Below right:** Examples of small-holed and open-fronted nest boxes. Siting advice can be found at [Where To Put A Bird Box | Nestboxes - The RSPB](#)

- ✦ **Recommendation 3 (Enhancement):** Any nests affected by the development are to be confirmed vacant prior to works commencing. 2 x Small-holed and 2 x Open-fronted nest boxes to be affixed to mature trees within the curtilage of the property.
