Agricultural Store / Outbuilding - Reinstatement of Collapsed Storm Damaged Building - Initial Proposal

| Project | Blaennant<br><del>Sun Y Nant</del> Barn Replacement |

Overview Of Proposed Concept Works

### Annotated Photographic Record

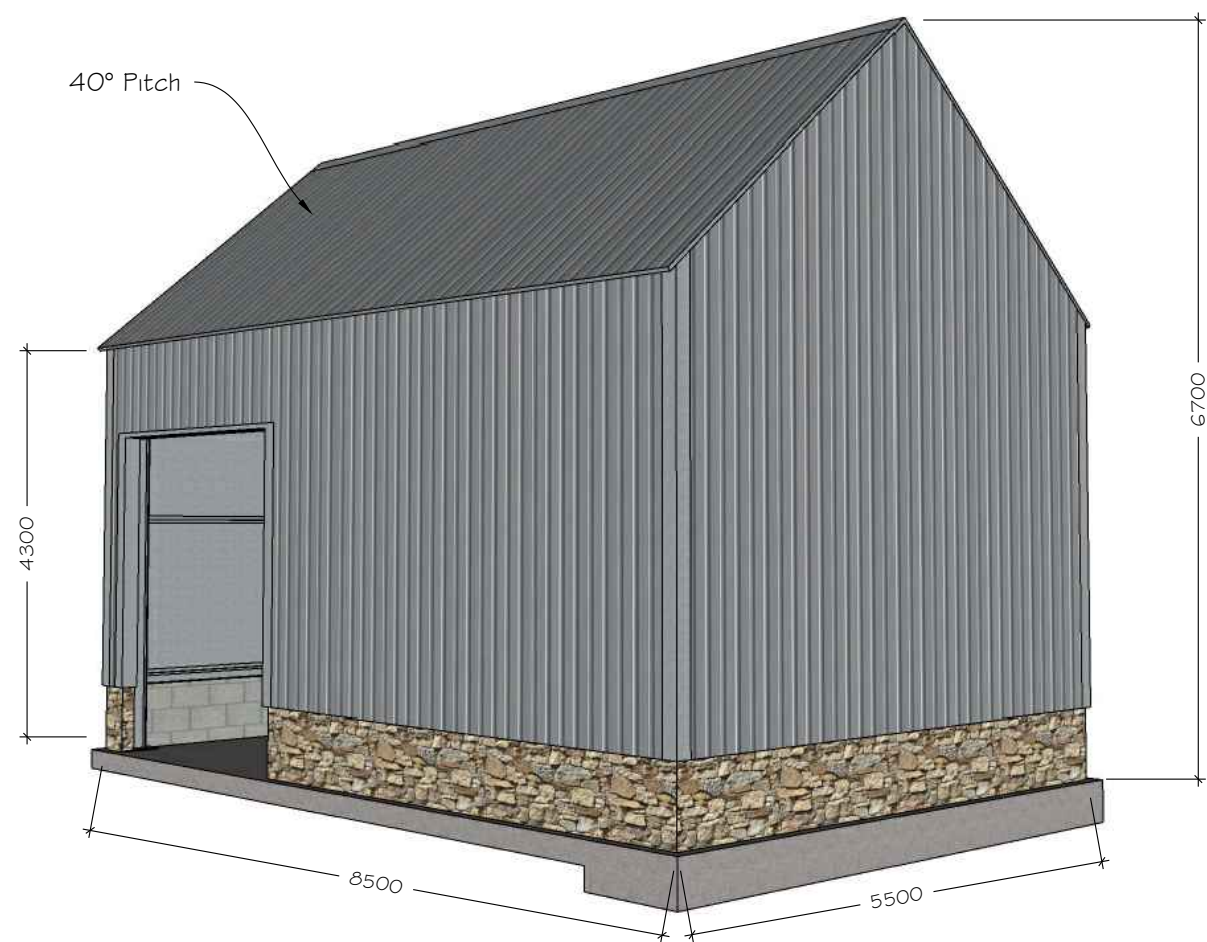
**Pic 1.** Proposed concept structure - guide dimensions taken during initial visit and scaled from photograph of existing - actual dimensions adjusted to match detailed measurement of remaining floor elements.

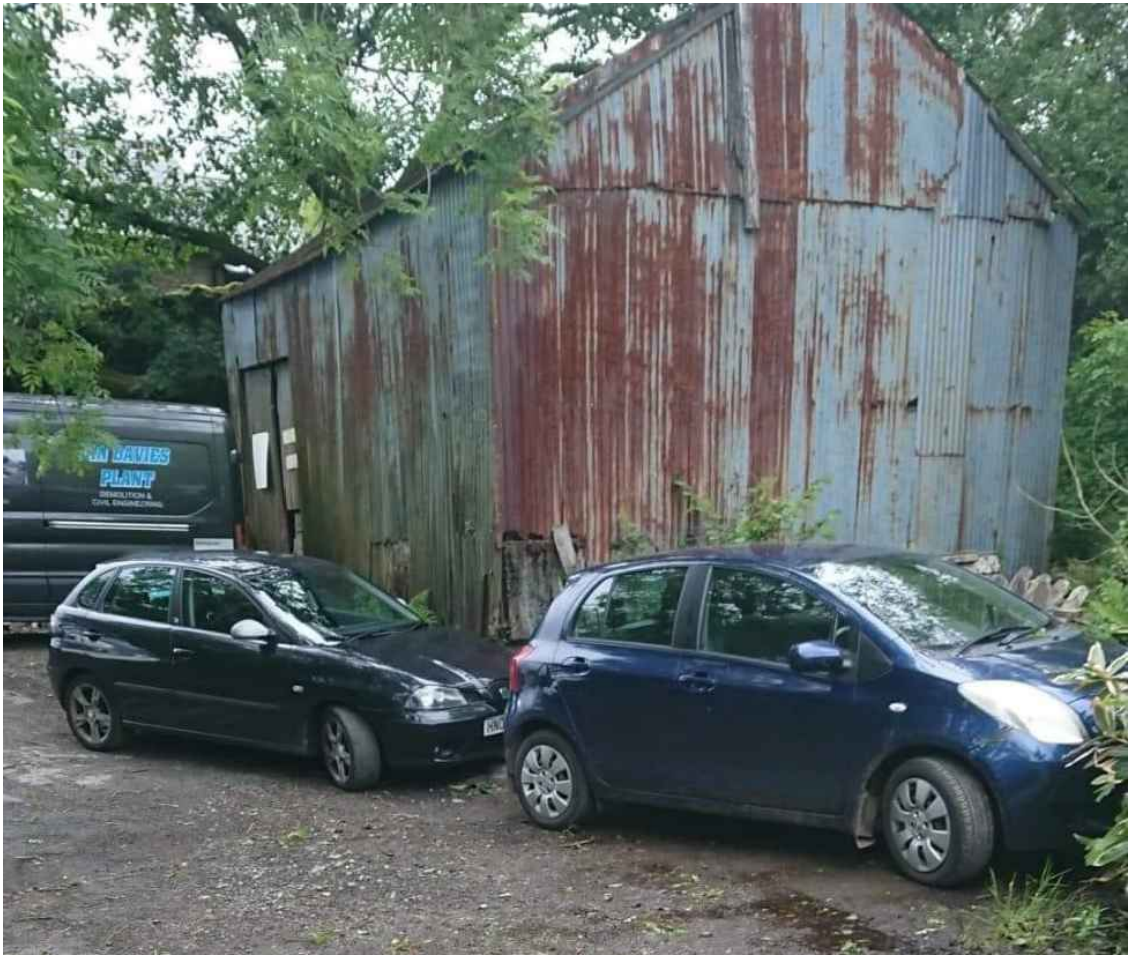
**Pic 2.** Photograph of structure pre-event and demolition used as reference

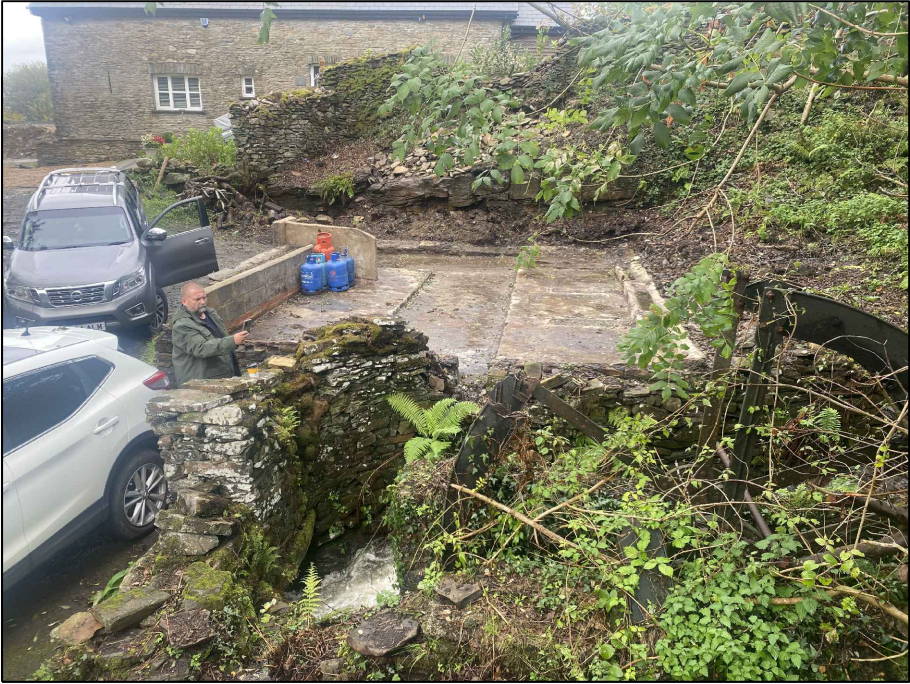
**Pic.3** There is a concrete floor slab remaining that was designed for use as a milking shed, which has a central channel for collection of cattle waste that could be washed directly into the brook (which would no longer be allowed). The site slopes downward toward the brook, which has a dry stone wall facing to the bank. Building in such close proximity to the brook will add complexity.

- The existing slab will require removal.
- The bank of the adjacent watercourse will likely require some consolidation works..
- The concept design as proposed herein is based on the type, form and dimensions of the pre-existing building, with modern building methods and arrangements introduced.

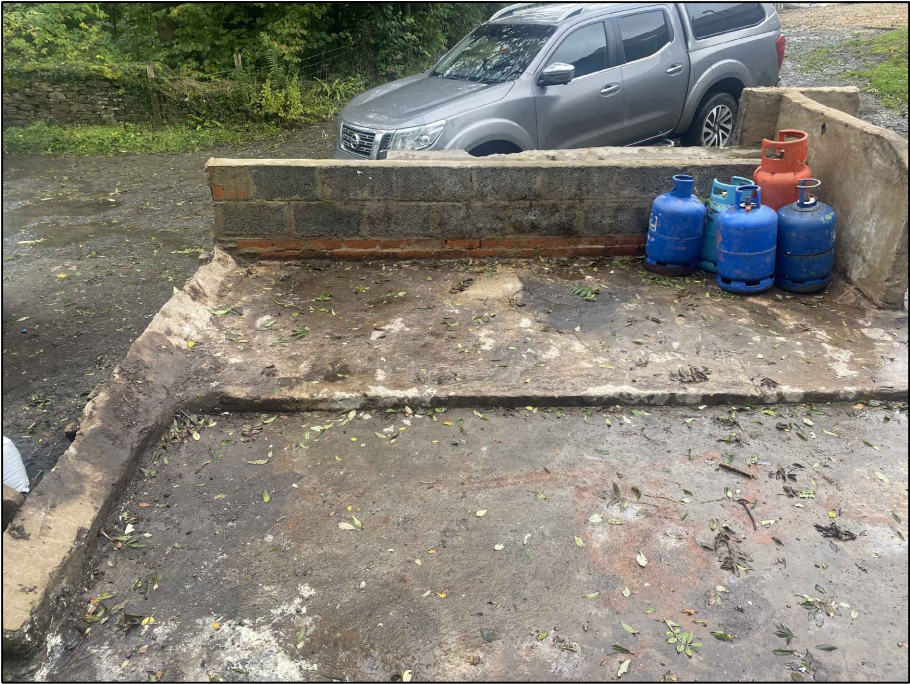
**Pic.6** View of slab / perimeter toward South West.

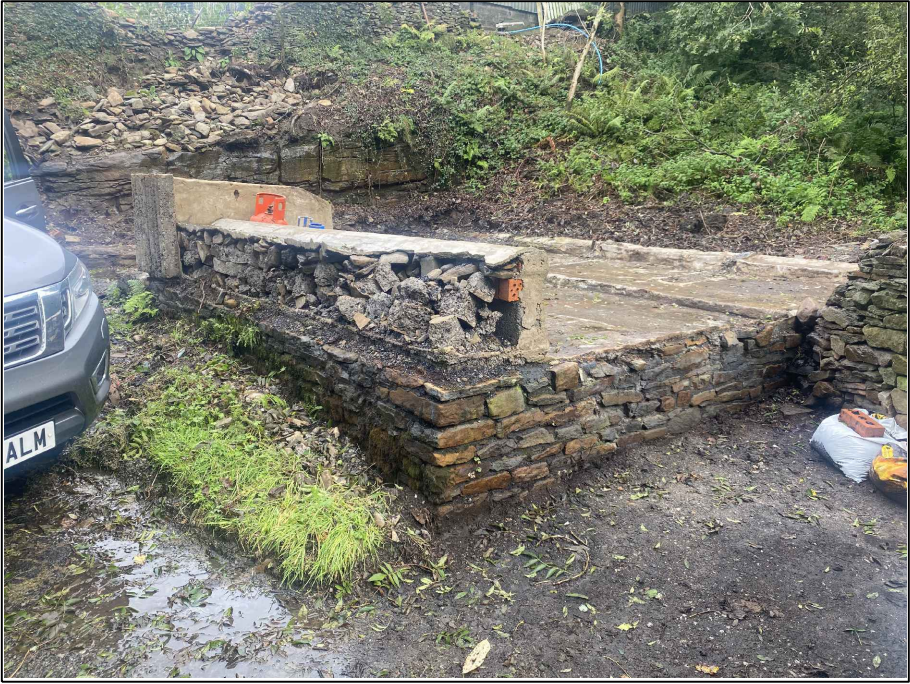
**Pic.4** The remaining substructure walls viewed from the South West aspect - natural stone walling used to form the perimeter along the sloping site. A small section of concrete block wall was present to the front elevation only

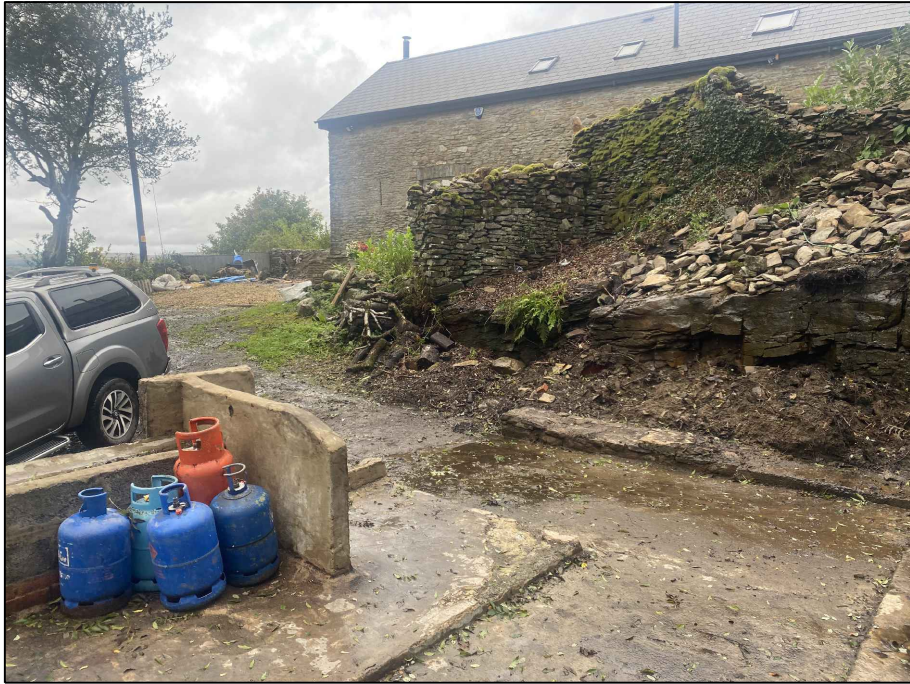
**Pic.7** View of slab / perimeter toward North West (vehicle entrance point).

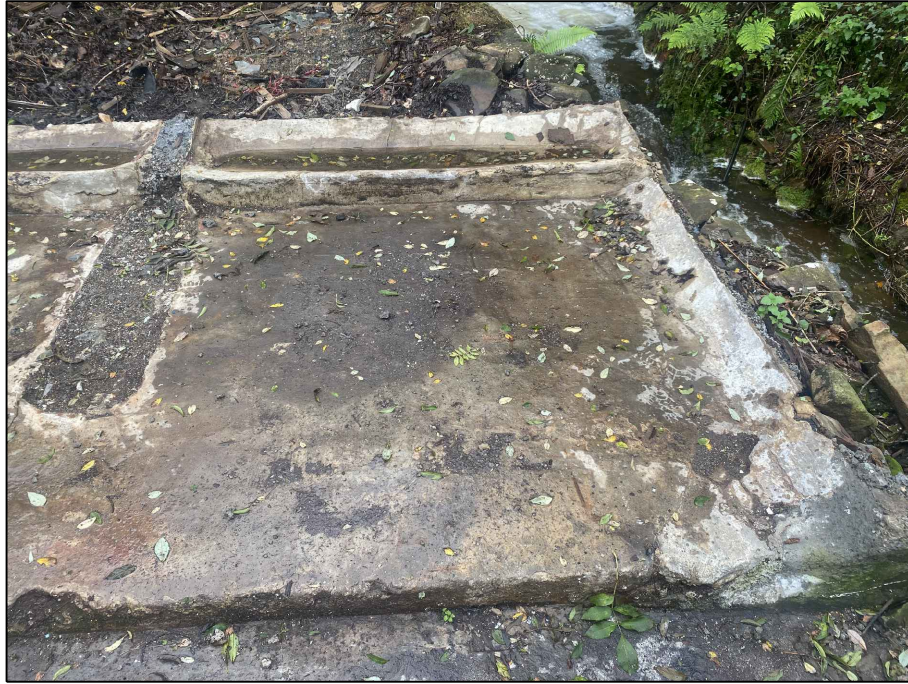
**Pic.5** Concrete floor slab - remnants of division panels and feeding trough along the rear wall base.

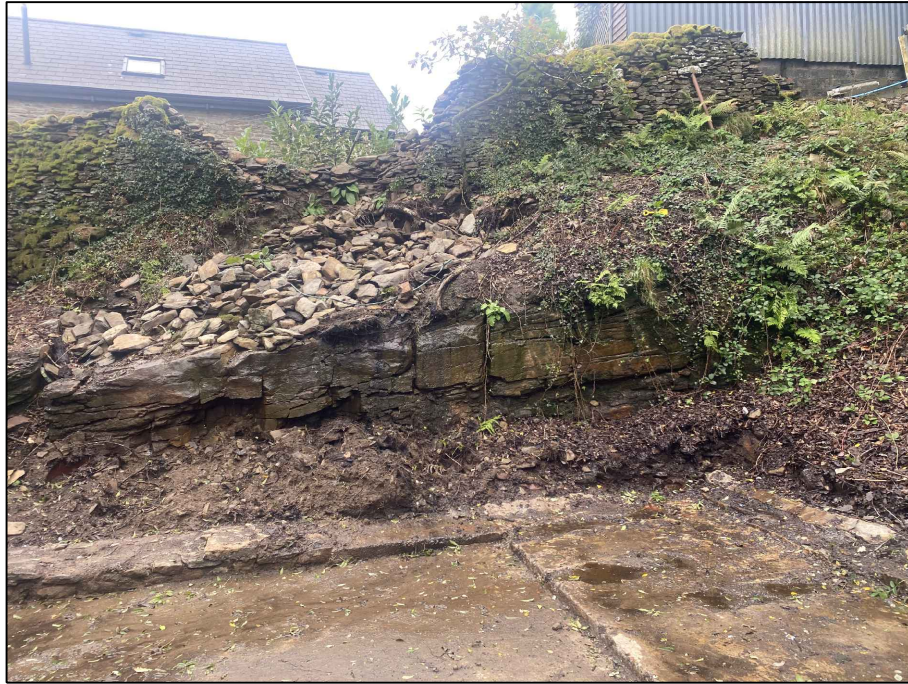
**Pic.8** View of slab / perimeter toward North East. Note the close proximity of the rock face bank and level of vegetation earth above slab level

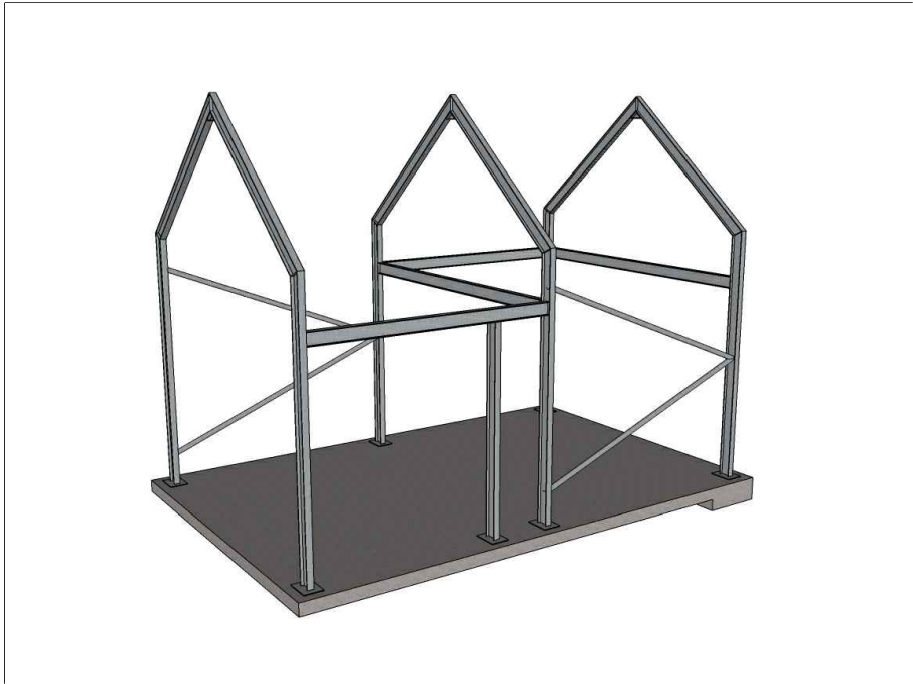
**Pic.9** Proposed concept substructure as a reinforced concrete raft with thickened section possibly required to end in close proximity to the brook (where some bank walling will require reinstatement also). Galvanised portal steel frame with lateral bracing and beams for heads of openings and forming structural support for partial upper floor store

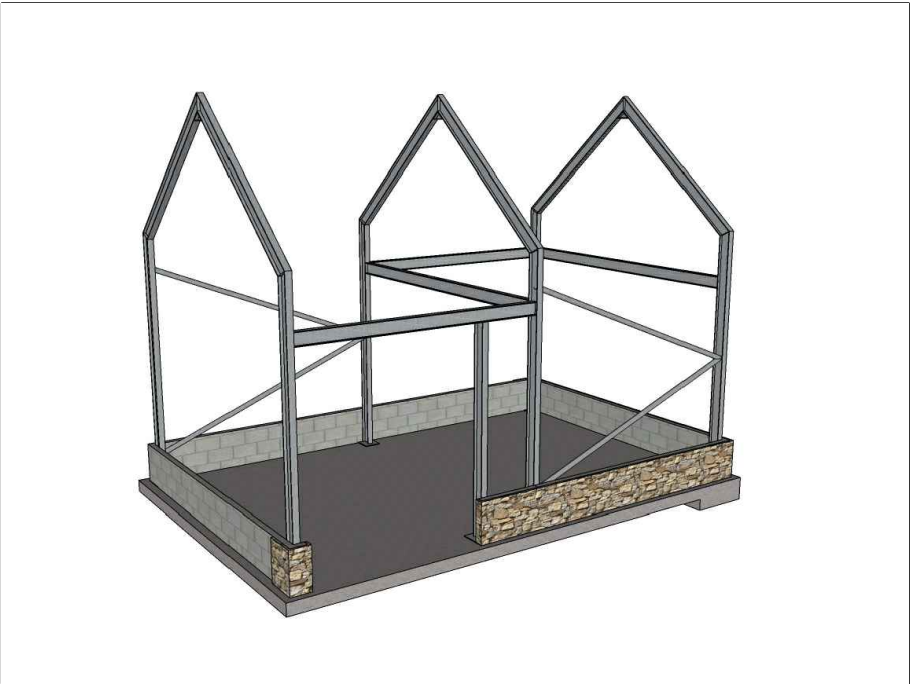
**Pic.10** 100 mm thick blockwork wall 3 course height to perimeter, with West and South facing blockwork being clad in natural stone 'Z Cladding'.

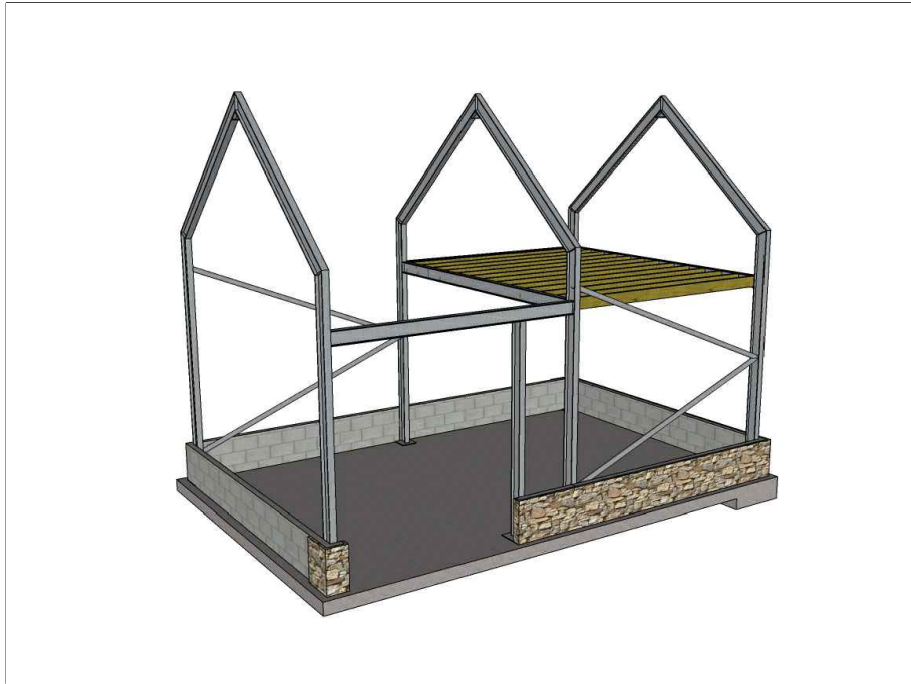
**Pic.11** Tanalised timber joists spanning between structural suspended floor members to provide storage accommodation to domestic floor standard capacity (1.5kN/m2). P5 Grade 18mm T&G flooring as deck. Soffit left exposed.

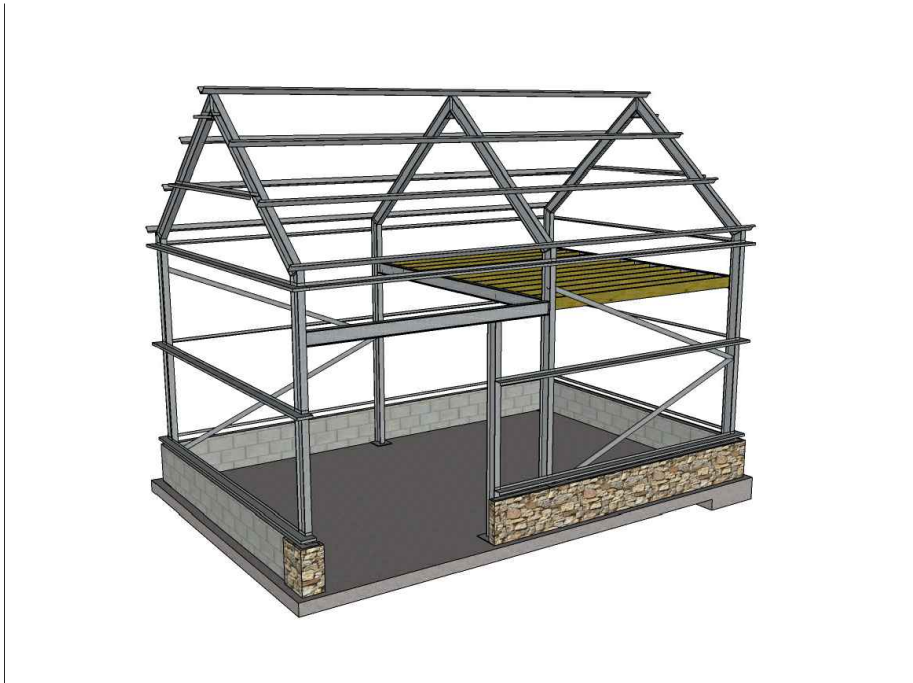
**Pic.12** Z Section galvanised purlins as cladding rails to walls and roof

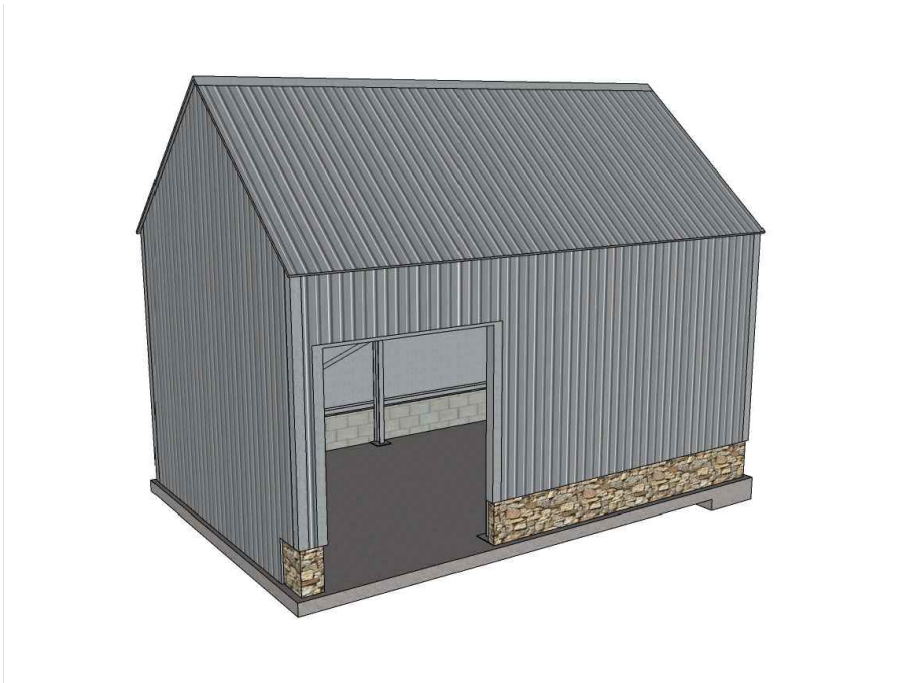
**Pic.13** Galvanised 32 / 1000 profile metal sheet cladding with associated cover flashings / trims to ridge, corners and vehicle opening. (The finish could be powder coated - typically Juniper green or Vandyke brown to farm buildings)

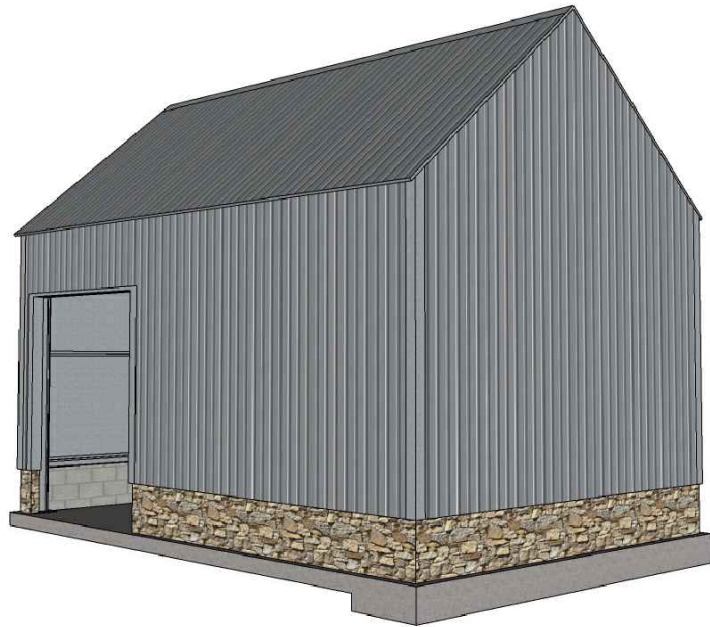
**Pic. 14** Front & Side Aspect Elevation (South West)  
Galvanised 32/1000 metal profile sheet cladding to walls and roof  
Natural stone cladding to height of approximately 650 mm

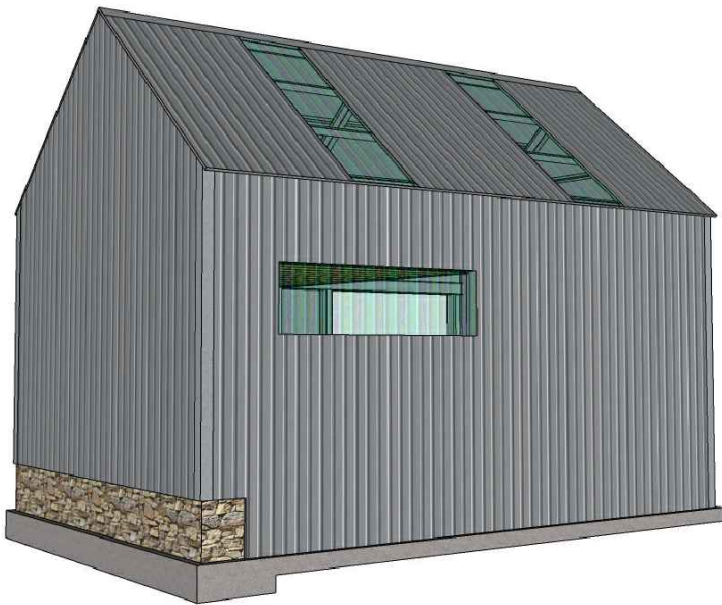
**Pic. 15** Rear & Side Elevation (South East)  
Side adjacent to brook proposed to have stone cladding to appx 650mm  
Clear polycarbonate profile sheets to form window and optional rooflights

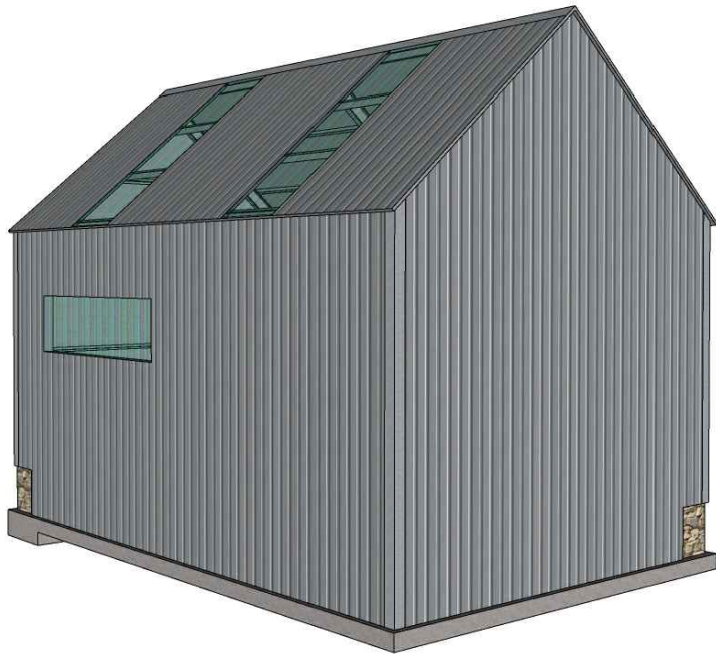
**Pic. 16** Rear & Side Elevation (North East).  
Cladding continued to ground level

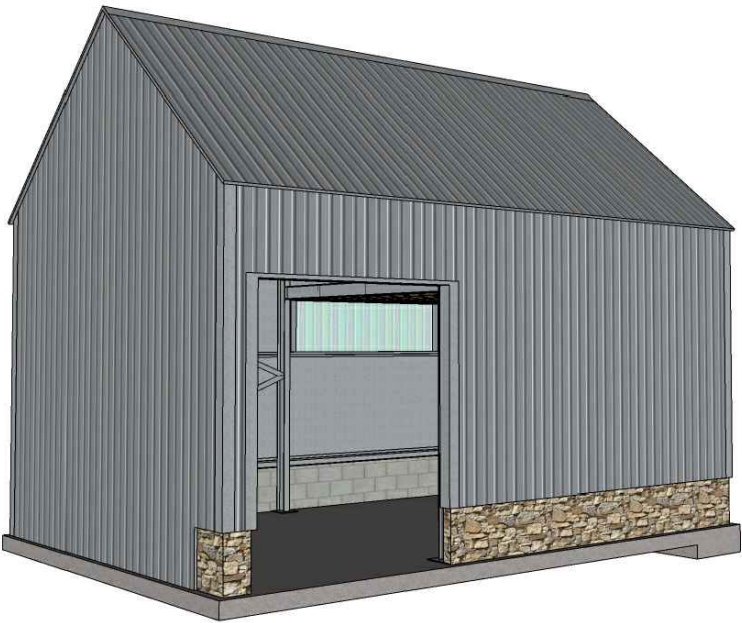
**Pic. 17** Front & Side Elevation (North West).  
Vehicle Entrance Opening dimension appx 2800 wide x 3300 height)  
'Barn Door' style on existing although replacement likely to be proposed as roller shutter
