# Preliminary Roost Assessment (PRA)

Min Yr Afon, Cwmafan

| <b>Report title</b> | PRA report |

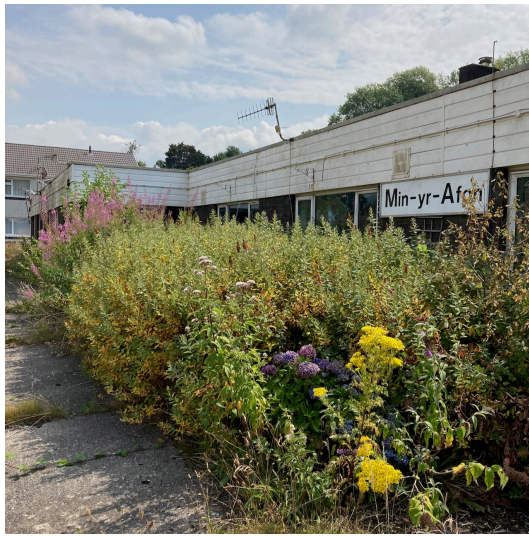
Figure 4. Single storey building with a flat roof.

- 4.3.1 Figure 3 below shows the existing layout of the Site. The building is single storey brick built and has a felted flat roof (see Figure 4). An additional structure is present on the roof of the building, towards the eastern edge, and is covered with uPVC cladding, with several areas of damage noted (Figure 5).

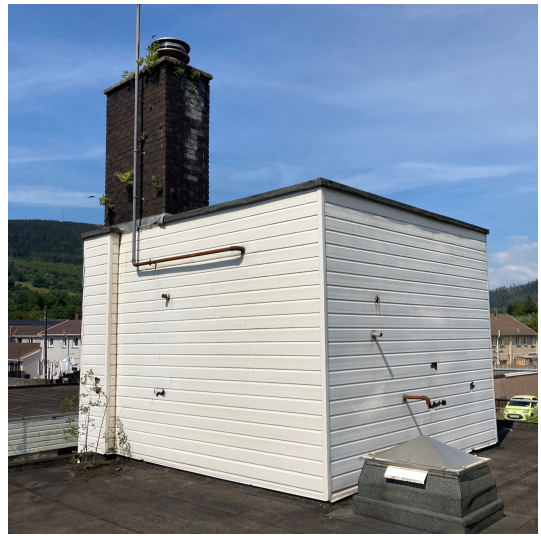
Figure 5. Additional structure on the roof to the east.

- TN1. Gap in wood under roof, single dropping on window directly below. Suspect pipistrelle roost.
- TN2. Wooden cladding/fascias, multiple gaps between wall and cladding along this whole elevation. Rot damage at top in the corner area too. Some areas of roof damaged repaired with black plastic.
- TN3. Wall crack. Potential for roost, including summer/hibernation roost, although west facing. No signs of bats noted during survey.
- TN4. Store cupboard, open on the external wall. Gaps along top of wall to the rear.
- TN5. Additional structure on roof with uPVC cladding, damaged sections on most sides.

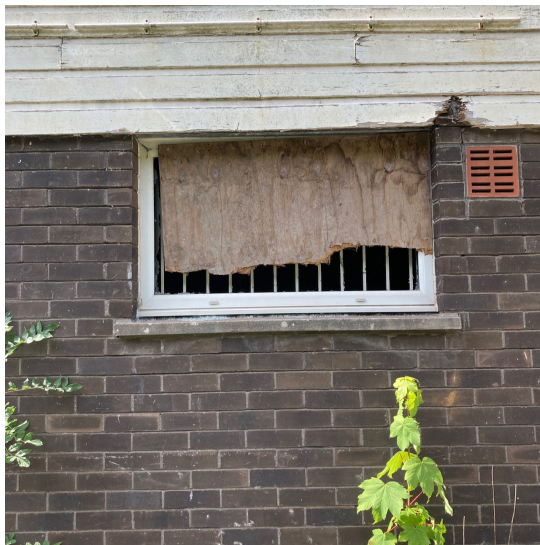
Figure 6. Window to the rear with missing glass.

- 4.3.2 The building is of brick construction with cladding on the top c.1m of the external walls. This is uPVC to the front (north) – and for a short section to the west and east – and wooden boarding to the rear (south) and much of the sides (west and east). The windows are uPVC framed and are nearly all well-sealed and boarded up. One or two windows to the rear have missing/damaged glass (Figure 6).

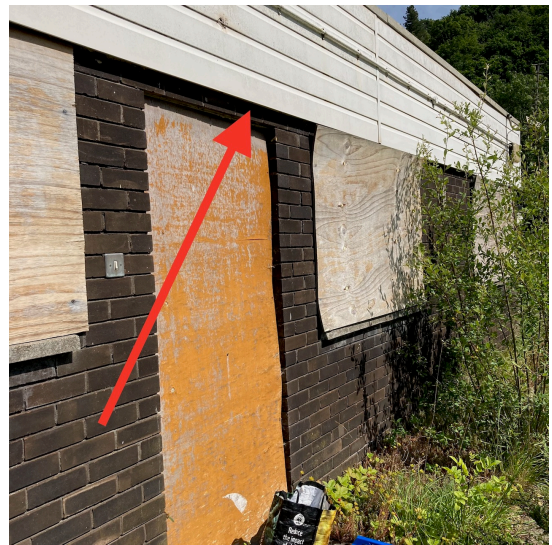
Figure 7. uPVC cladding – gaps underneath.

- 4.3.3 The uPVC cladding is in reasonable condition, although a number of areas there are gaps around the tops of this, particularly above windows, and gaps underneath (see Figures 7 – 9 for some examples). The wooden cladding is in poor condition and there are numerous areas where this is rotten, damaged, lifted away from the walls or just missing completely, exposing the brickwork below – which in many areas to the rear is also damaged (see Figures 10 – 12 for some examples).

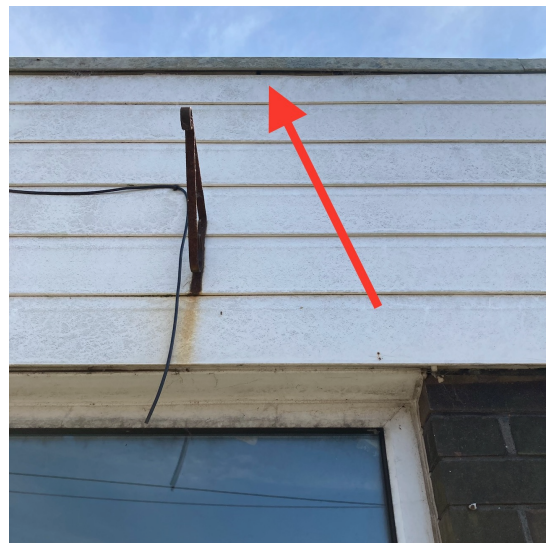
Figure 13. Suspected roost access point, dropping on window below.

- 4.3.4 A single suspected bat dropping was noted on one window to the front, directly below a gap in the roof verge above (see Figures .

- 4.5.1 The results of the lab analysis of the single dropping revealed this to be of common pipistrelle – see Figure 17 below for the lab report.

dropping directly below an obvious potential access point indicates that there is a likely roost already identified within the building.

- 5.4.3 Further survey work is required in order to a) confirm/discount this as a roost, b) characterise roost if confirmed, c) confirm presence/likely absence of any other bat roosts, and if present, d) characterise those roosts as well. The requirement for additional survey work is addressed in more detail in Section 6 of this report.

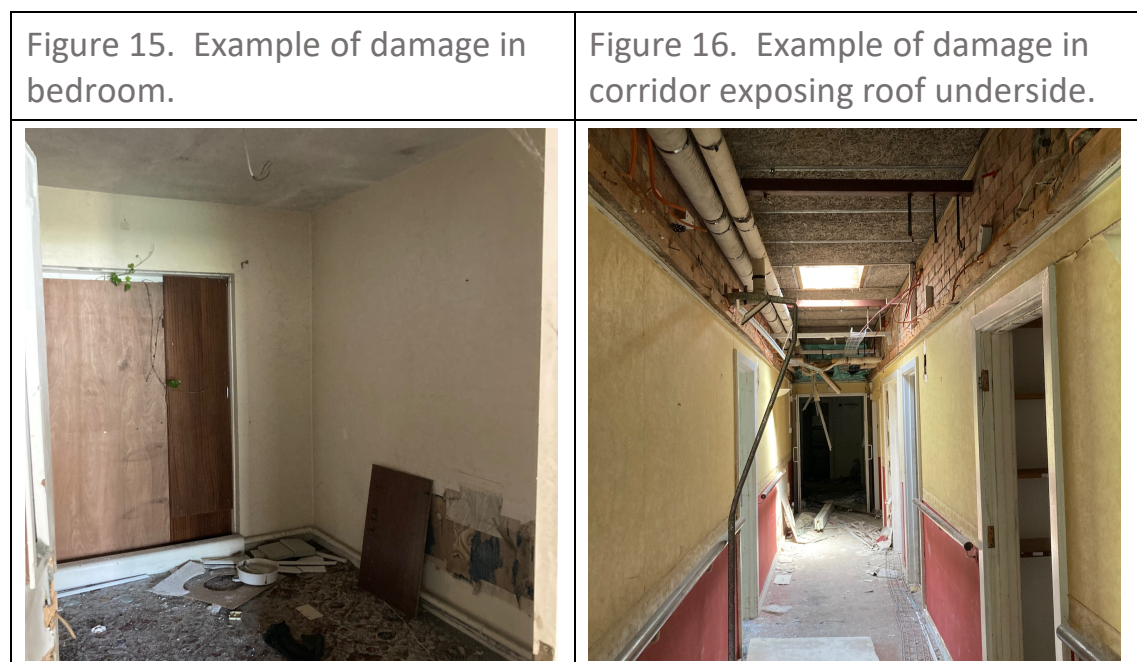
- 4.3.8 Internally, the building contains multiple rooms laid out on both sides of a circular corridor, and includes bedrooms, communal areas, kitchens, bathrooms, store cupboards etc. These are all in poor condition (see Figure 15), having been subject to theft and vandalism. All windows and doors that face onto the central courtyard were either boarded or bricked up at the time of the survey. Many of the rooms are also very dark, due to the external boarding.

- 4.3.9 No loft void is present, due to flat roof construction, and the internal ceilings comprise suspended ceiling tiles in corridors, and plasterboard in individual rooms. In the corridors, significant damage is present, with pipe work and wiring having been removed by vandals. In some places it was possible to confirm the underside of the roof covering is of OSB construction (see Figure 16).
- 4.3.10 No evidence of bats was noted in any of the rooms, cupboards or corridors internally, although it should be noted that due to missing glass in two windows to the rear, it is possible that bats may be able to access the internal areas of the building.
