**former TONMAWR SCHOOL  
TONMAWR  
NPTCBC**

**BAT & PROTECTED spp SURVEY**

**May-September 2021**

former Tonmawr School, Tonmawr Rd, Tonmawr SA12 9UW  
SS800962

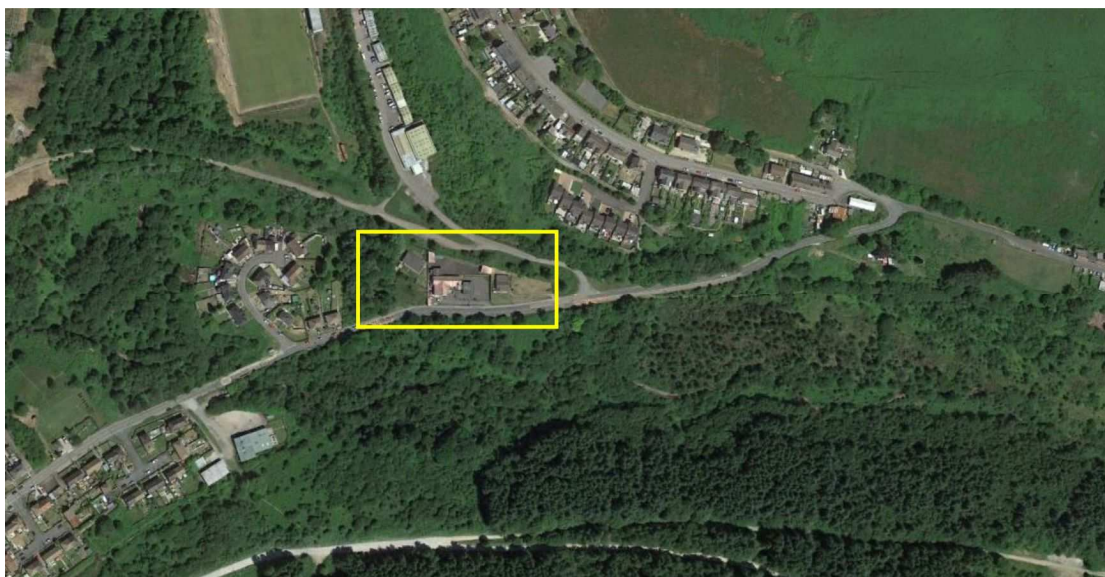
The main school building (A) is tall but single storey; the principal ridged roof is east-west aligned, with a same height north-south subsidiary ridged roof (Ai) at the (west end of) the south (front) longwall and a lower north-south “wing” (Aii) at the east end; there are various lower “extensions” at the south/front; a link corridor connects A to a flat roofed single storey east end extension (B); a flat roofed rear extension (F) is internally connected to A; a modern prefabricated unit (D) is to the north-west of the main building; three small outbuildings (E,G,F) are at the north of site retaining wall, with one small outbuilding (C) at the south boundary.

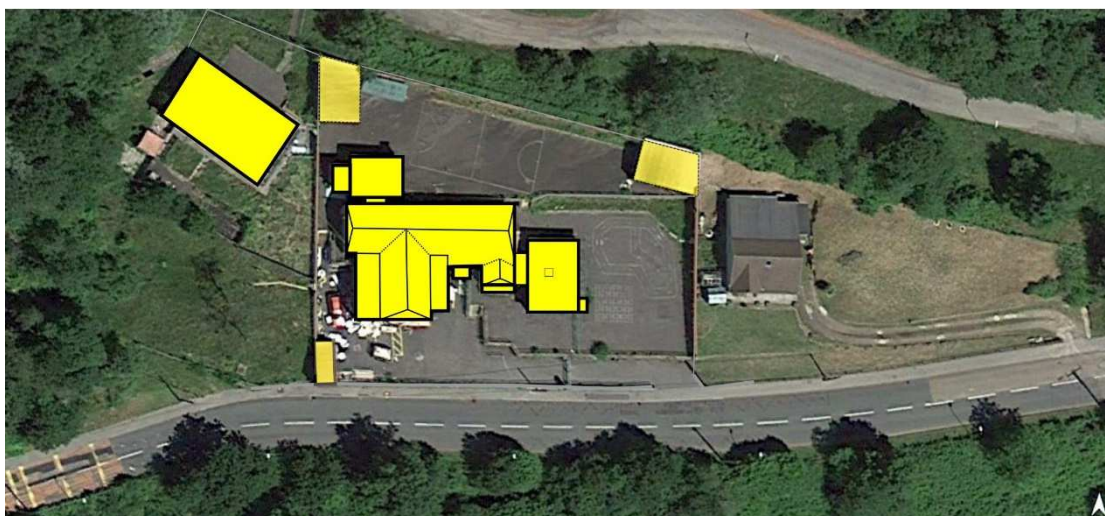
At the time of survey, the internally interconnected areas A-B-F were in use for the storage of building materials.

There is (rank, abandoned) lawn/amenity grass to-south/downslope of building C, adjoining the contiguous to-west recently planted patch of woodland, and very narrow strips of amenity grass west-east across the eastern school yard and below the north perimeter retaining wall; all other areas are tarmac/metalled.

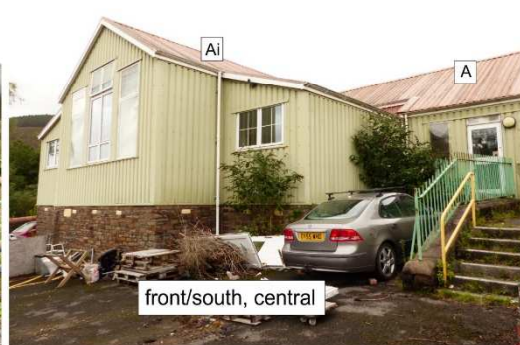
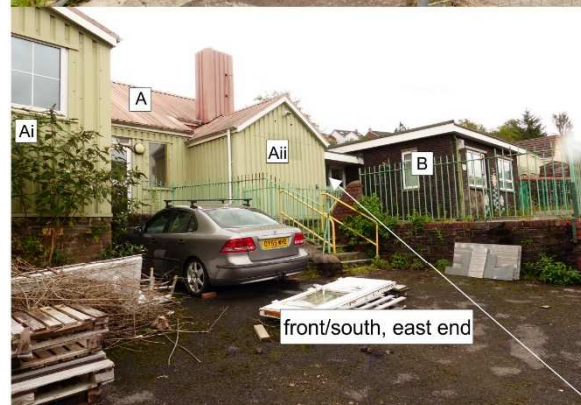
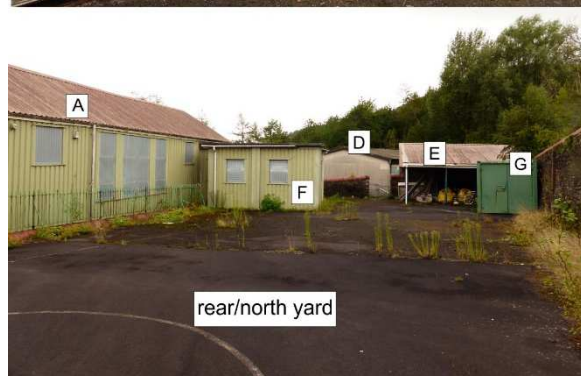
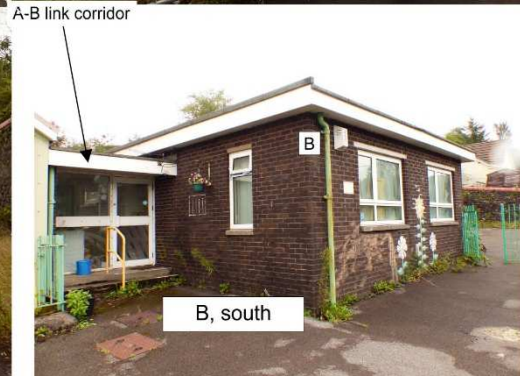
9.2 general description; bat access points; potential bat-roost opportunity; evidence of bat presence:

**A:** Above 1.8m dwarf masonry walls, all of the walls of the main building (A) are corrugated metal sheeting, in good repair and with intact/tight fitted (uPVC) windows/doors: there is no fly-in bat access opportunity, and no (visible) possibility of bat access to behind the sheeting.

Walltops have metal fascias/barges, with (retro-fitted?) uPVC soffits tight-sealed directly onto the metal edges; sheet corrugations give possible bat-access opportunity to behind fascias/barges but i) the gaps are large- too large for bat use?- and ii) access would require the animals to land directly onto the metal sheeting- not unheard of but extremely unlikely.

All roofs at A are good-repair corrugated metal sheeting, with metal ridge cappings: sheet corrugations give the potential for bat access to the under-ridge cappings: temperature fluctuation under the thin metal ridge caps makes an unlikely roost-opportunity for bats, and, as at the walltops, bat-landing onto the metal is unlikely.

Internally, the three roof sections have an under roof/attic space of <1m height, above hipped, timber planked, ceilings; access to these areas is effectively precluded by the presence of attic-filling metal ventilation chutes/ducts.

**B:** Internally connected to A, is an east-end single storey, flat roofed, extension. Walls are good repair brick, with tight fitted/intact windows/doors: there is no intra-masonry bat access, and no fly-in opportunity. Walltops are tight sealed to uPVC soffits, and the roof's bituminised felt cladding "fold over" is tight sealed to these.

Direct examination of the flat roof underside is not possible but there is no (visible) bat-access potential to this "roofskin".

**F:** Internally connected to A, a rear (north) single storey, flat roofed, extension has the same wriggly-tin wall/walltop construction as A, with intact/tight fitting windows/door; the roof's bit. felt cladding "fold over" is tight sealed to uPVC soffits. A subsidiary falt-roofed extension (Fi) is same construction.

**C:** At the south-west corner of the metallised school yard, a small shed/store has good-repair stone walls with a tight-sealed door/window; the monopitch single skin-wriggly tin "wraps over" walltops to give 0-2" inch behind-fascia gaps that had no evidence of bat use.

**D:** A single-storey, ridge-roofed, demountable building stands at the north-west site corner. Pre-fab wall panels are in good repair, and windows/doors tight-sealed, giving no intra-wall or fly-in opportunity; walltops are tight-sealed to wooden soffits. The ridged roof has cement-tile cladding, in good repair but with some inter-tile irregularities giving possible bat-access.

Direct examination of the roof underside is not possible, giving a beyond-examination "roofskin".

**E&G:** an open fronted/sided, single-skin wriggly tin roofed, shelter (E) at the n-w yard corner, and adjacent metal container (G), have no bat-use potential (and no breeding bird use at the survey dates).

**H:** an open fronted lean-to shelter at the n-e yard corner has the site perimeter wall at rear and one side, and a tight sealed stone wall at its inner side; the roof is single skin wriggly tin. No bat-use potential is identified (and no breeding bird use was found).

**summary:** No bat (or bird) evidence was found, externally or internally, at any of the site buildings.
