Title: **ZONE 1 - MICROGRAVITY SURVEY RESULTS**

Project: **ONLLWYN COAL WASHERY, NEATH-PORT TALBOT**

The slope to the north of the site was examined in particular detail as an embankment up to 41m high on sidelong ground is planned in this part of the site. Risks related to a slope stability hazard were identified due to the topography along with the presence of glacial till and an extensive history of mining activity in this area.

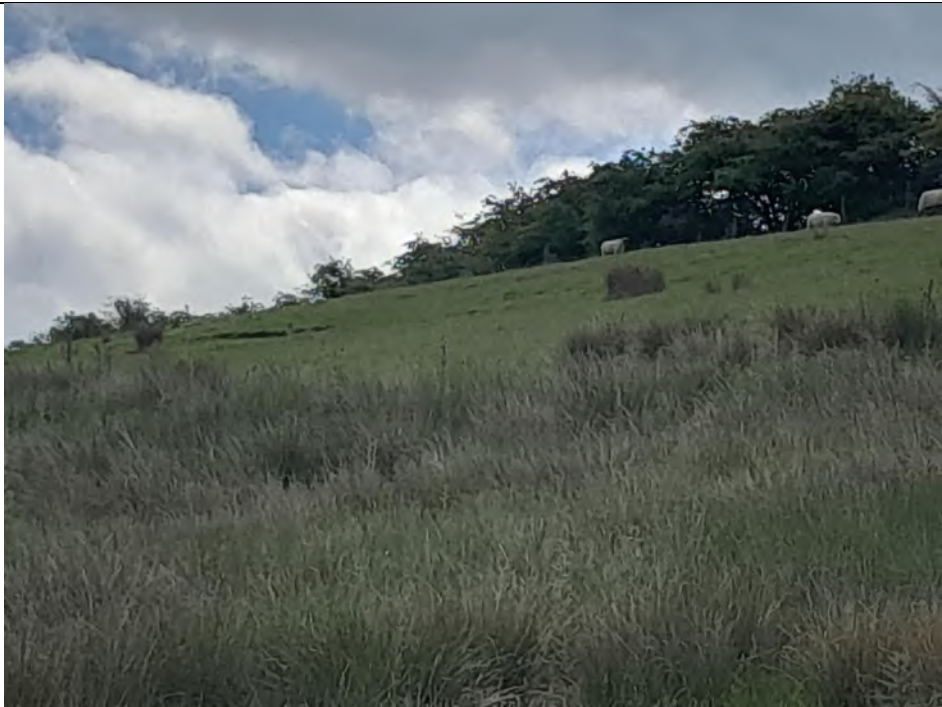
| Location / photo ref | Easting | Northing | Location | Observation and Implication |
|---|---|---|---|---|
| 1 | 283483.6 | 211797.8 | South of access road in vicinity of backfilled Onllwyn opencast. | Possible small scarps noted on hillside at change in slope angle. May be indicative of slope instability. |

| Location, direction, and brief description. | Photo |
|---|---|
| <p>1</p> <p><i>Looking southeast.</i></p> <p>Break in slope.</p> | |

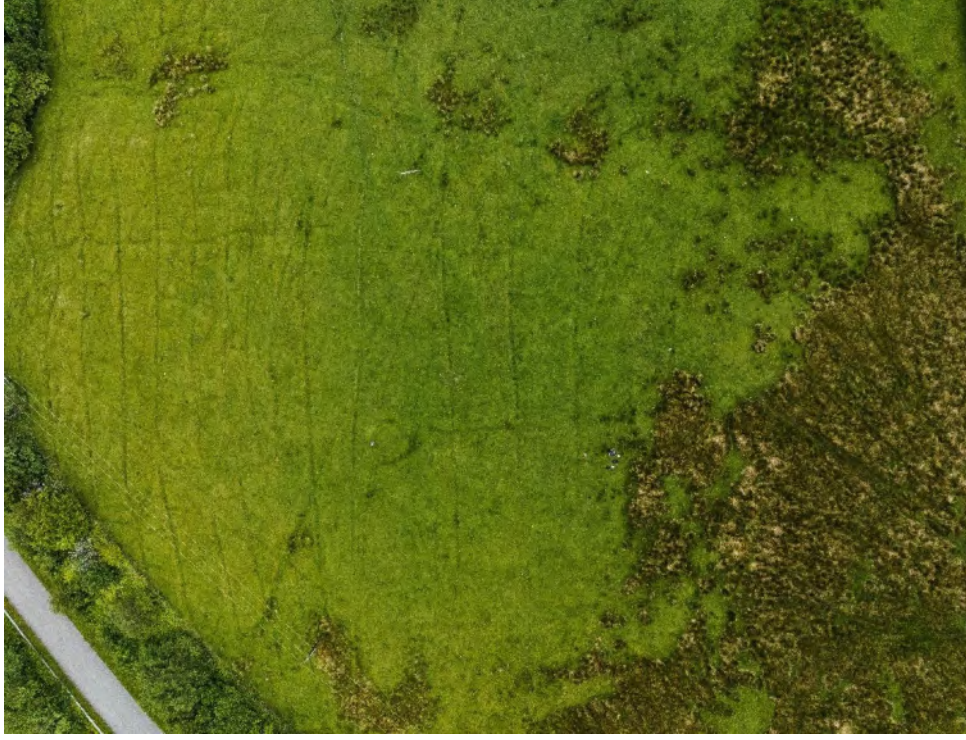
| <p>6</p> <p>Aerial shot showing backfilled mineshaft.</p> | |

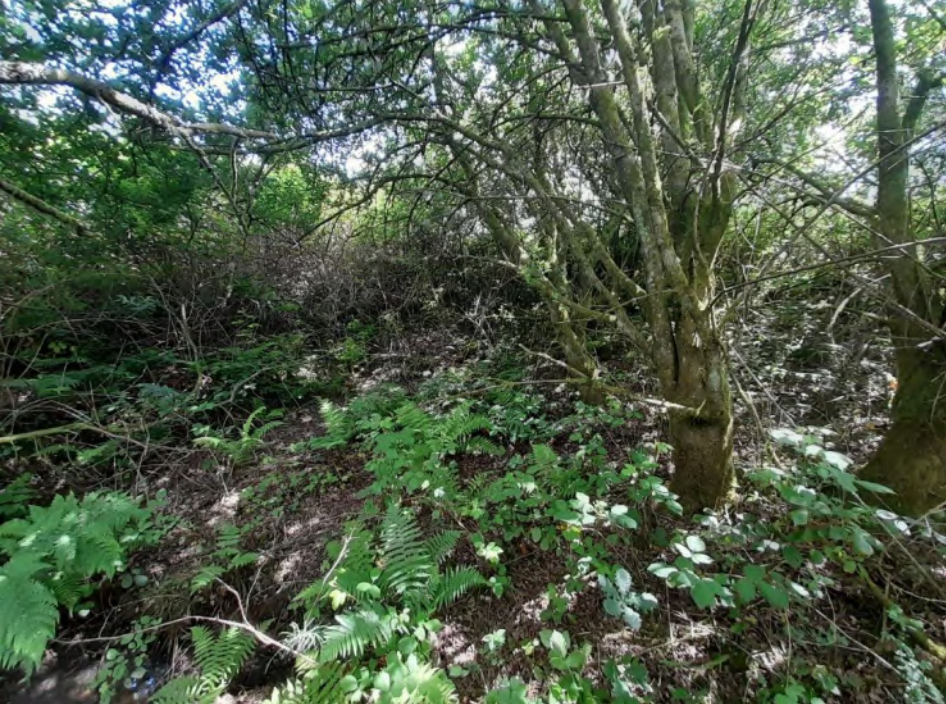
| <p>18</p> <p><i>Looking southeast.</i></p> <p>Collapsed mine adit.</p> | |

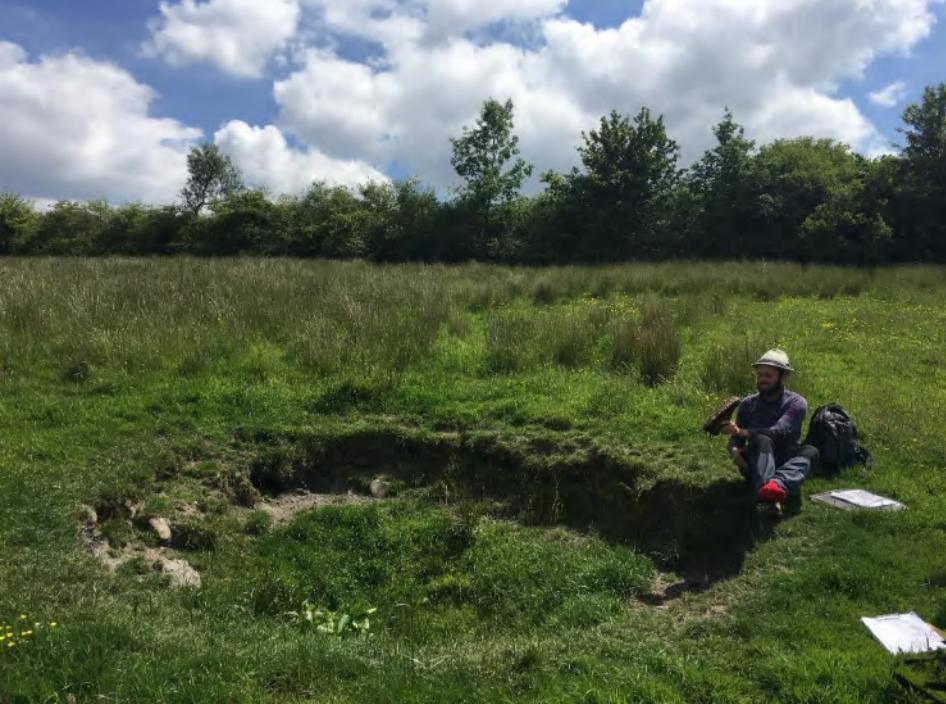
| Location / photo ref | Easting | Northing | Location | Observation and Implication |
|---|---|---|---|---|
| 19 | 282965.8 | 211881.4 | | Crown hole short distance north of mine adit. Likely to be related to the collapsed mine adit noted above. |

| <p>19</p> <p><i>Looking southeast.</i></p> <p>Crownhole to immediate south of collapsed mine adit.</p> | <p>A photograph showing a person wearing a hat and a backpack sitting on a grassy slope. To their left is a small, rectangular, earthen crownhole. The background features a line of trees under a blue sky with white clouds.</p> |

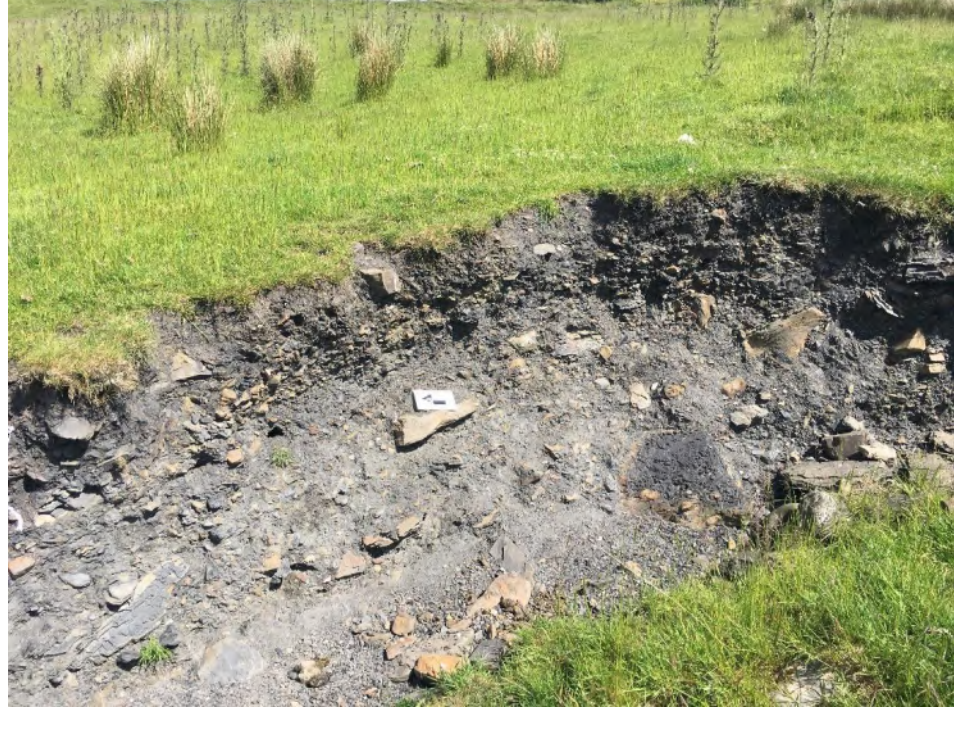
| <p>23</p> <p><i>Looking east.</i></p> <p>Washout gully in opencast backfill.</p> | |

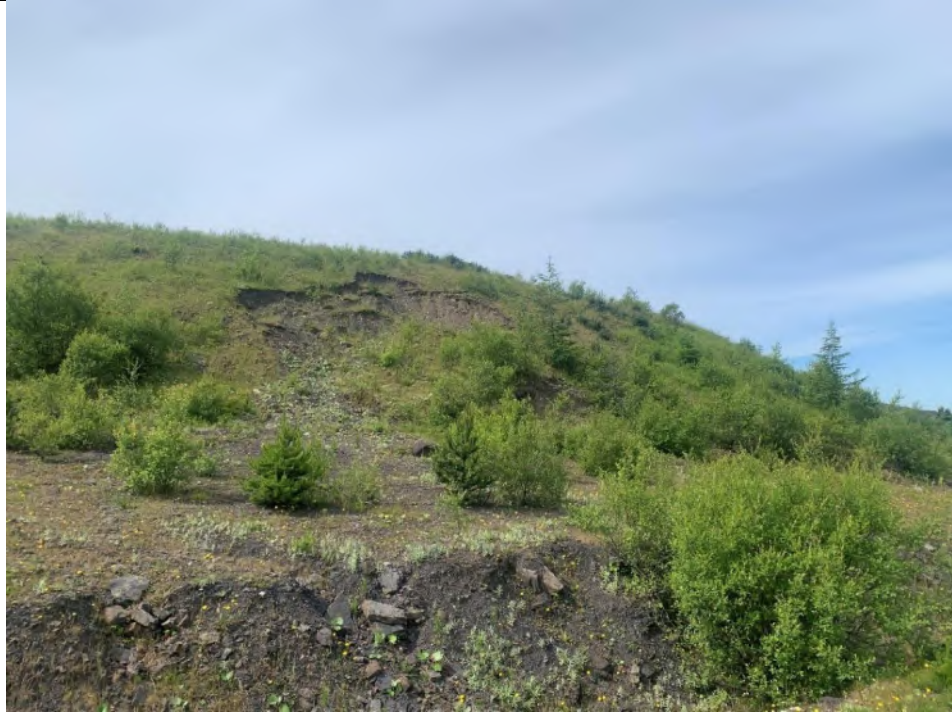
| Location / photo ref | Easting | Northing | Location | Observation and Implication |
|---|---|---|---|---|
| 33 | 282058.9 | 211721.8 | | Slope failure in artificial slope composed of colliery spoil at angle of around 30 degrees showing the relatively low angles at which this poorly graded material can fail. |

*Looking southwest towards slope failure in pile of colliery spoil.*

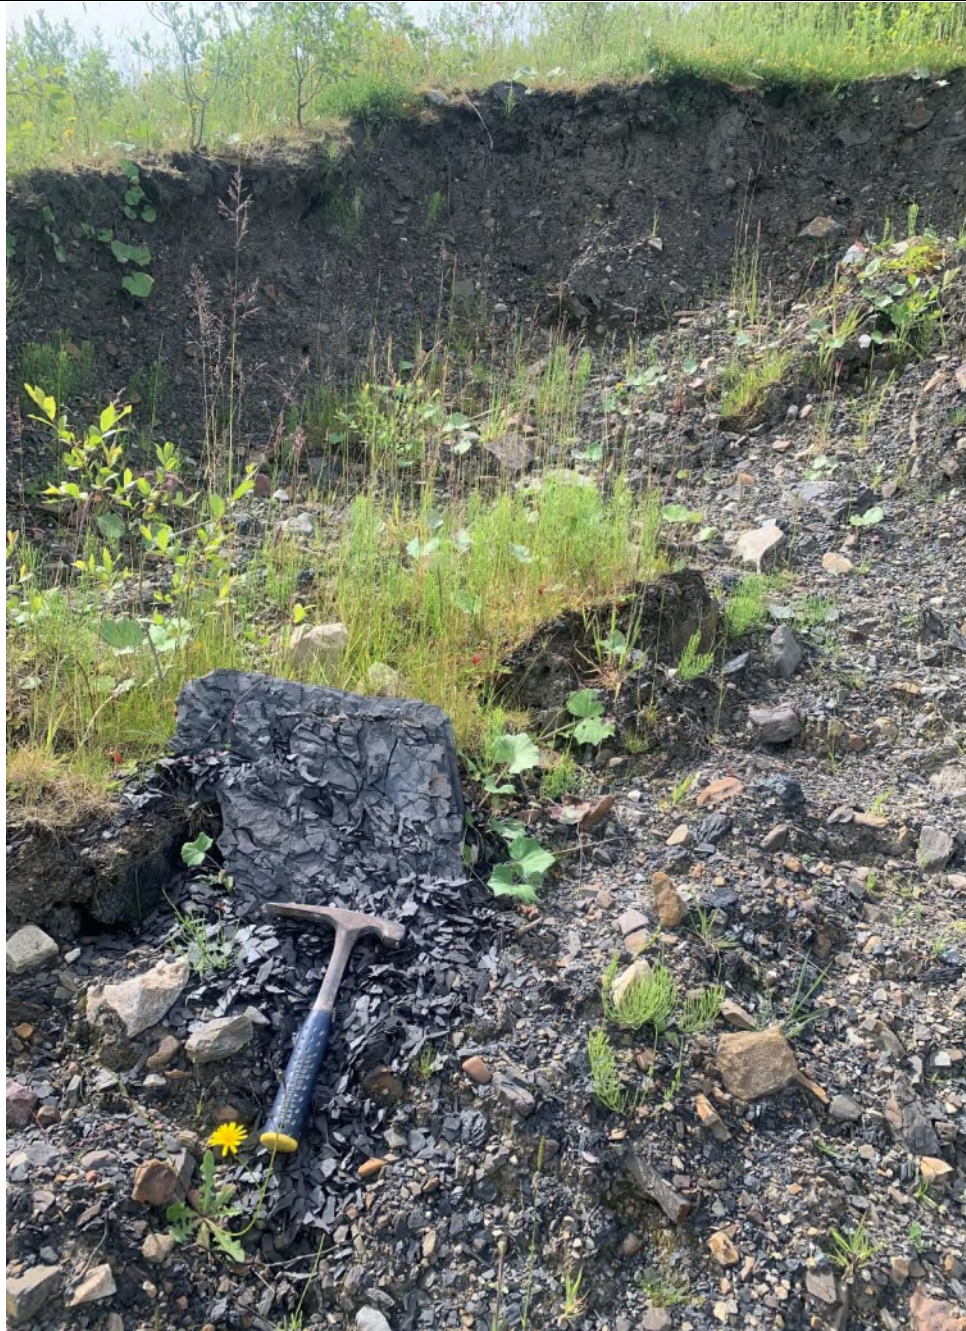
| Location / photo ref | Easting | Northing | Location | Observation and Implication |
|---|---|---|---|---|
| 34 | 282039.0 | 211707.9 | | Debris within the slope failure. Note the poor sorting and weathered and degraded nature of the boulder in the left foreground of the picture. |

Close up of  
slope failure  
material.

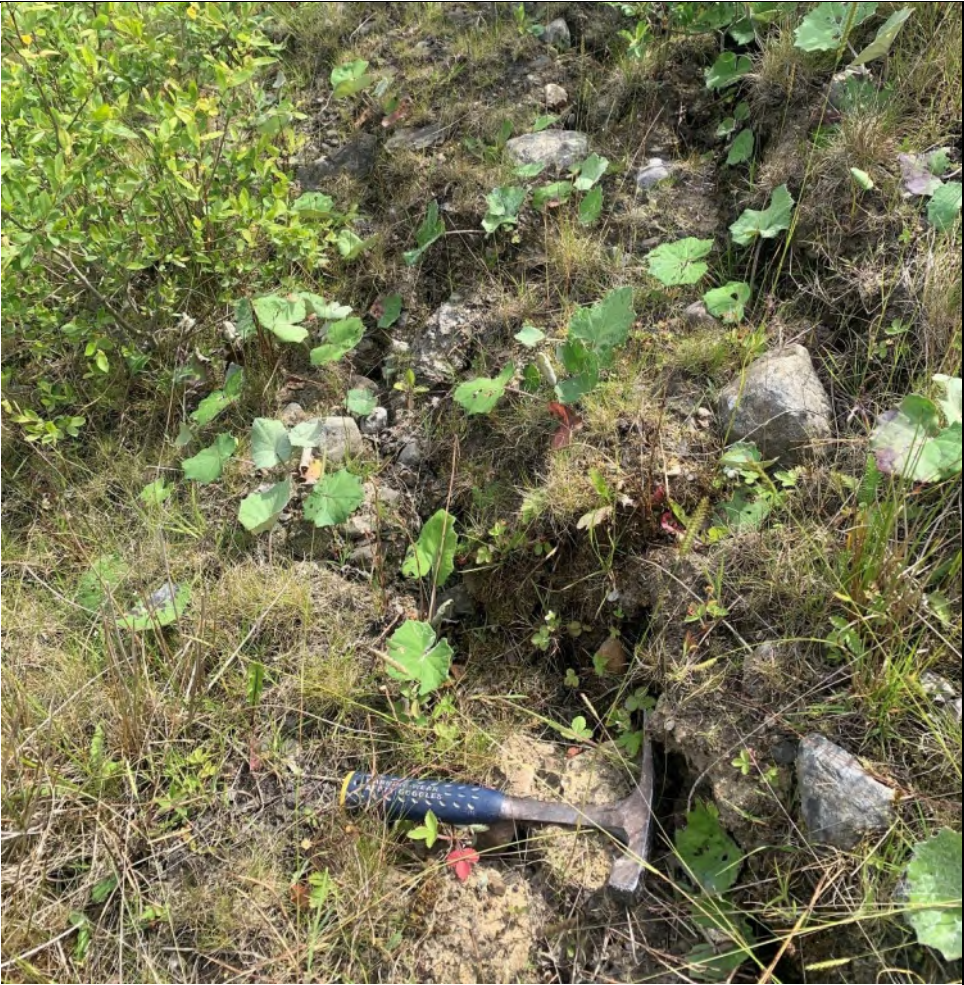
| Location / photo ref | Easting | Northing | Location | Observation and Implication |
|---|---|---|---|---|
| 35 | 282025.1 | 211702.6 | | Tension cracks noted west of main failure. Indicating that this slope is still metastable and that further failure is possible. |

| <p>35</p> <p>Tension cracks behind main scarp of slope failure.</p> | |
