EXPLORATORY HOLE PHOTOGRAPHS

| Project | Global Centre of Rail Excellence | Easting | 283263.34 | Equipment | 13 Tonne Tracked Excavator |
| Client | Walters UK Limited | Northing | 211886.54 | Method | TP |
| Project No | G22069 | Level | 236.96 mAOD | Termination Reason | Scheduled depth |

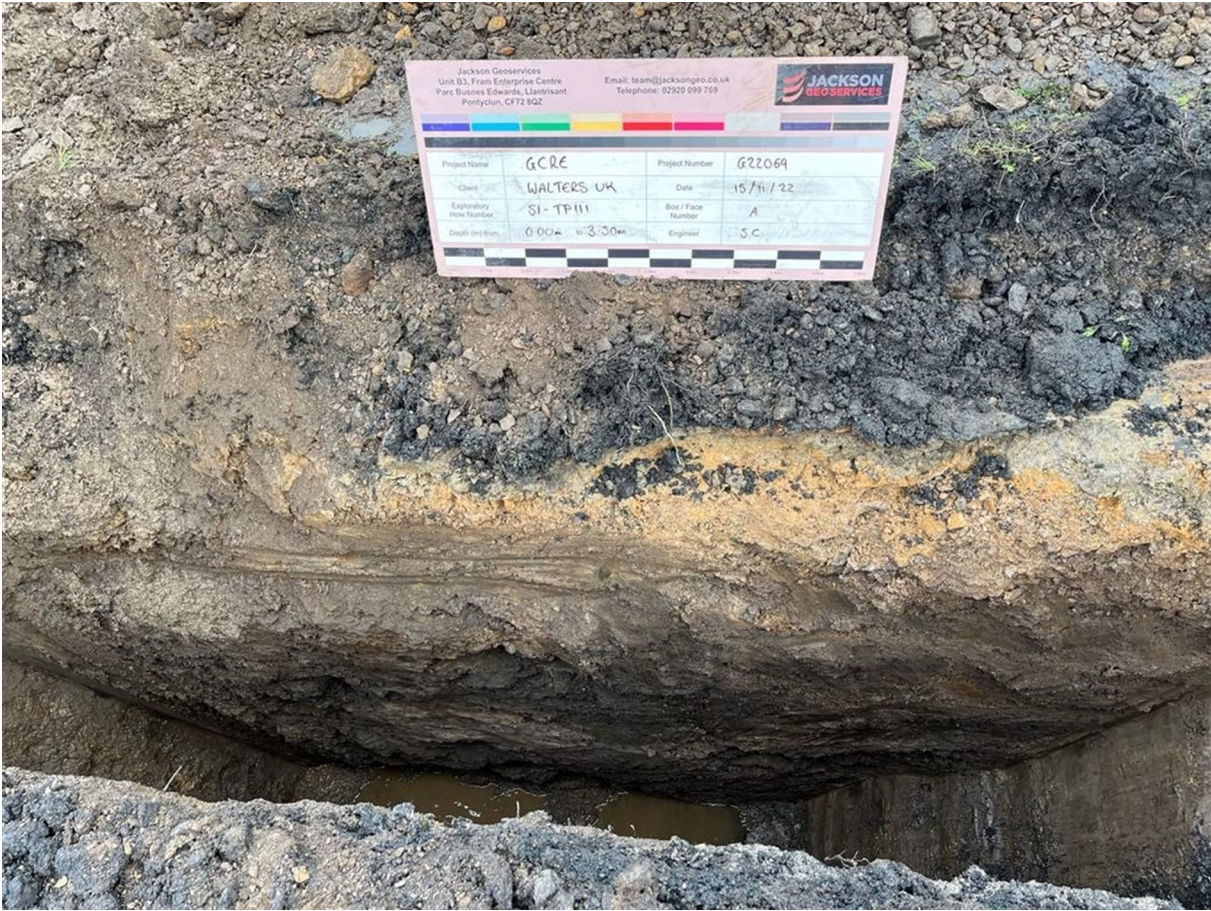
S1-TP111 Face A

| <div>3 B</div> | <div>0.10 - 0.30</div> | <div>PID: 0.0ppmv</div> | | <div>0.00</div> | | <div></div> | <div>Soft greyish black silty slightly sandy gravelly CLAY. Sand is medium to coarse. Gravel is subangular medium to coarse of limestone. (MADE GROUND)</div> | | | | | <div></div> |
| <div>6 ES</div> | <div>0.90 - 1.00</div> | <div>PID: 0.0ppmv</div> | | | | | <div>Firm to stiff brownish grey mottled orangish grey slightly silty sandy gravelly CLAY with low boulder content. Sand is medium to coarse. Gravel is angular to subangular fine to coarse of mudstone and occasional sandstone. Boulders are subangular of mudstone (400mm x 500mm x 70mm). (Weathered SOUTH WALES MIDDLE COAL MEASURES)</div> | | | | | |
| <div>10 B</div> | <div>2.00</div> | | | | | | <div>Dark brown slightly clayey sandy angular to subangular fine to coarse GRAVEL of mudstone. Sand is coarse. (Weathered SOUTH WALES MIDDLE COAL MEASURES)</div> | | | | <div>2.00</div> | <div></div> |
| <div>14 D</div> | <div>3.50</div> | | | | <div>227.75</div> | <div></div> | <div>End of Exploratory Hole at 3.50m</div> | | | | <div>3.50</div> | <div></div> |

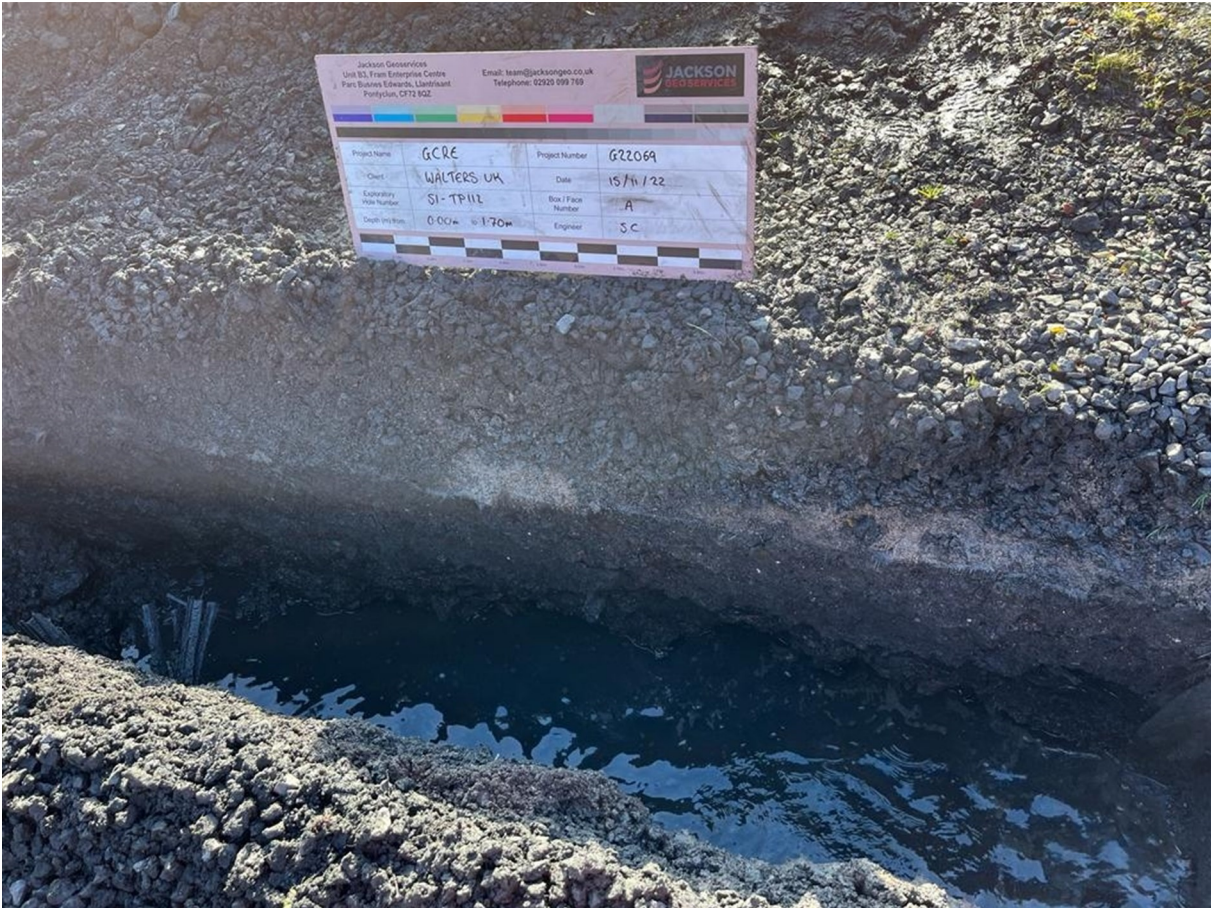
S1-TP112 Face A

| Samples | Sampling and Testing Depths | Insitu Testing and Depth Related Remarks | Depth (Thickness) | Level (mAOD) | Legend | Description | Scale | Backfill |
|---|---|---|---|---|---|---|---|---|
| 1 B<br>2 D<br>3 ES<br>4 ES<br>5 D<br>6 D | 0.20 - 0.30<br>0.20 - 0.30<br>0.20 - 0.30<br>0.20<br>0.30 - 0.40<br>0.30 - 0.40<br>0.30<br>0.50 - 0.60 | PID: 0.0ppmv<br><br>PID: 0.0ppmv | 0.00<br>(0.20)<br>0.20<br>(0.10)<br>0.30 | 231.96<br><br>231.86 | | Blackish grey silty subangular coarse GRAVEL of limestone. (MADE GROUND)<br>Geology Code: MGR 2nd Geology Code: GR<br><br>Grey slightly clayey gravelly coarse SAND. Gravel is angular fine of mudstone and occasional sandstone. (MADE GROUND)<br>Geology Code: MGR 2nd Geology Code: GR<br>Blackish grey slightly silty sandy subangular fine to coarse GRAVEL of clinker, mudstone and coal. Sand is coarse. (MADE GROUND)<br>Geology Code: MGR 2nd Geology Code: GR<br>0.35m - 0.35m Geotextile membrane. | 0.50 | |
| 7 D<br>8 ES<br>9 B | 0.90 - 1.00<br>0.90 - 1.00<br>0.90 - 1.00<br>0.90 | PID: 0.1ppmv | (1.40) | | | 0.90m - 0.90m Wooden sleeper.<br>0.90m - 0.95m Soft black sandy SILT. | 1.00 | |
| 10 D<br>11 ES<br>12 B | 1.50 - 1.60<br>1.50 - 1.60<br>1.50 - 1.60<br>1.60 | PID: 0.0ppmv | | 230.46 | | 1.69m - 1.70m Brown sandy gravelly CLAY. (Probable weathered SOUTH WALE COAL MEASURES)<br>End of Exploratory Hole at 1.70m | 1.50<br>2.00<br>2.50<br>3.00<br>3.50<br>4.00 | |

| Stability | Unstable, collapsing from 1.30m | | | | | Log presents Face A unless otherwise noted. | 15/11/2022 11:52 | 1.50 | 1.10 | 20mins |
