| | | <b>EXPLORATORY HOLE PHOTOGRAPHS</b> | | <b>Remarks</b><br>Machine excavated trial pit from GL to 2.00m. | | <b>Exploratory Hole</b> |
| <b>Project</b> | Global Centre of Rail Excellence | <b>Easting</b> | 282853.57 | <b>Equipment</b> | 13 Tonne Tracked Excavator | Sheet 1 of 2 |

| <div><div>JACKSON</div><div>GEO SERVICES</div></div> | | | | TRIAL PIT EXPLORATORY HOLE LOG | | | | Exploratory Hole Progress by Time | | | Exploratory Hole | |
| Date and Time | | Depth | Water Depth | | | | | S1-TP101 | | | | |

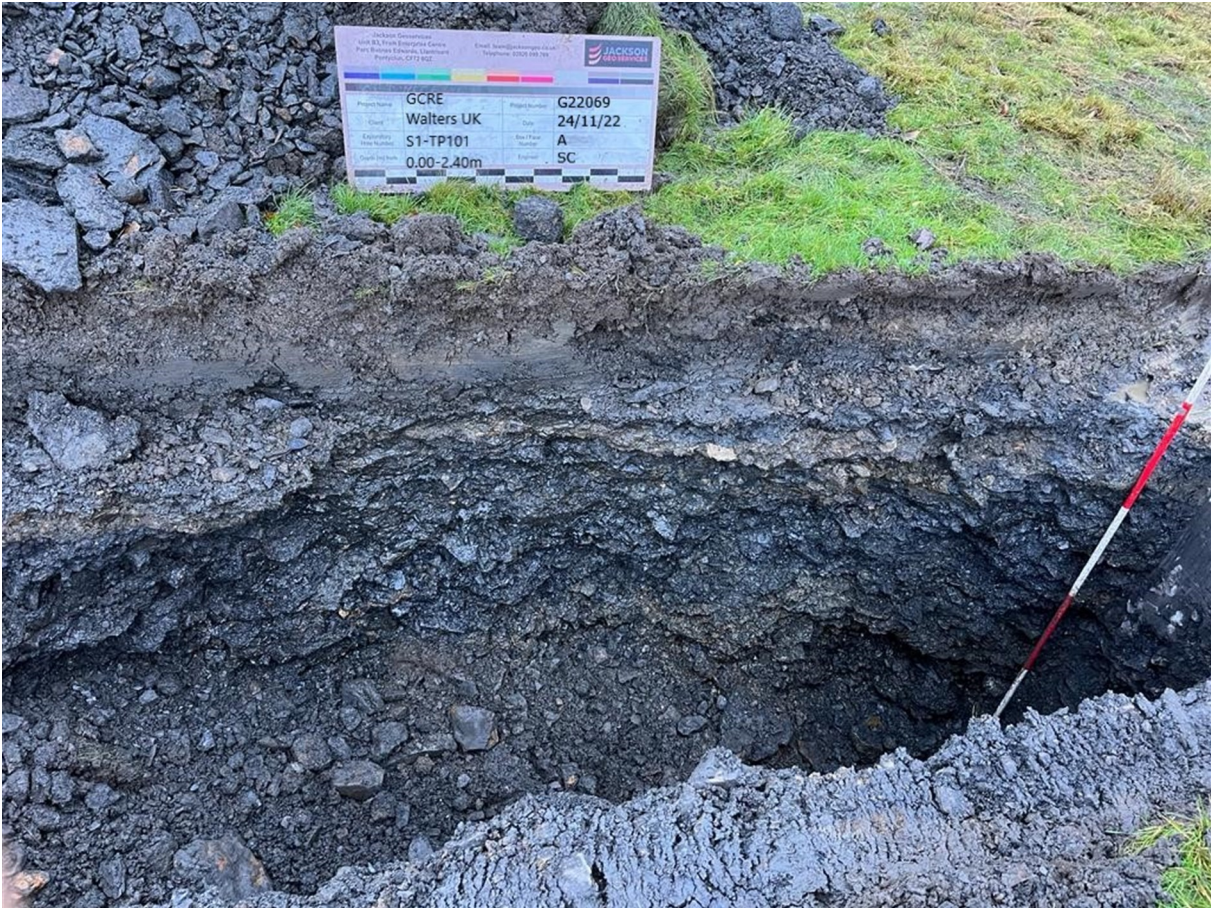
S1-TP101 - Face A

| 1 ES<br>2 D<br>3 B | 0.20 - 0.25<br>0.20 - 0.30<br>0.20 - 0.50<br>0.20 | PID: 0.2ppmv | (0.30)<br><br>0.30 | 219.11 | | Firm dark grey silty sandy very gravelly CLAY with abundant rootlets. Sand is fine to coarse. Gravel is angular to subangular fine to coarse of mudstone and occasional coal.<br>(TOPSOIL)<br>Geology Code: MGR 2nd Geology Code: CL | | | | | | |
| 4 ES<br>5 D<br>6 B | 0.50 - 0.55<br>0.50 - 0.60<br>0.50 - 0.80<br>0.50 | PID: 0.0ppmv | | | | Dark grey with occasional orangish grey mottling silty slightly clayey sandy angular to subangular fine to coarse GRAVEL of mudstone, coal and rare sandstone with low cobble and boulder content. Sand is medium to coarse. Cobbles are angular of mudstone. Boulders are angular to subangular of mudstone (300x400x450mm).<br>(MADE GROUND)<br>Geology Code: MGR 2nd Geology Code: GR | | | | | | |
| 15 B<br>16 ES<br>17 D | 2.30 - 2.40<br>2.30 - 2.40<br>2.30<br>2.35 - 2.40<br>2.40<br>2.40<br>2.40 | PID: 0.0ppmv<br><br>HV: P: 36kPa R: 15kPa<br>HV: P: 38kPa R: 22kPa<br>HV: P: 39kPa R: 20kPa | 217.01 | | End of Exploratory Hole at 2.40m | 2.50 | | | | | | |
