| | | <b>EXPLORATORY HOLE PHOTOGRAPHS</b> | | <b>Remarks</b><br>Machine excavated trial pit from GL to 1.70m | | <b>Exploratory Hole</b> |
| <b>Project</b> | Global Centre of Rail Excellence | <b>Easting</b> | 284486.56 | <b>Equipment</b> | 21 Tonne Tracked Excavator | Sheet 2 of 3 |
| <b>Project No</b> | G22069 | <b>Level</b> | 232.16 mAOD | <b>Termination Reason</b> | Water ingress and instability | |

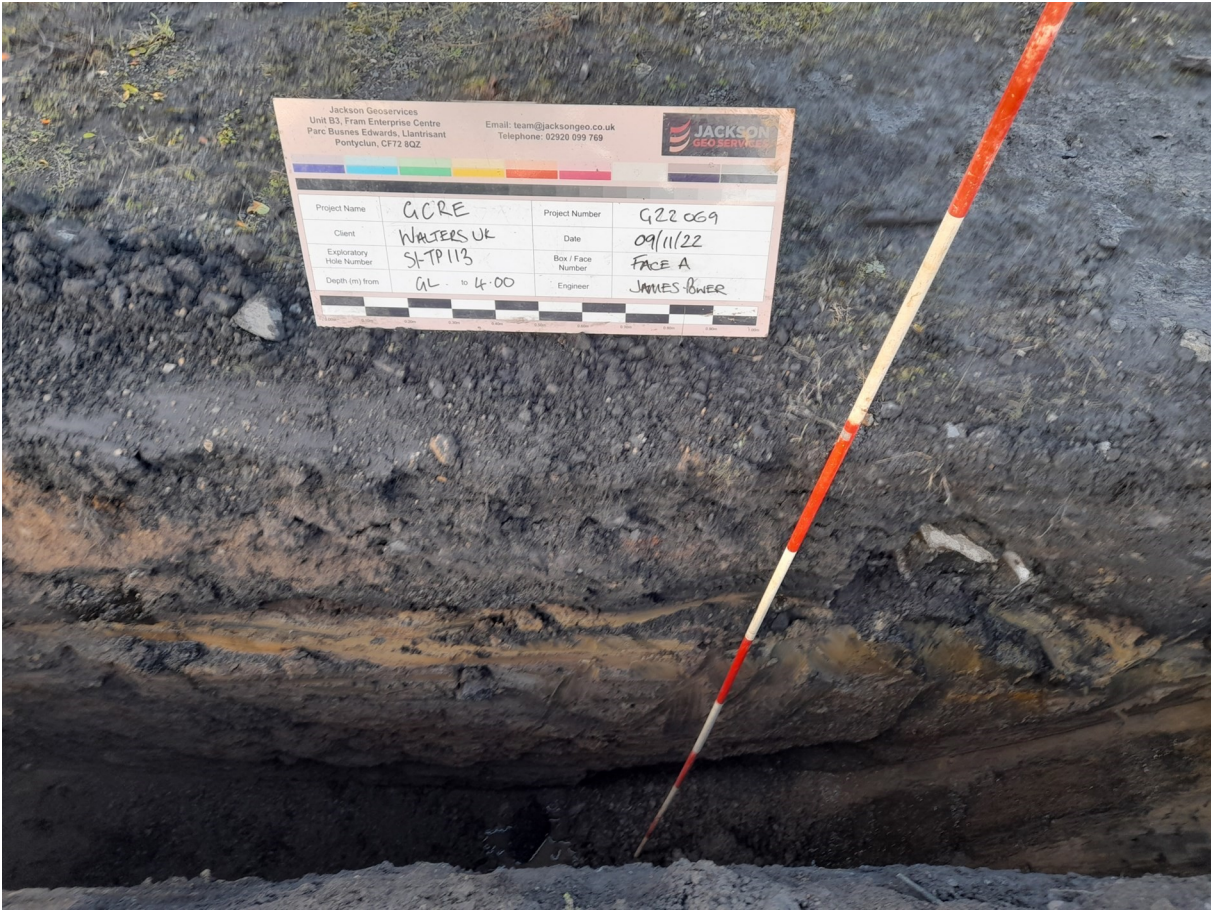
S1-TP113 Face A

| JACKSON<br>GEO SERVICES | | | | | TRIAL PIT EXPLORATORY HOLE LOG | | | | | Exploratory Hole Progress by Time | | | Exploratory Hole | | |
|---|---|---|---|---|---|---|---|---|---|---|--|---|---|---|---|
| 4 B | 0.50 - 0.70 | Broken land drain from Face A to Face C. | | | | | | Soft yellowish brown mottled light grey, orange and white slightly gravelly slightly sandy SILT. Gravel is angular to rounded fine to coarse of mudstone and sandstone. Sand is fine to coarse. (Weathered SOUTH WALES MIDDLE COAL MEASURES FORMATION)<br>Geology Code: SWCM 2nd Geology Code: SL | | | | | 1.00 | | |

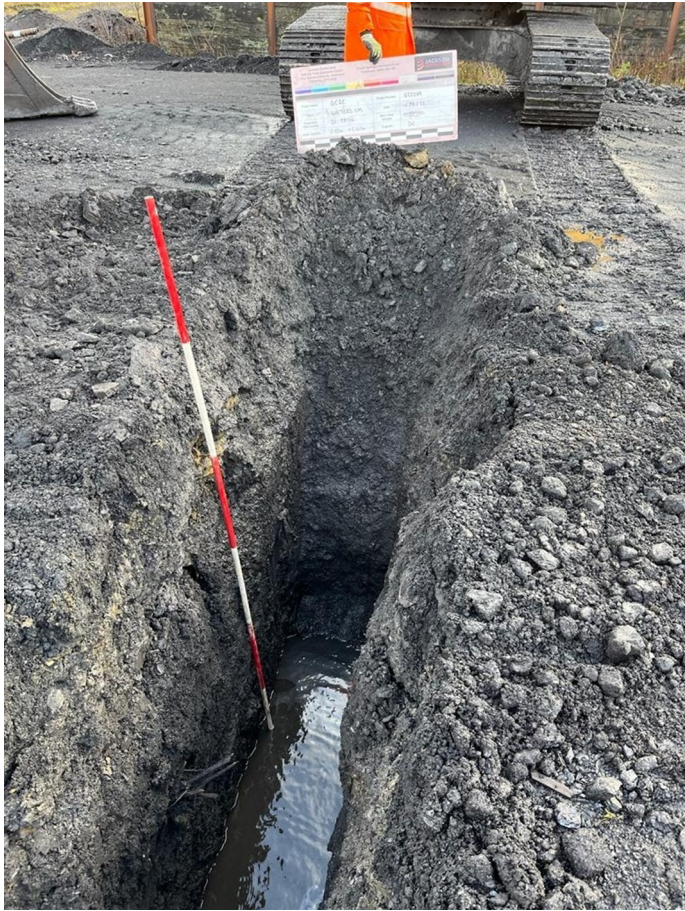
S1-TP114 Face D

| Project No | G22069 | Level | 239.99 mAOD | Termination Reason | Water ingress and instability | |

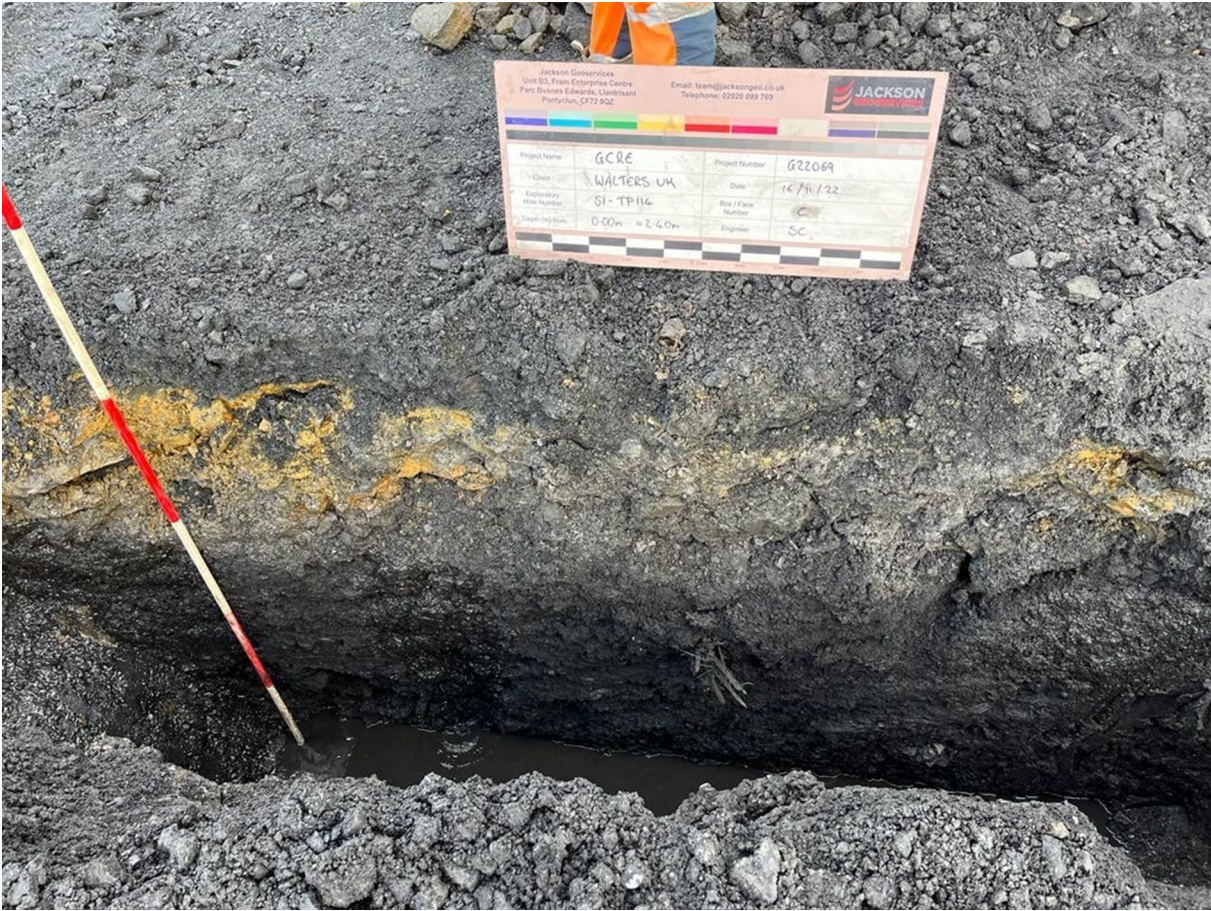
S1-TP114 Face C

| <b>Project No</b> | G22069 | <b>Level</b> | 239.99 mAOD | <b>Termination Reason</b> | Water ingress and instability | |
