**Blue Field Land Limited**

**Pontardawe Foundry  
Old Foundry Road, Pontardawe, SA8 4EZ**

**Site Investigation Report**

12360/RAH/19/SI

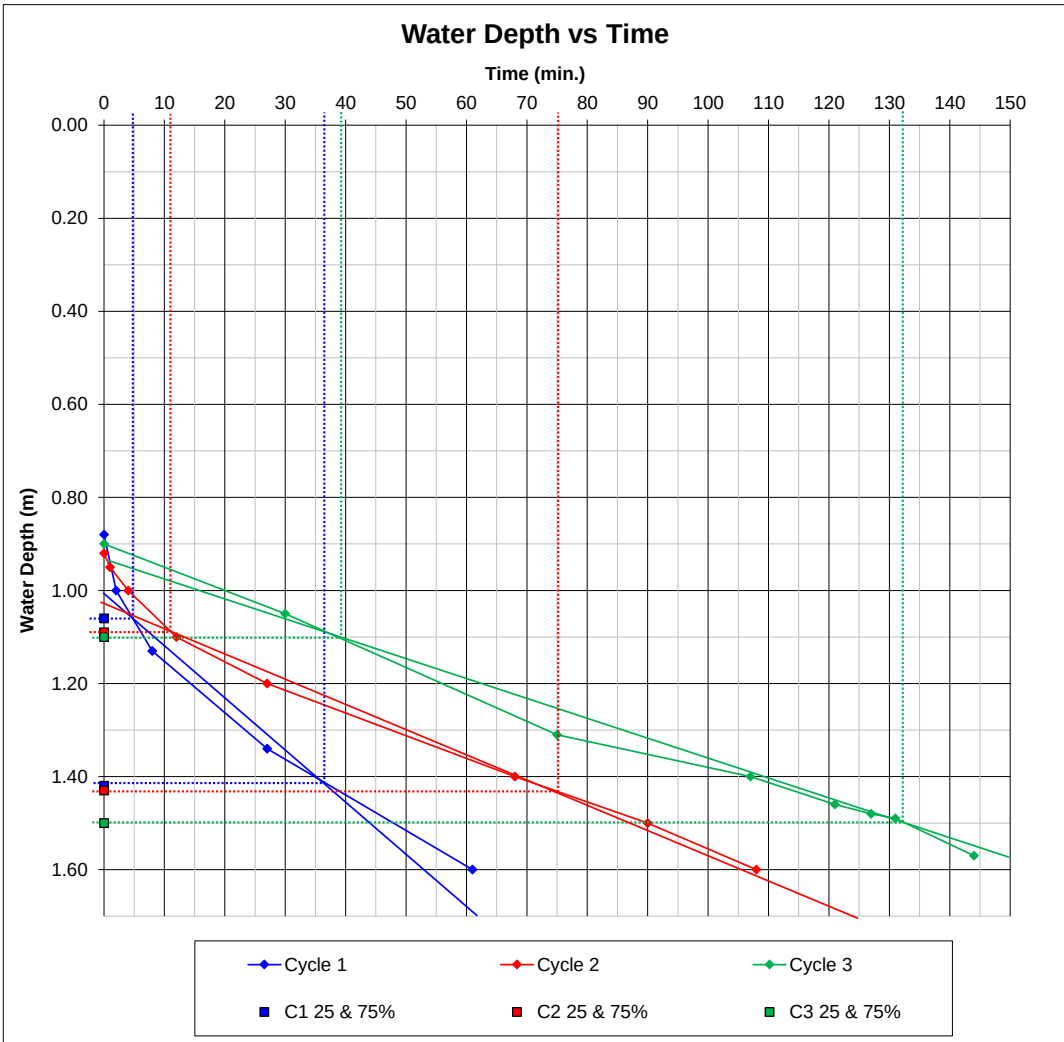
Design Soil Infiltration Rate: 3.0E-05 m/s

Large scale infiltration testing was completed in one trial pit only (TP104), three repeat cycles were undertaken on 04/02/2019.
