**LanzaTech UK Ltd**

# **P&C Project Dragon - Marine Ecology**

Benthic survey report

December 2022

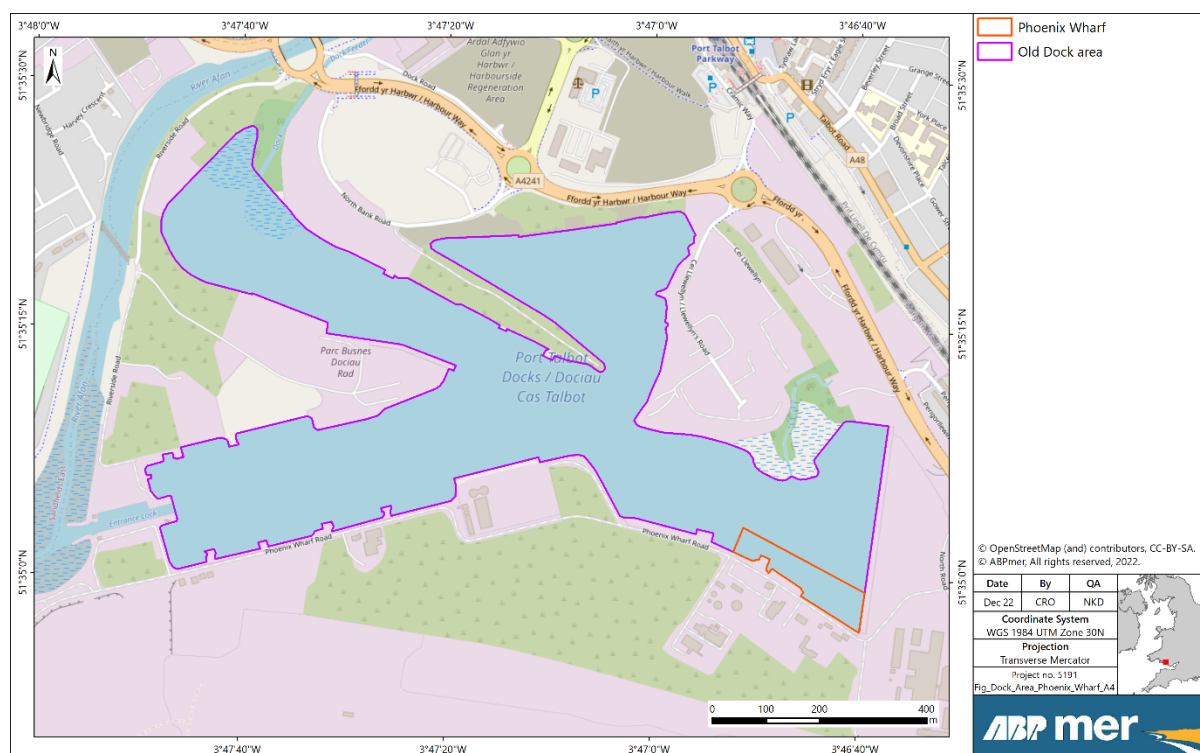
**Figure 1.** The Old dock area within the Port of Port Talbot, and the proposed development area at Phoenix Wharf

LanzaTech UK Ltd, are proposing to apply for a marine licence to carry out development works at Port Talbot as part of P&C project Dragon. The proposed development will see the construction of a new jetty and associated infrastructure and handling facilities within Port Talbot's enclosed 'Old Dock' at Phoenix Wharf (Figure 1). The development is likely to involve piling to secure the jetty with the inclusion of breasting and/or mooring dolphins to allow safe berthing for vessels.

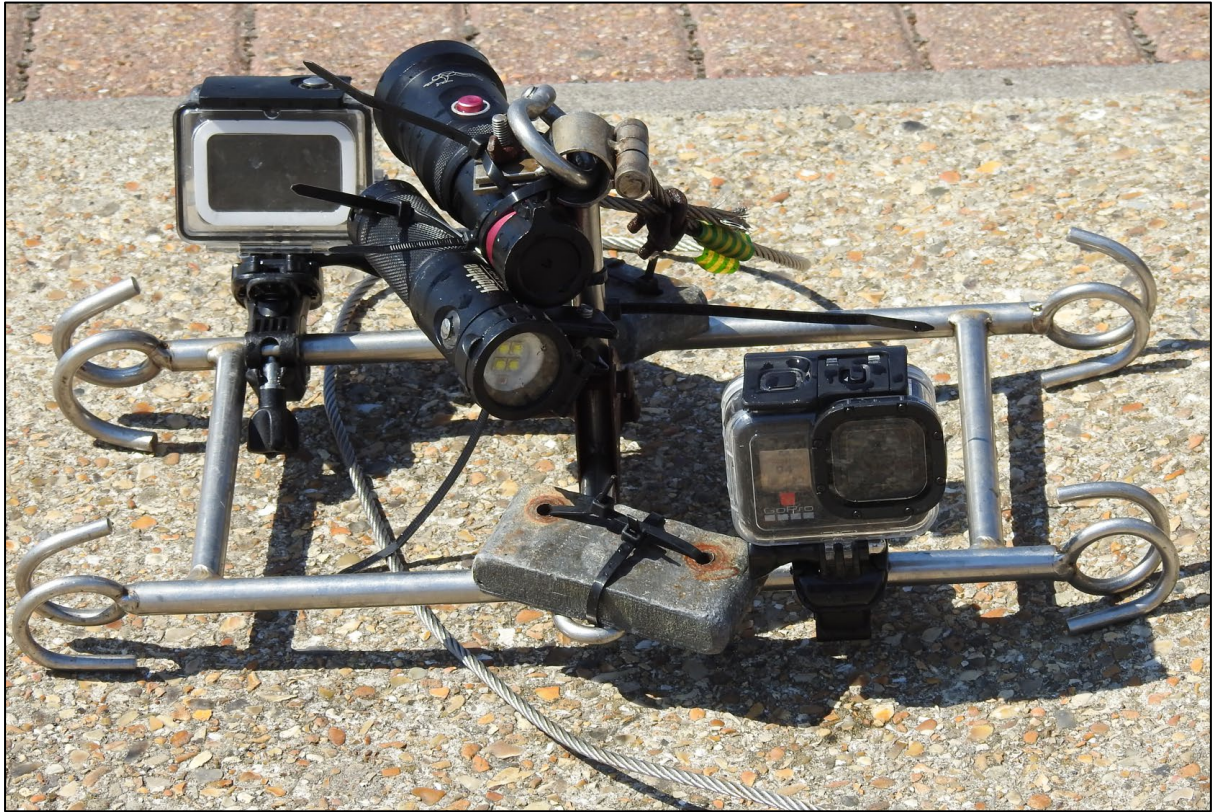
Figure 3. The Drop-down video (DDV) system used during the subtidal survey

The DDV system consisted of two frame mounted high-definition GoPro cameras (forward and rear facing) with external lighting, Figure 3 shows the DDV system and its configuration. When deploying the DDV system the surveyor slowly lowered the frame through the water column until reaching the seabed. Once this had been achieved the frame was then pulled back up through the water column. The camera system recorded footage on both the descent and ascent of the equipment.

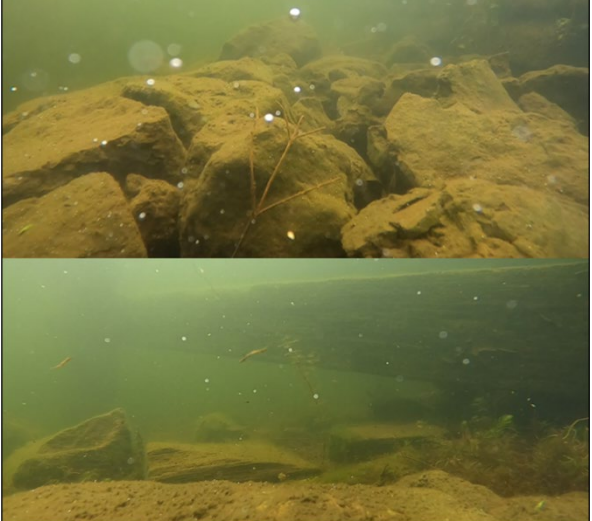
| Sediment Type | Station No's. | Description | Image |
|---|---|---|---|
| Rock | 6-9 | <p>Rock substrate.</p> <p>Images show Stations 7 (top) and 8 (Bottom).</p> | |
