**MOOSE HALL, CASTLE STREET, NEATH**

**BAT ACTIVITY SURVEY - ADDENDUM REPORT**

DOCUMENT REF: E21106701/Doc 02. 25 August 2022

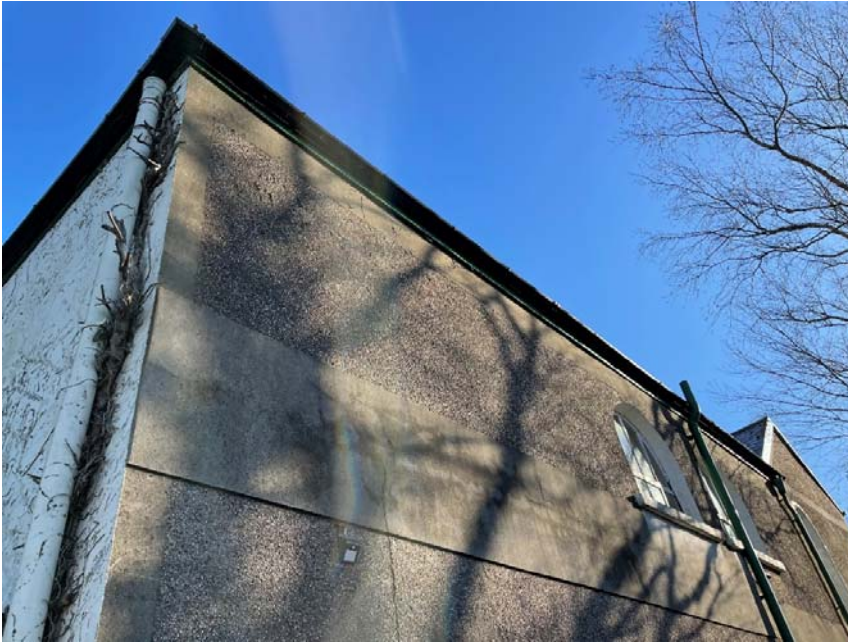
**Plate 1** Surveyor view on western elevation. Photo taken during January day-time inspection

2.2 The dusk survey commenced 15 minutes before sunset at 21.05h and extended for 90 minutes after sunset to 22.50h. Surveys were conducted using broad-band bat detectors (Peersonic & Bat Box Duet). Bat calls were either identified in the field or using computer-based sonogram analysis software (Wavesurfer). Surveyors were positioned as described in Section 1.2 so as to allow visual coverage of the areas/features identified as of Low potential during the day-time inspection (SBE, 2022). The front cover photograph illustrates the view from the surveyor positioned on the eastern elevation with the second surveyor positioned directly opposite the frontage (southern elevation) on Castle street. The third surveyor was positioned in the walkway alongside the western elevation (north west corner) to afford a view of the fascia and windows on this elevation (Plate 1).

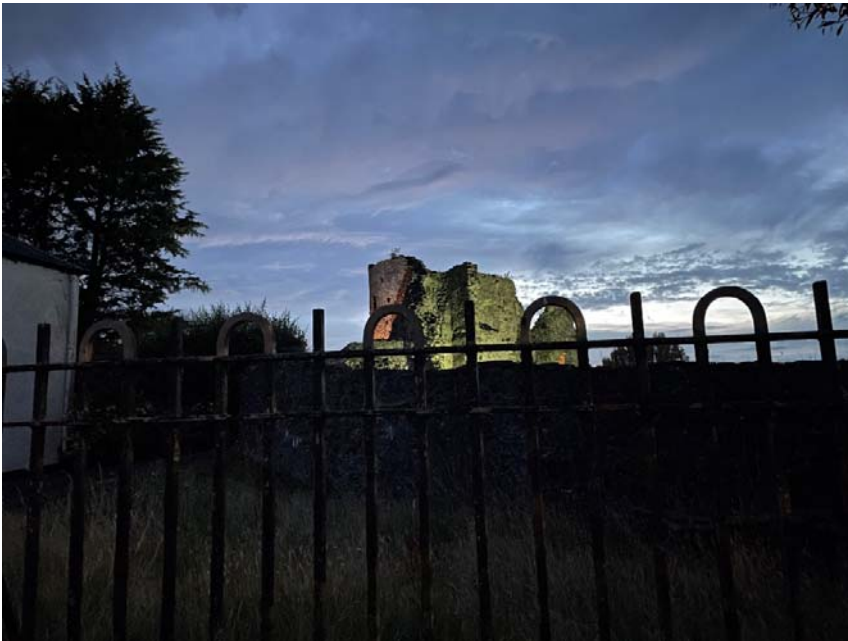
**Plate 2** Castle lighting alongside northern elevation

2.4 No access was possible to afford a view of the northern elevation – the Castle Gardens are locked at night – although this was not considered a significant constraint as relatively few features were associated with the roof or fascia on this elevation (SBE 2022) and surveyors positioned to the east and north west were in a position to note any bat activity associated with this area. During the course of the survey, it became evidence that the Castle itself is illuminated at night which is likely to limit the suitability of this area for bats (Plate 2).

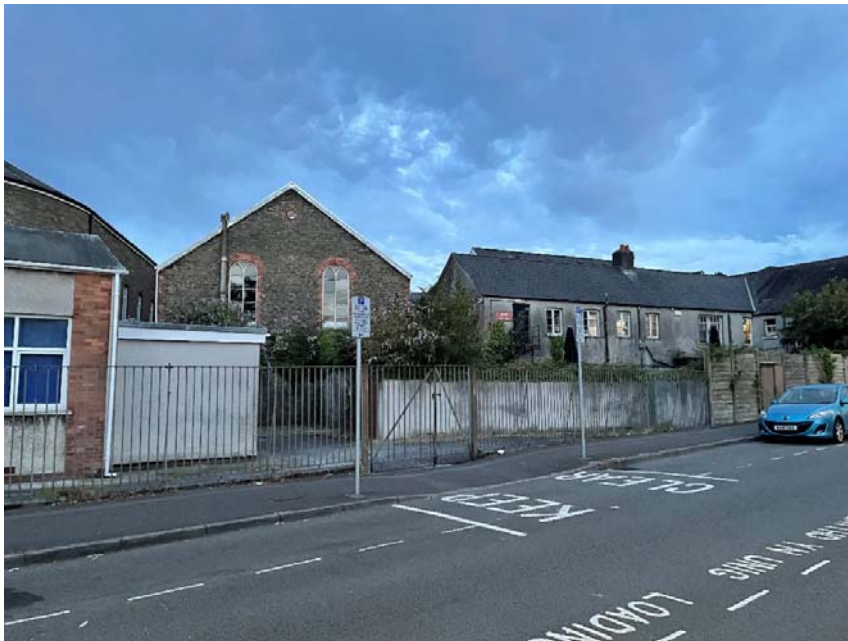
**Plate 3 Rear of Buildings south of Castle Street where regular bat activity recorded**

- 3.2 The first bat activity noted was for Common Pipistrelle *Pipistrellus pipistrellus* at 21.35h approximately 15 minutes after sunset with an individual Pipistrelle foraging around the scattered scrub/yard area to the rear of the buildings south of Castle Street (Plate 3). Regular observations of 1 or 2 individual bats foraging in this area were made throughout the survey period by surveyors on Castle Street (i.e. positioned at southern and eastern elevations of Moose Hall). Foraging by Common Pipistrelle was also noted around a Willow tree east of the building and occasional foraging/commuting by individual bats (8 observations in total) was also associated with the walkway on the western elevation. Low levels of bat activity were noted throughout the survey period throughout the survey period although the majority of observations were in the period between 21.35h & 22.10h (16 of the 26no. total observations).
