**Former Grove Public House Carpark, Port  
Talbot**

**Ground Investigation**

**Factual and Interpretative (Phase II) Report**

**G22075**

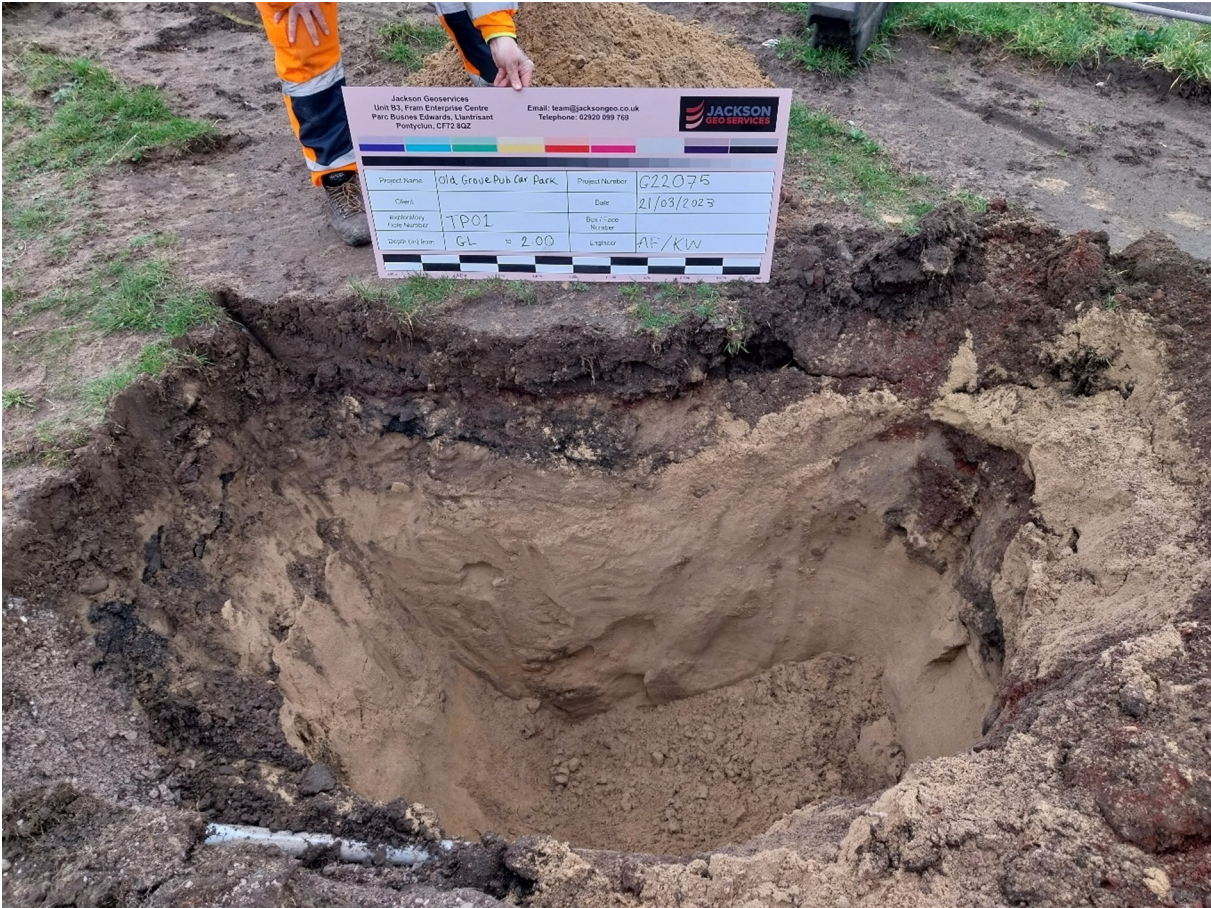
TP01 Face A

| | | <b>EXPLORATORY HOLE PHOTOGRAPHS</b> | | <b>Remarks</b><br>Machine excavated trial pit from GL to 2.00m | | Exploratory Hole |

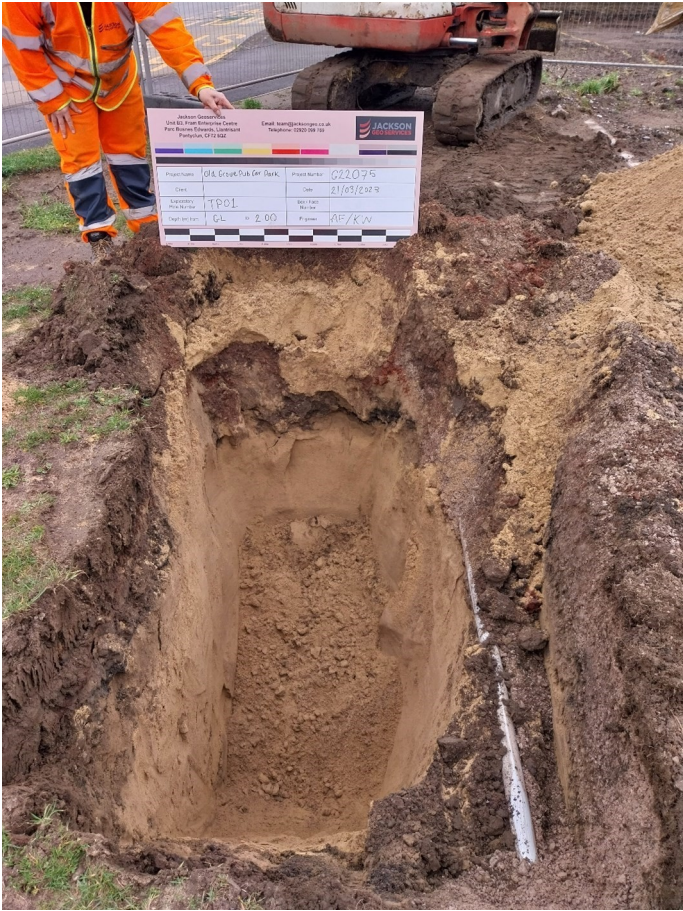
TP01 Face B

| | | <b>EXPLORATORY HOLE PHOTOGRAPHS</b> | | <b>Remarks</b><br>Machine excavated trial pit from GL to 2.00m. | | <b>Exploratory Hole</b> |

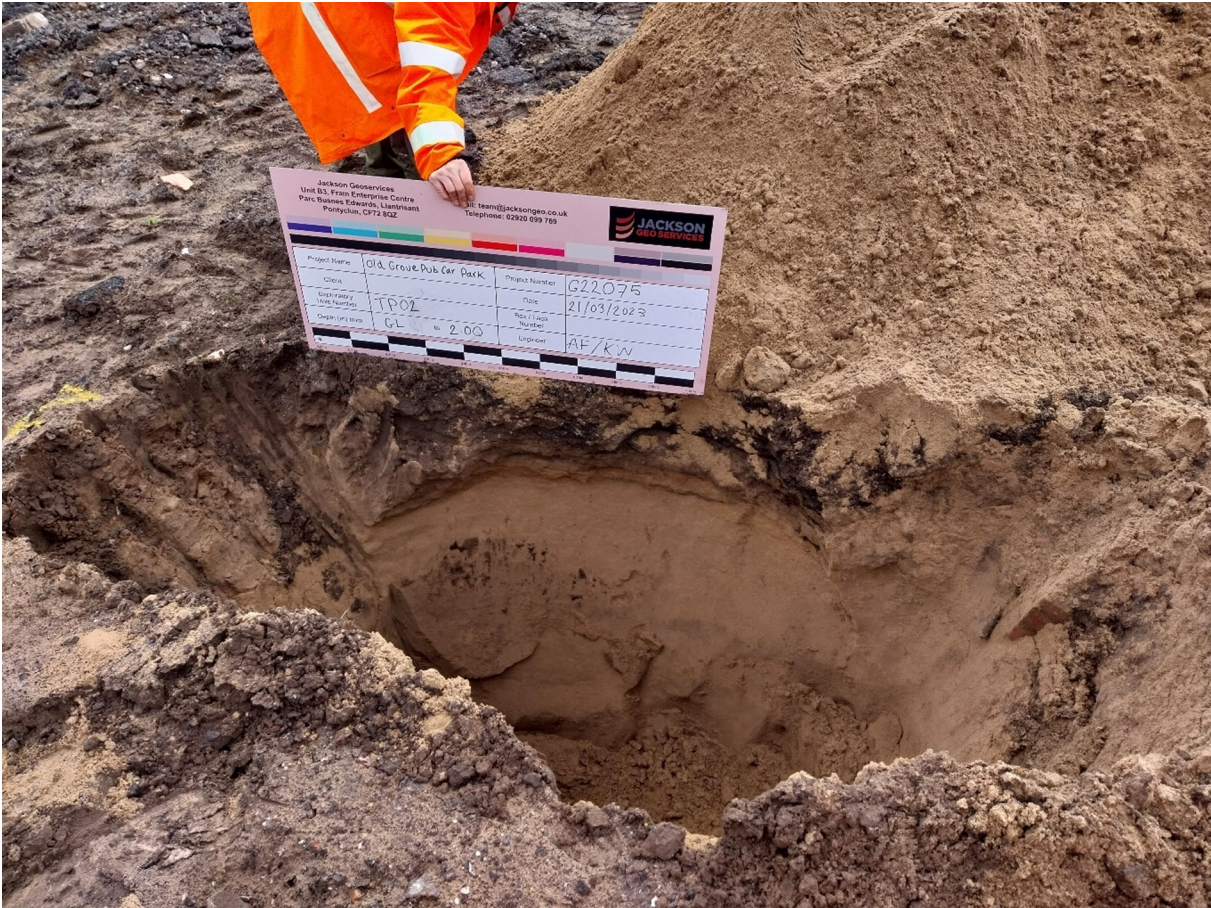
TP02 Face A

| | | <b>EXPLORATORY HOLE PHOTOGRAPHS</b> | | <b>Remarks</b><br>Machine excavated trial pit from GL to 2.00m. | | <b>Exploratory Hole</b> |

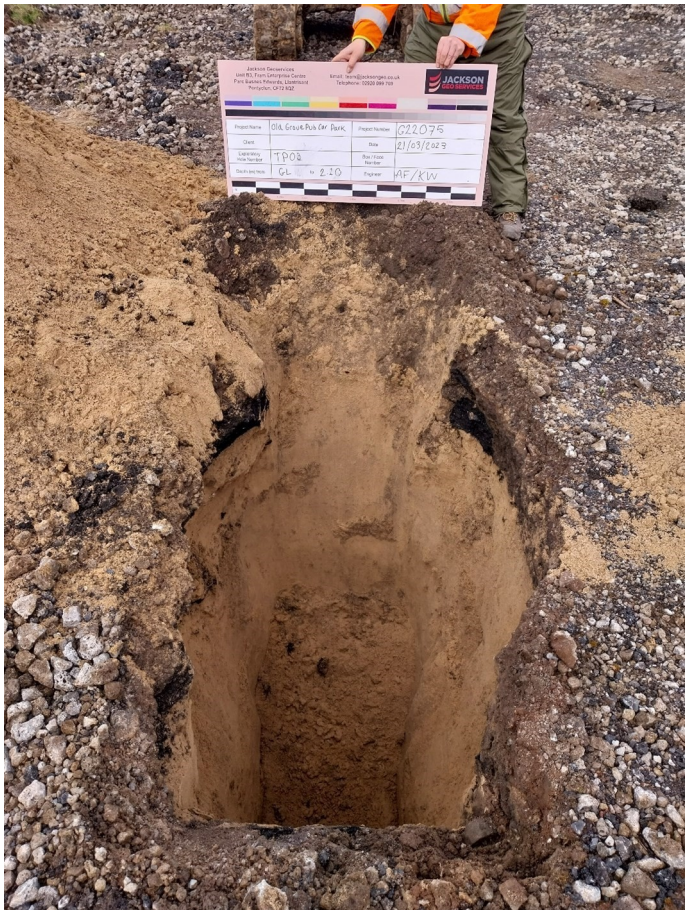
TP03 Face B

| | | <b>EXPLORATORY HOLE PHOTOGRAPHS</b> | | <b>Remarks</b><br>Machine excavated trial pit from GL to 2.10m | | <b>Exploratory Hole</b> |

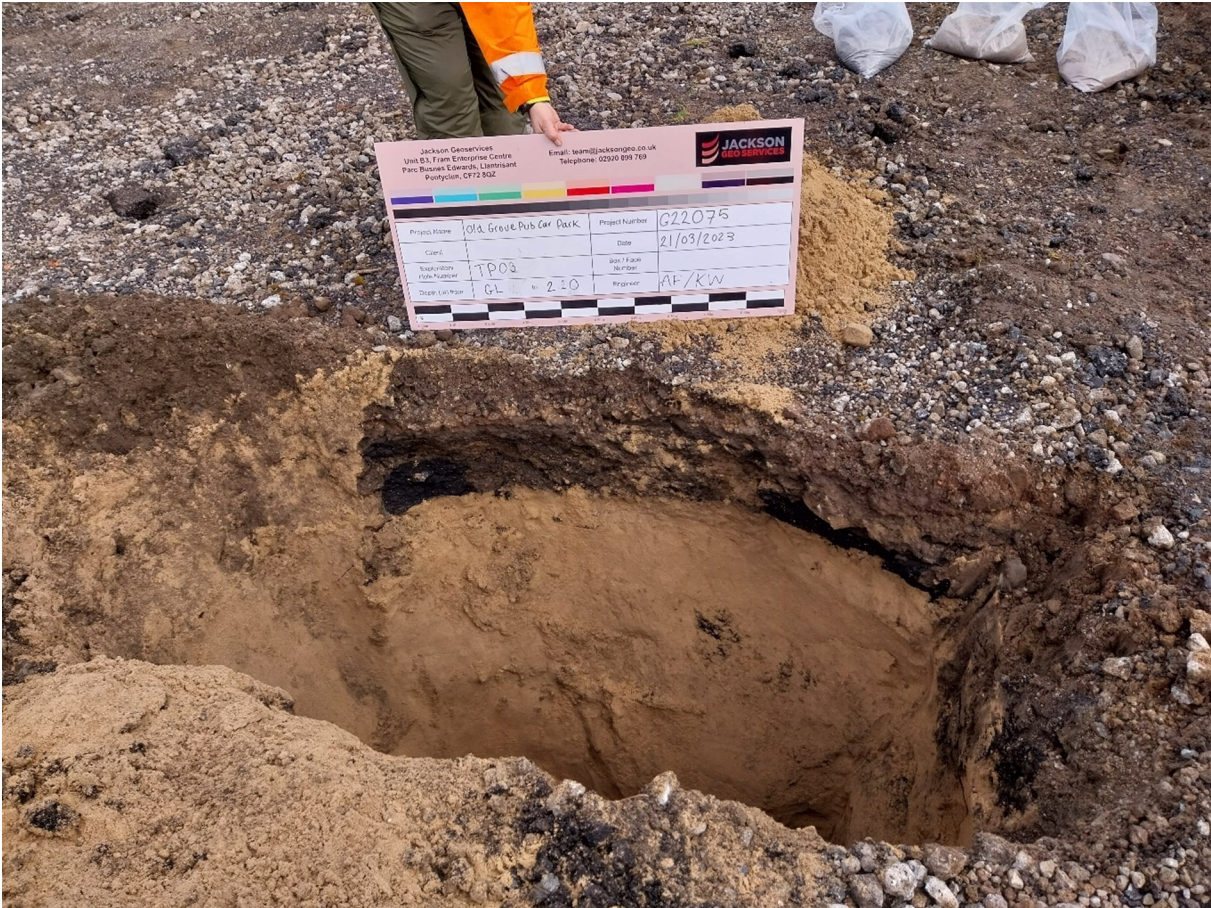
TP03 Face C

| <div><div><div></div><div>JACKSON<br/>GEO SERVICES</div></div></div> | | | EXPLORATORY HOLE PHOTOGRAPHS | | Remarks<br>Machine excavated trial pit from GL to 2.10m | | Exploratory Hole |
