**CARDONNEL COURT NURSING HOME, CARDONNEL ROAD,  
NEATH**

**BAT SURVEY**

**Bat Survey Report**

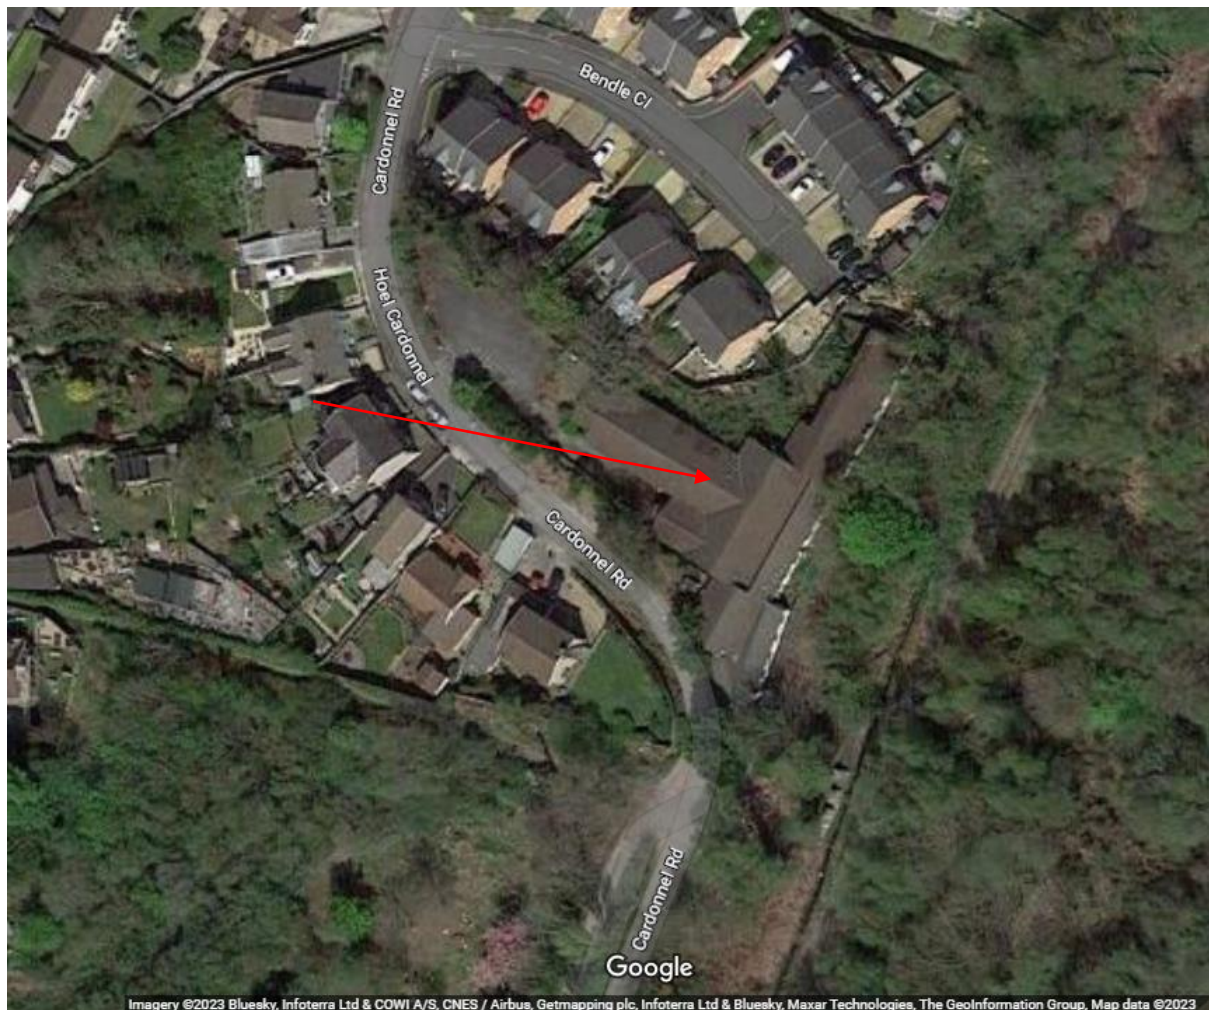
Figure 1- detailed view of site (arrowed red) (Google Maps, 2023)

The building is a brick and block built, pebble dash rendered structure beneath a clay tile roof. The building is located immediately to the west of Cardonnel Road, Skewen, Neath (figure 1). The building is large and complex with multiple rooves, valleys and pitches. Generally the ridges run from south west to north east and north west to south east. The building is the subject of antisocial behaviour and vandalism.

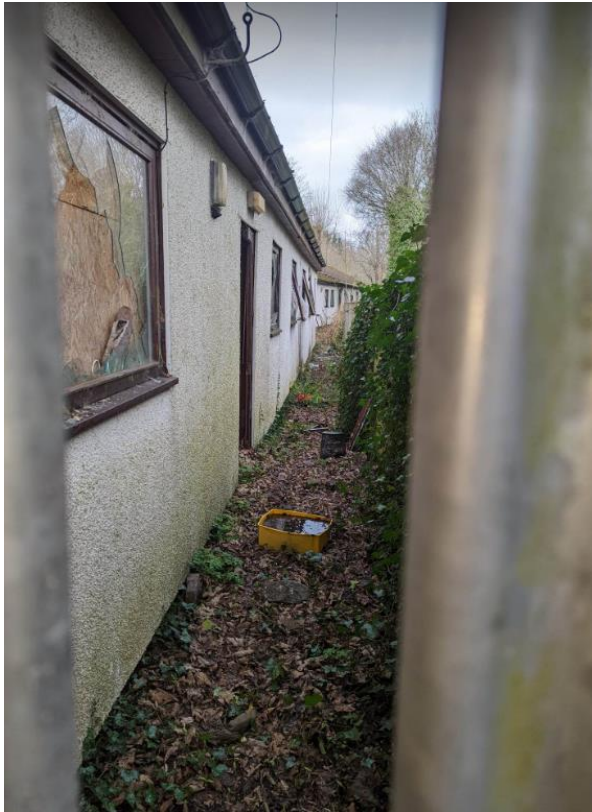
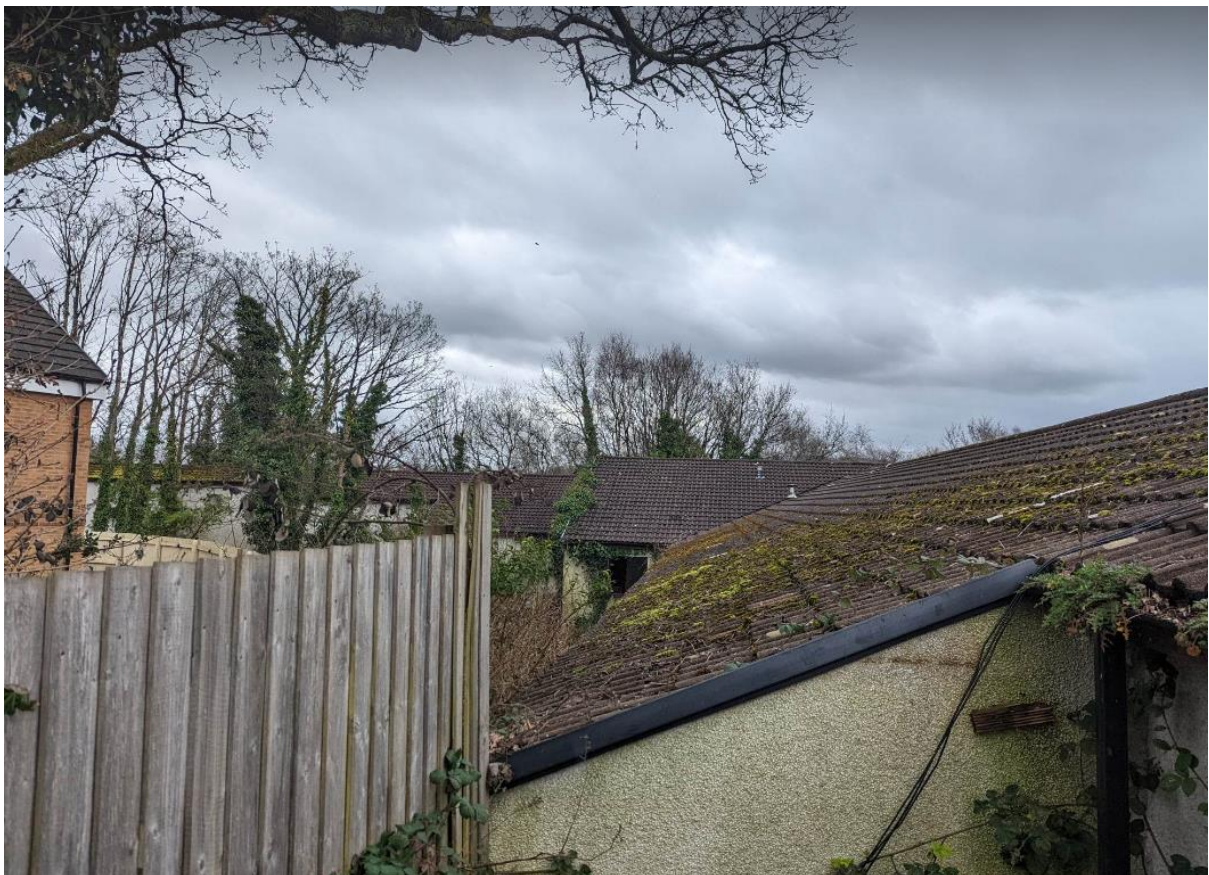
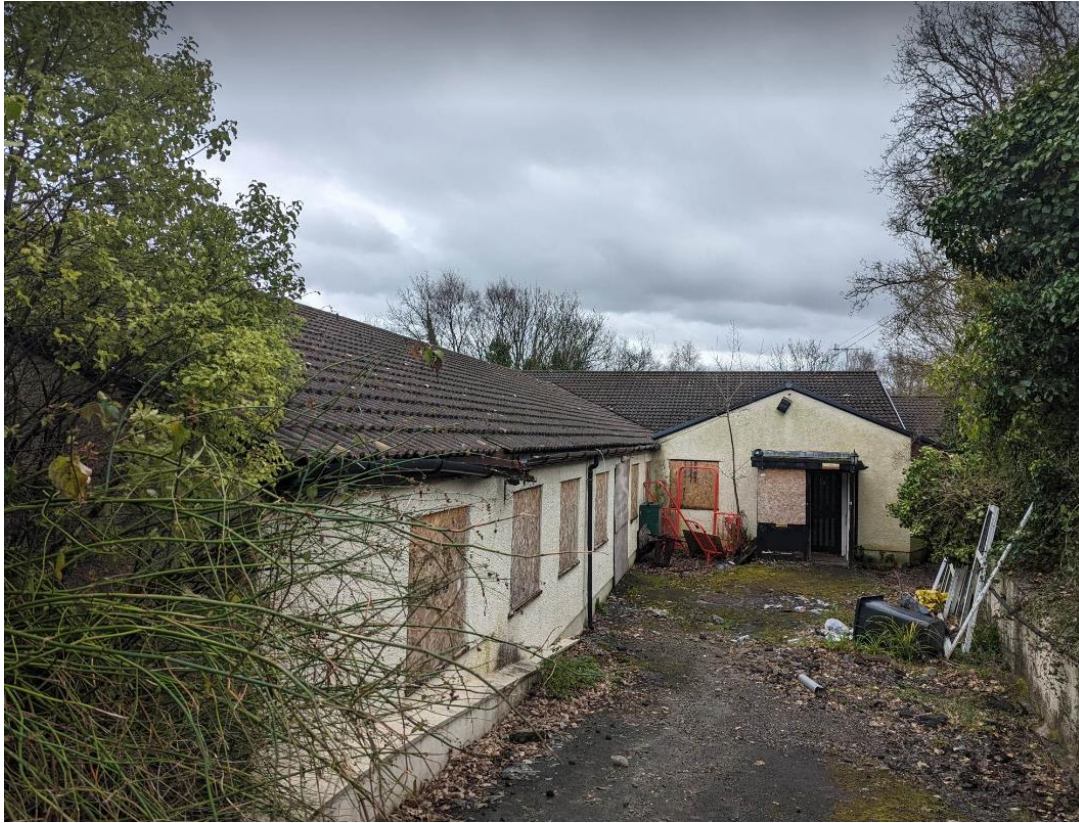
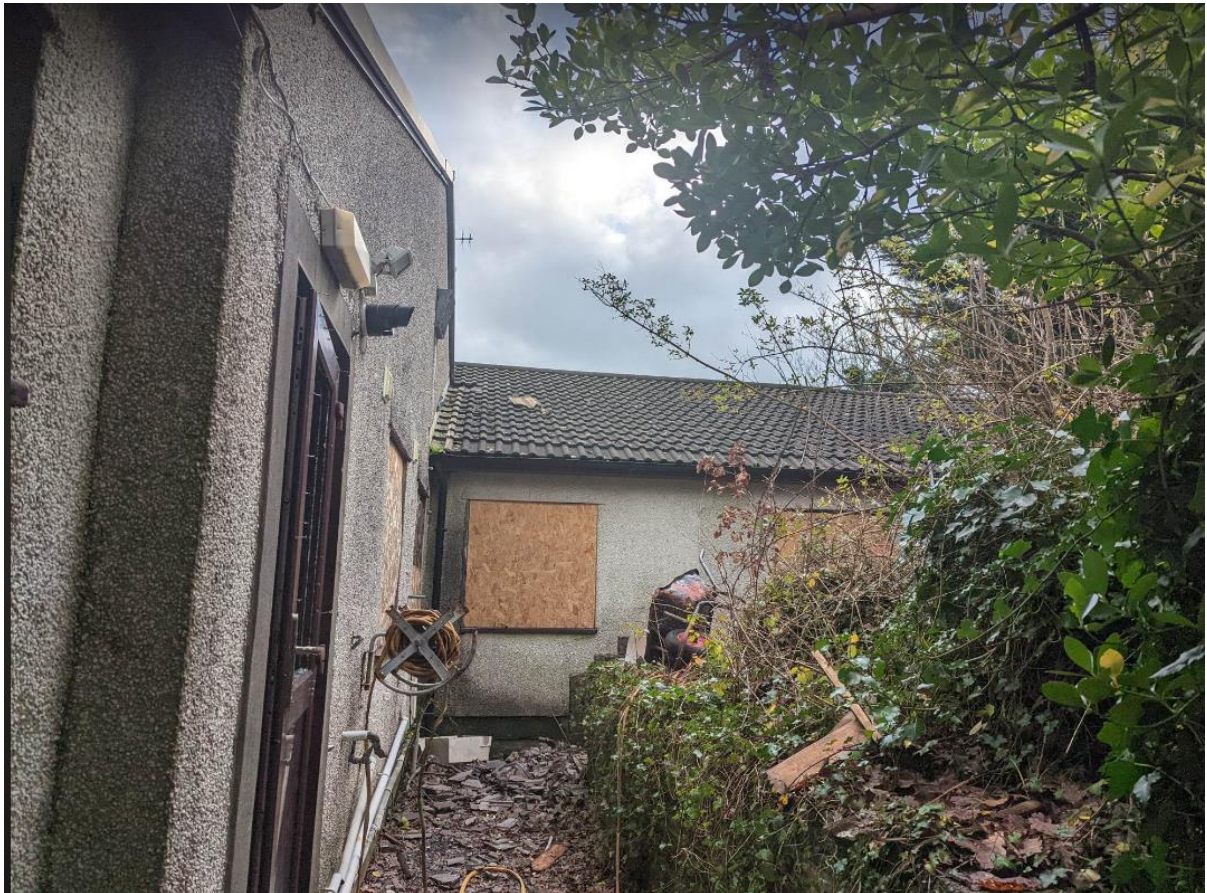
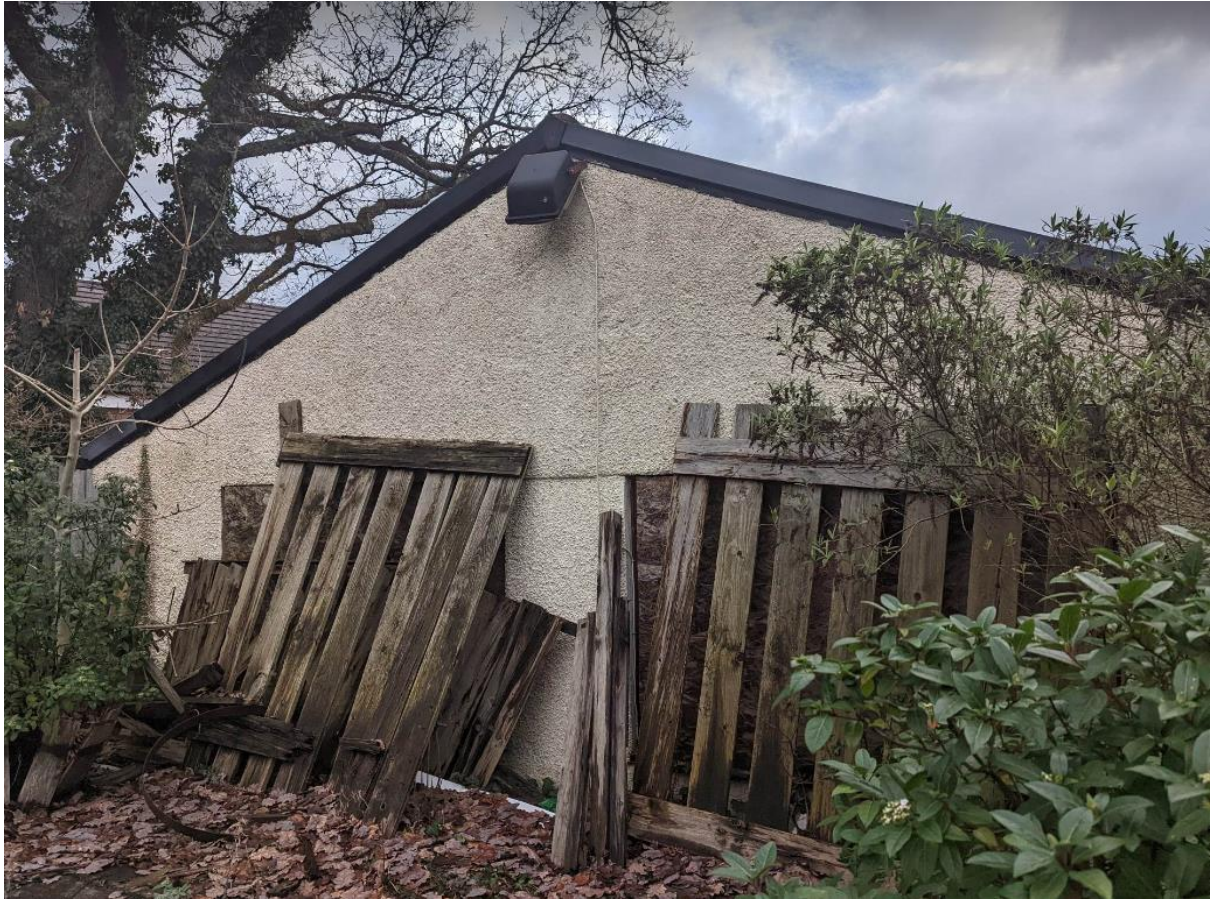
## APPENDIX A- PHOTOGRAPHS

The survey carried out by BE Ecological Ltd revealed no droppings or evidence of bats on the exterior of the building. However, a number of potential access points for bats were noted. These include but are not limited to:

- Gaps beneath ridge tiles
- Gaps beneath slipped/missing tiles
- Gaps via smashed windows and doors
- Gaps beneath fascias/soffits
- Gaps beneath lead flashing
