# PHOTOGRAPHS

Project Number : PCI14596

Project : Coed Darcy Urban Village, North Site Reservoir Dam

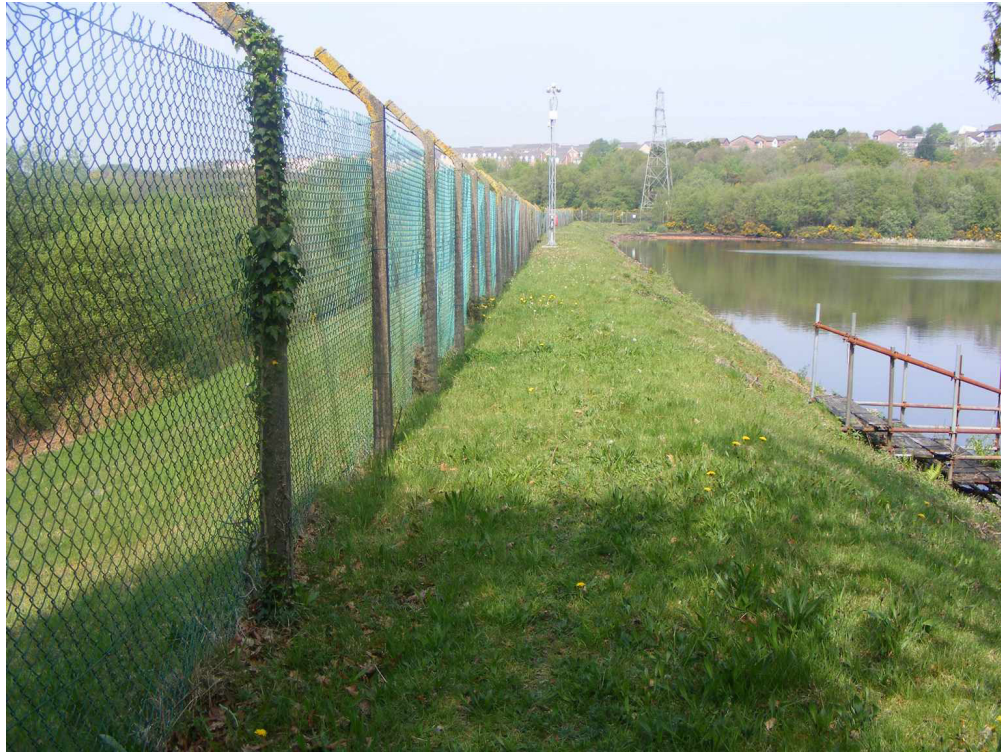
View looking north west along the crest of the dam

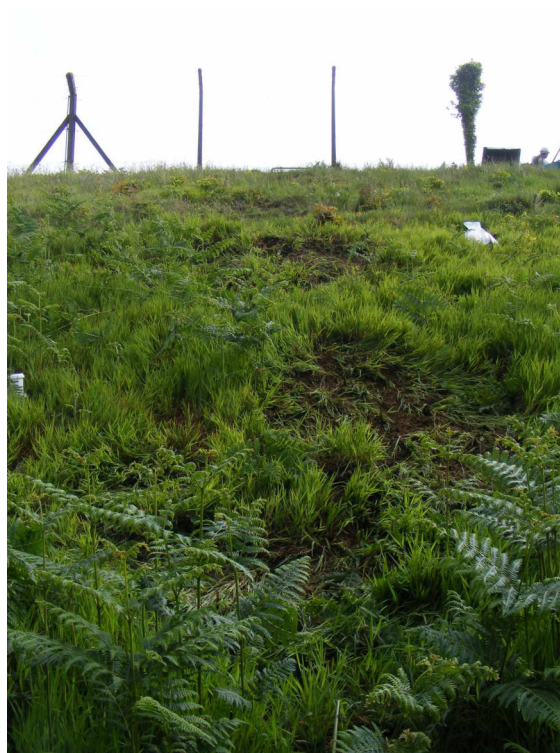
View from TP06 looking north east

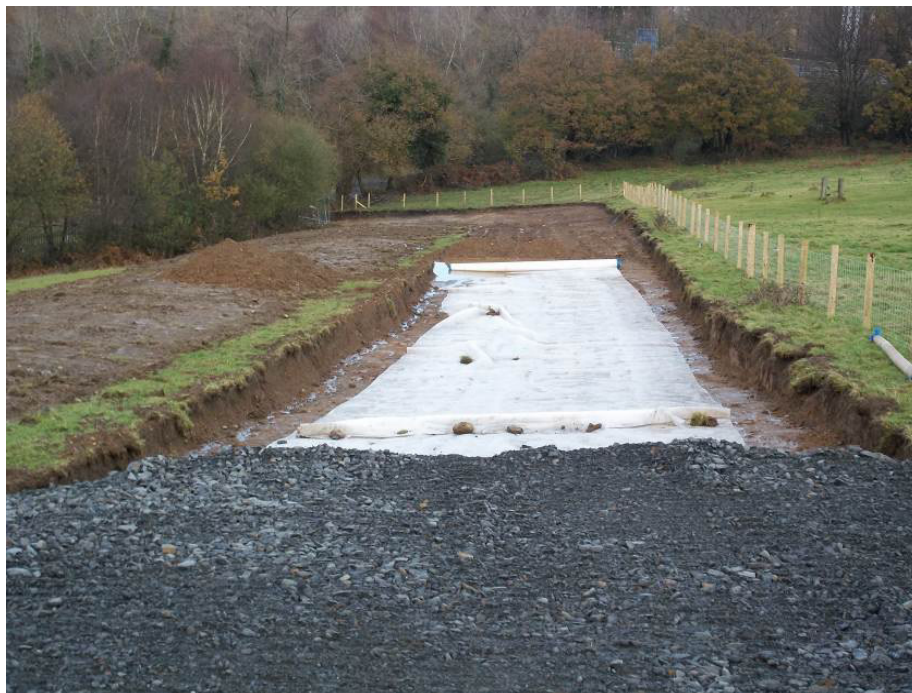
**Photograph 1 – East Bay Access Road**

In order to undertake the remediation works at East Bay, an access road was created that linked the main refinery to East Bay. The road crosses farmland to the south of East Bay and enters the site from the south eastern corner. The road was created by stripping an area approximately 6 m wide and 0.3 m deep (exposing the subsoil). A geomembrane was placed and covered by imported granular material (see Photograph 1).

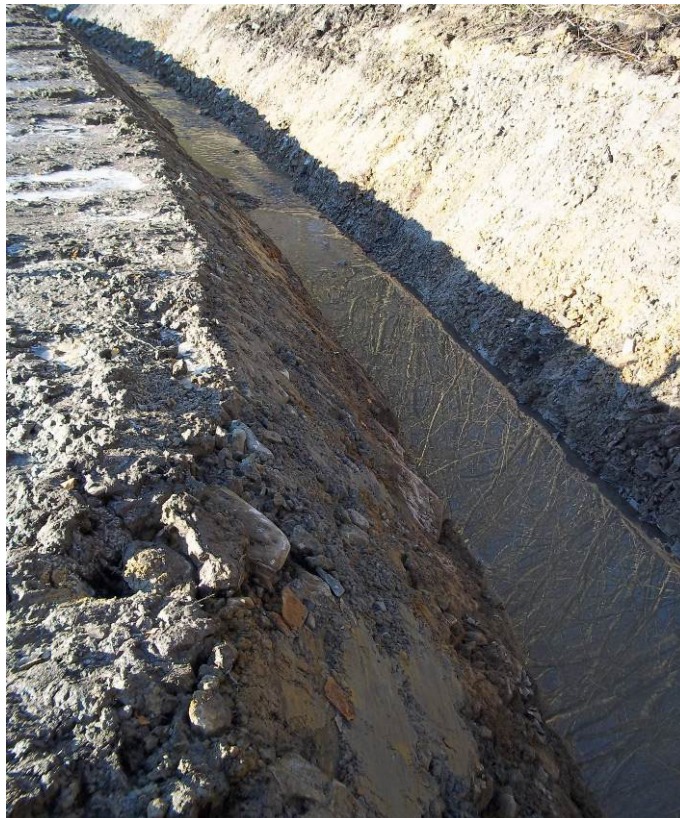
**Photograph 2 – Motorway Drainage Diversion**

East Bay was fed by two main inflows, the first was a spring line that entered the site from the south eastern corner and the second was surface run-off from the M4 that entered the site from the east. Two open diversion trenches were installed around the perimeter of East Bay that diverted the two identified inflows directly into the NSR (Photograph 2 and 3).

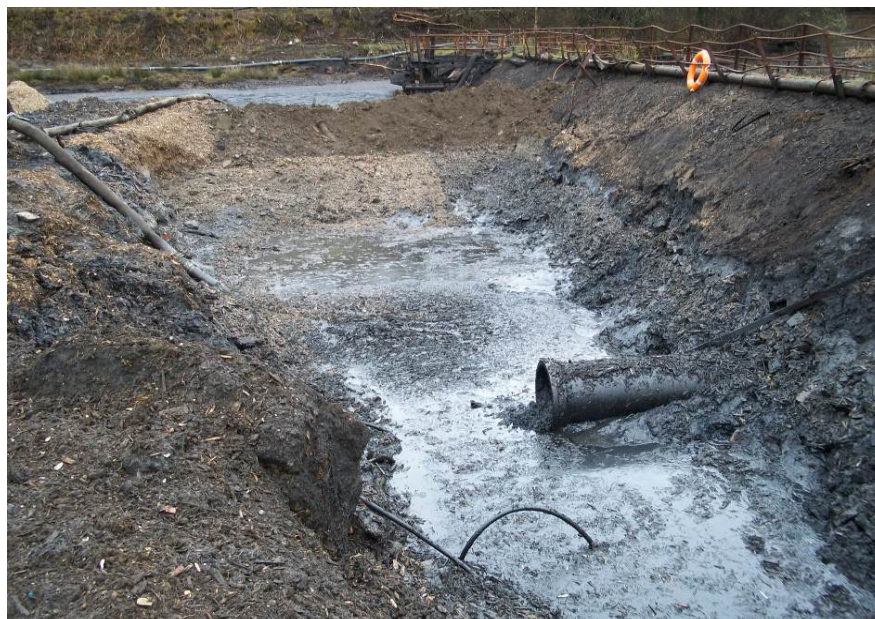
**Photograph 4 – Low level pipe linking East Bay to NSR**

During the remediation works three large diameter low level pipes were encountered running through the embankment between NSR and East Bay. A clay plug was placed over the pipe inlet on the NSR side, however this only reduced the inflow as water continued to seep through the pipes but also through the surrounding embankment (see Photograph 4).

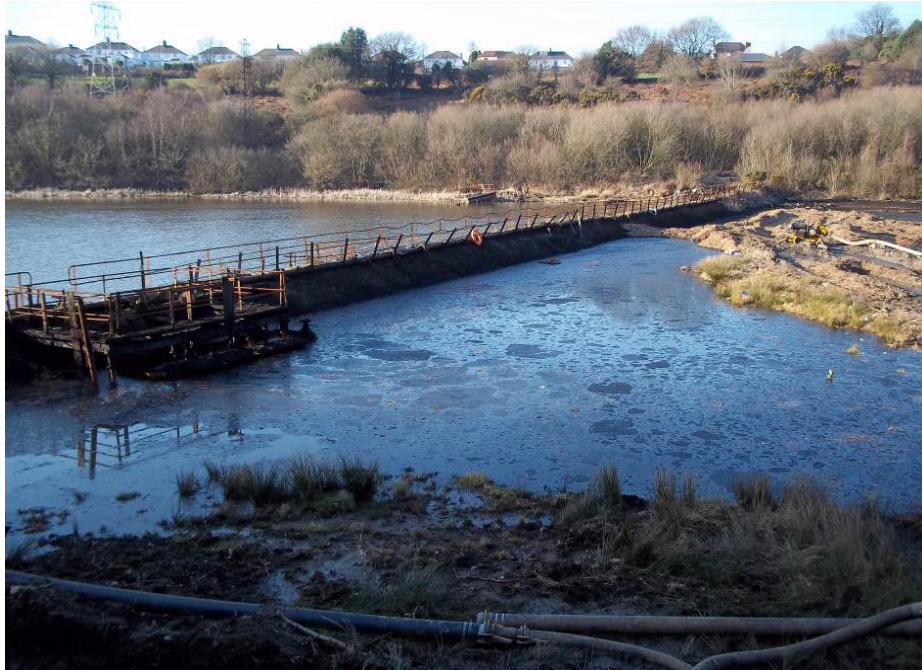
The water inflow entering East Bay from NSR was controlled by creating a low permeability bund around the area of the most significant inflow to prevent it from impacting the wider works (see Photograph 5).

**Photograph 5** – Low permeability bund, in the top right, created within East Bay

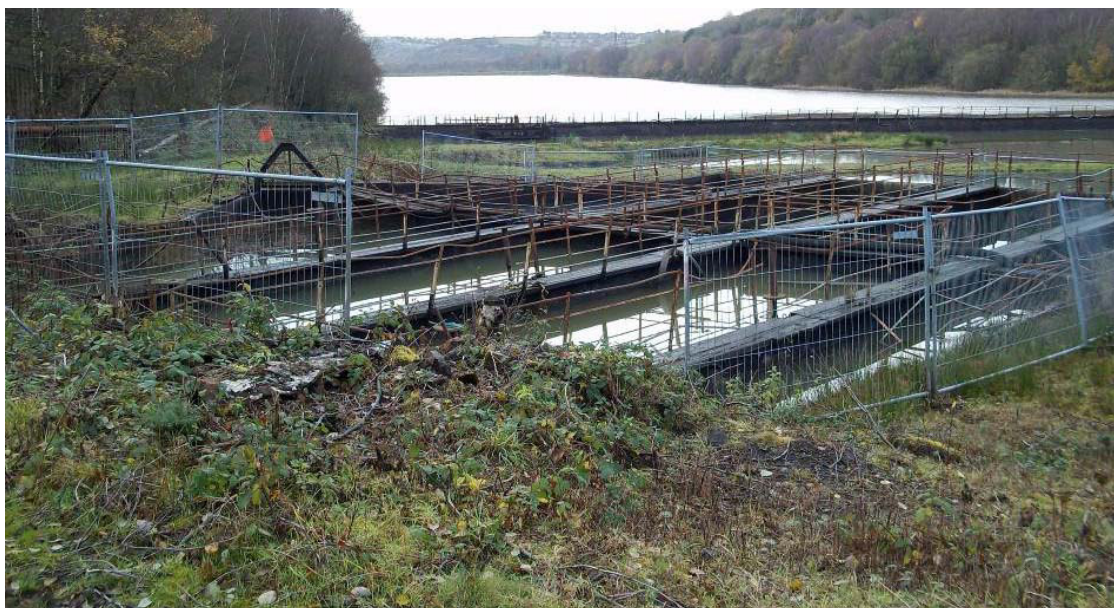
As part of the remediation works Celtic were required to clean and dismantle a redundant oil/ water separator located within the south eastern corner of East Bay (Photograph 6).

**Photograph 6** – Separators prior to Demolition

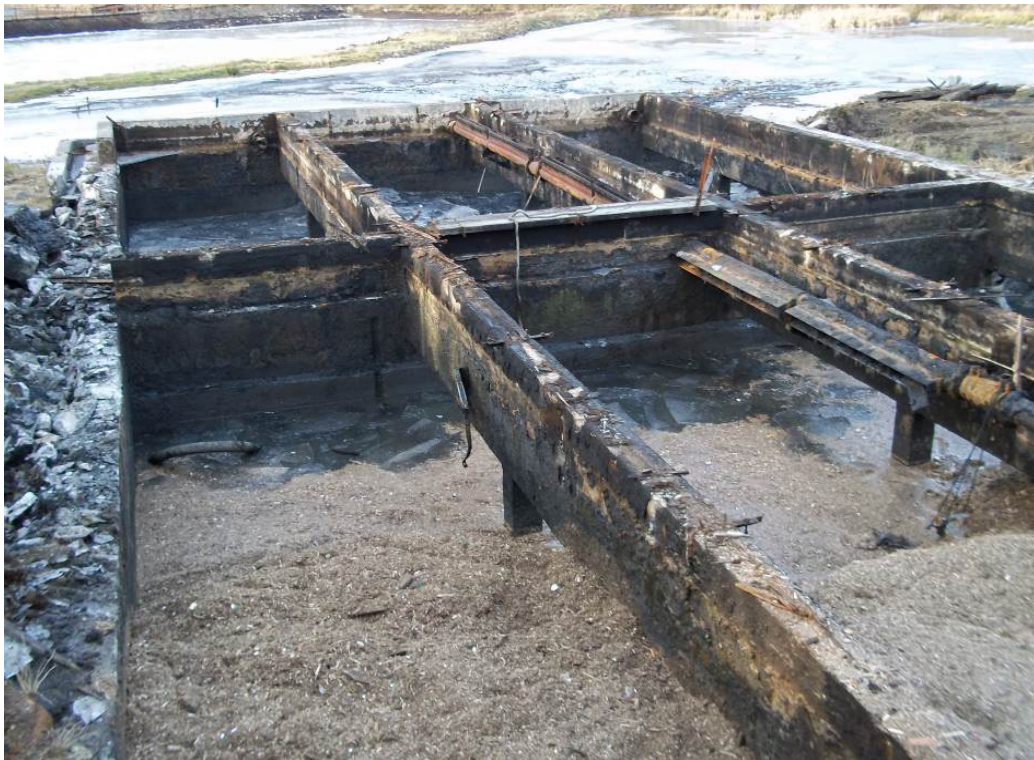
**Photograph 7 – Mixing and removal of material within the separators**

Hydrocarbon impacted material within the separators was mixed with wood fines (Photograph 7), which were then transported to a treatment pad. The base of the separators comprised a significant thickness of concrete with no visible cracking or damage noted. It is therefore unlikely that any of the hydrocarbon impacted material contained within the separators have impacted the underlying material.

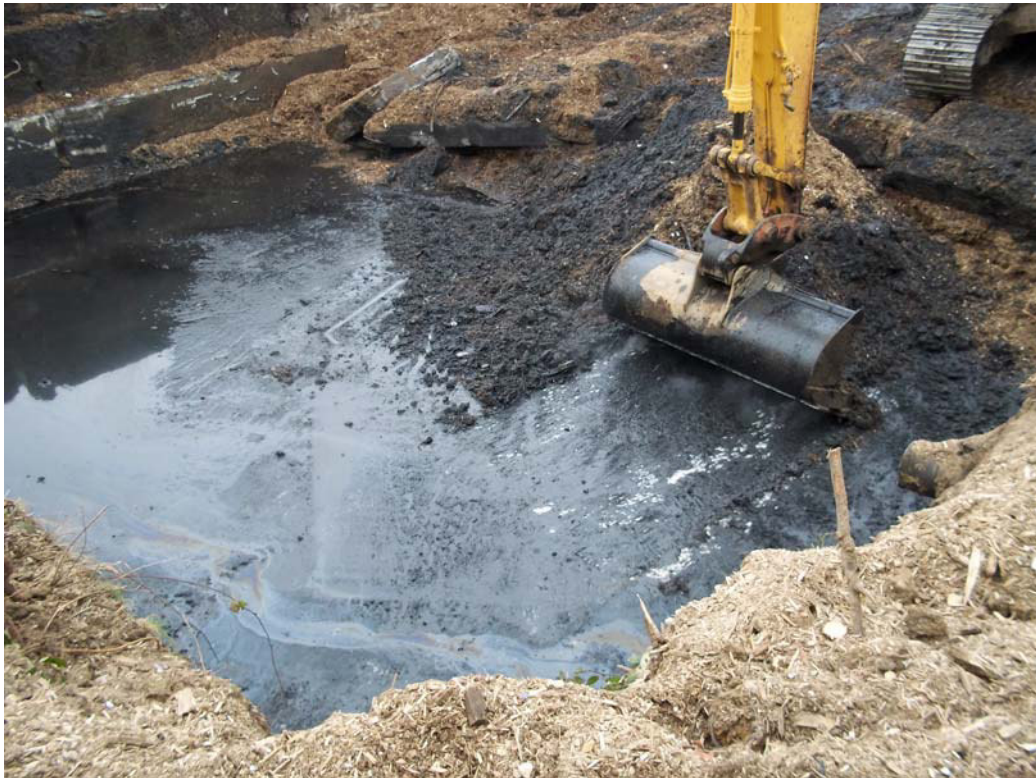
**Photograph 8 – Scraping of concrete base of separators**

Prior to demolition the base of the separators were scrapped to ensure that the hydrocarbon impacted material had been removed (Photograph 8). The concrete base to separator was then broken up (Photograph 9) and the remaining concrete from the sides placed on top.
