**Tyn-y-Caeau, Margam Road, Margam, Port  
Talbot, Neath Port Talbot, SA13 2NW**

**Bat Survey Report for Recycling Plant & Machinery Ltd**

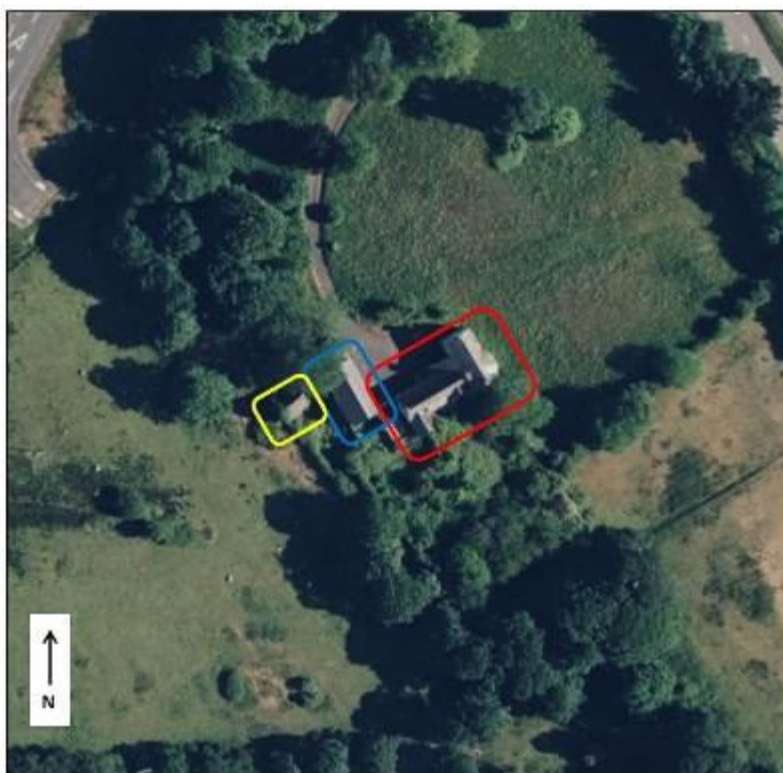
**Figure 1:** Aerial view of the property – the **Dwelling** is outlined in red, the **Annexe** is outlined in blue, and the **Outbuilding** is outlined in yellow (from Apple® Maps)

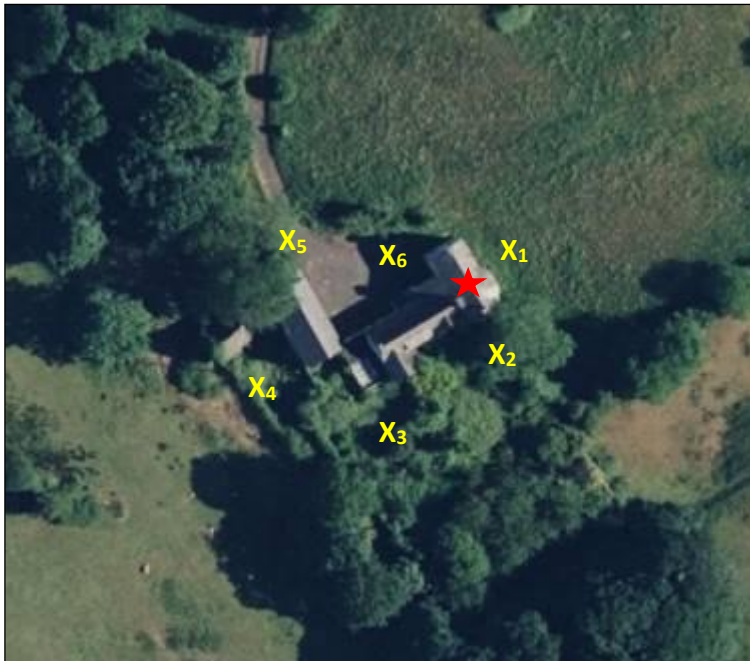
3.1.7 Figure 5 shows the position of surveyors during the activity surveys. Each surveyor had a Magenta 5 or an Elekon Batscanner bat detector to assist in identification and detection of bats and their behaviour. **Surveyors moved along the elevation they were watching during the survey, and the location of the Anabat is shown by a red star.**

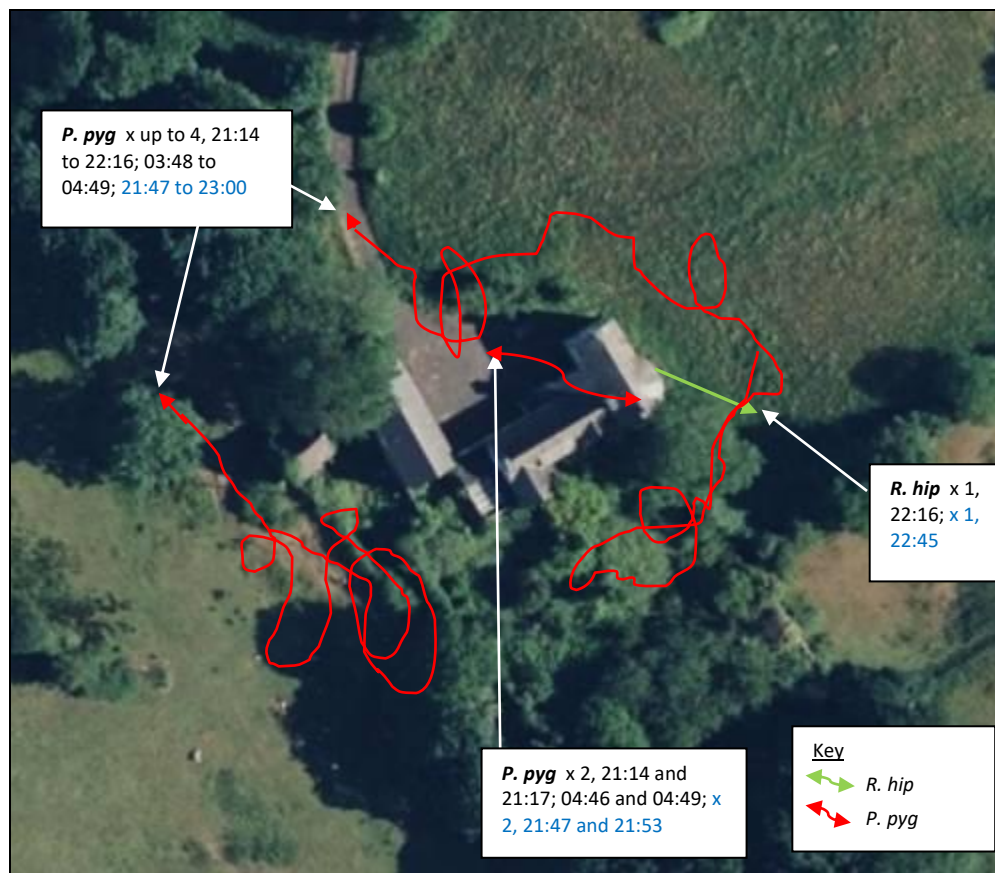
**Figure 6:** Aerial map showing the flight lines of bats detected (from Apple© Maps)

3.2.3 Figure 6 shows the flight lines of bats detected and the times they were detected. The species of bats detected during the surveys, and the nature of their activity follows.

- ***P. pygmaeus***: Two bats were seen to emerge from under a loose slate around the chimney pot to the left of the front elevation on both dusk surveys and two bats were seen to enter the same area on the dawn survey. In addition, on all surveys, bats were detected foraging and commuting on all sides of the buildings. The earliest activity on the 1<sup>st</sup> dusk survey was an emergence five minutes after sunset, the earliest activity on the 2<sup>nd</sup> dusk survey was an emergence 11 minutes after sunset, and the latest activity on the dawn survey was a re-entry 21 minutes before sunrise.

- ***R. hipposideros***: On the dusk surveys, an individual bat was seen (using night vision equipment) to leave the Dwelling via a missing pane of glass to the front. The bat emerged at 67 minutes after sunset on the 1<sup>st</sup> dusk survey and 69 minutes after sunset on the 2<sup>nd</sup> dusk survey. No bats were seen to enter or leave on the dawn survey but calls were heard to the south just after the survey started at around 120 minutes before sunrise.

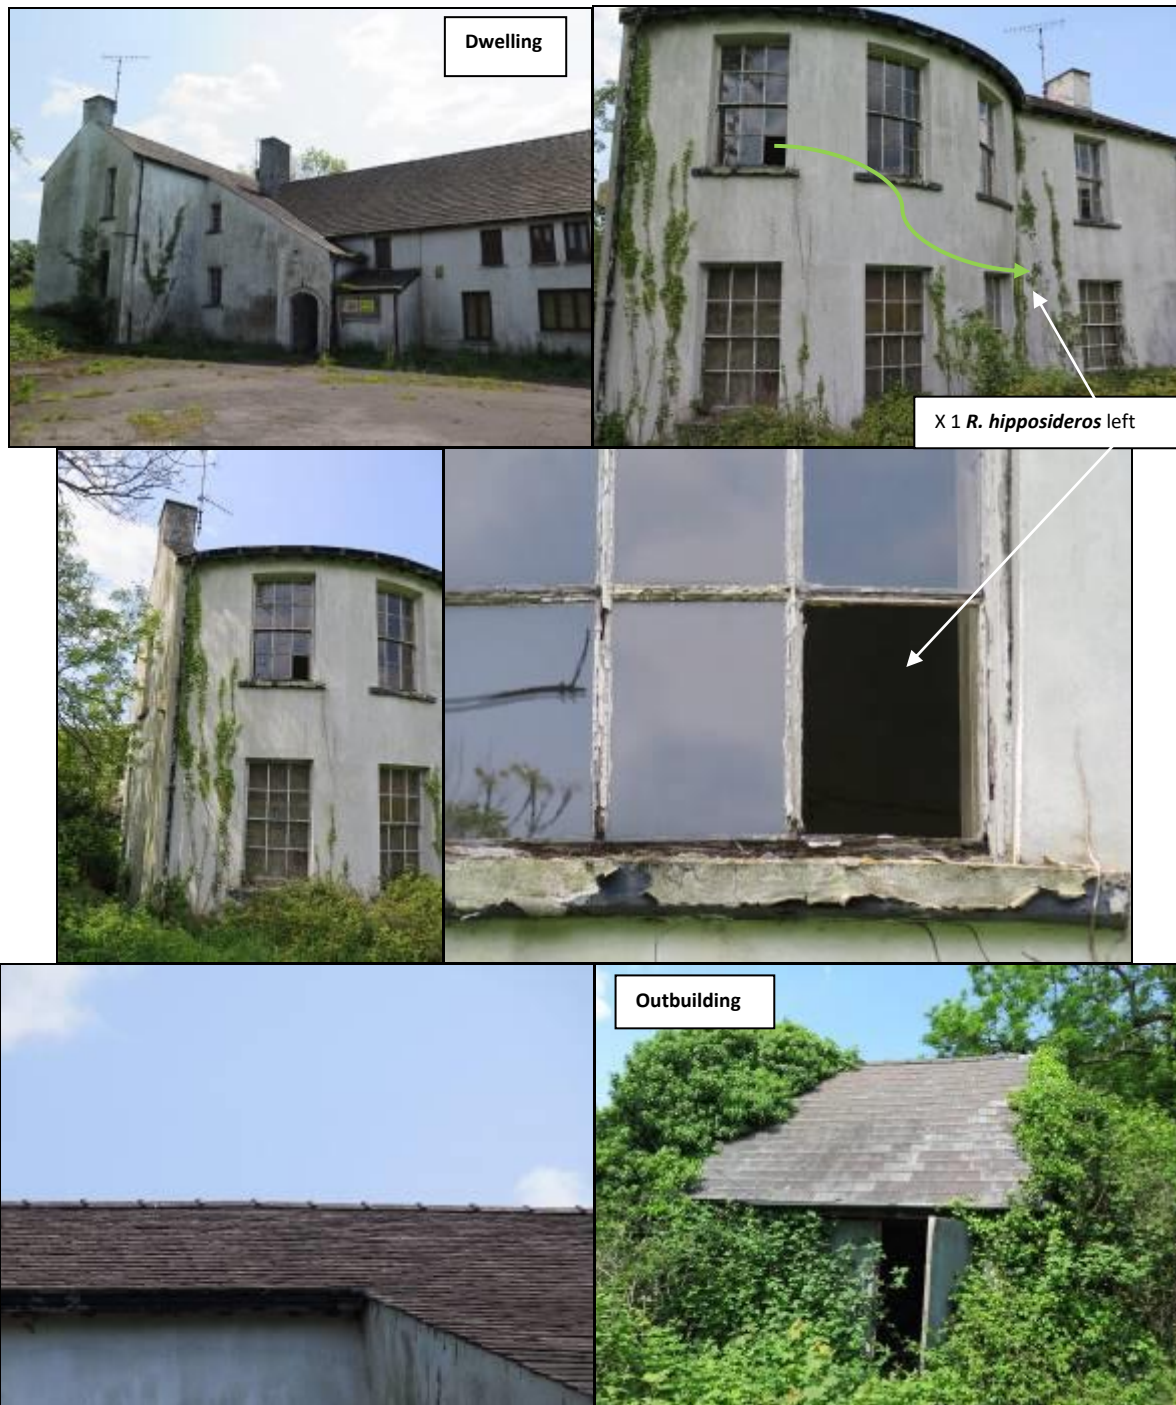
The property is subject to proposed plans for change of use of to a guest house with the addition of a café and erection of rear single-storey extension to accommodate spa facilities. The original period **Dwelling** is a large north-west facing predominantly two storey detached building constructed of rendered and painted walls and has natural slate roofs with lead flashing around the chimneys. The detached, north-east facing, two storey (with subterranean rooms to the rear so this aspect is three storey) **Annexe** is constructed of smooth rendered walls with a slate roof, brown uPVC framed windows and doors, and brown uPVC soffits/fascias/weatherboards and rainwater goods while the detached **Outbuilding** is constructed of stone and has an unlined slate roof with a lot of vegetation coverage. There have been no material changes to the property itself since the previous surveys but it was noted that no droppings were present during the 2023 survey. The walls of the original house remain intact with only small cracks while the timber soffits/fascia/weatherboards are predominantly tight to the walls with only a small number of potentially exploitable gaps. The roof slates themselves are predominantly in good condition with no missing or damaged slates, but there are areas where they have slipped; thus, creating potentially exploitable gaps, and there is also some loose lead flashing around the chimney pot to the left of the front elevation. The windows and doors remain generally intact with only one pane of glass in the original timber framed windows to the front still missing.

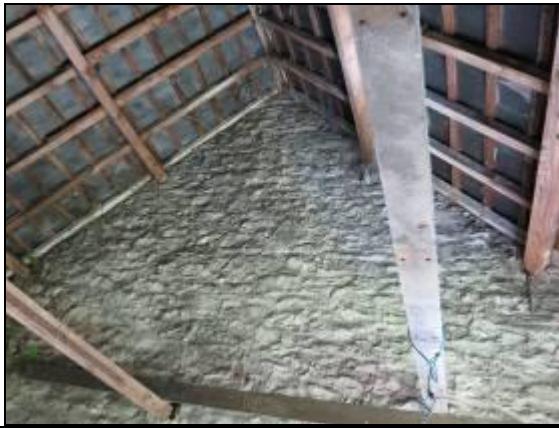
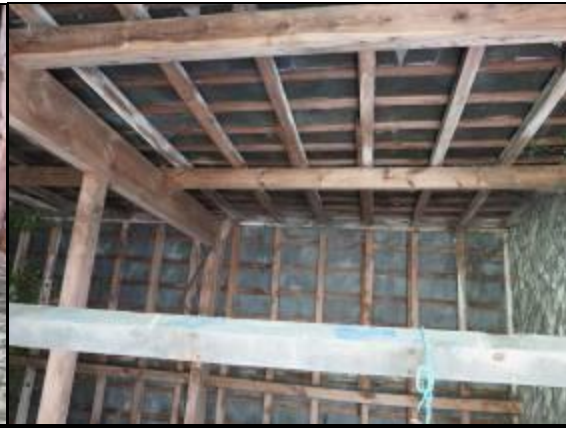
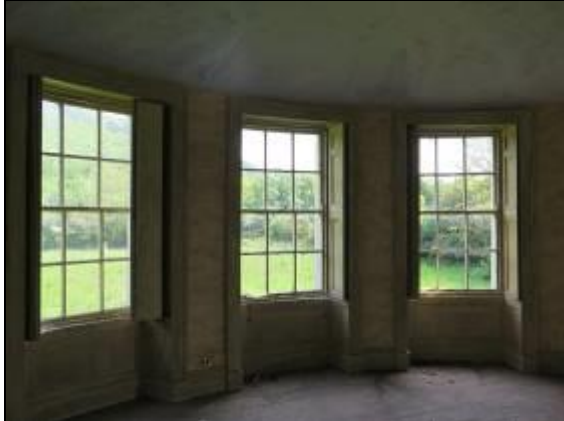
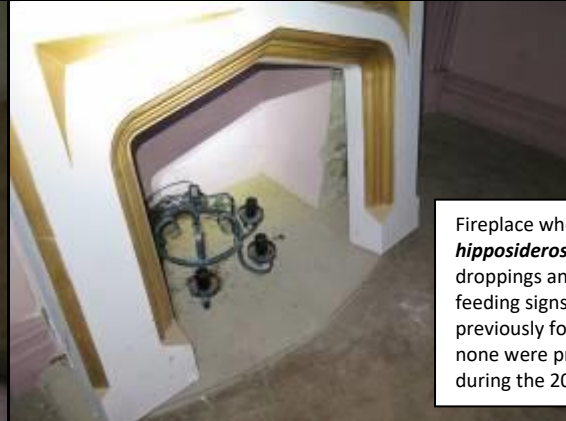
Fireplace where *R. hipposideros* droppings and feeding signs were previously found – none were present during the 2023

- ✦ As part of the 2023 scoping survey of the **Dwelling**, no bats or their signs were found, but droppings and feeding signs (peacock butterfly wings) were previously found within the hall fireplace area, which 2020 DNA analysis confirmed were from **Lesser horseshoe**. The Anabat recorded only **Lesser horseshoe** calls while during the dusk surveys **one Lesser horseshoe left the Dwelling via a missing glass pane**. In addition, **two Soprano pipistrelle** bats were seen to leave/enter via a loose slate close to a chimney pot to the left of the front elevation.

2.2.5 The 2020 (updated September 2022) Bat Survey Report produced by I&G Ecological Consulting Ltd reported that droppings and feeding signs (peacock butterfly wings) were found within the hall fireplace area, which DNA analysis confirmed were from *R. hipposideros*. The Anabat recorded only *R. hipposideros* calls while during the 2<sup>nd</sup> dusk survey, **one *R. hipposideros* was detected entering the building via a slipped glass pane to the front, and during the dawn survey, one bat of the same species was seen to leave the same area.** In addition, **three *P. pygmaeus*** bats were seen to leave loose lead flashing around the chimney pot to the left of the front elevation on the first dusk survey, **five *P. pygmaeus*** bats were seen to leave on the 2<sup>nd</sup> dusk survey and **four *P. pygmaeus*** bats were seen to enter on the dawn survey. Three *P. pygmaeus* were seen to enter the same area on the 2<sup>nd</sup> dawn survey on 3<sup>rd</sup> June 2022, and a solitary *R. hipposideros* was heard and not seen commuting and foraging over the site. There was also an area where the roof steps down to the rear of the dwelling where **two *P. pipistrellus*** bats were seen to leave on the 1<sup>st</sup> dusk survey. These and a further one species (*Myotis species*) was seen/detected by the surveyors utilising the immediate surroundings for foraging and commuting. It was concluded that **the Dwelling was being used as a feeding perch for an individual (probably male) *R. hipposideros*. The loose roof materials were also providing refuge for up to five *P. pygmaeus* and two *P. pipistrellus*.**

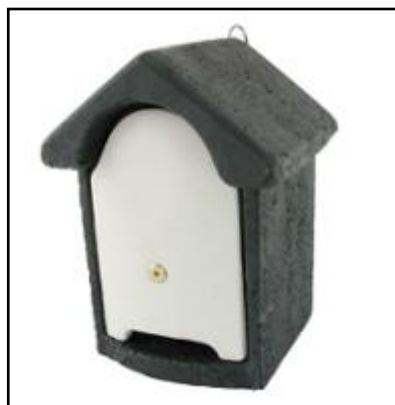
**Left:** The Harlech WoodStone bat box offers excellent insulation with a minimum of condensation for roosting bats. WoodStone® is a mixture of sawdust from FSC wood sources and concrete, and it is designed to last for years. It is breathable so there will be no problems with condensation and Woodstone maintains a consistent temperature inside, providing excellent insulation for roosting bats. Height 24cm x width 19cm x depth 18cm; Weight 4.4kg; Colour: Black with White front panel; Hook for hanging; Removable front panel for inspection/cleaning; and 10 Year Manufacturers Guarantee.

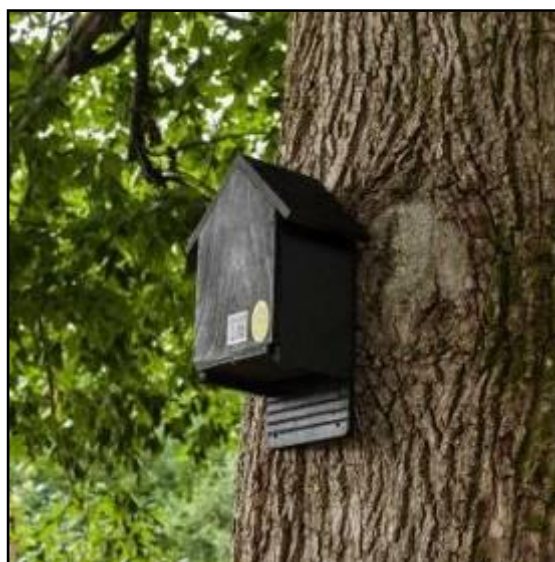
following features: FSC Certified, Suitable for the British cavity-dwelling bats including the Brown Long-Eared and natterer's, External panels precision cut from 12mm Exterior Grade FSC plywood, for improved heat insulation, Exterior surface stained black with water based wood stain for improved thermal input, whilst avoiding any possibility of deterring the bats due to vapour from the stain, Overhanging apex roof for protection from UK weather, Single large cavity inside, with varying temperature characteristics, Wide entrance with accurately sized opening. Ideal for cavity dwelling bats and deters unwelcome birds etc., Internal ceramic heat sink ensures improved temperature stability, Improved "Bat Ladder" at base of box facilitates bats landing and climbing into box, Ladder continues inside box, while textured internal surfaces ensure bats find it easy to move around inside box and on the walls, Ladder acts as "convective heater" for box - when sun shines on ladder, warm air rises into the box, but does not come out when the outside cools, Easy and safe to erect box on walls or trees.

- ✦ **Recommendation 1 (Site Bat Enhancement):** Prior to works commencing, x 2 Harlech Woodstone (or similar), x and x 2 Improved Cavity (or similar) bat boxes to be affixed to mature trees at the property.

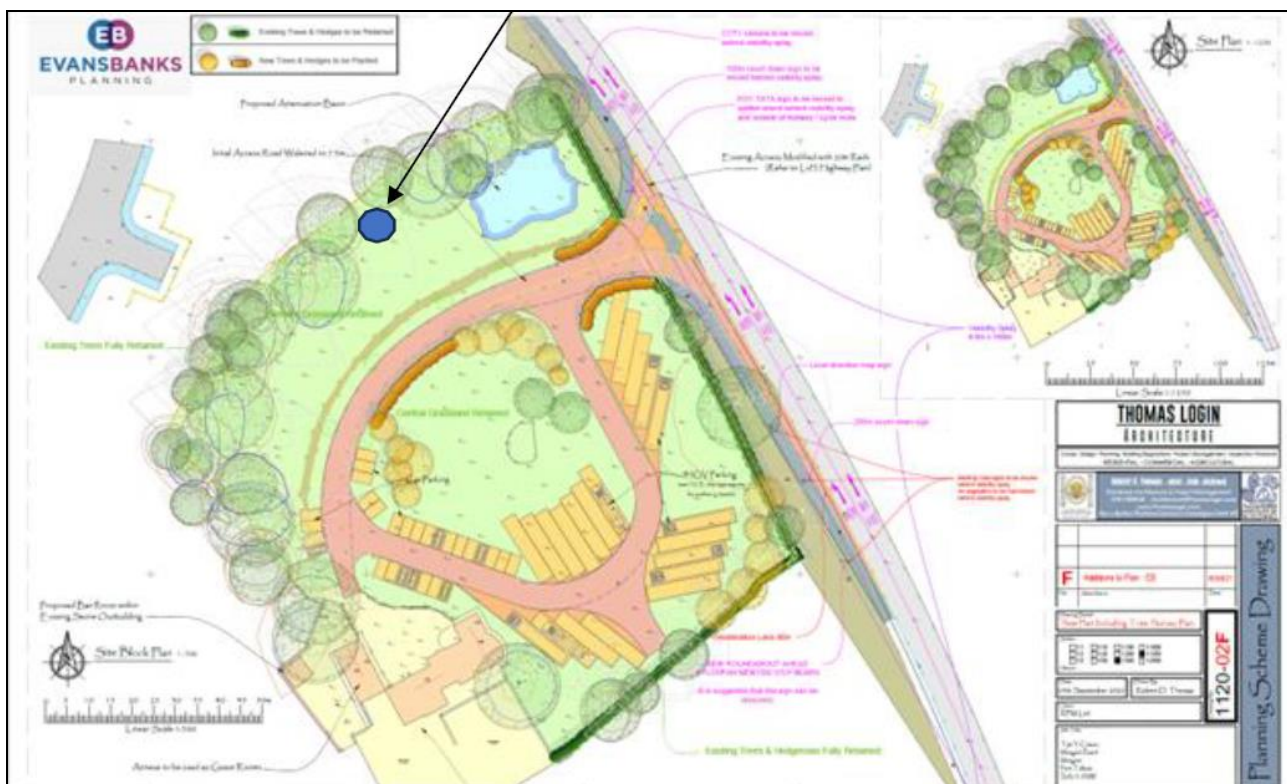
The bat house will be located as shown by the blue dot below on the northern edge of the property where there is a woodland edge and close to the proposed amenity pond. The roost will be approximately 3.6m wide by 3.6m long by 3.7m high which is larger than the minimum required size for an *R. hipposideros* night roost. It will have masonry cavity walls with a clay stock multi facing brick to match the houses and brock soldier course to the door head. The roof will be Marley Eternit Edgemere Interlocking slates with angular ridge tiles secured with dry fix system; the door will be vertical boarded painted timber with a hardwood frame; and the rainwater goods will be black uPVC half-round gutters with circular downpipes. The door will be kept locked at all times except for accessed by a licensed bat ecologist. The cowed 400mm x 300mm bat roost entry point for *R. hipposideros* bats will be at the apex of the southern elevation and there will be a 20mm gap between the fascias and the walls (with access internally) to allow access by all crevice dwelling (and most roof void dwelling) bat species.

- ✦ **Recommendation 2 (Dwelling Bat Mitigation):** Prior to works commencing, a dedicated bat house will be constructed close to the northern boundary with fly in access suitable for **Lesser horseshoe**. Soffit gaps are to be created for **Pipistrellus** species.

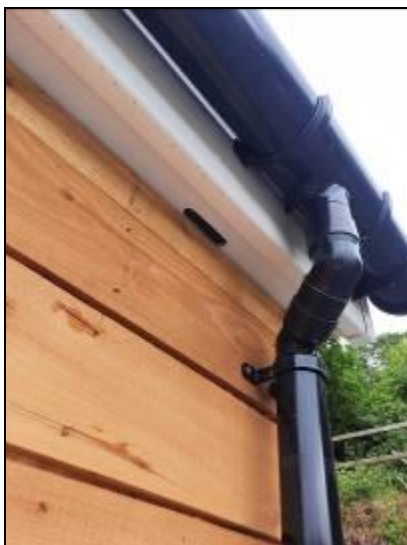
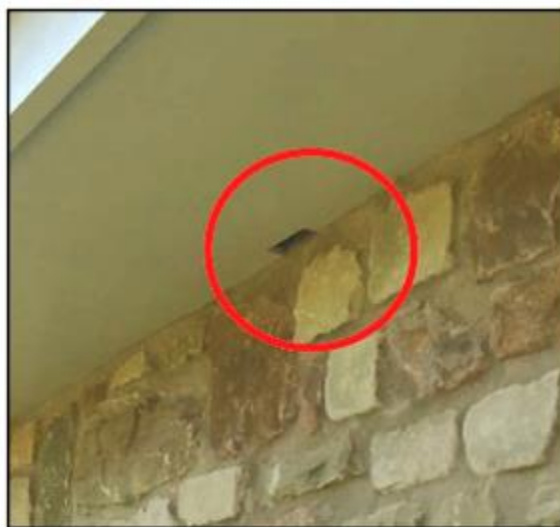
**Below:** Examples of soffit gaps.

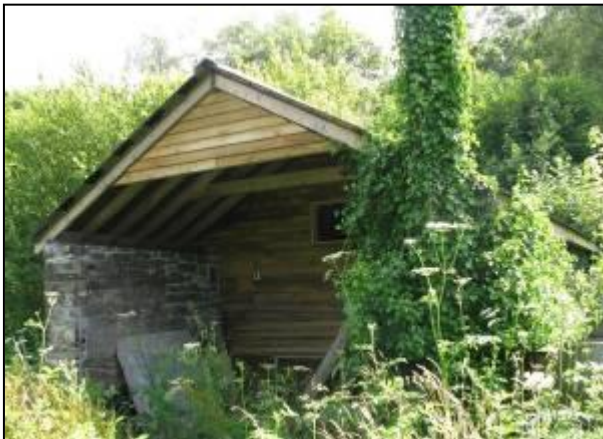
important social function prior to the bats leaving the roost. This behaviour can be seen in the video below. Mitigation schemes can try to create a covered area where bats can undertake this behaviour as shown in the image on the left.

Example of a cowled hood for horseshoe bat access

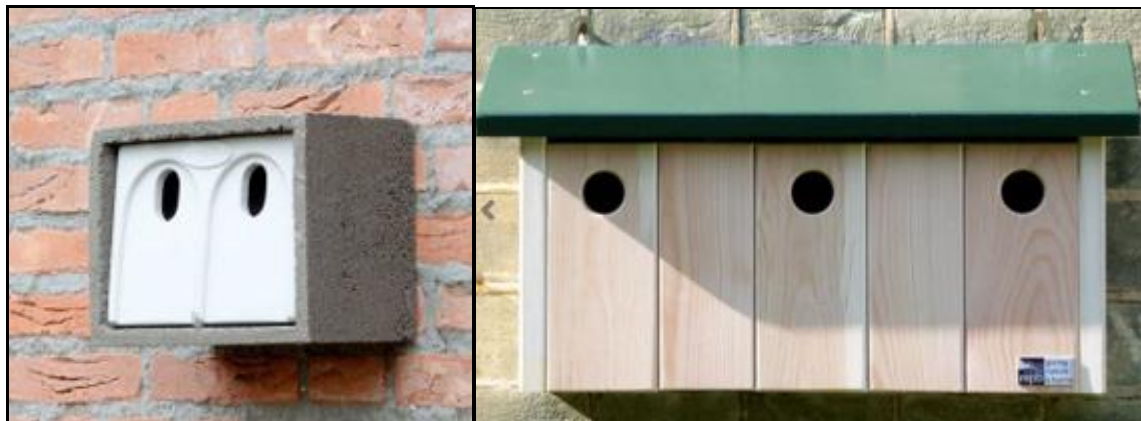
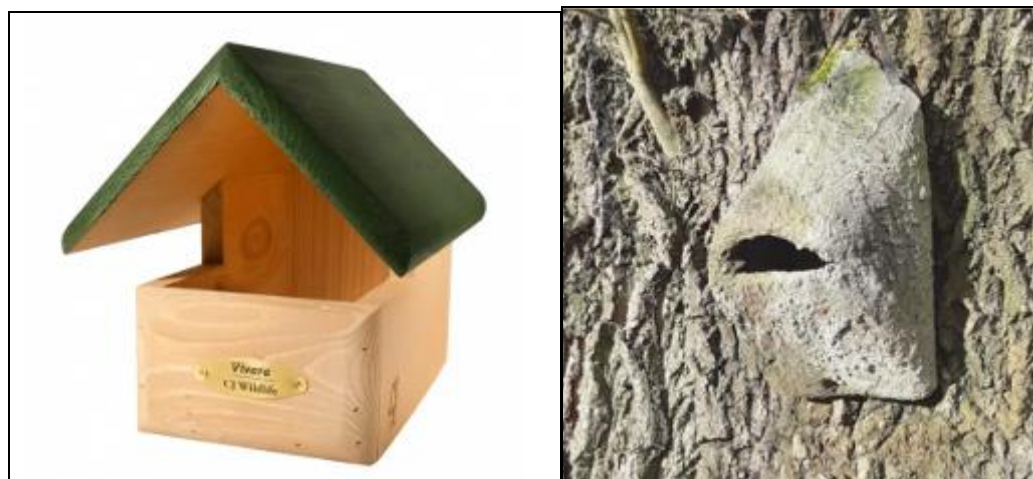
Examples of Sparrow terraces, House martin nest cups, Open-fronted nest boxes, and Small-holed nest boxes. Siting advice can be found at [Where To Put A Bird Box | Nestboxes - The RSPB](#)

- ✦ **Recommendation 5 (Annexe Bird Enhancement):** x 2 Sparrow terraces and x 1 House martin nest cup to be affixed to the north-west elevation of the **Annexe**.

- ✦ **Recommendation 6 (Site Bird Enhancement):** Prior to works commencing, x 3 open-fronted and x 3 small-holed bird boxes to be affixed to mature trees within the curtilage of the property.
