# Remediation Strategy Report

Site: Proposed Residential Development,  
Neath Workingman's Club, Neath

Prepared For: Castell Construction Ltd

**REPORT REFERENCE** : **JA-050723-17464-01**

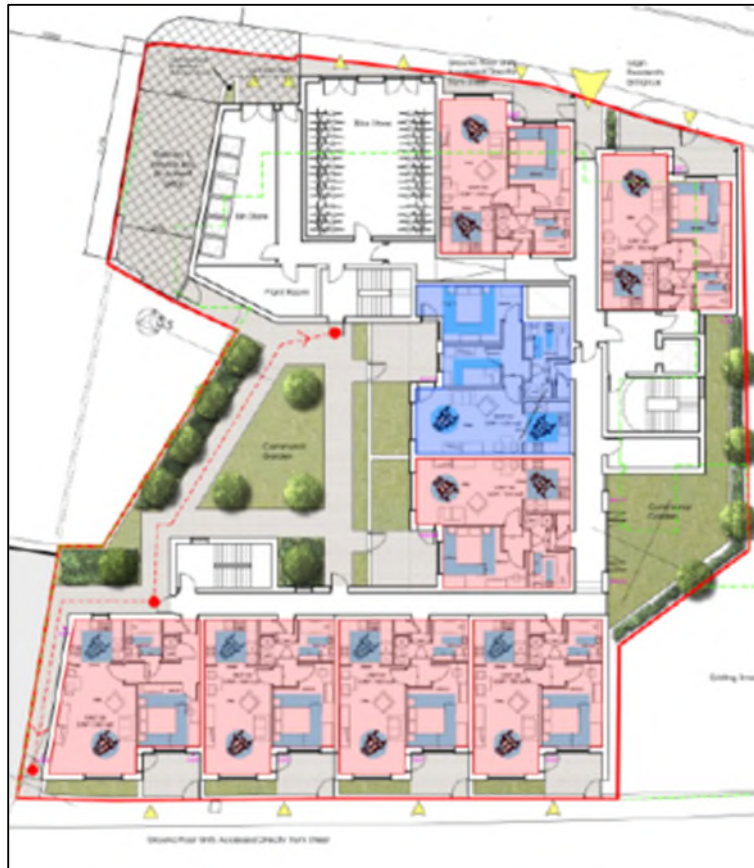
**Figure 1.1 Proposed Site Layout**

Castell Construction Ltd (the Client) is proposing the demolition of the current building on site and development of a four-story block of apartments at Neath Workingman's and Social Club in Neath. The proposed development can be seen in **Figure 1.1**.
