**Llandarcy Academy, Neath**

## GROUND-GAS MEMBRANE VALIDATION REPORT

Client: Portable Venues (Group)  
Limited (Smart Space)

IN21655 CL 003

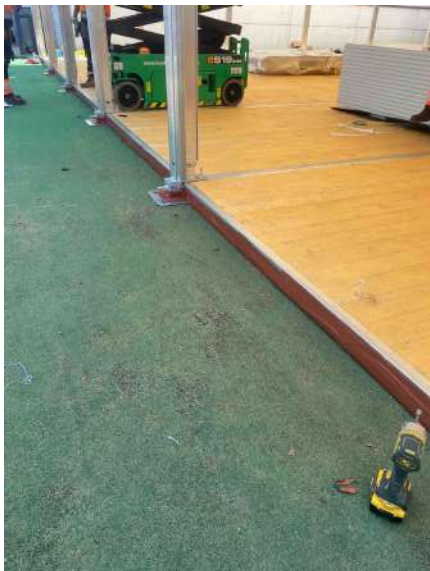
| Work Completed By Contractor | Observations and Recommendations by Verifier |
|---|---|
| A PAGeotechnical standard gas barrier was successfully installed. All laps were welded. Patchwork comprises gas resistant self-adhesive membrane. | Protective fleece was installed on top of membrane. Membrane installation was verified in accordance with CIRIA 735.<br><br>Modular building plates (perimeters) need to be sealed and verified at a later date. |

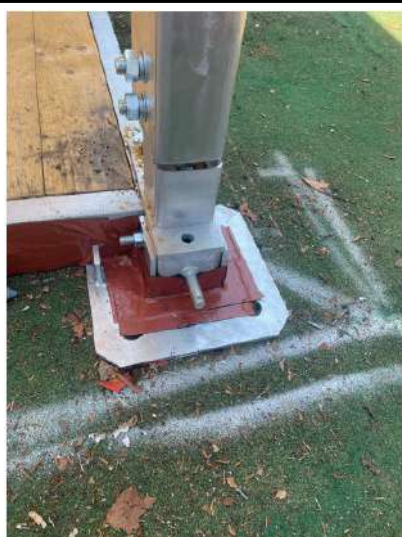
Photograph Three - View of continuous seal

The installers have used the PAG SAGR to create a continuous seal between the terminated perimeters and the steel columns.

Previously installed PAGeotechnical standard gas barrier has been terminated to perimeters using PAG SAGR. Verified in accordance with CIRIA 735.

PAG SAGR cannot be left exposed to possible damage/elements. Evidence of protective measures will be needed prior to sign-off.

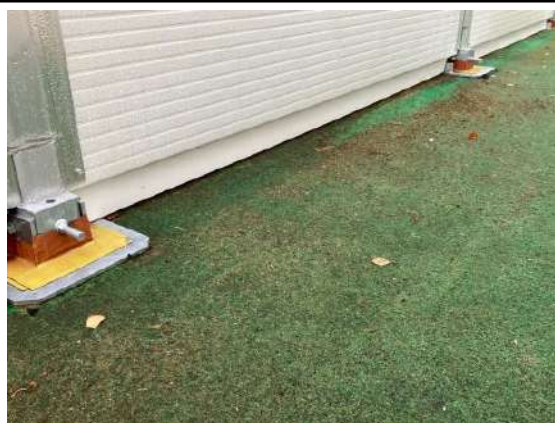
Photograph Five - Evidence that perimeters have now been protected with a PVC trim.

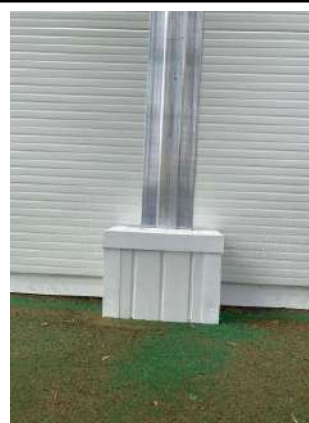
Photograph Six - Evidence that steel columns have now also been protected - with a PVC box.

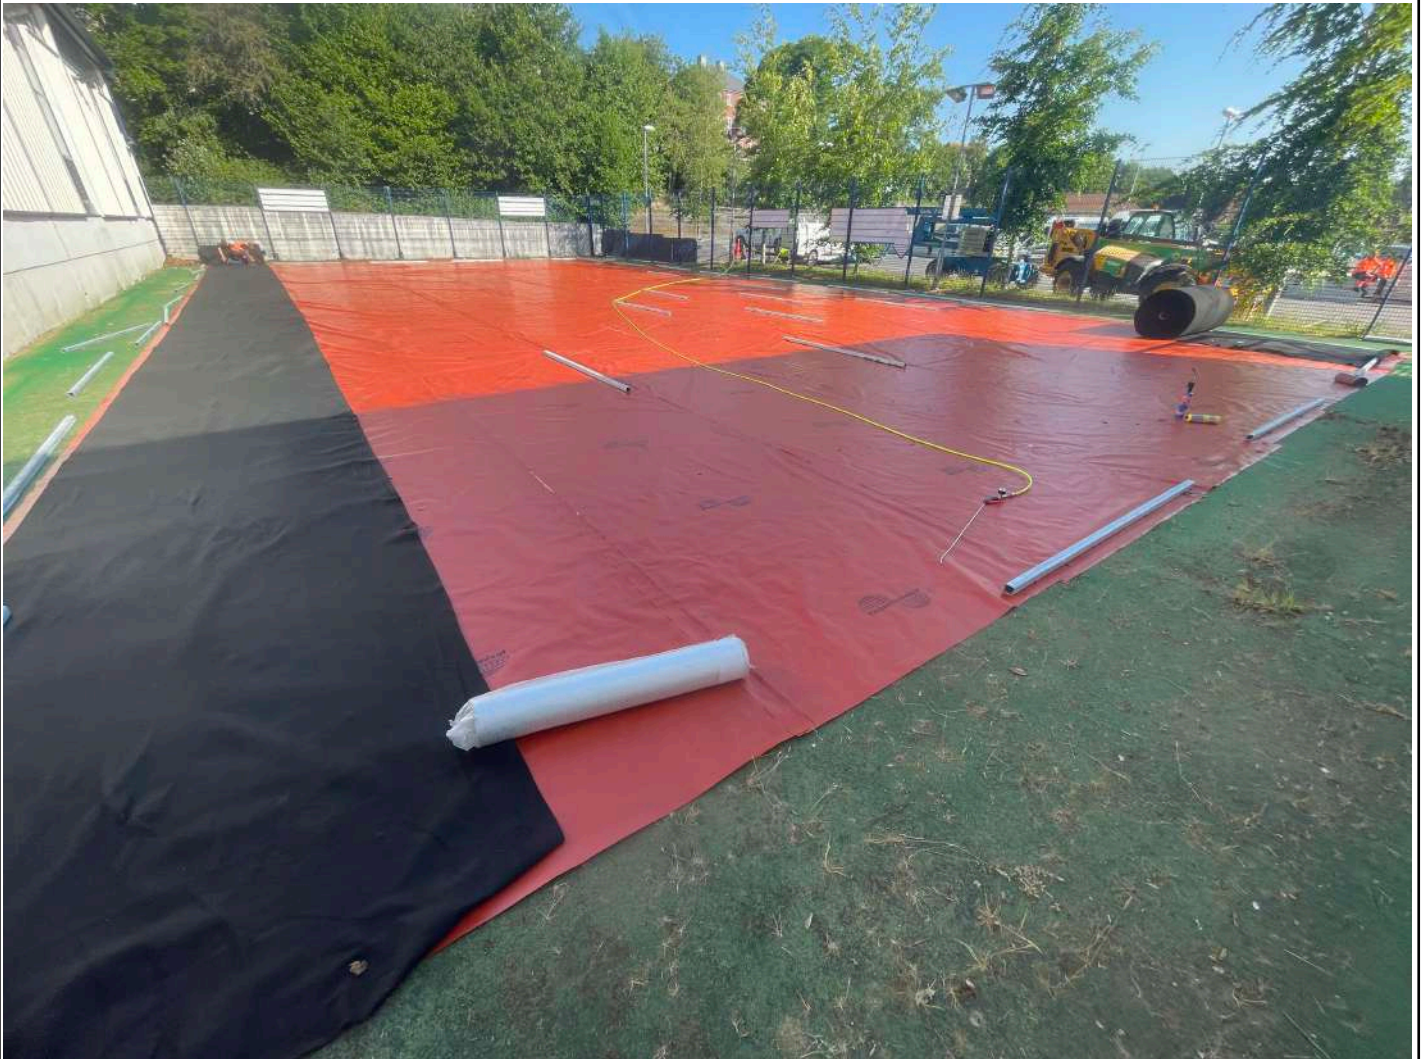
The photograph above shows an overview of the modular building area

where the PAG Standard Gas Barrier has been installed.

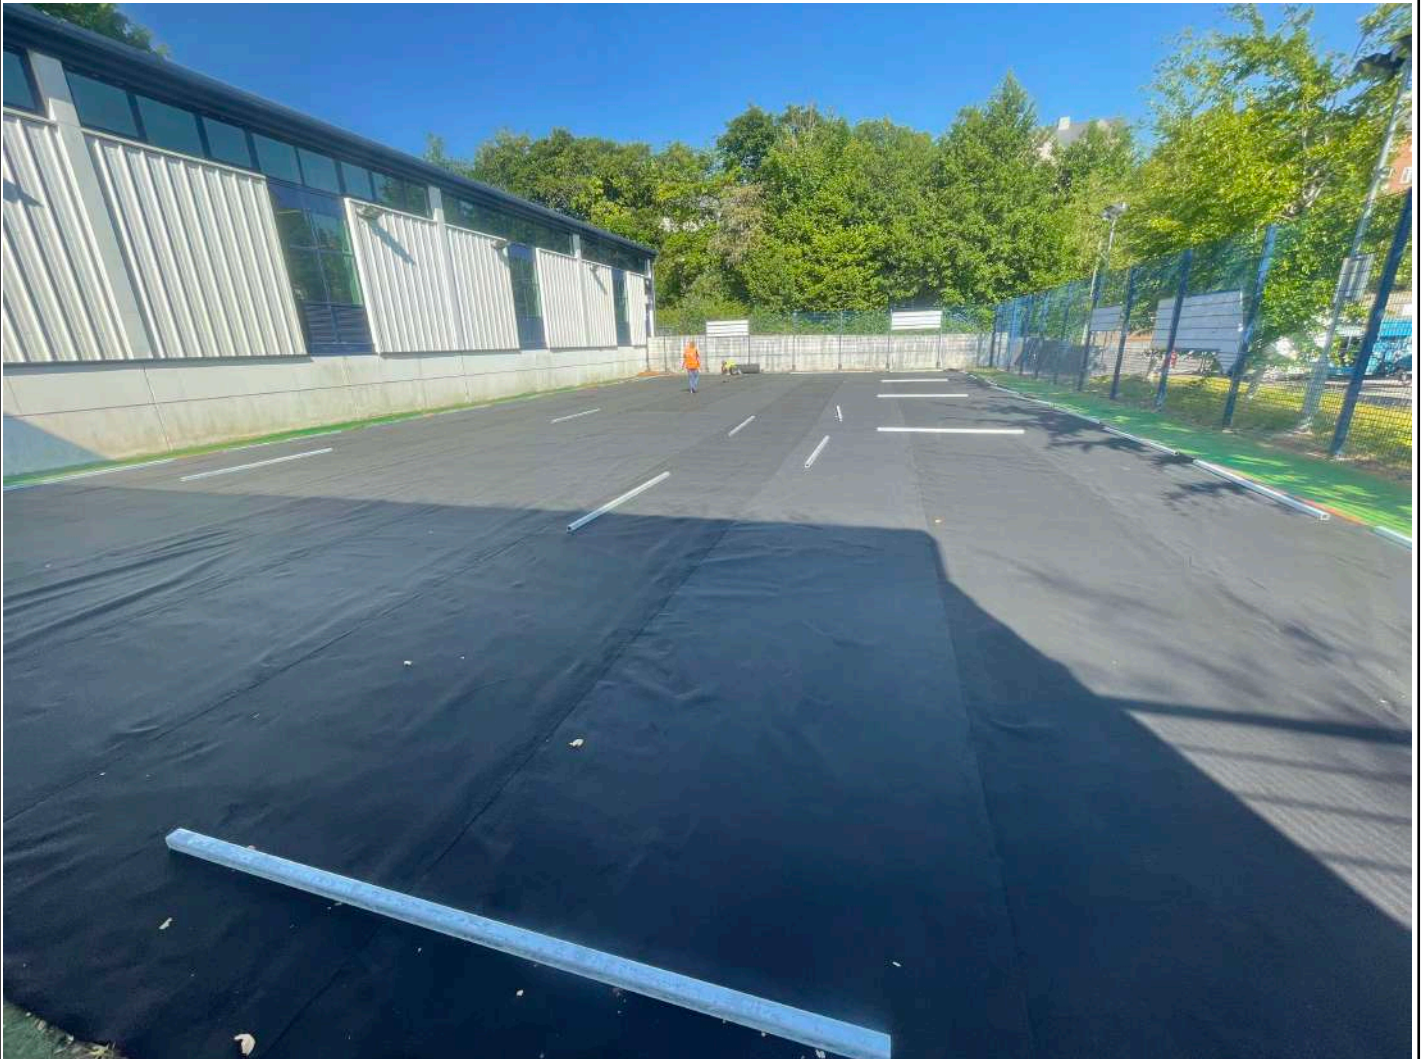
The photograph above shows the membrane has been protected using a

fleece.

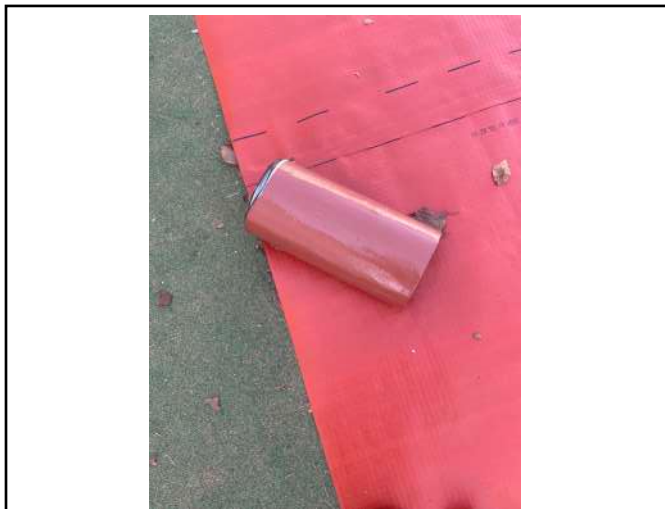
## VERIFICATION ITEM TWO

NOTES: Patch repairs.

A couple patch repairs had been carried out prior to this visit to site. Any patch repairs have been carried out using gas resistant self adhesive membrane.

To ensure a strong seal has been achieved a gas blow torch has been used to aid in the adherence of the gas resistant self adhesive membrane.

The second photograph above shows a pick and probe test carried out to a sealed

A patch repair.

Verified in accordance with CIRIA 735.

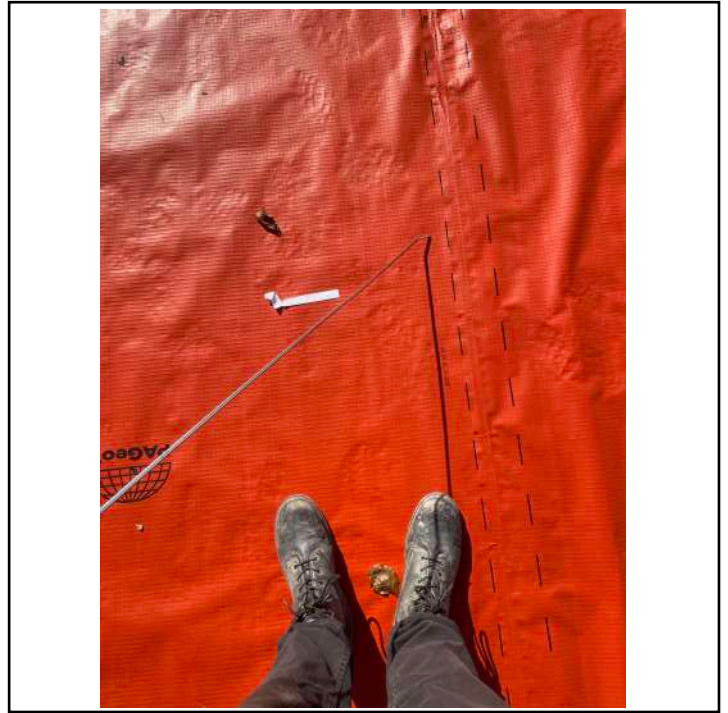
Air lance test to welded lap.

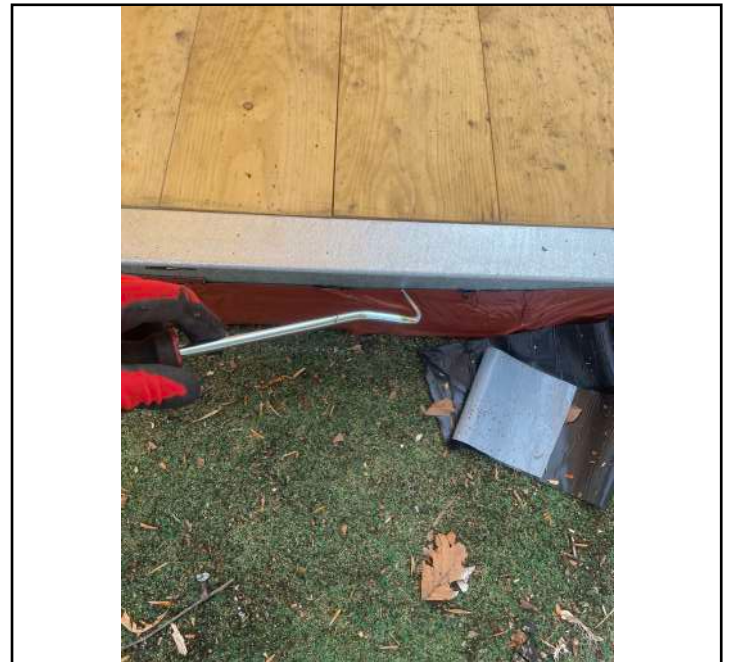
NOTES: Termination of the PAG Standard Gas Barrier.

The installers have terminated the previously installed and verified PAG Standard Gas Barrier to the perimeters of the modular building using PAG SAGR. A gas blow torch has been used to aid in the adherence of the PAG SAGR.

The second photograph above shows a pick and probe test carried out to the seal achieved. Verified in accordance with CIRIA 735.

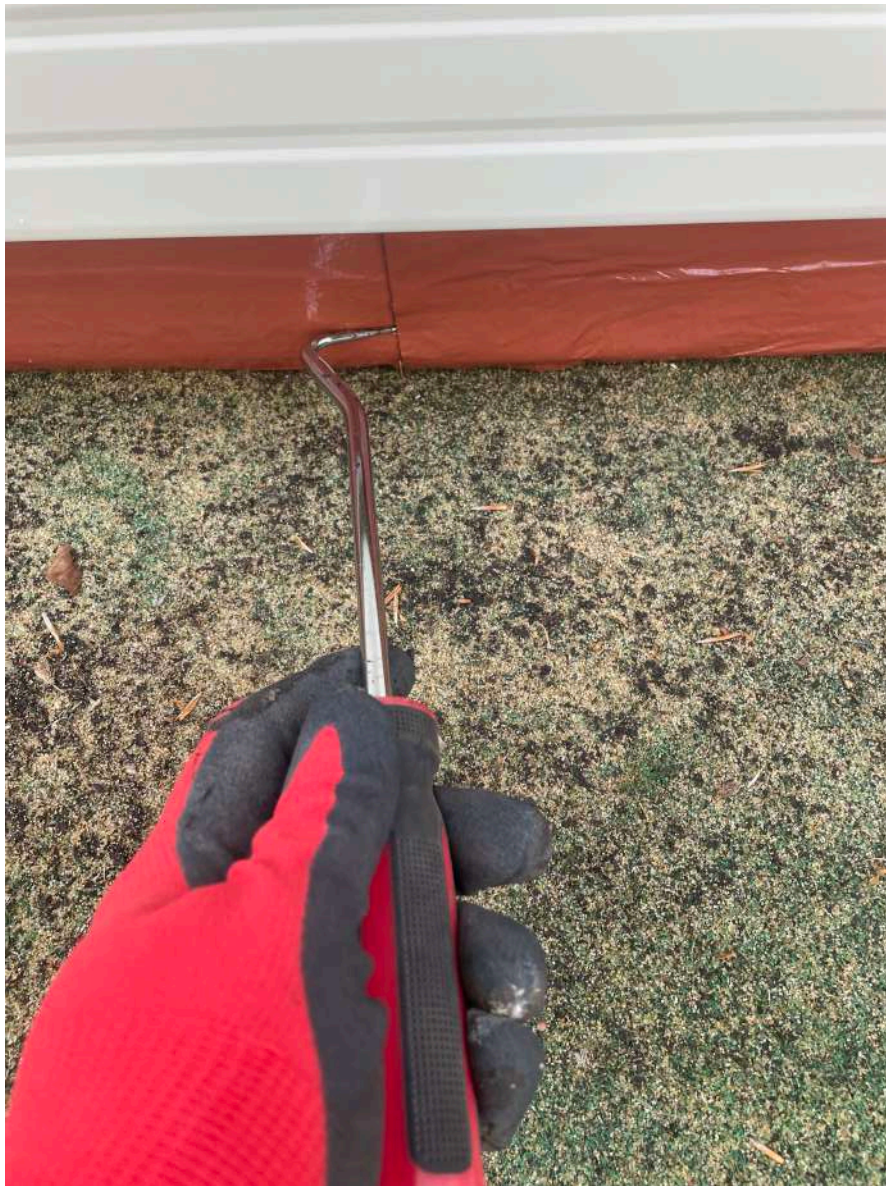
## VERIFICATION ITEM ONE

The photograph above shows a pick and probe test carried out to a sealed lap of the

PAG SAGR. The installers have lapped the SAGR a sufficient amount before using

No faults or defects were identified. Verified in accordance with CIRIA 735.

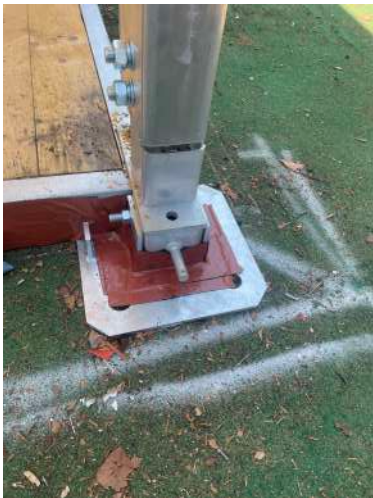
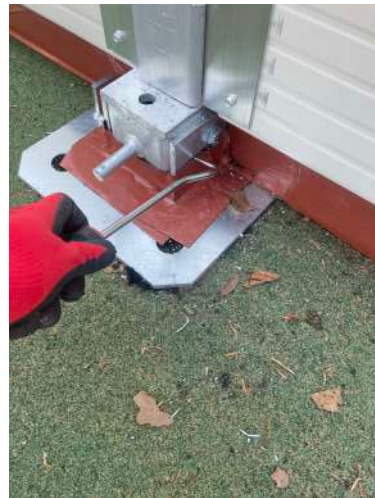
NOTES: Steel columns sealed.

The first photograph above shows an example of a steel column. The installers have used the PAG SAGR to to create a continuous seal between the terminated perimeters and the steel columns.

The installers have used a gas blow torch to aid in the adherence of the PAG SAGR.

The second photograph above shows a pick and probe test carried out to a sealed steel column.

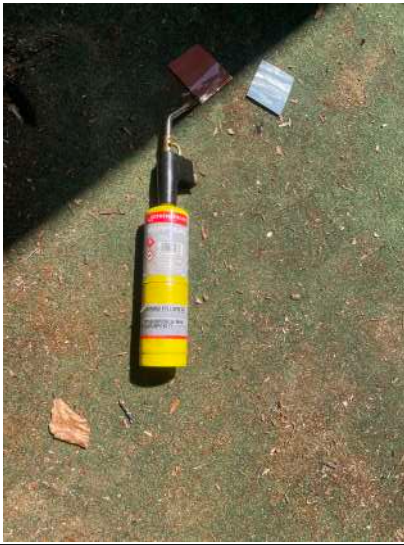
Gas blow torch used to aid in the  
adherence of the PAG SAGR.

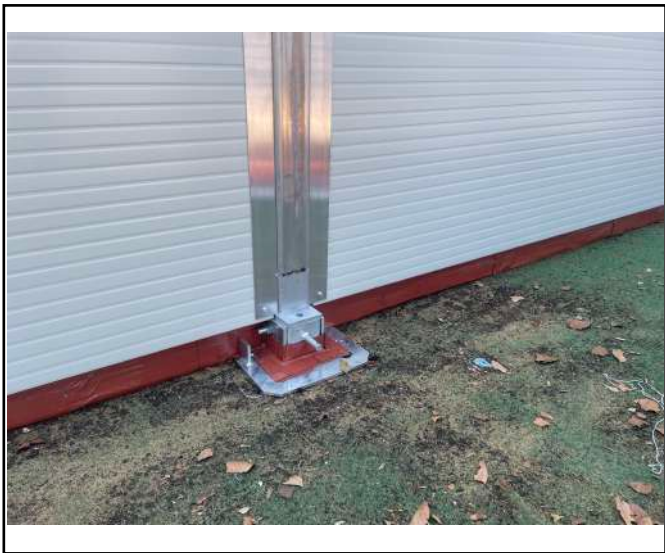
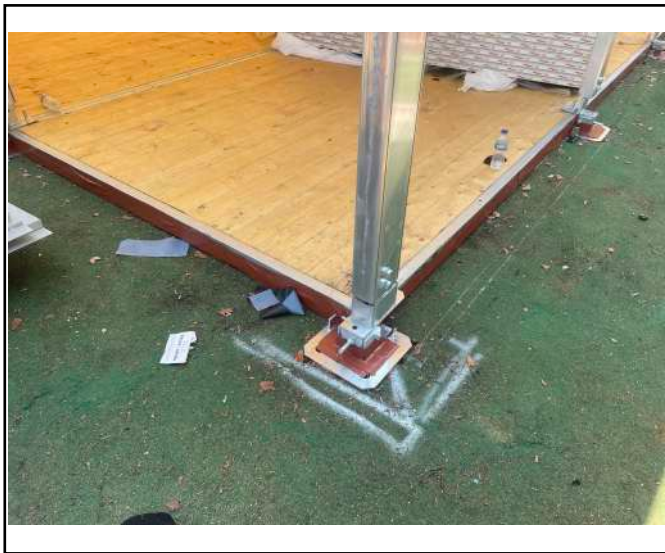
Additional sealed steel column.

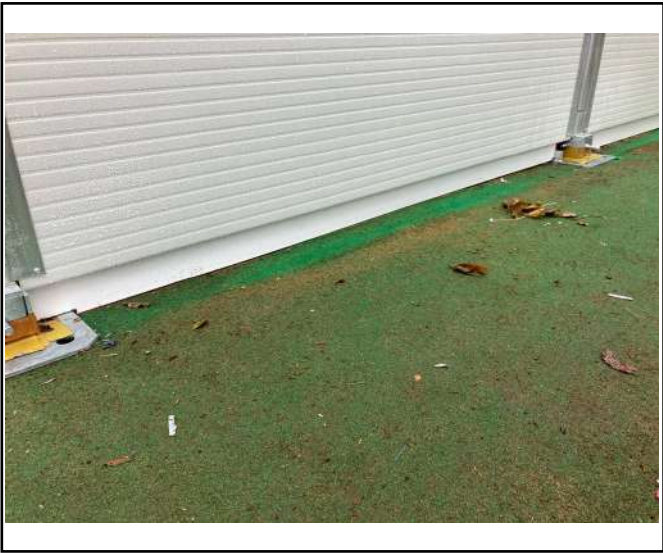
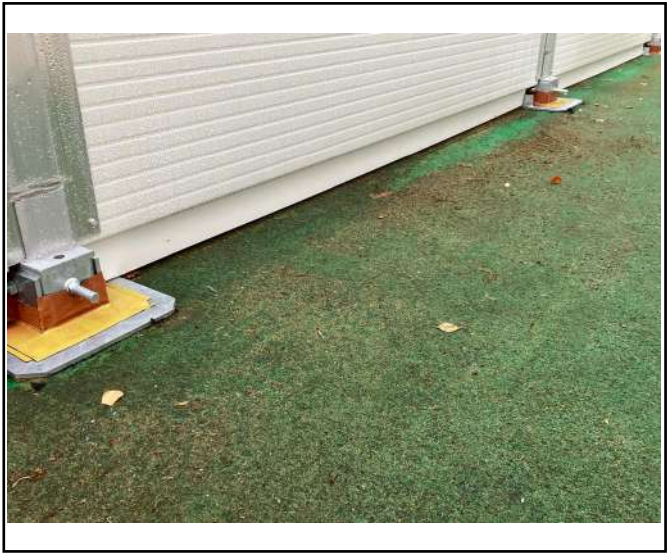
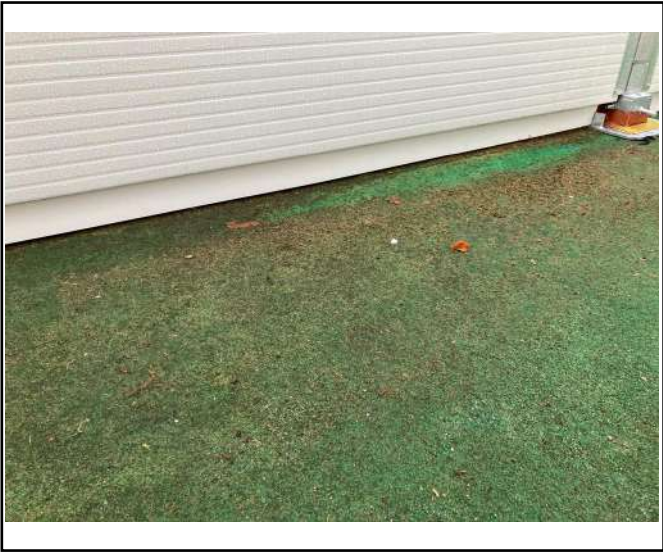
Perimeters protected.

The perimeters need to be protected from damage or being exposed the the material degrading over time. Evidence of this needs to be provided before sign off - Evidence now provided and displayed in additional photos of this report. Installed in accordance with BS 8485:2019.

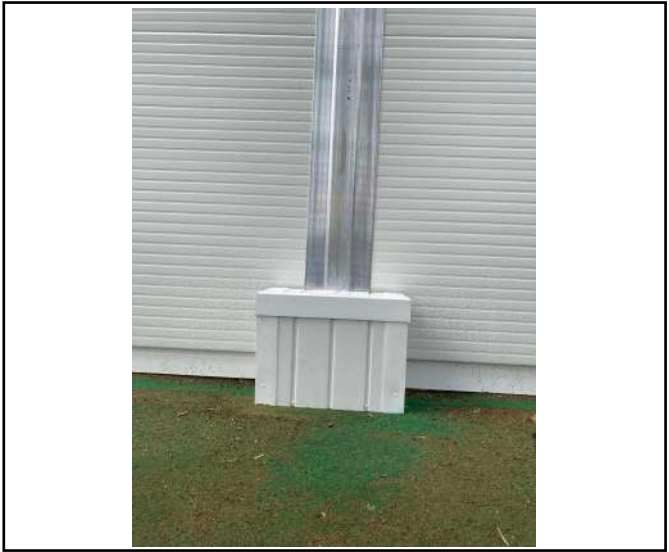
Steel column protected.
