# **Barratt Associates Ltd.**

**REPORT ON SAMPLING AND LABORATORY TESTING**

**Contract: 23205**

**3 FERNFIELD,  
BAGLAN SA12 8AL**

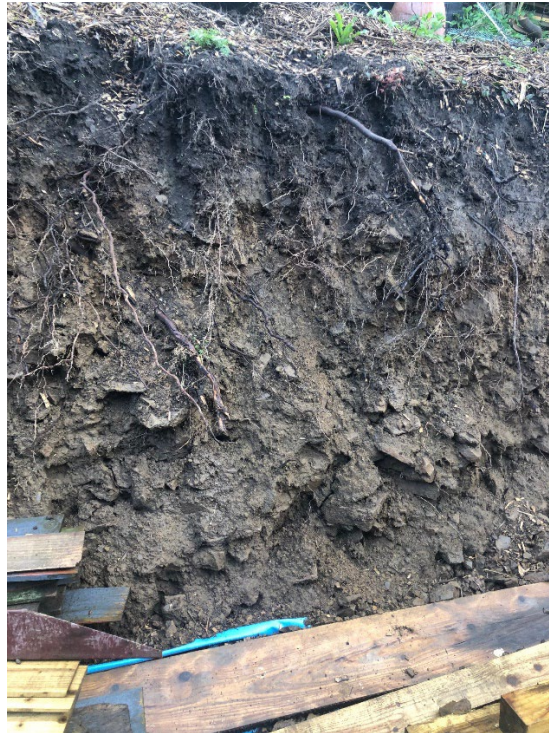
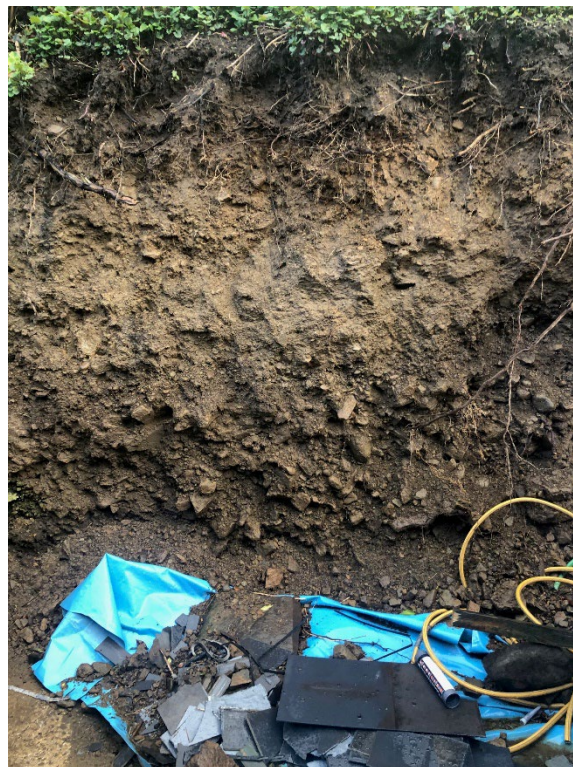
- 3.1 The site work was carried out on the 6<sup>th</sup> April 2023. The location of the slope is indicated on the aerial photograph in Appendix 1, Figure A1.1. The slope had partially been excavated by the Client which had exposed the soil to be retained as indicated in the photographs below:

5.1.1 The material recovered was described as brown silty fine to coarse sand and gravel with some cobbles and occasional boulders and based on the angular nature of the gravel and cobbles, appeared to be the partially weathered top of the mudstone stratum.

3.2 Representative disturbed bulk samples of the soil in the slope were taken by hand excavation and despatched to the laboratory. The total weight of the samples was approximately 120kg. The slope was dry at the time of the site visit.

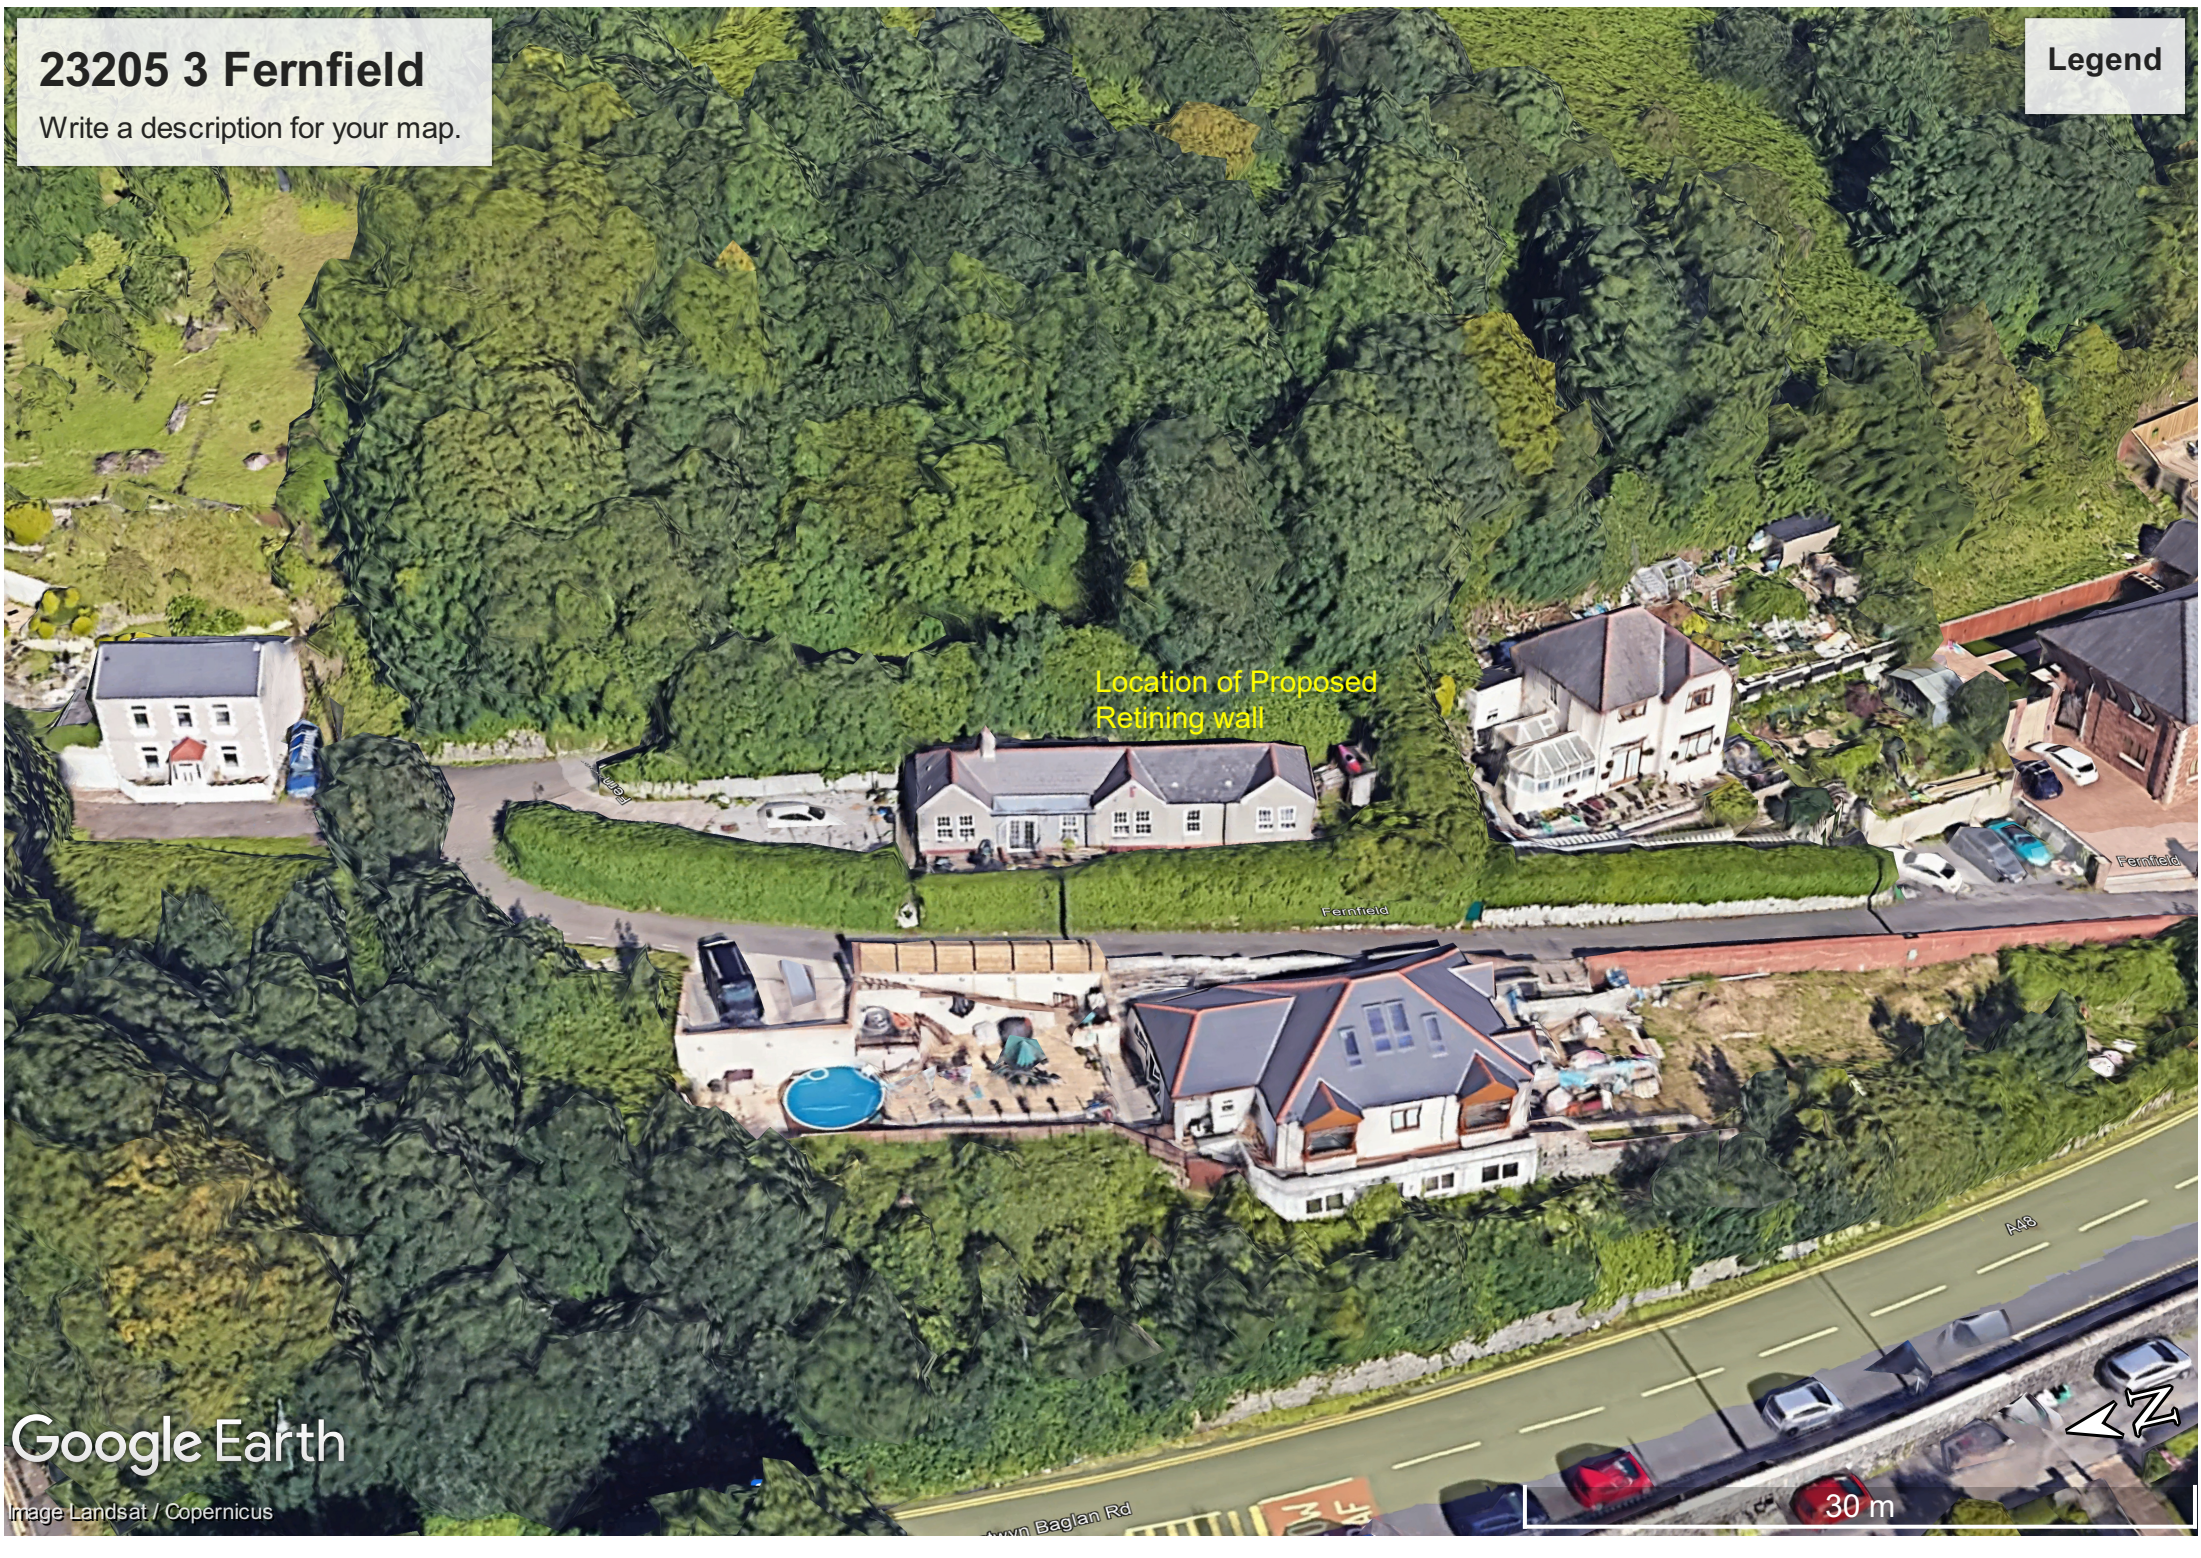
23205 3 Fernfield

Location of Proposed  
Retaining wall

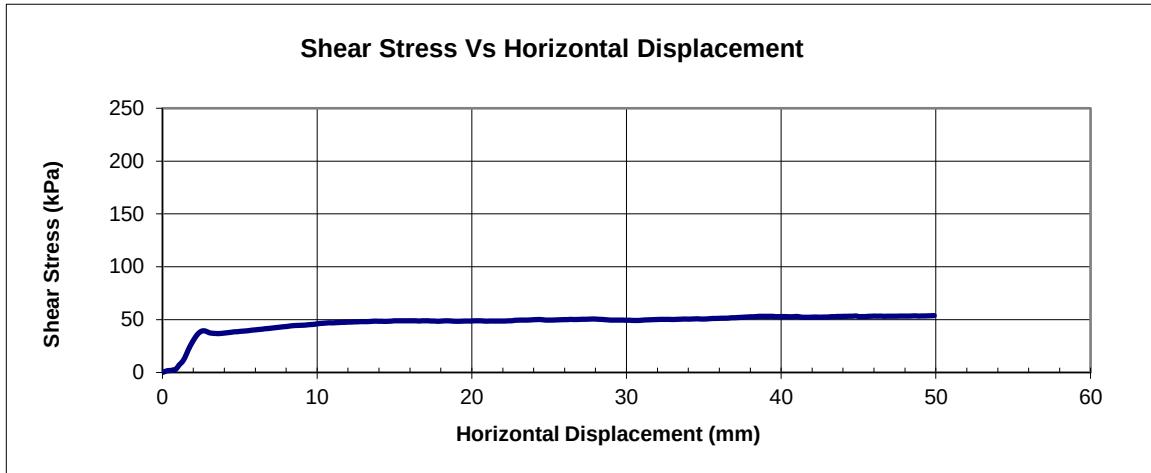
**50 kPa**

Normal Loading

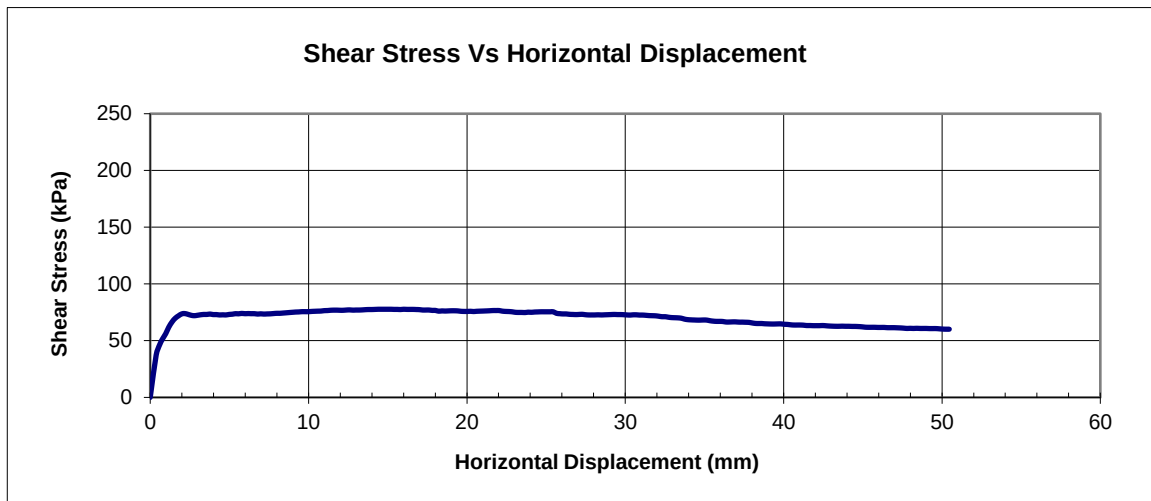
**100 kPa**

Normal Loading

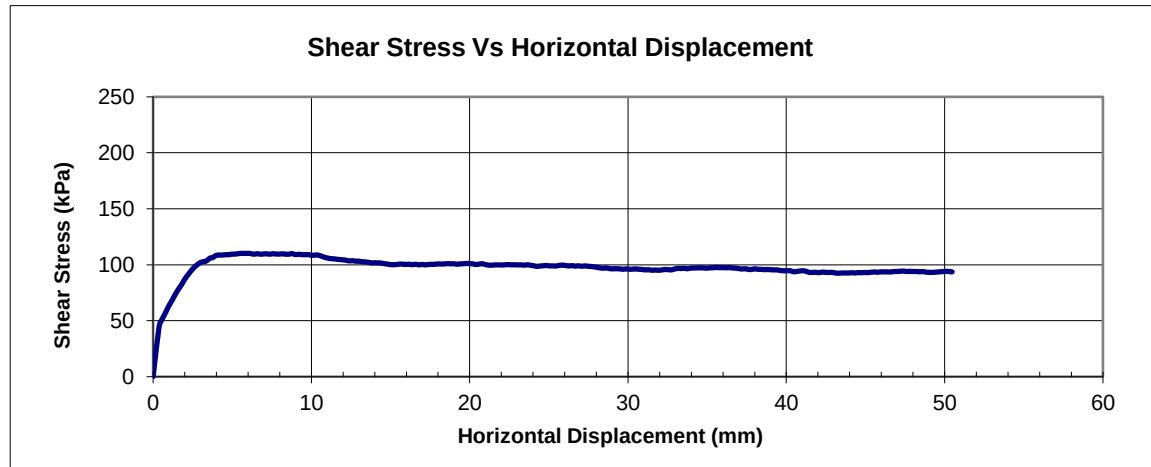
**200 kPa**

Normal Loading

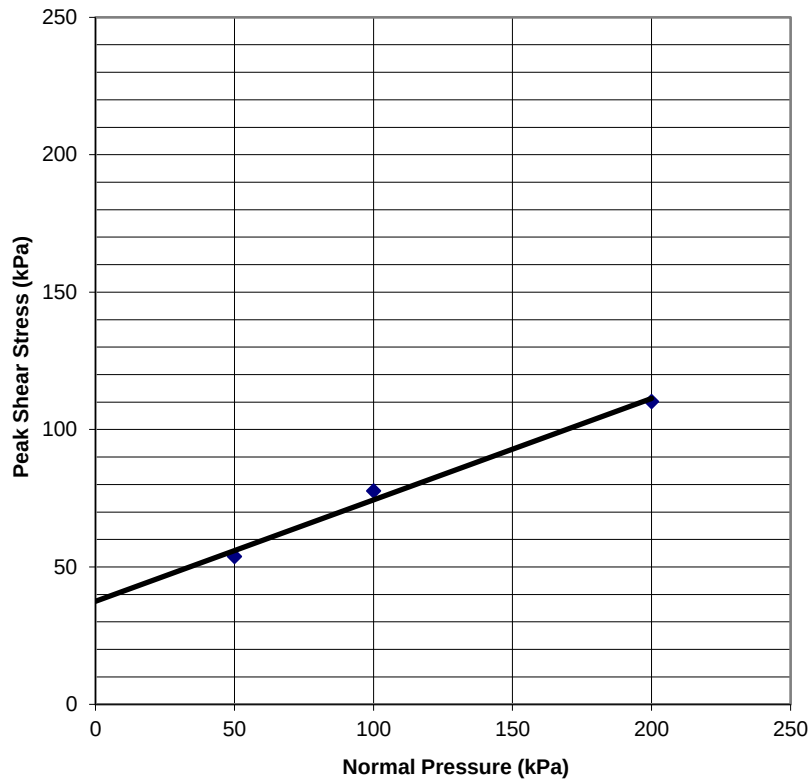
**Angle of Shearing Resistance & Cohesion**

| Normal Pressure (kPa) | 50 | 100 | 200 |
| Peak Shear Strength (kPa) | 54 | 78 | 110 |
| Effective Cohesion : $c'$ = | 38 kPa | | |
| Effective Angle of friction : $\phi'$ = | 20 ° | | |

- 6.2.1 The results of the laboratory shear box testing are included in the Appendix 3. The results indicated that the Effective cohesion ( $c'$ ) of the soil was 38kPa and the Effective Angle of Friction ( $\psi'$ ) was 20 degrees. It is recommended that these parameters be adopted for the design of the retaining structure.
