## Technical Note: Mitigation Method Statement

Site: Land at Hillside, Neath

Author: Siân Musgrave BSC (Hons) MCIEEM Principal Ecologist AEC Ltd

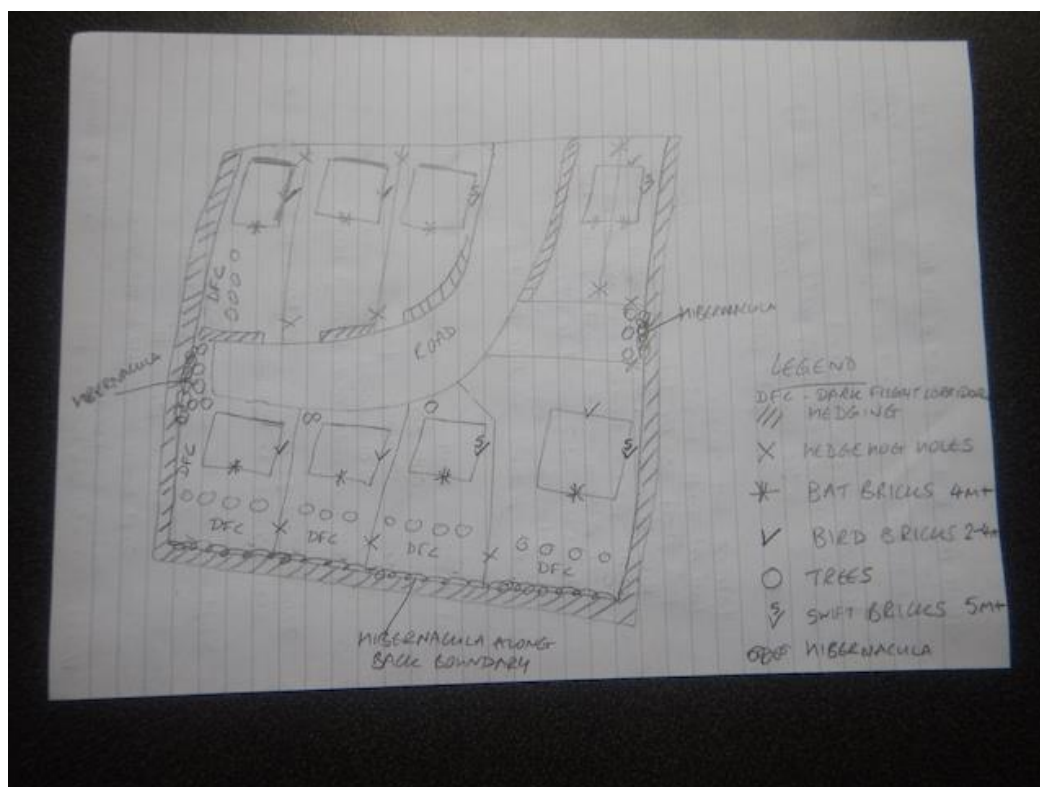
**Figure 5:** Sketch site plan with mitigation measures shown

These mitigation measures are shown in **Figure 5**.
