Project Name: Dyffryn Cellwen

Project No:  
14753

**ANNEX E**  
**Rotary Percussive Borehole**  
**Logs**

**ANNEX F**  
**Laboratory Soil Chemical Test Results**

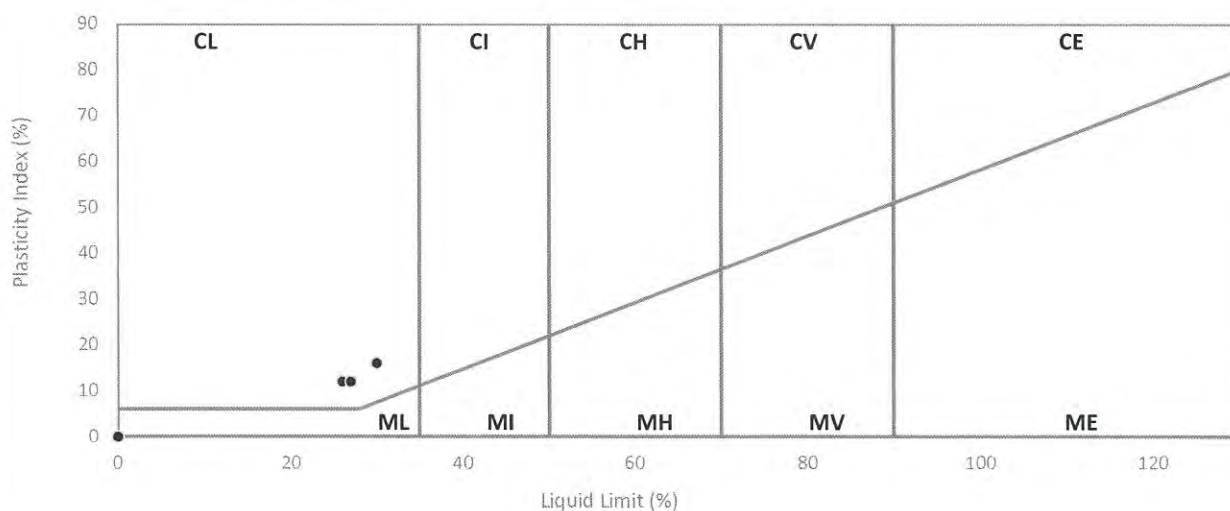
**PLASTICITY CHART FOR CASAGRANDE CLASSIFICATION**  
**BS 5930:1999+A2:2010**

# : Liquid Limit and Plastic Limit Wet Sieved

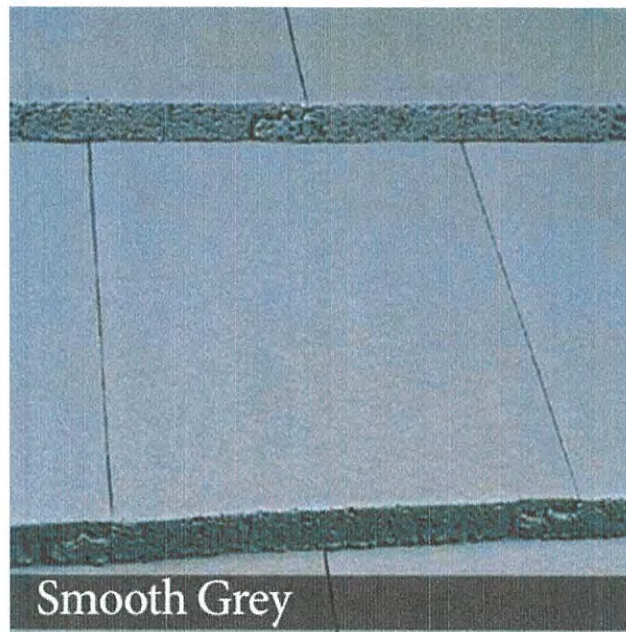
### **Roof**

- Roof covering to be Marley Modern concrete interlocking tiles, colour Smooth Grey.
- Ridge tiles to be complimentary Marley concrete angular tile, colour Smooth Grey.

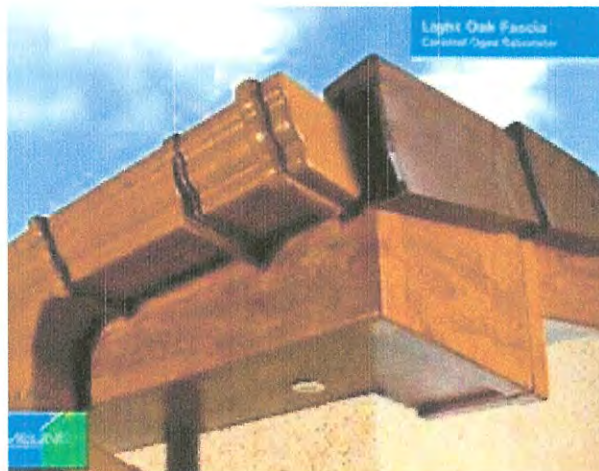
### **Soffits, Fascias and Rainwater Goods**

- All soffits, fascias and rainwater goods to be uPVC, colour Light Oak.

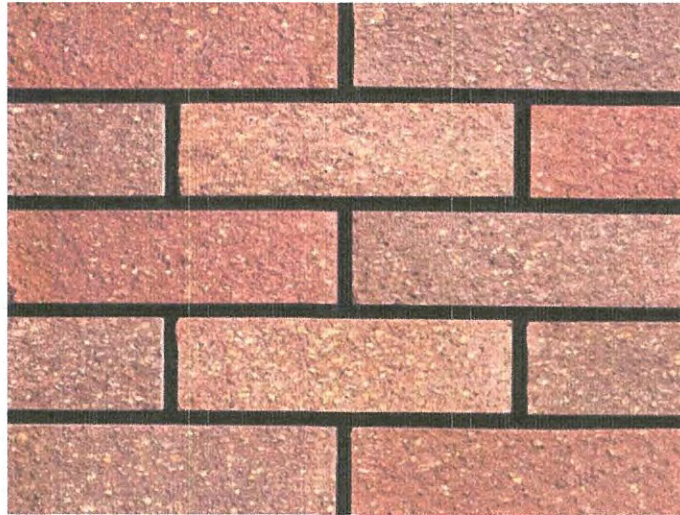
## **Walls**

- All external wall surfaces to be Facing Quality Brick Chepstow Brindle Rustic by PD Edenhall.

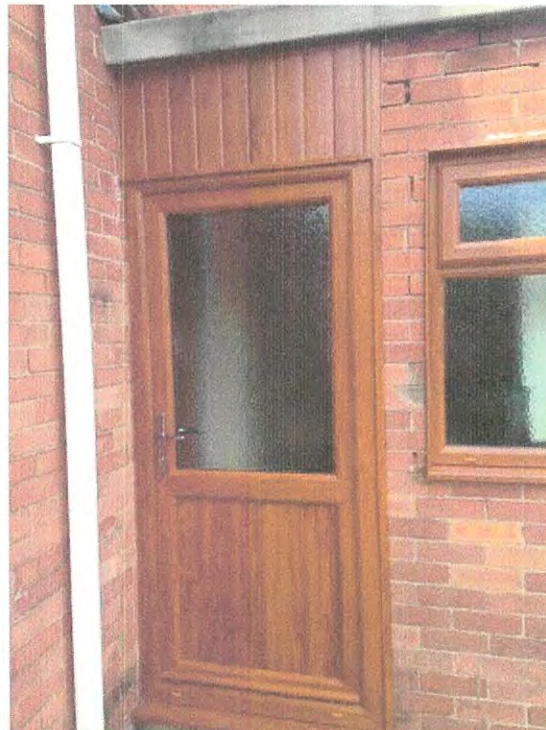
## **Windows and Doors**

- All windows and doors to be uPVC double glazed products. Frame colour to be Light Oak.

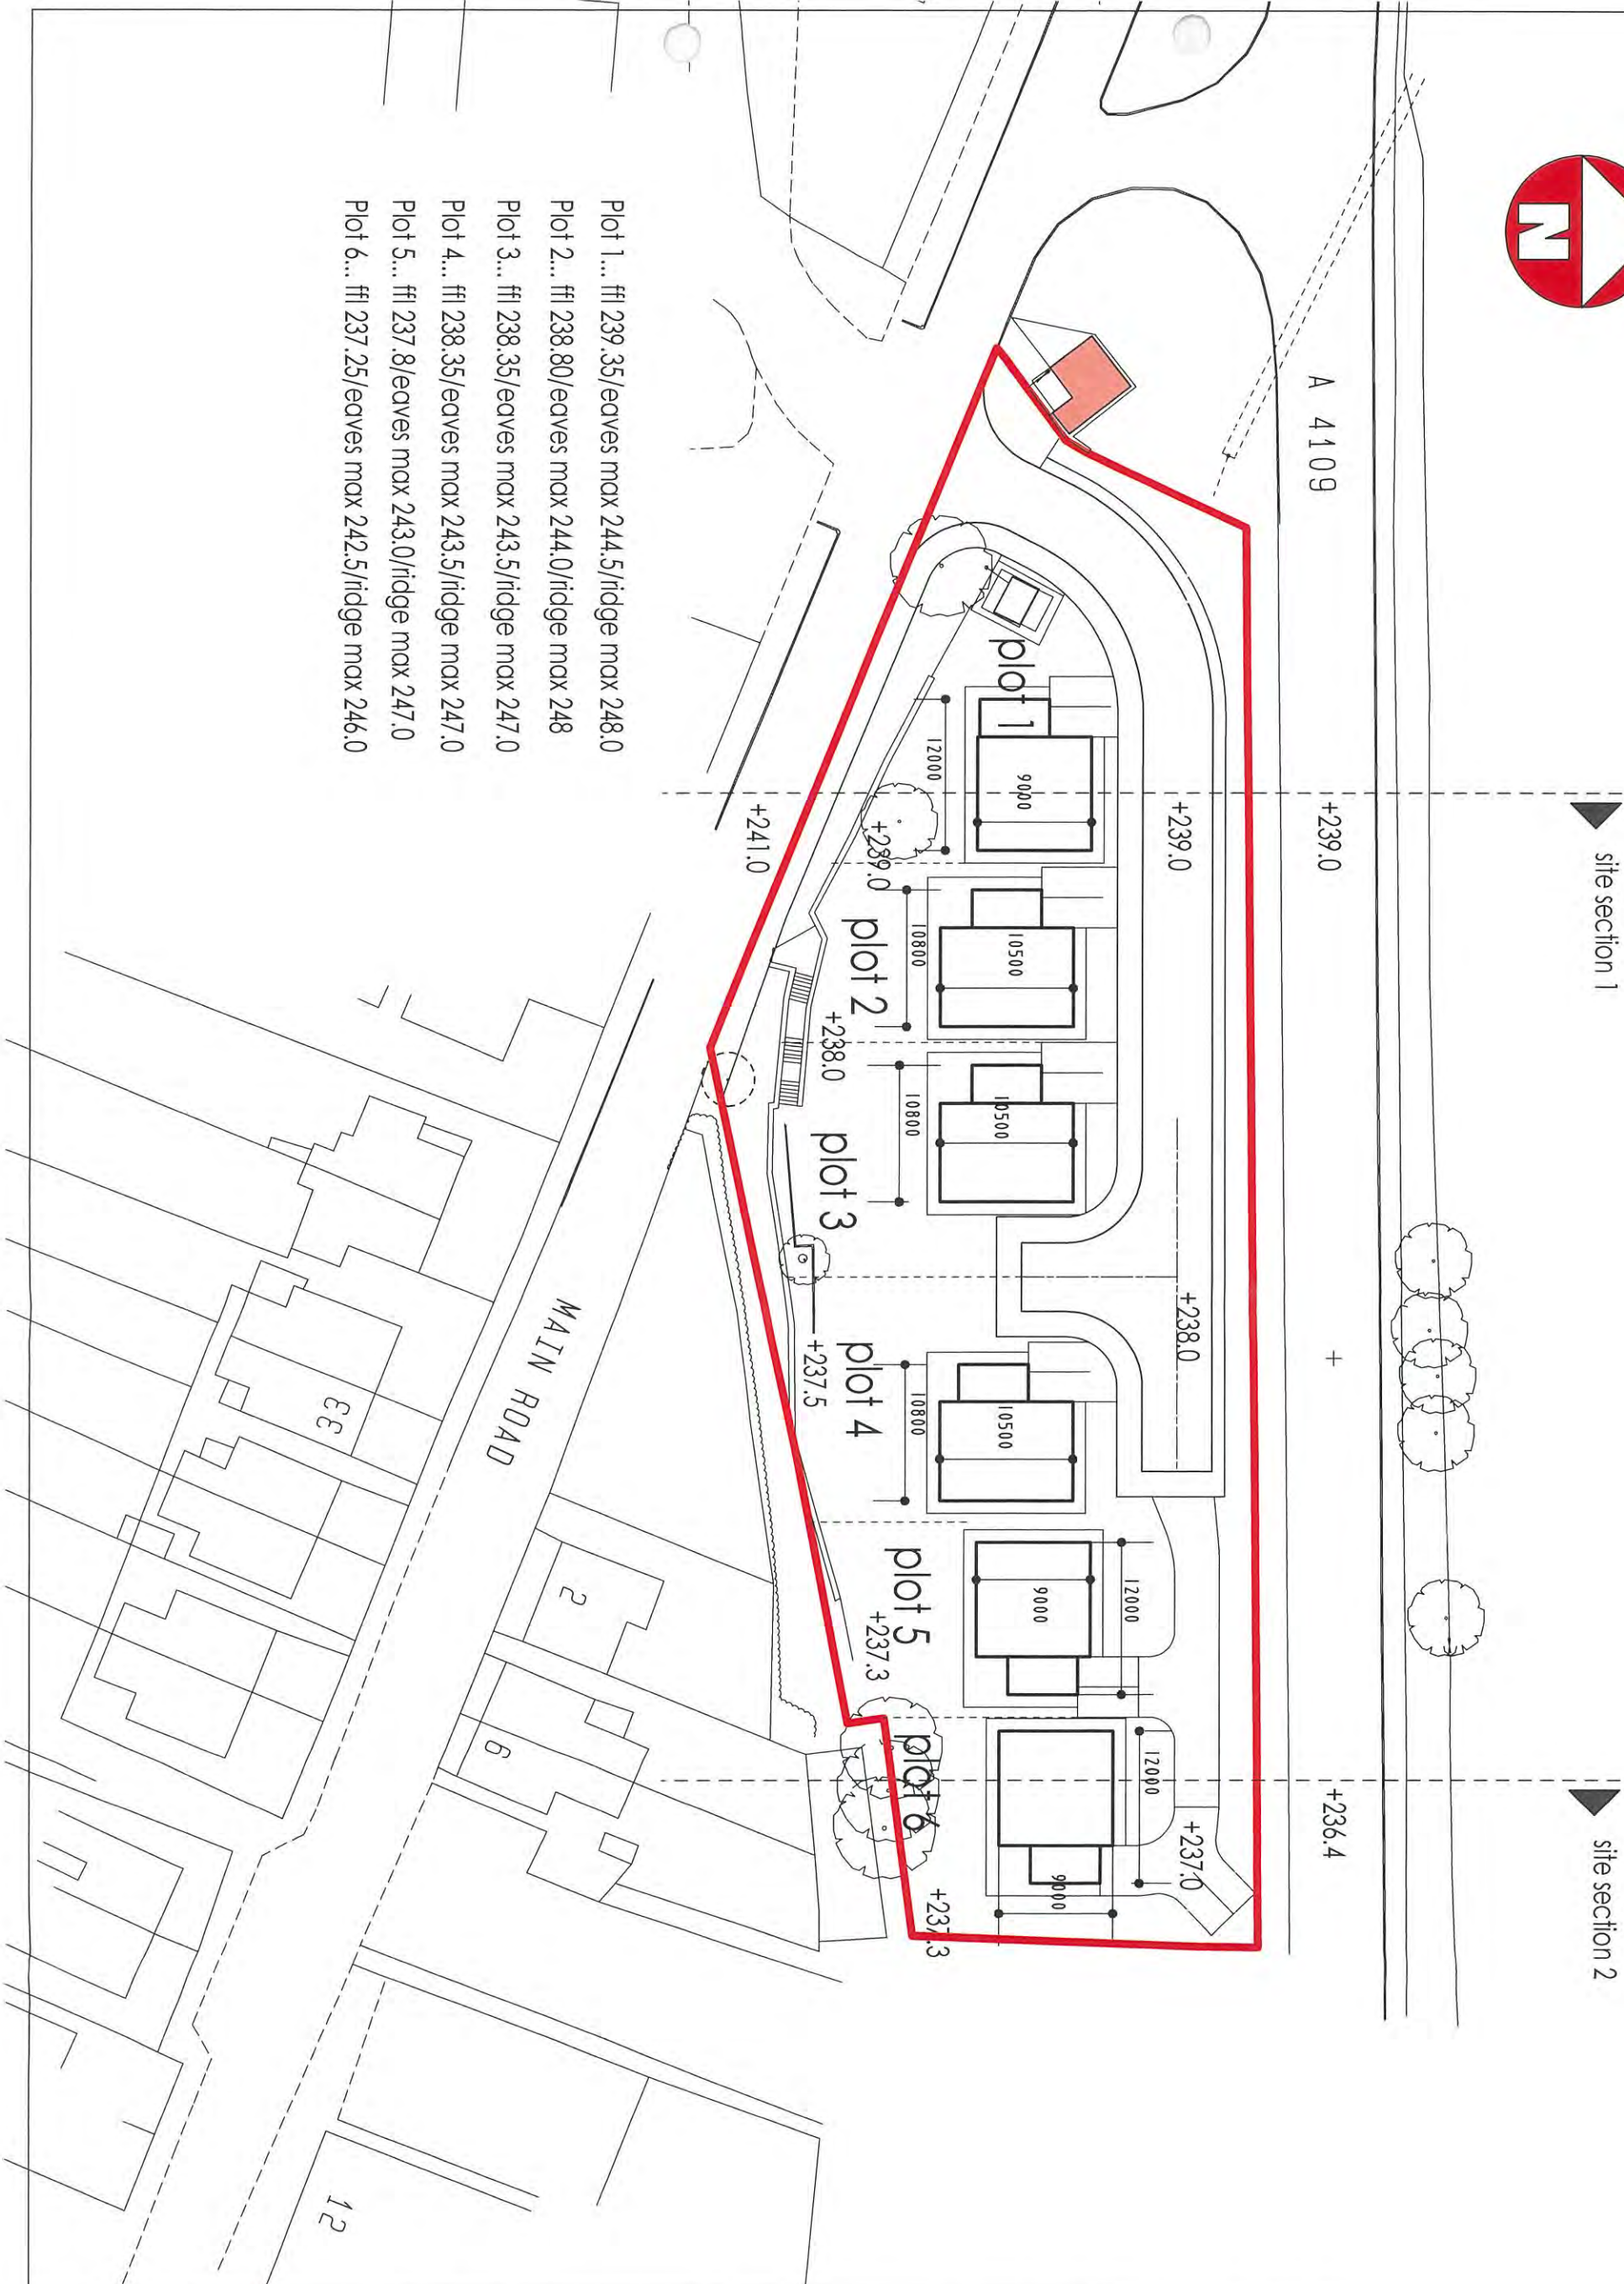
site section 2

- Plot 1... ffl 239.35/eaves max 244.5/ridge max 248.0  
Plot 2... ffl 238.80/eaves max 244.0/ridge max 248  
Plot 3... ffl 238.35/eaves max 243.5/ridge max 247.0  
Plot 4... ffl 238.35/eaves max 243.5/ridge max 247.0  
Plot 5... ffl 237.8/eaves max 243.0/ridge max 247.0  
Plot 6... ffl 237.25/eaves max 242.5/ridge max 246.0

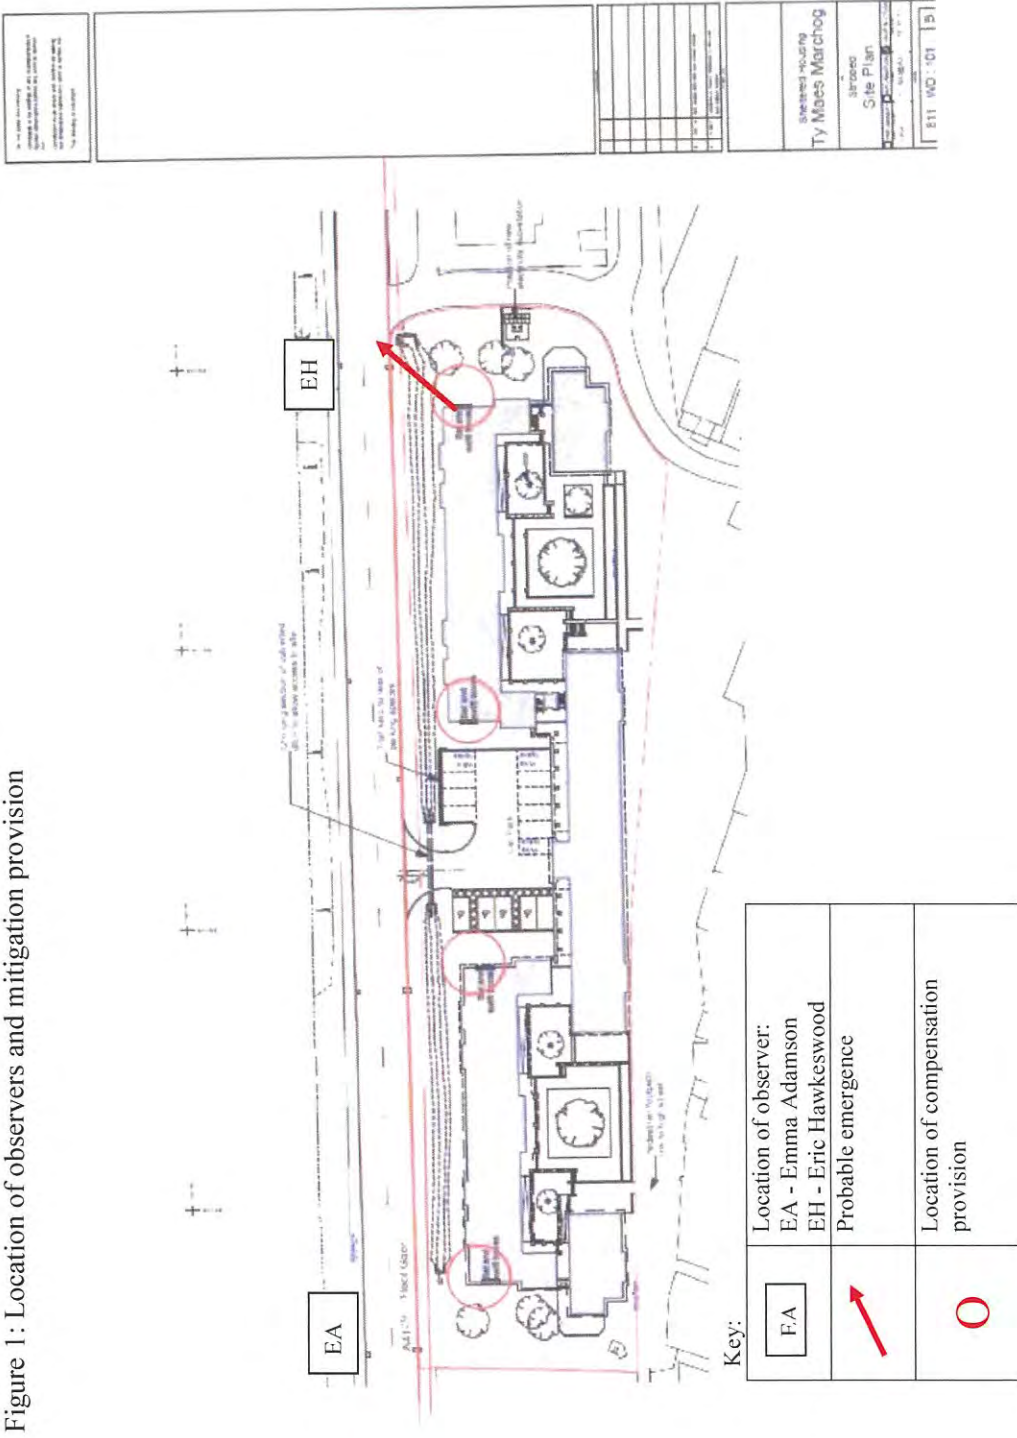
**FIGURE 1:  
LOCATION OF OBSERVERS AND COMPENSATION PROVISION**

Figure 1: Location of observers and mitigation provision

- 6.1 A common pipistrelle was thought to emerge from a bat tube on the eastern elevation of the building. No other activity was noted that could be associated with the building.
- 6.2 A probable common pipistrelle nursery roost was identified from a house in Cross Road to the rear of the building but the house number could not be confirmed; this is unrelated to the Ty Maes Marchog building.
- 6.3 No passes by brown long-eared bat were noted in either monitoring survey.
