## **BAT ROOST METHOD STATEMENT**

**TY MAES MARCHOG,**

**DYFFRYN CELLWEN, NEATH PORT  
TALBOT.**

**NPT HOMES**

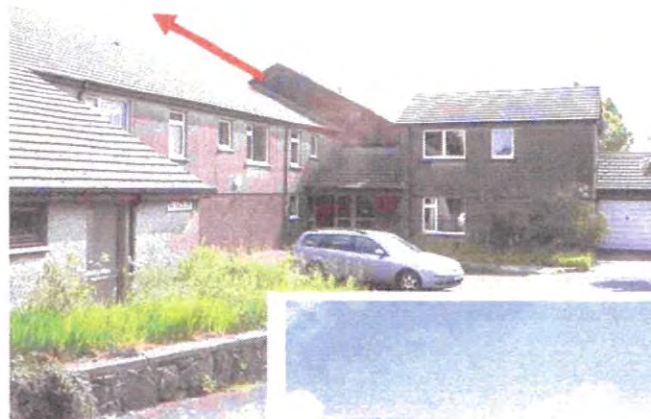
Emergence points  
identified in 2012  
(EWS) survey

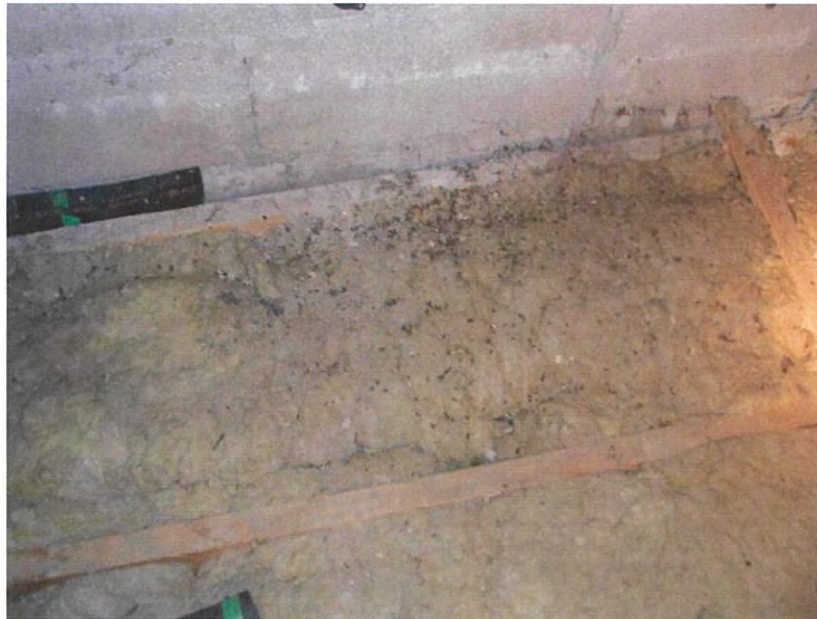
Typical scattering of old and fresh pipistrelle droppings at gable wall.

- 2.5 Access to the soffits and roof voids was noted around most of the building, particularly in the rendered section on the western end of the structure. (see Appendix 1 Photographs). The building consisted of two long sections lying approximately on an east-west axis, slightly offset at their union, giving effectively four gable walls. Droppings were found internally at all gable walls.

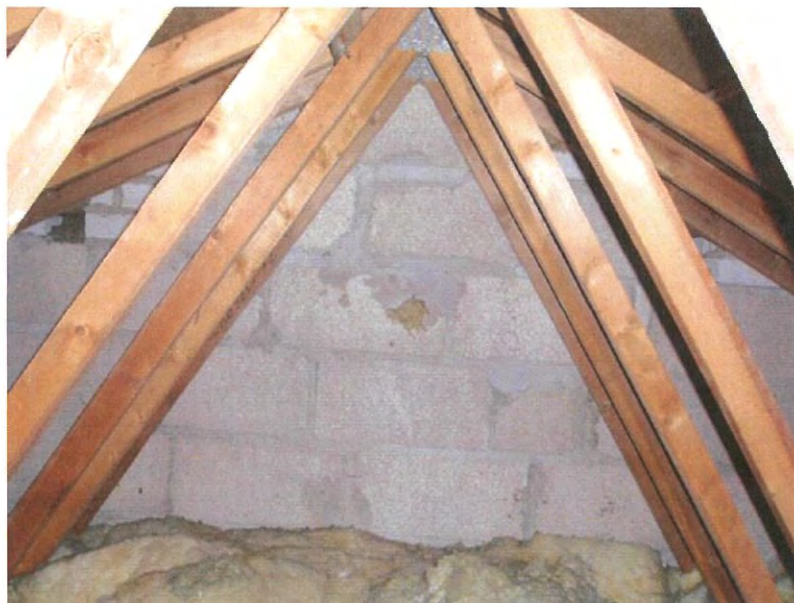
Typical roof structure

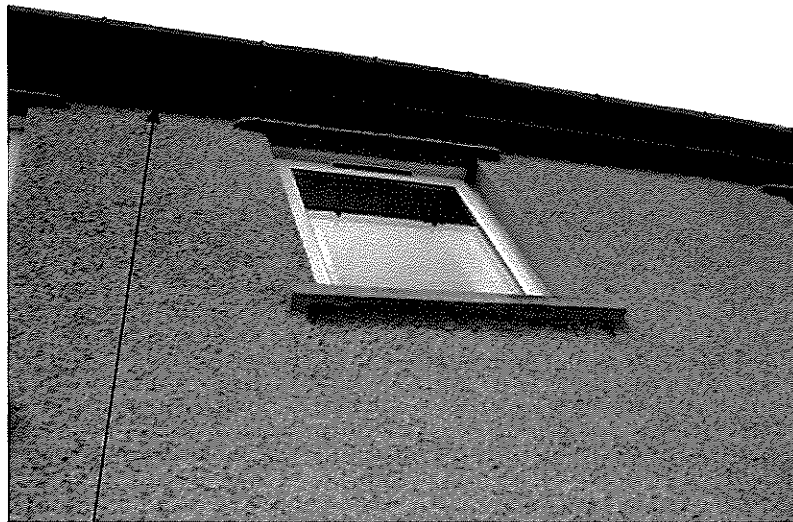
Significant gaps between render and soffits in western wing

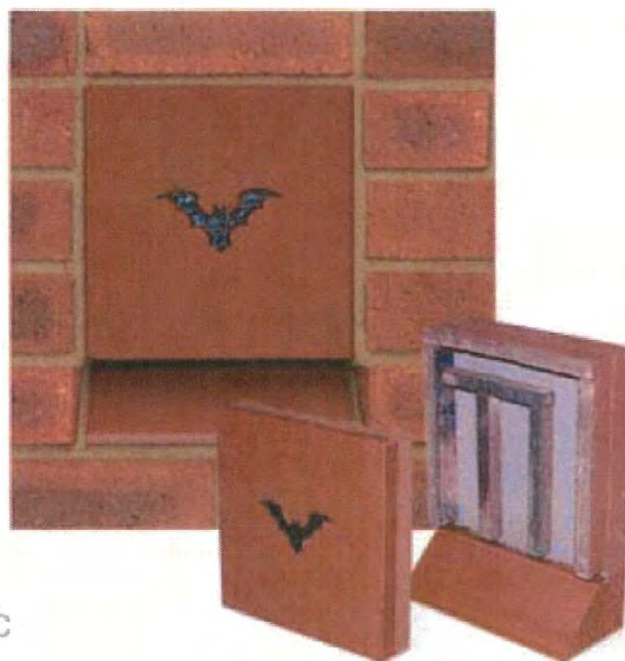
**APPENDIX 3:  
IBSTOCK TYPE C BAT BOX**

**Enclosed Bat Box C with engraved motif**

- ◆ Designed specifically for the pipistrelle bat
- ◆ Available in smooth blue, smooth gold & smooth red
- ◆ Attractive "bat" motif
- ◆ Discrete home for bats
- ◆ Various sizes
- ◆ Several roosting zones are created inside the box
- ◆ Bats are contained within the bat box itself
- ◆ Maintenance free with entrance at the base
- ◆ Ideal for new build & conservation work

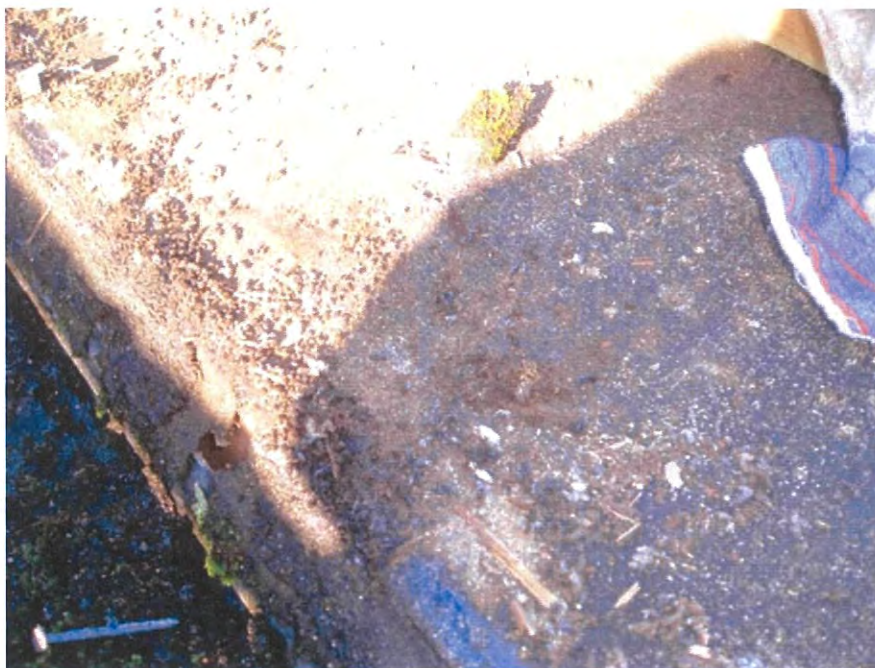
Droppings under the tiles on the southern pitch of the roof

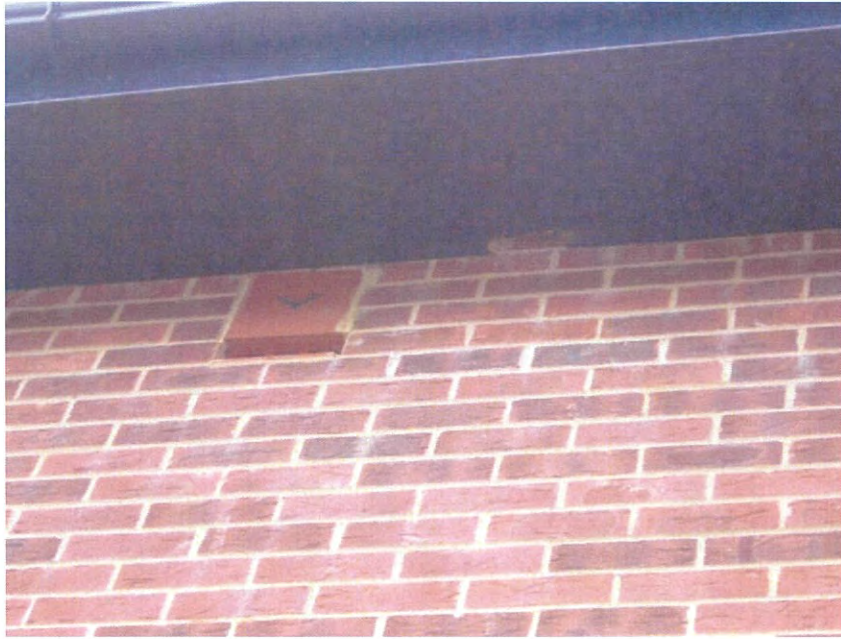
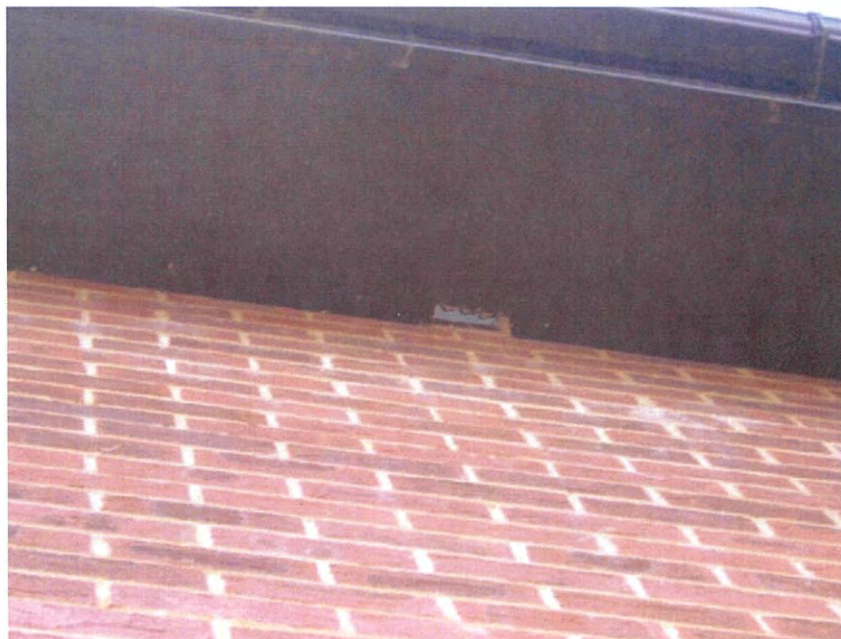
Mitigation in new build, bat bricks and access to wall tops and soffit.
