Visitor Centre  
Bat Survey Report and  
Preliminary Ecological  
Appraisal

Date: August 2023

Lewis Badham & Megan Price  
Planning Ecologist/ Ecologist  
(Planning and Consultancy)  
Countryside and Wildlife Team  
Neath Port Talbot CBC

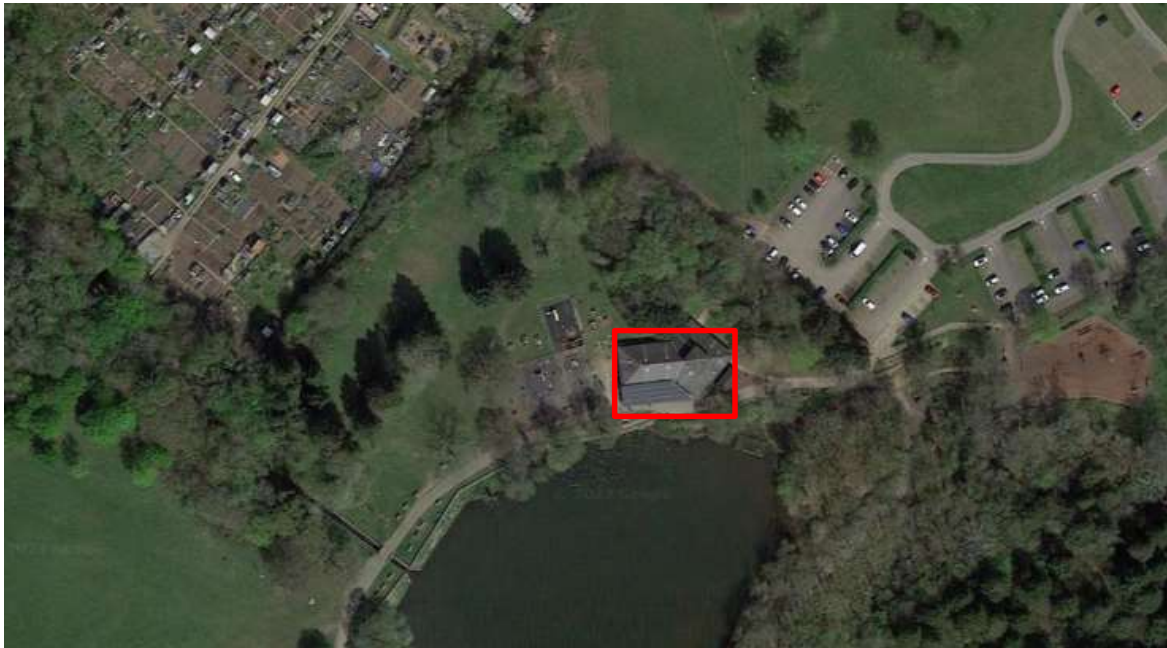
**Figure 1 The Gnoll Visitor Centre Location**

At the time of writing this report, the existing Visitor Centre of Gnoll Country Park is due to be demolished and re-constructed. Below is an aerial photograph of the site; the grid reference is: SS 76504 97489.

The Visitor Centre building is located at the centre of the country park and is set in an area surrounded by hard standing pathways and car parking areas. Several scattered trees are sporadically found across the immediate vicinity with areas of woodland situated to the north and south-east. A large lake is situated immediately opposite on the south of the building.

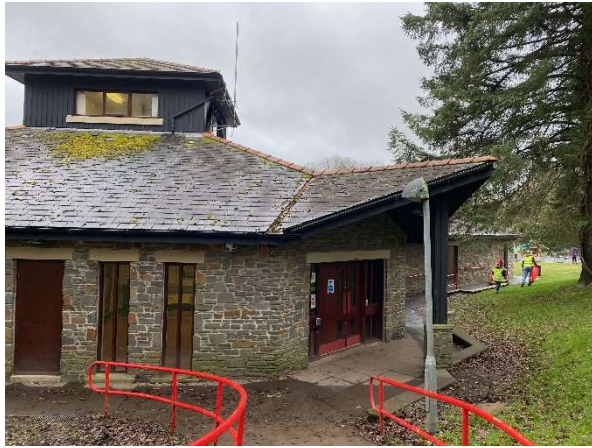
North-eastern and portion of north-western elevations.

The areas of the roofline associated with lifted lead flashing were considered to offer roosting potential for crevice dwelling species. Lifted ridge tiles which are known to support nesting house sparrows were also of interest for their ability to support roosting bats. Overall, the building was considered to be of Moderate potential to support roosting bats, given the features present and the environment in which the building is situated, namely parkland with immediately adjacent woodlands and large waterbody.

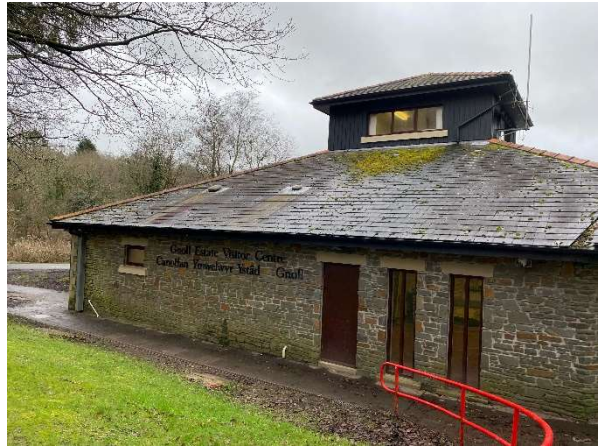
North-eastern elevation.

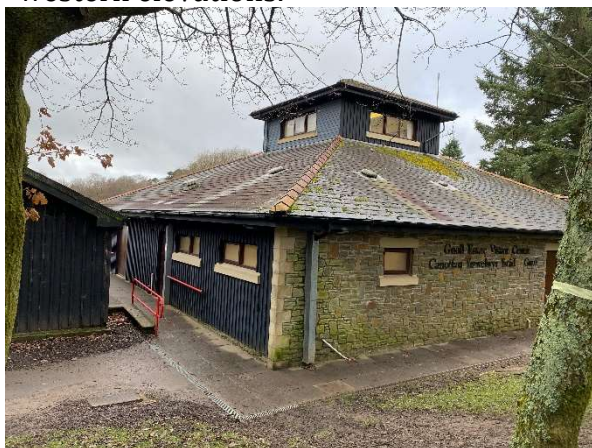
North-eastern and south-eastern elevations.

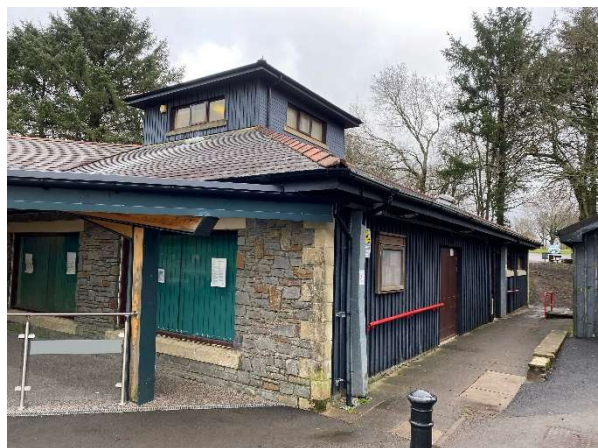
Southern elevation.

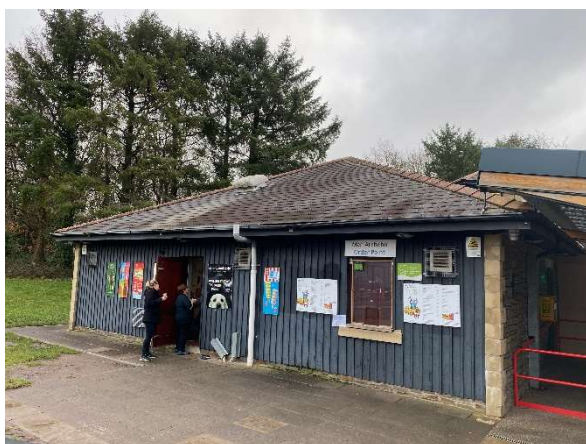
Western elevation.

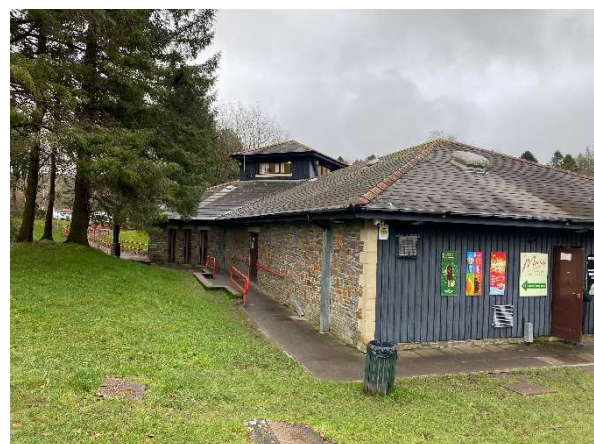
Northern and north-western elevations.

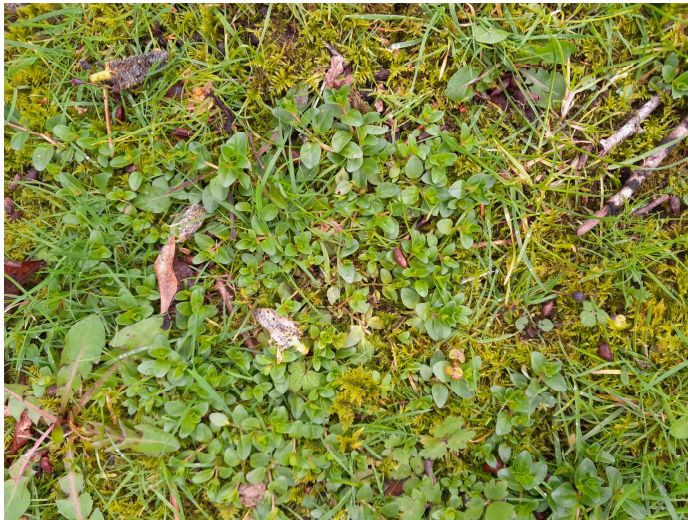
A large area of the land surrounding the visitor centre is amenity grassland containing species such as dandelion (*Taraxacum*), daisy (*Bellis perennis*), selfheal (*Prunella vulgaris*), Yorkshire fog (*Holcus lanatus*) and perennial rye grass (*Lolium perenne*) as

Figure 4 common amenity grassland species

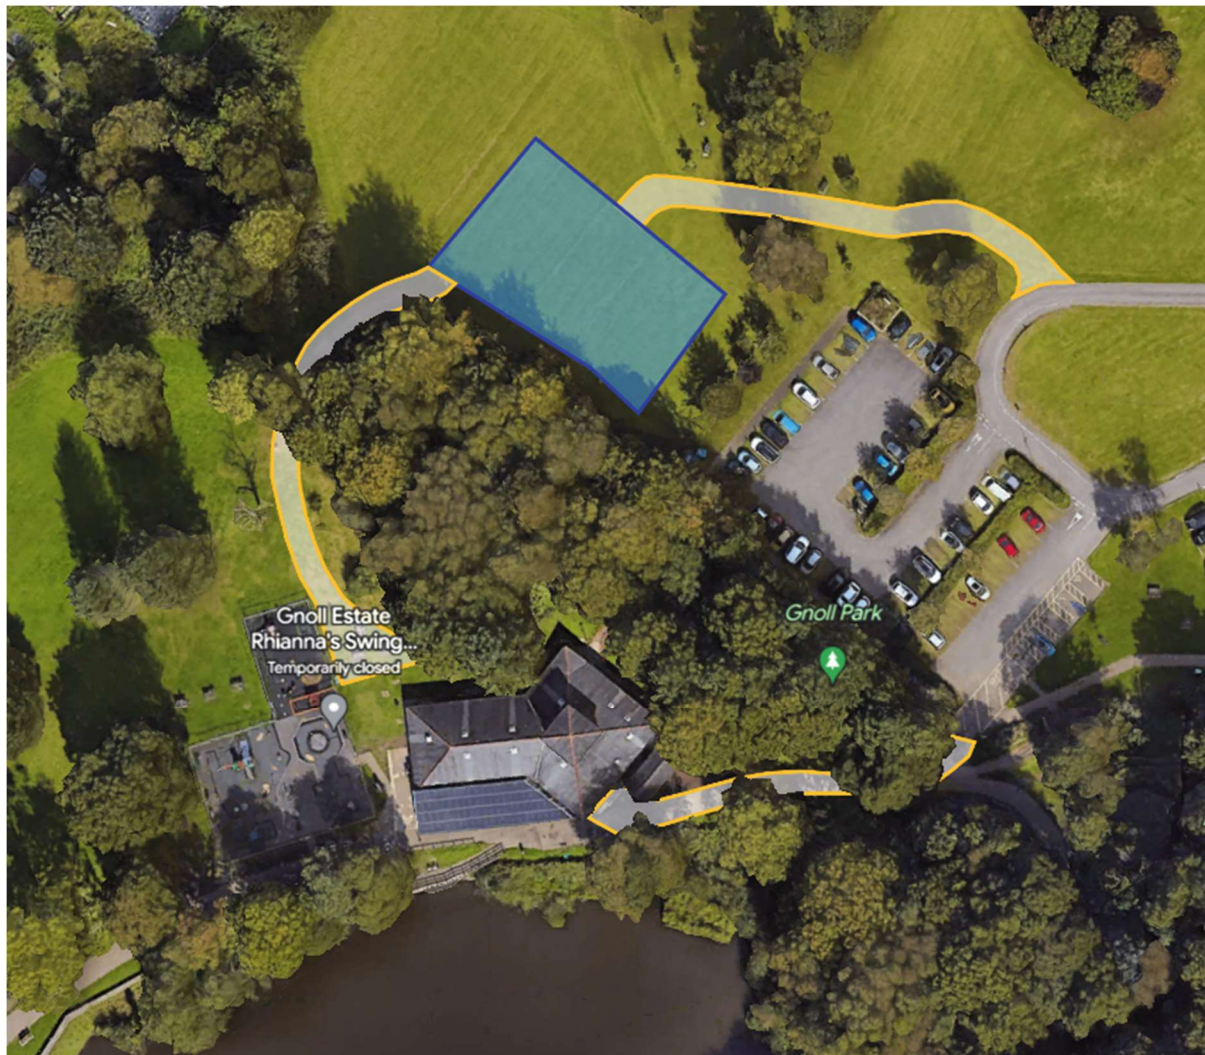
**Figure 5 Proposed site compound location**

The site compound is currently anticipated to be located on the amenity grassland to the North of the visitor centre (see below indicative plan).

Illustrated above as a blue square is the compound area and the yellow edged path is the access to and from the compound.

Appropriate Root Protection Zone (RPZ) will be put in place to protect any retained trees that could possibly be impacted and floating pathways will also be used to protect any tree roots.

After the site compound is dismantled, an appropriate seed mix will be used to make good the site and enhance local biodiversity.

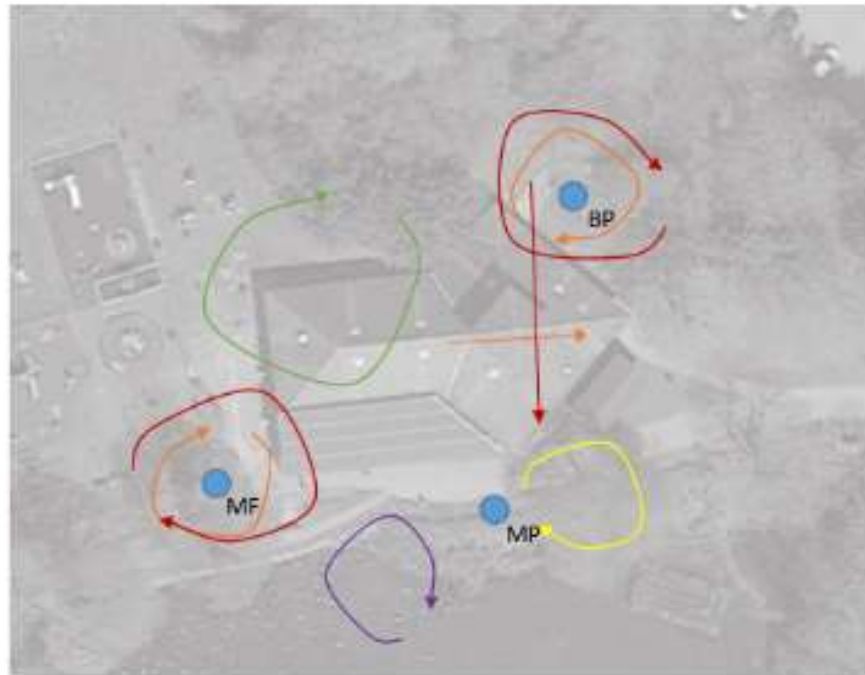
## APPENDIX B – 2022-09-29: FLIGHT LINES & SURVEYOR POSITIONS

Low levels of bat activity were recorded on site during the emergence survey. No bats were observed emerging from the building. Soprano and Common Pipistrelle, Noctule, Daubenton's and Brown Long-eared Bat (*Plecotus auritus*) were all observed foraging within the immediate area of the visitor centre building. A plan highlighting surveyor positions and bat activity over the course of the survey can be found at Appendix B summary table of the data collected over the course of the survey can be found at Appendix D.
