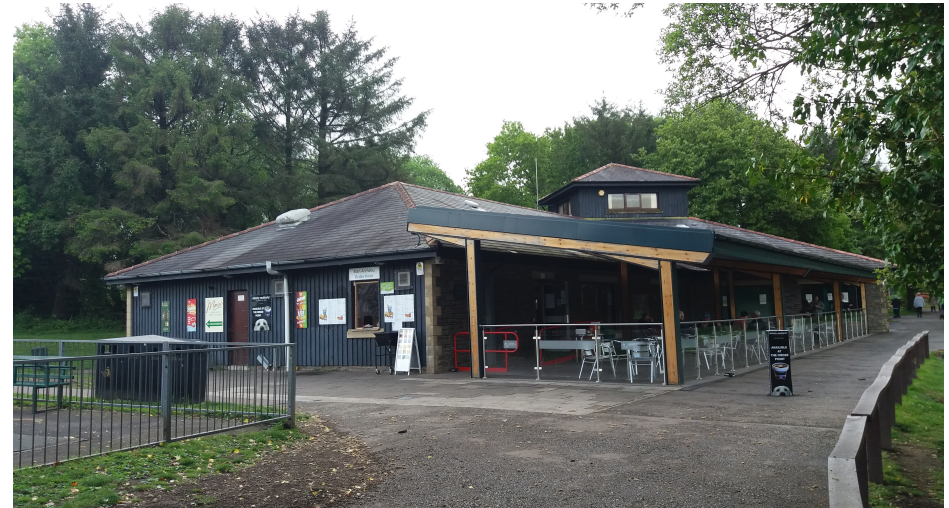
*Approaching along the lakeside path from the east - photo showing general massing and the later-added external canopy*

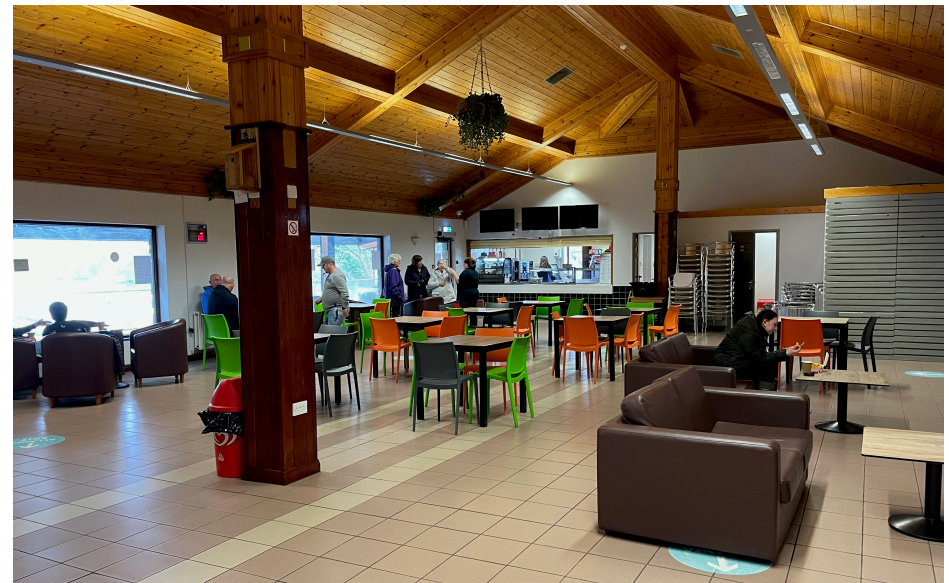
- The internal volume is generous. However, the double height space has been compromised by the introduction of store rooms to the corner of the main café space.

- A lack of the right sized/ arranged storage leads to clutter, which means rooms cannot be properly occupied. Stacked chairs in the main café space create an unwelcoming atmosphere.

*Existing café facilities within the visitor centre.*
