Pond Cottage  
Bat Survey Report &  
Preliminary Ecological  
Appraisal

Date: August 2023

Lewis Badham & Megan Price  
Planning Ecologist/ Ecologist  
(Planning and Consultancy)  
Countryside and Wildlife Team  
Neath Port Talbot CBC

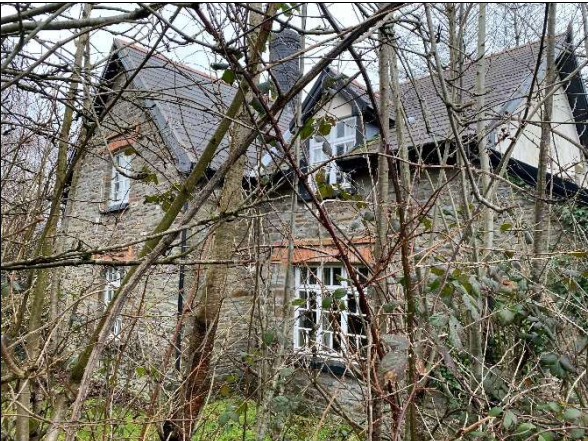
| <p>Overview of north-western elevations.</p> | <p>Overview of north-eastern and portion of north-western elevations.</p> |

The areas of the roofline associated with lifted lead flashing were considered to offer roosting potential for crevice dwelling species. Lifted ridge tiles which are known to support nesting house sparrows also provided roost potential as do the damaged fascias and soffits. Overall, the building was considered to be of Moderate potential to support roosting bats, given the features present and the environment in which the building is situated, namely parkland with immediately adjacent woodlands and a large waterbody.

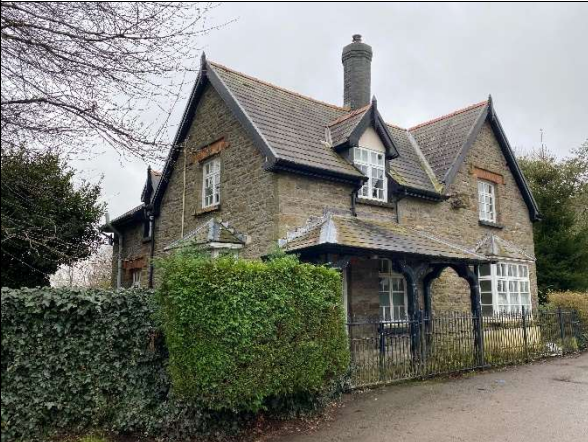
| <p>Overview of north-eastern and south-eastern elevations.</p> | <p>Overview of southern elevation.</p> |
