# Agricultural Store / Outbuilding - Reinstatement of Collapsed Storm Damaged Building - Initial Proposal

| Project | Blaennant<br><del>Sun Y Nant</del> Barn Replacement |
| Purpose / Stage | Concept |

### Annotated Photographic Record

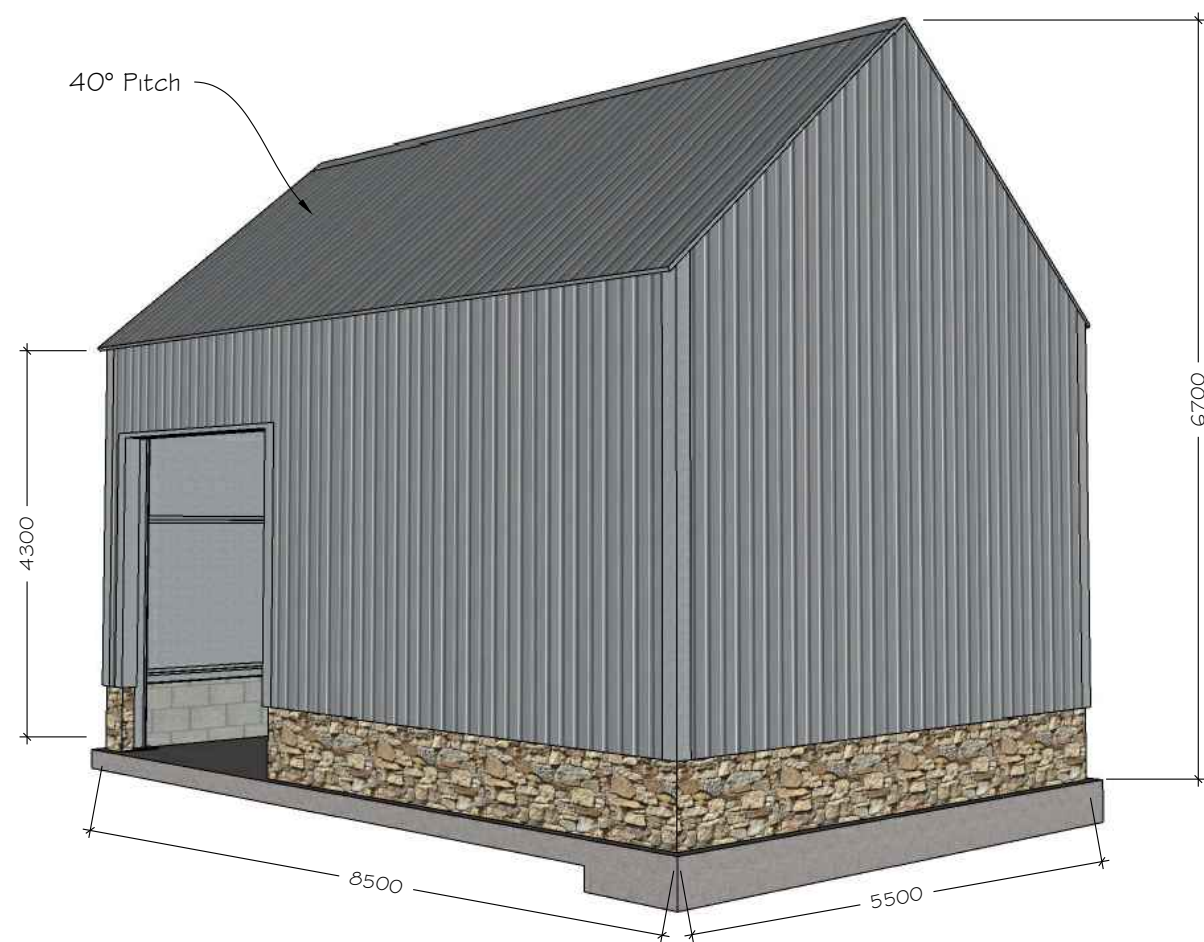
**Pic 1.** Proposed concept structure - guide dimensions taken during initial visit and scaled from photograph of existing - actual dimensions adjusted to match detailed measurement of remaining floor elements.

- The existing slab will require removal.
- The bank of the adjacent watercourse will likely require some consolidation works..
- The concept design as proposed herein is based on the type, form and dimensions of the pre-existing building, with modern building methods and arrangements introduced.

- The proposal consists of a steel reinforced concrete ground slab with a galvanised steel portal frame and upper floor beams, block and stone cladding perimter low level walls and profiled metal sheet cladding to walls and roof.

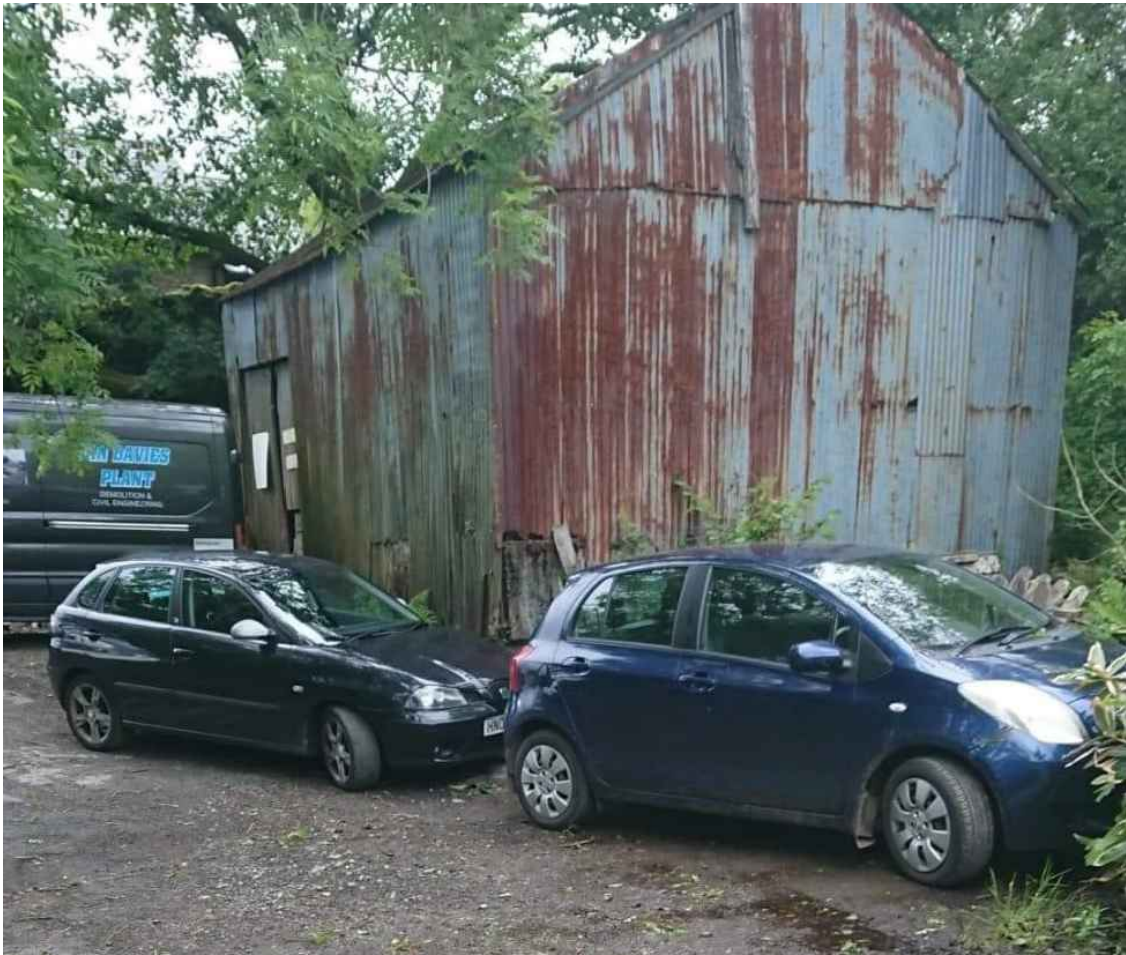
**Pic 2.** Photograph of structure pre-event and demolition used as reference
