# Cwmavon

## Ground Investigation Report

784-B035234

**Neath Port Talbot County Borough Council**

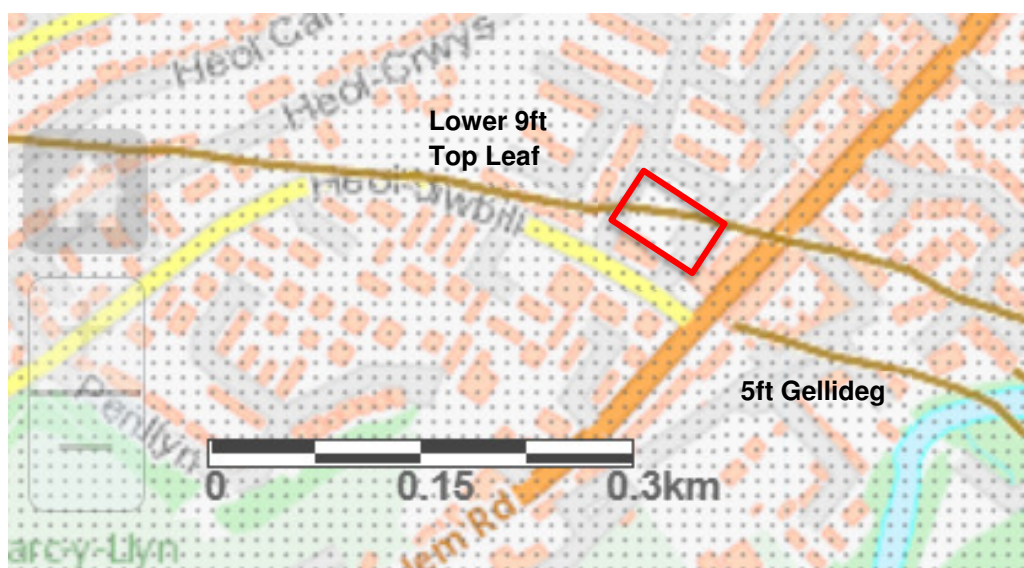
#### Extract 1: From BGS Geoindex

The BGS geology map indicates that the site is underlain by the South Wales Middle Coal Measures Formation. This formation generally consists of grey, (productive) coal-bearing mudstones/siltstones, with seatearths and minor sandstones.

The two boreholes drilled on site (BH01 and BH02) recorded 10.5m of overburden (1.9m MG and 8.6m Alluvium) and 12m of overburden (1.5m MG and 10.5m Alluvium), respectively. A 0.7m thick intact coal seam was encountered in both boreholes at depths of 28.3m bgl and 18.8m bgl, respectively. This has been inferred to the Lower Nine Foot Top Leaf as identified in the Coal Authority report. Based on the distance between the boreholes (12m) this would imply a dip to the north of circa 30 degrees, although the BGS information implies it is steeper. This would position the seam outcrop approximately 10-12m south of the BH02 and the site.

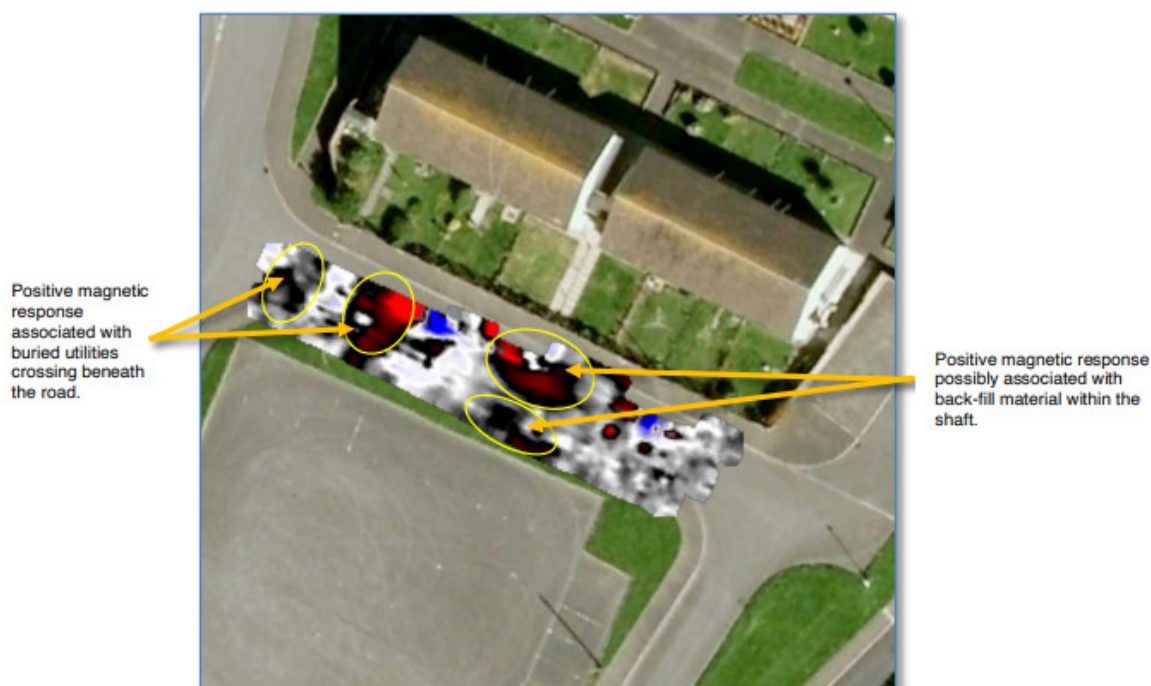
### Extract 2: From Geophysical Survey Report

Four high amplitude positive magnetic anomalies typically associated with backfilled depressions were identified within the survey area. Two identified responses to the west of the survey area appear to be related to buried utilities/services. The GPR results corroborate this interpretation. The two more significant responses identified east of the survey area are a single truncated response cut in two by a relatively shallow (c.0.5m) buried utility.

Evidence from the geophysical surveys suggests the capped mineshaft is located beneath the carriageway of Waun Wen. An asphaltic patch repair over a circa 10m section of the carriageway may be an indication of subsidence associated with the former mineshaft. This also corresponded to an area of anomalous response identified by the magnetometer data.

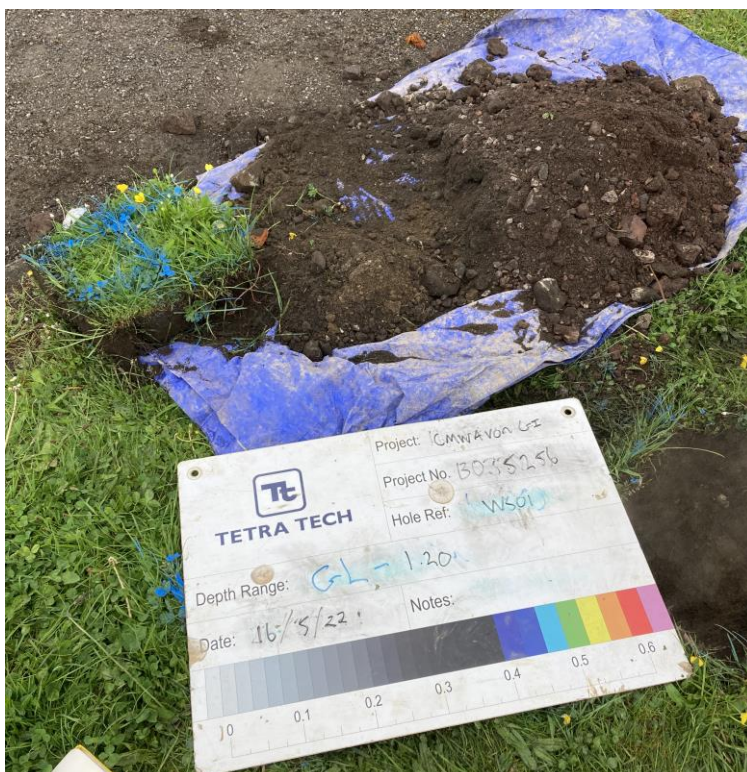
**Plate 1**

WS01 inspection pit following excavation to 1.20m bgl.

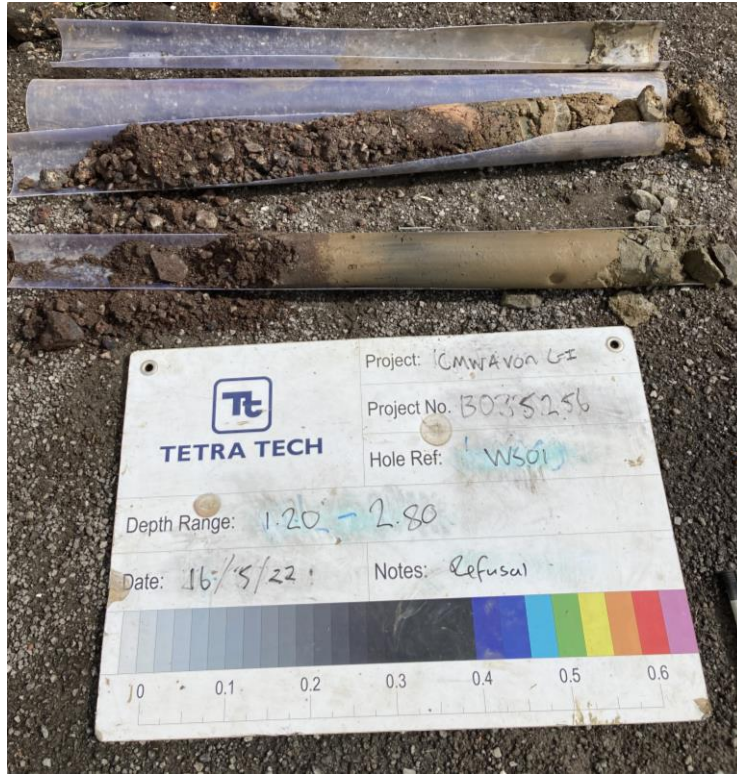
**Plate 3**

WS01 sample recovery with refusal at 2.50m bgl.

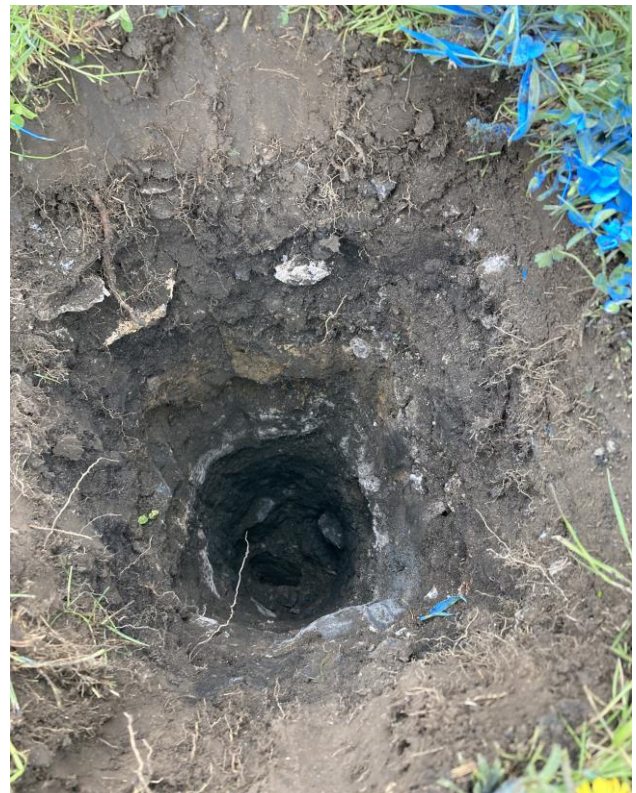
**Plate 4**

WS02 inspection pit following excavation to 1.20m bgl.

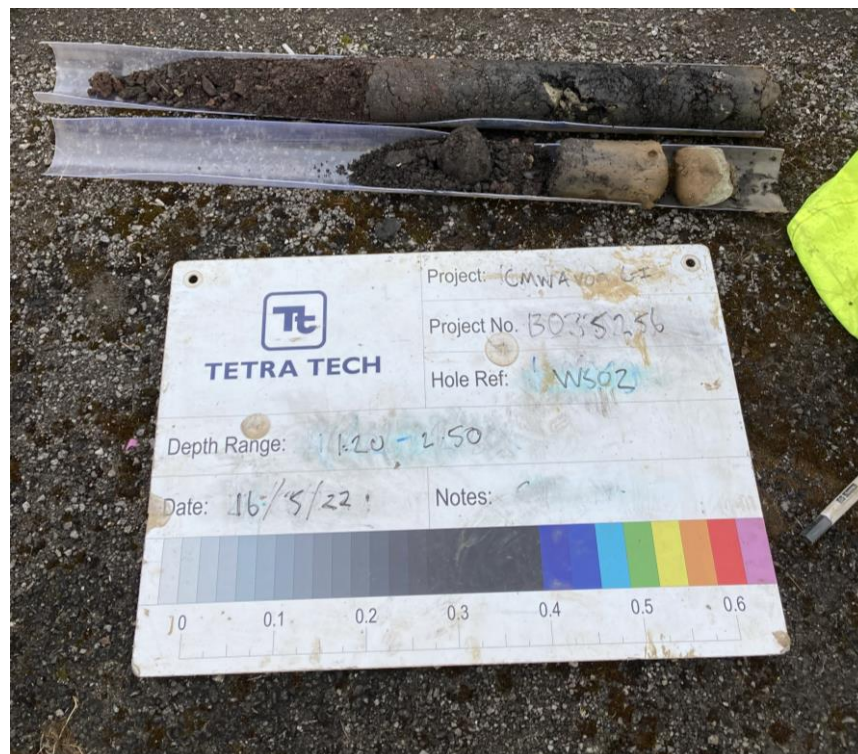
**Plate 6**

WS02 sample recovery with refusal at 2.50m bgl.

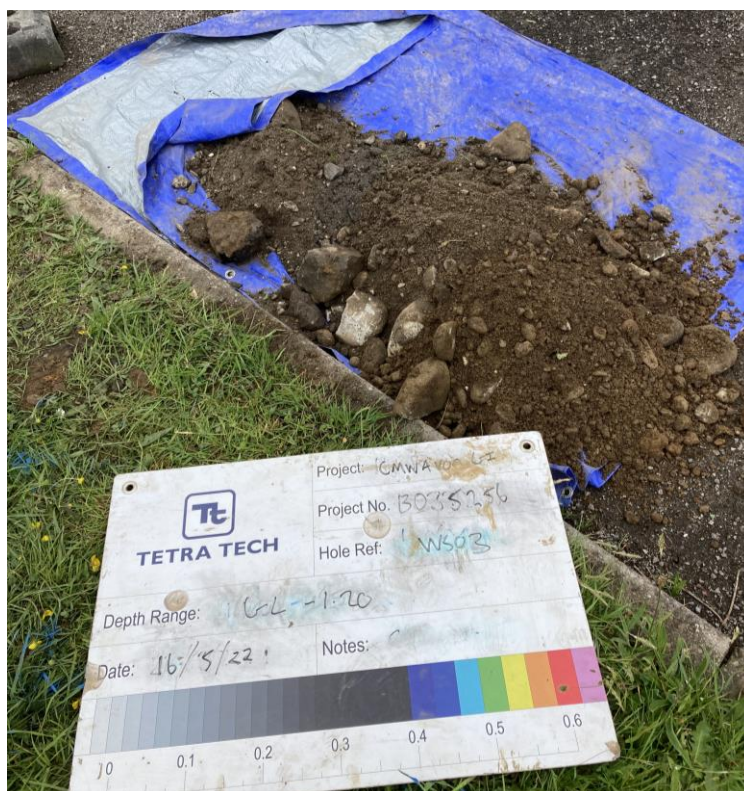
**Plate 8**

WS03 inspection pit arisings

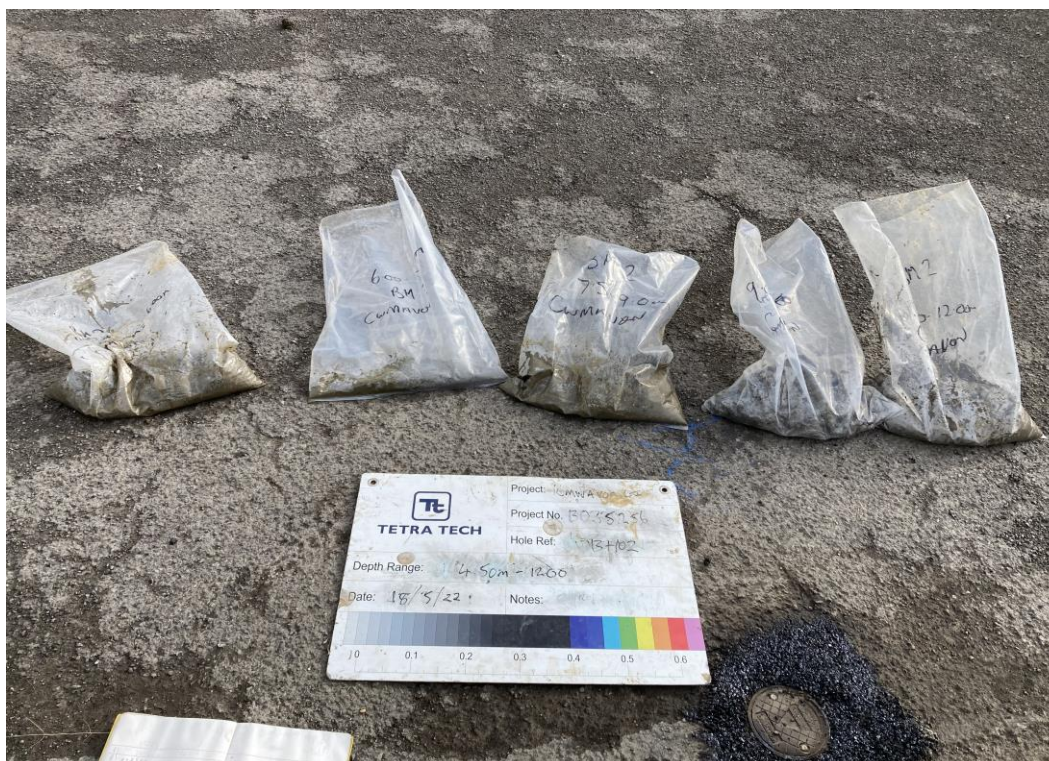
**Plate 48**

Sample recovery from BH02. Poor recovery from dynamic sampling runs
