22177/R2

September 2023

**CWMAVON – SUPPLEMENTARY GROUND INVESTIGATION**

**Spectrum Geo Services  
Foxglove Cottage,  
Cwm Risca Lane,  
Tondy,  
BRIDGEND  
CF32 0EH**

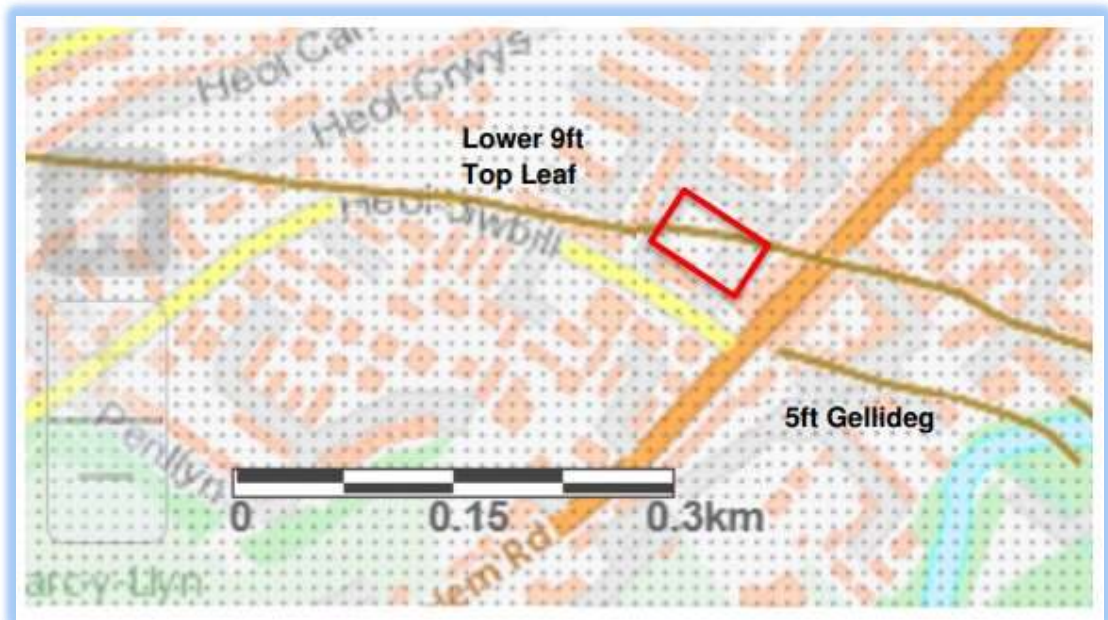
**Fig 10: Geoindex Extract**

The drilling operations noted in both this and the original phase of investigations, several relatively thin seams, which may be the Lower 9ft top leaf or the Bute. No workings were noted and no loss of flush recorded in any of the holes.

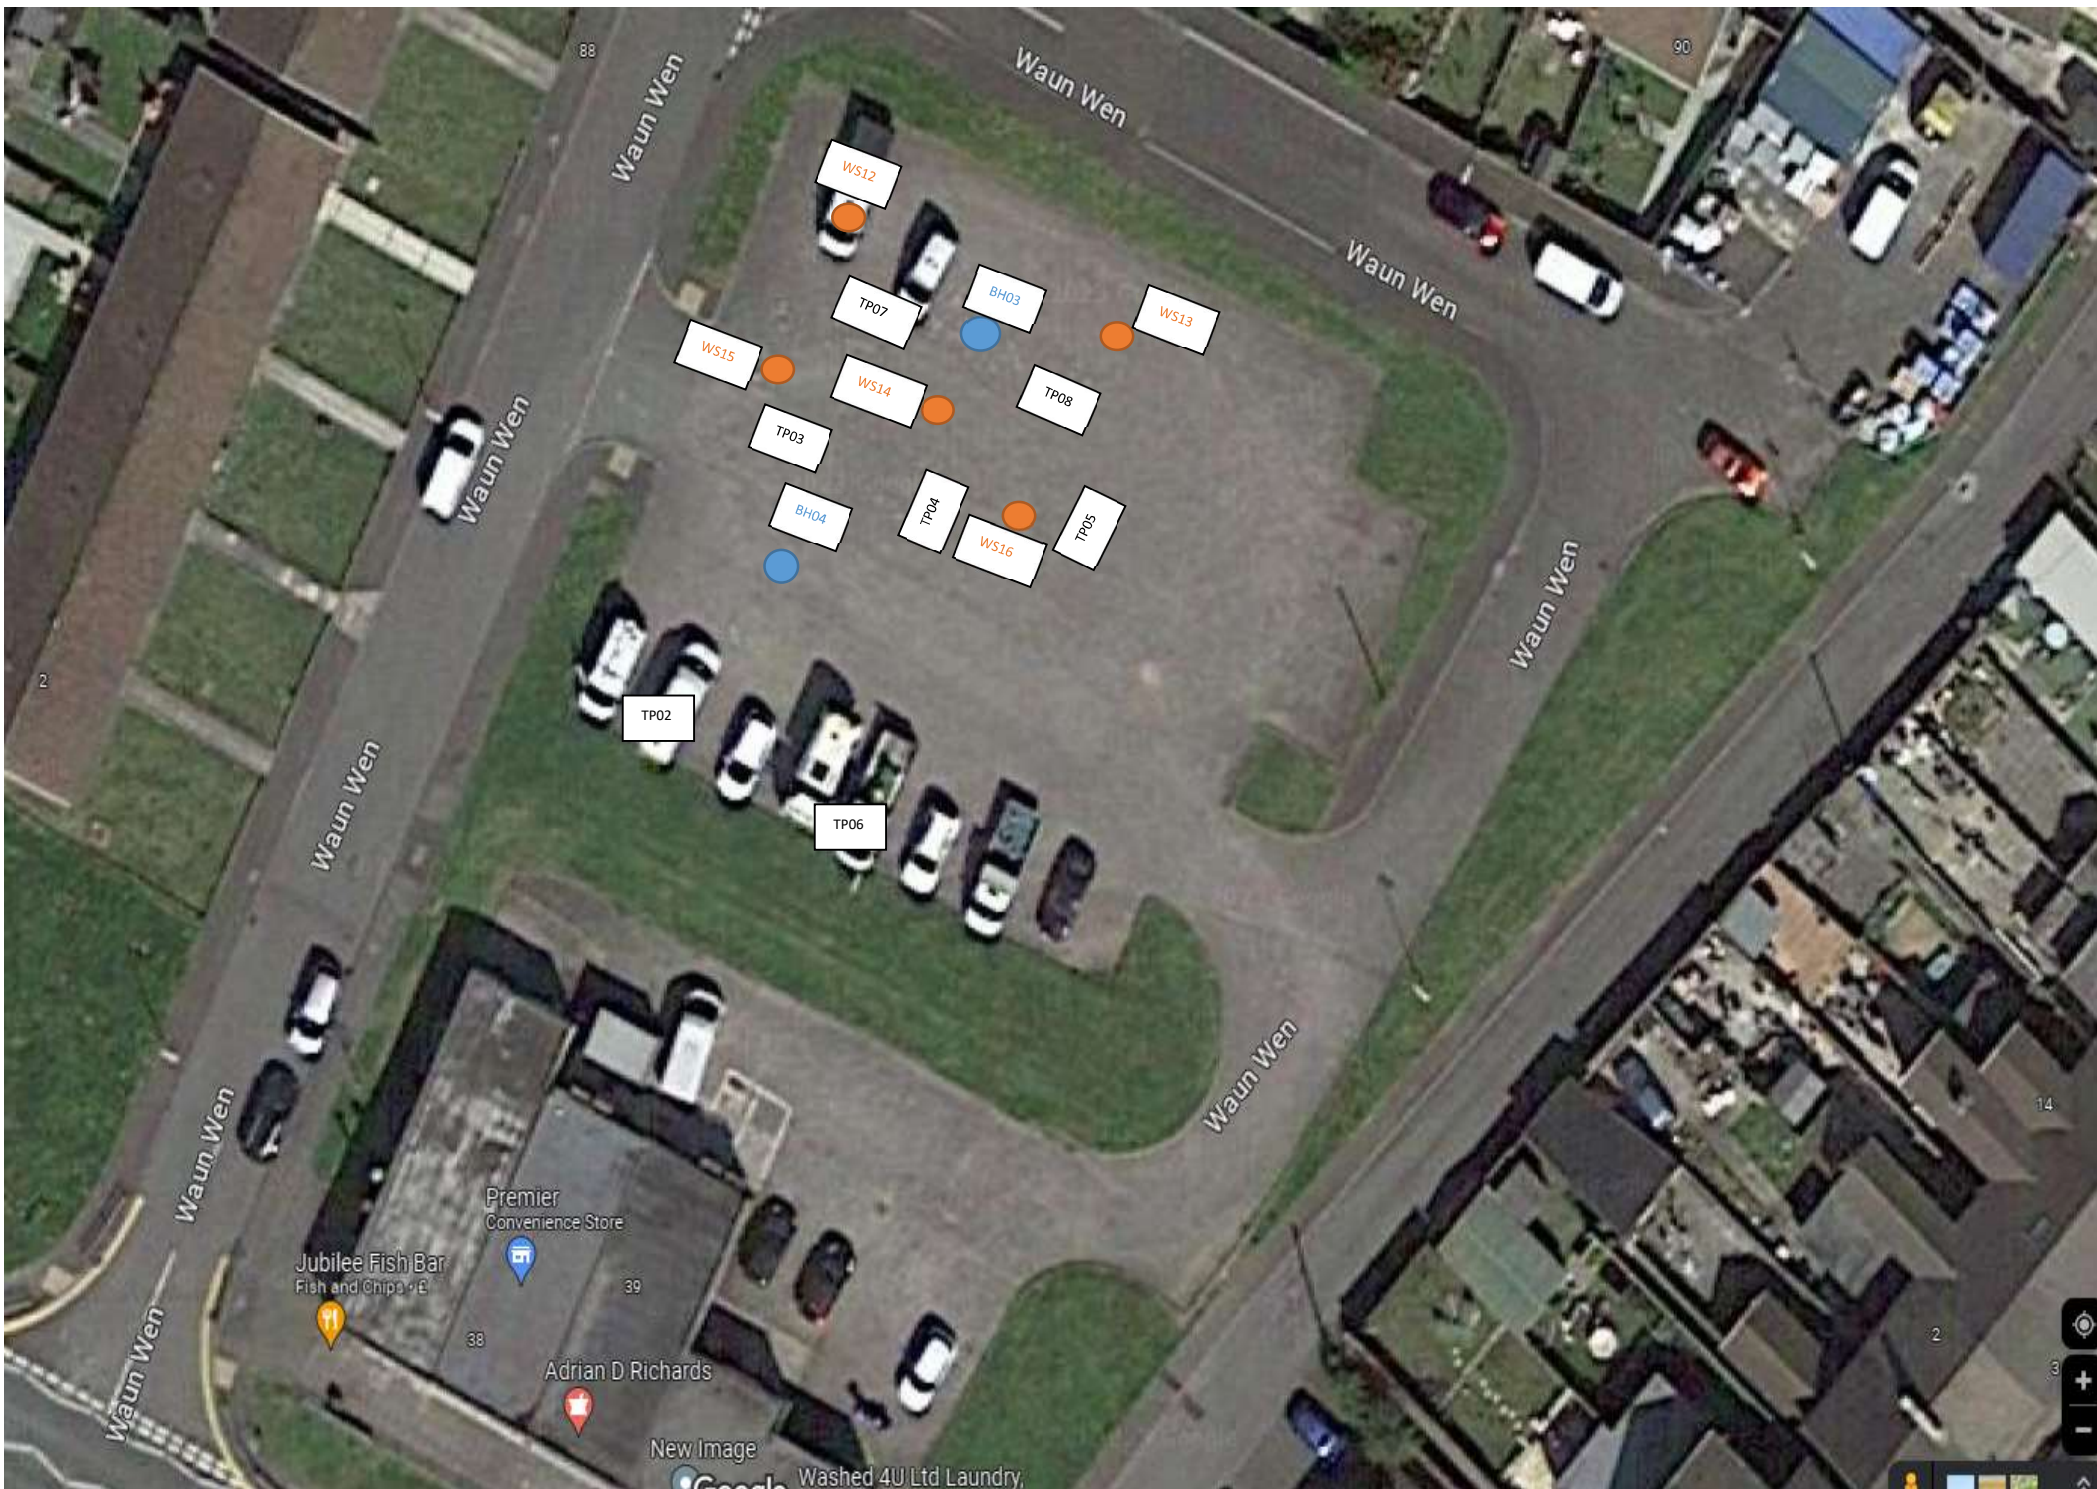
Drawing 22177\_Sections

Cross sections show the depth of the seams and assume a 60 degree dip to the north.
