## Coal Mining Risk Assessment

Ffordd Dinas

Cwmavon

**Report No. A4081/21**

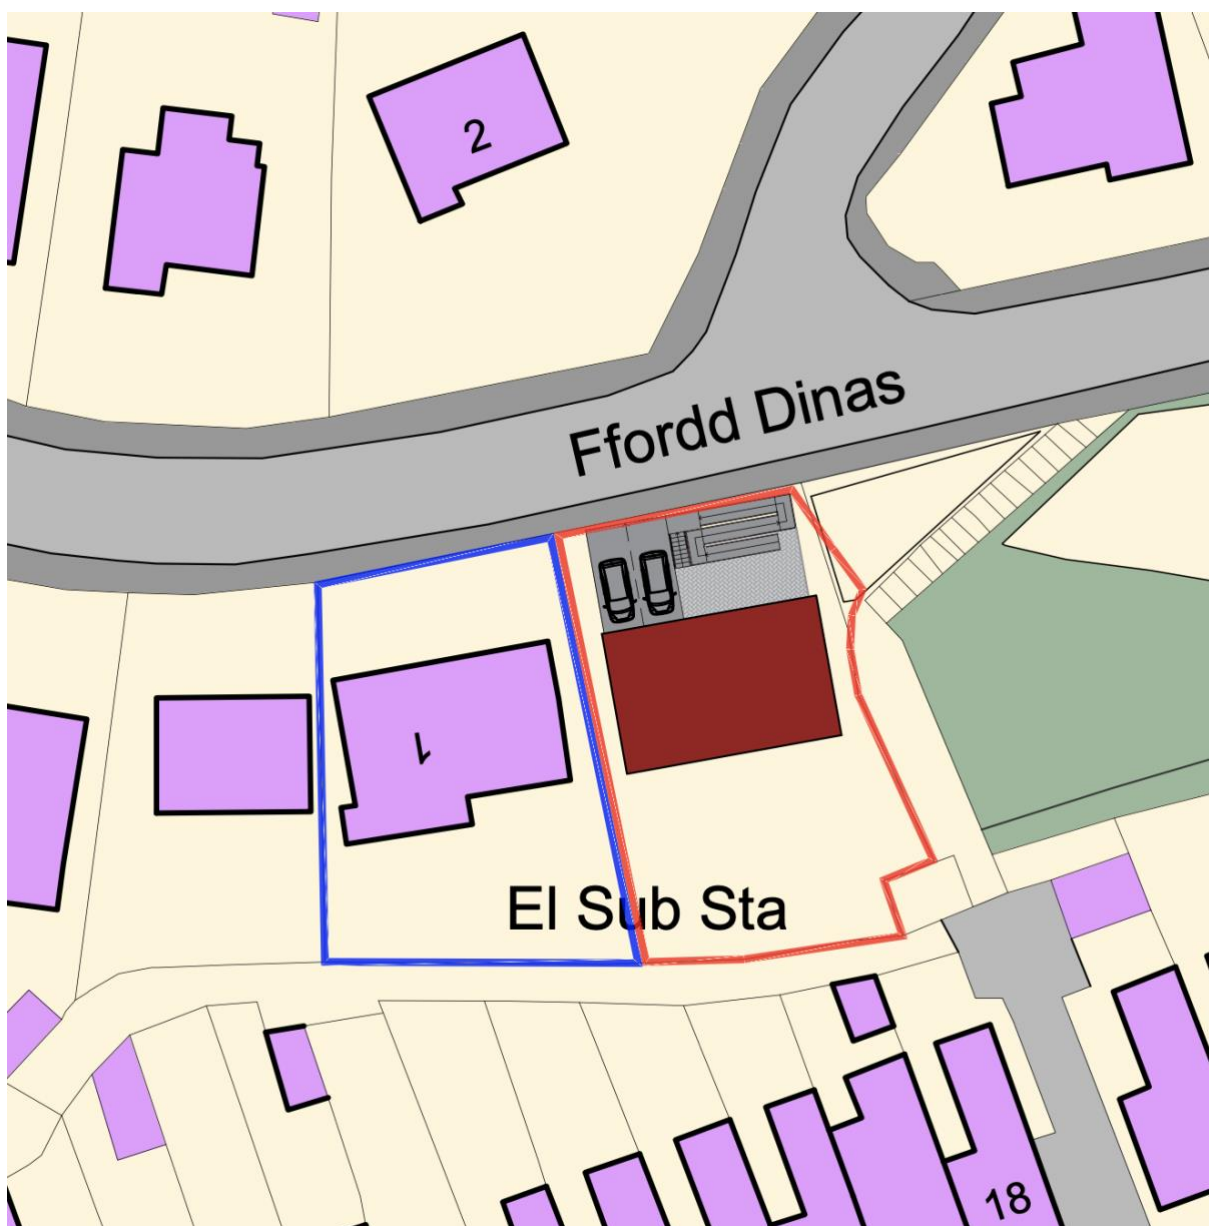
**Figure 1 Proposed Development Plan**

- 1.1 Earth Environmental & Geotechnical Ltd have been commissioned by Darkin Architects on behalf of Mr. Williams (the Client), to undertake a Coal Mining Risk Assessment for a proposed development on land adjacent to Plot 1 Ffordd Dinas, Cwmavon.
- 1.2 It is understood that the Client is seeking planning permission for the construction of one three-storey (with a basement) detached dwelling.
- 1.3 A proposed development plan has been provided and is shown as Figure 1.

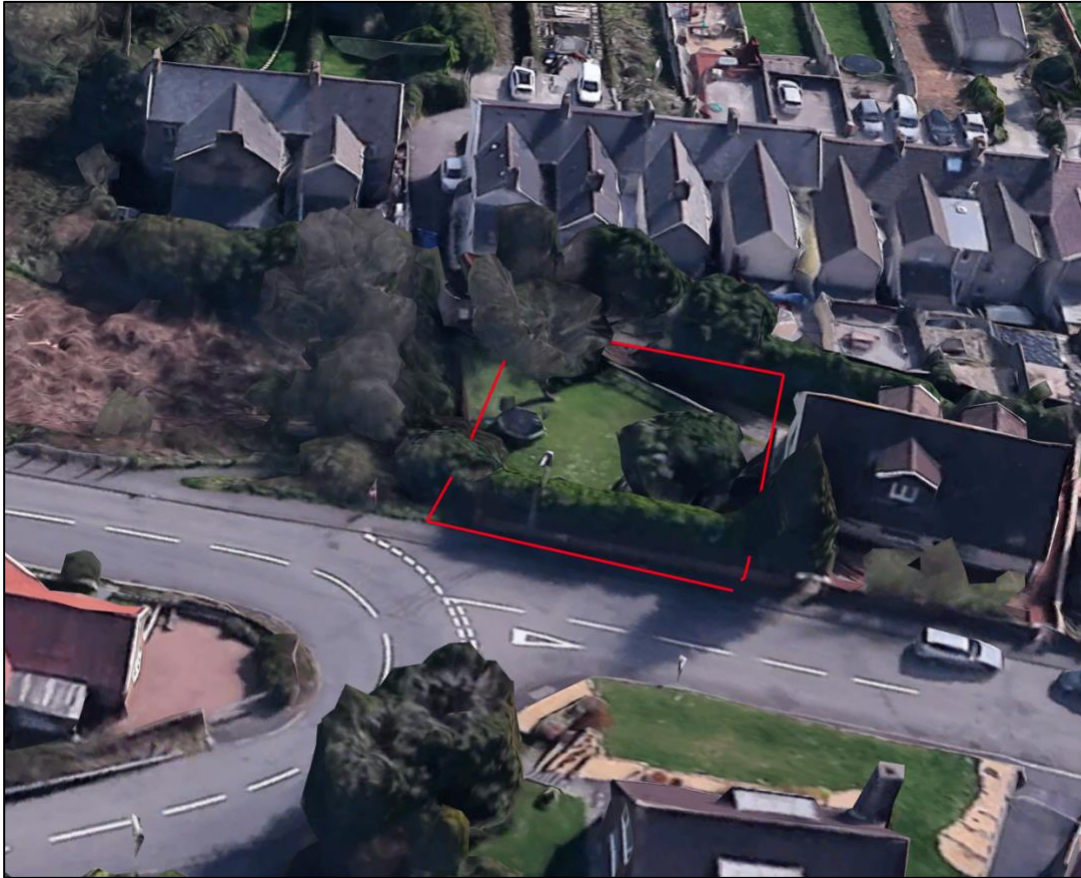
**Figure 3 Site Photograph**

- 2.1 The site is located approximately 141m north of Cwmafon village centre and lies at an elevation of 55mAOD (centre of site). The approximate National Grid Reference for the centre of the site is SS 77753 92220 with the closest postcode being SA12 9BS.
- 2.2 A location plan is shown below as Figure 2 together with an aerial photograph as Figure 3 (overleaf).

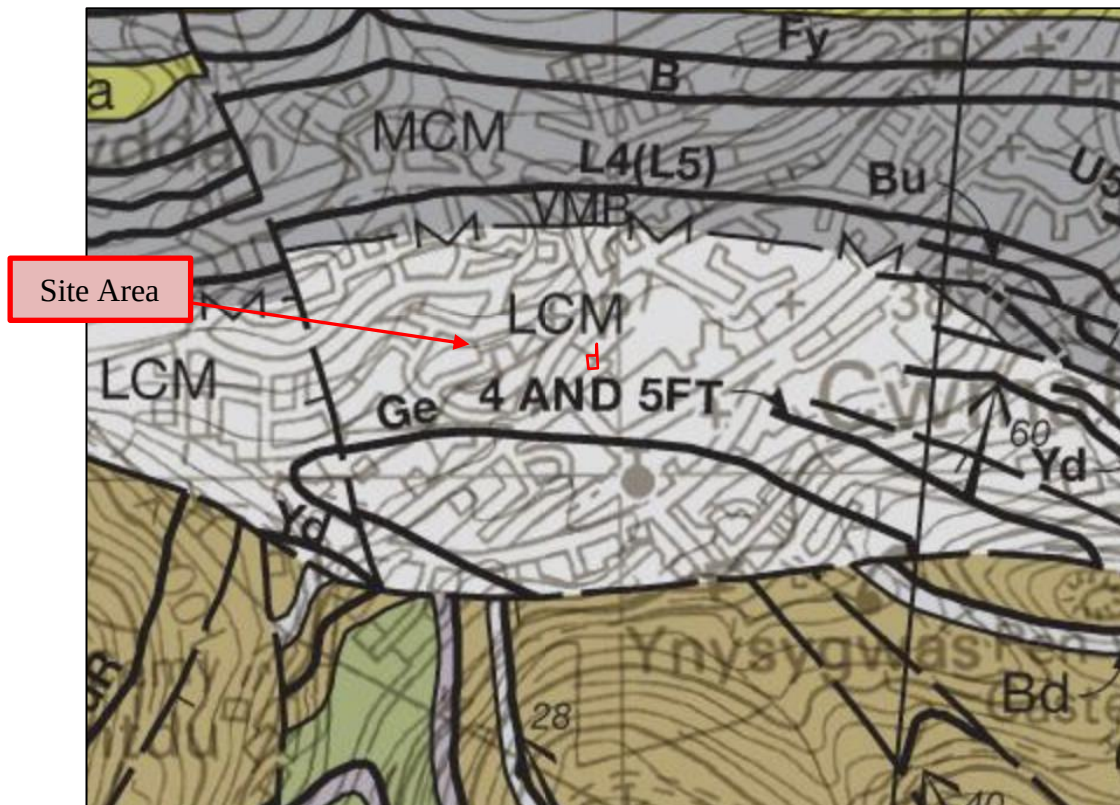
**Figure 4 Geology Map Extract**

- 3.2 The site is underlain by superficial deposits of Devensian Till, comprising Diamicton, commonly known as Boulder Clay.
- 3.3 The solid geology beneath the site is shown to be the South Wales Lower Coal Measures Formation consisting of cycles (cyclothems) of coal seams, sandstone, mudstone, siltstone and seatearth.
- 3.4 There are no BGS borehole records that allow for further assessment of the local geology or shallow coal mining regime.
- 3.5 An extract from the most recently published geological map showing the approximate site location and key local geological features are presented below in Figure 5.
- 3.6 The regional dip of strata within the area is sixty degrees to the north.

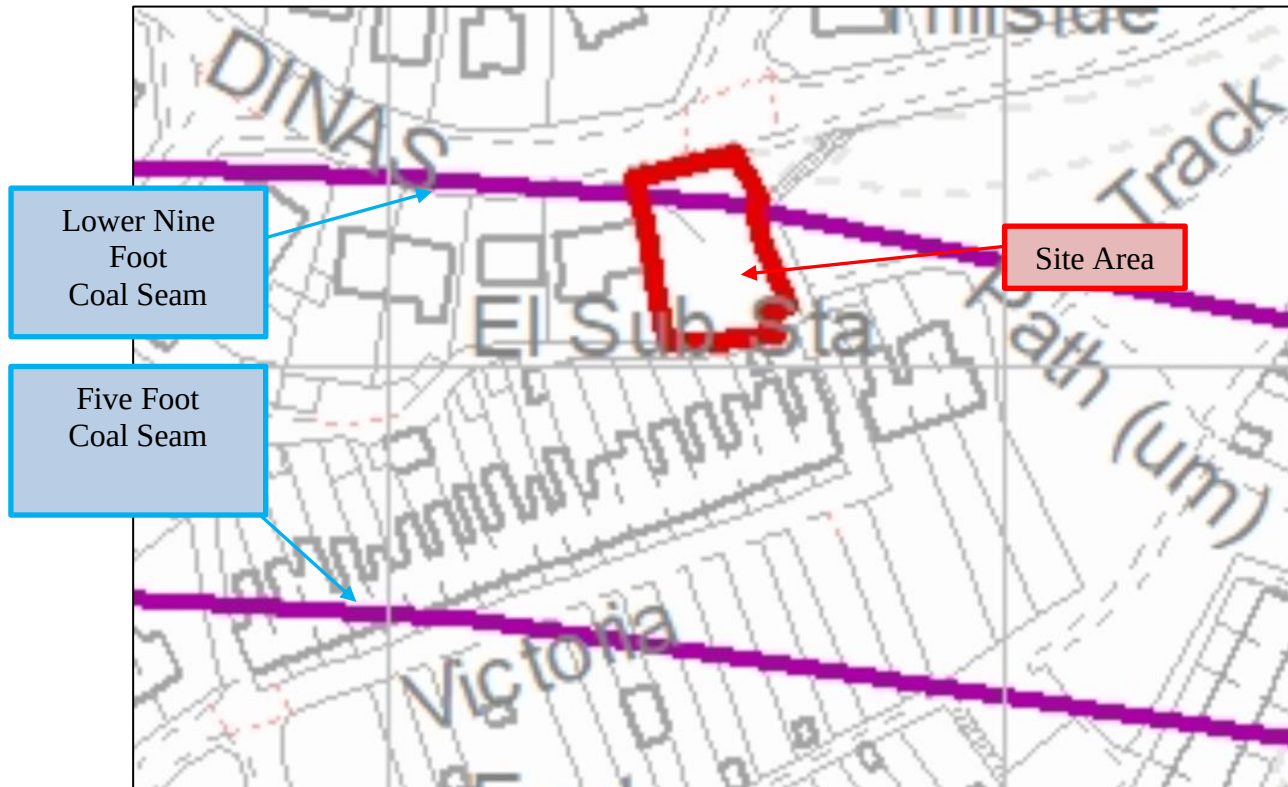
**Figure 5 Coal Authority Map Extract**

- 3.7 Reference to the Coal Authority Online Interactive viewer shows the site to be located within a Development High Risk Area and within an area of Probable Shallow Coal Mine Workings.
- 3.8 A Coal Authority Mining Report (extract shown as Figure 5) has been acquired for the site and reveals that there are no proven records of past underground mine workings beneath the site.
- 3.9 To the north of the site the Lower Nine Foot (Top Leaf) coal seam was worked at a depth of 18m in 1900. The coal seam dips at eighteen degrees to the north.

- 3.10 The Coal Authority report suggests that there are probable unrecorded shallow workings beneath the site.
- 3.11 The Lower Nine Foot (Top Leaf) coal seam outcrops on the site and is noted to be workable.
- 3.12 There are no records of any managed tips, remediated sites, areas of coal mining subsidence within 50m of the site.

- 4.7 The development area lies within a Coal Authority Development High Risk Area and within an area of probable shallow workings due to locally outcropping coal seams.
- 4.8 The Lower Nine Foot coal seam outcrops on the site and was formerly mined at a shallow depth to the north. The coal seam dips to the north at an angle of eighteen degrees from the horizontal.
