# Gnoll Country Park, Neath

**Title** Ground Conditions Assessment Report

Andrew Scott Limited working on behalf of the local council is proposing infrastructure enhancements at specific sections of the Gnoll Estate Country Park in Neath, including the construction of a new visitor centre. To assist with the development of the site proposals, Jubb Consulting Engineers (Jubb) have been appointed to undertake a geotechnical and geo-environmental assessment of the ground conditions for the proposed site use.

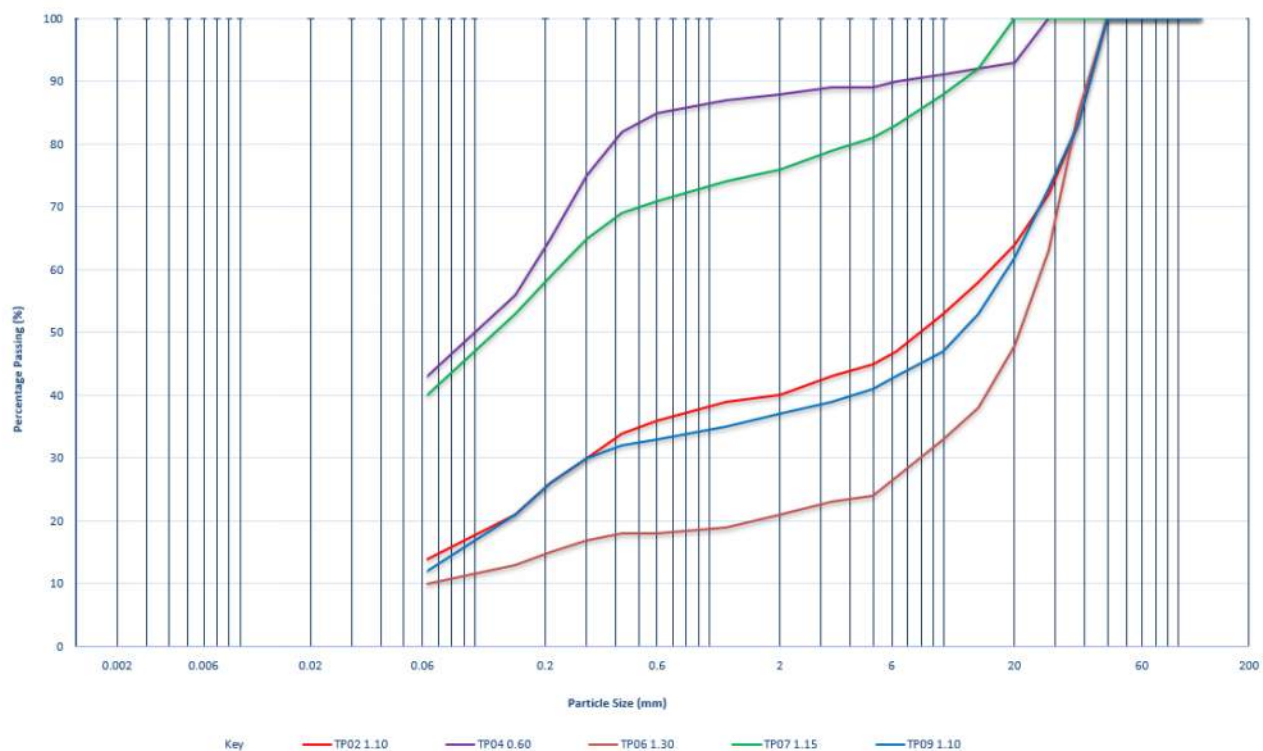
Figure 6: Weathered Pennant Sandstone Formation PSD Curve

Based on the single PSD results, the residual soils could be typically classed as clayey/silty sandy gravel. The PSD curves show two sets of different gradings suggesting the residual soils are slightly varied across whole site, but appears to become more granular with depth as shown both below and the exploratory hole logs contained in **Appendix G**.

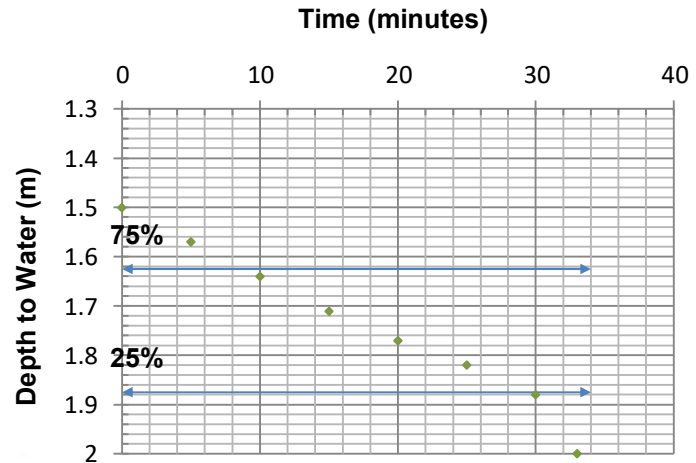
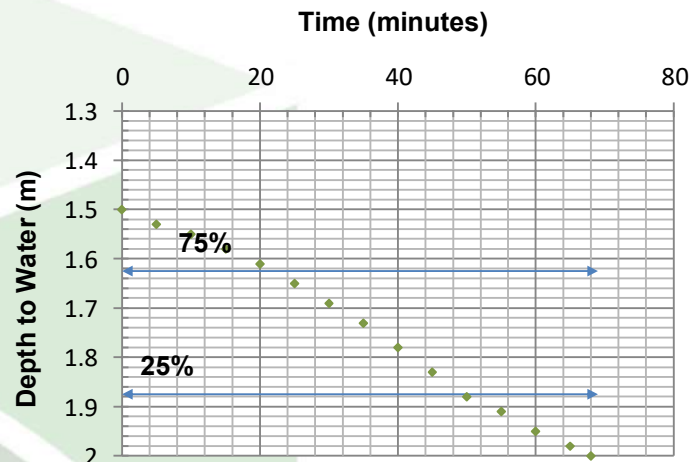
$V_{p75-25}$  0.225 m<sup>3</sup>  
 $a_{p50}$  1.95 m<sup>2</sup>  
 $t_{p75-25}$  9 minutes

Soil Infiltration Rate,  $f$  2.14E-04 ms<sup>-1</sup>

Length 1.50 m  
Width 0.60 m  
Depth 2.00 m  
Fill Level 1.50 m

$V_{p75-25}$  0.225 m<sup>3</sup>  
 $a_{p50}$  1.95 m<sup>2</sup>  
 $t_{p75-25}$  20 minutes

Soil Infiltration Rate,  $f$  9.62E-05 ms<sup>-1</sup>

$V_{p75-25}$  0.225 m<sup>3</sup>  
 $a_{p50}$  1.95 m<sup>2</sup>  
 $t_{p75-25}$  25 minutes

Soil Infiltration Rate,  $f$  7.69E-05 ms<sup>-1</sup>

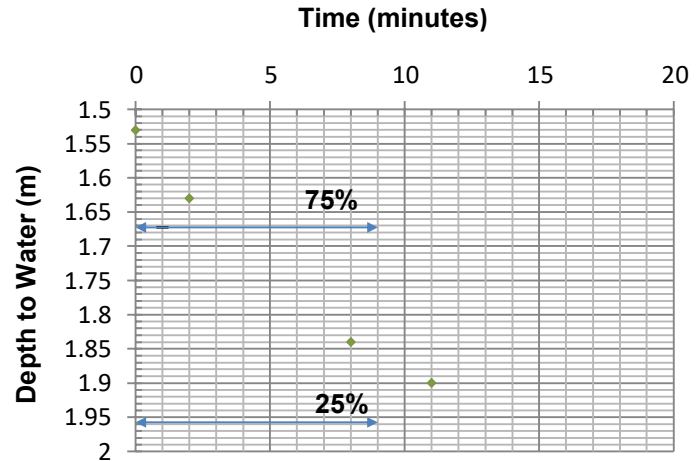
$V_{p75-25}$  0.342 m<sup>3</sup>  
 $a_{p50}$  2.682 m<sup>2</sup>  
 $t_{p75-25}$  8 minutes

Soil Infiltration Rate,  $f$  2.66E-04 ms<sup>-1</sup>

Length 2.00 m  
 Width 0.60 m  
 Depth 2.10 m  
 Fill Level 1.48 m

$V_{p75-25}$  0.372 m<sup>3</sup>  
 $a_{p50}$  2.812 m<sup>2</sup>  
 $t_{p75-25}$  2 minutes

Soil Infiltration Rate,  $f$  1.10E-03 ms<sup>-1</sup>

Length 2.00 m  
 Width 0.60 m  
 Depth 2.10 m  
 Fill Level 0.50 m

$V_{p75-25}$  0.36 m<sup>3</sup>  
 $a_{p50}$  2.76 m<sup>2</sup>  
 $t_{p75-25}$  12.5 minutes

Soil Infiltration Rate,  $f$  1.74E-04 ms<sup>-1</sup>

| <b>Drainage</b> | Infiltration drainage will likely be suitable in areas where the base of the soakaways is within the weathered bedrock where infiltration rates of between $1.74 \times 10^{-4}$ m/s and $7.69 \times 10^{-5}$ m/s were recorded. Soakaways were carried out with the base within the residual and failed to infiltrate therefore soakaways within the clays will not be suitable, although they could potentially be extended down to the weathered granular bedrock subject to further testing. |
