Project Name: Gnoll Park, Neath

2080-01-JUB-S-RP-00001-S2-P1

Appendix C - 2080-01-JUB-S-DR-SK003

| TITLE:<br>RUINS SITE VISIT | | |

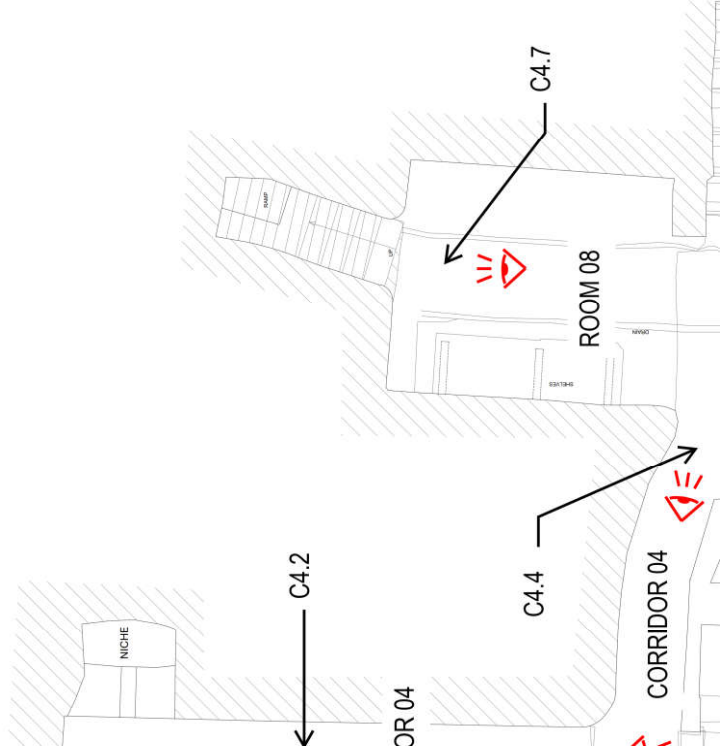
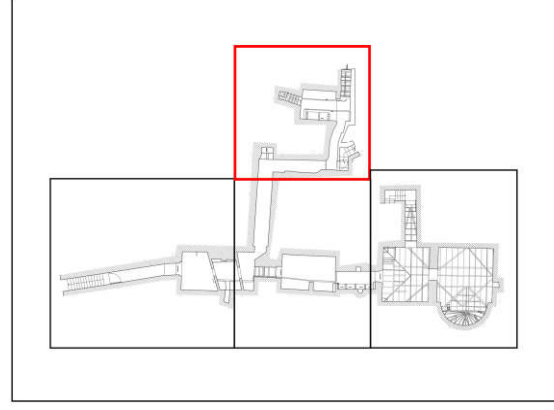
- C4.1 - SIDE OF ROOF ARCH DOES NOT HAVE A BEARING AND MAY NOT BE ADEQUATELY SUPPORTED.
- C4.2 - CORRIDOR 04 HAS A FLAT ROOF.
- C4.3 - DAMAGED GATE.
- C4.4 - FLAT ROOF.
- C4.6 - WOODEN TRUSS ROOF ABOVE STAIRS.
- C4.7 - STAIRS CLOSED OFF BY PRE-CAST CONCRETE.

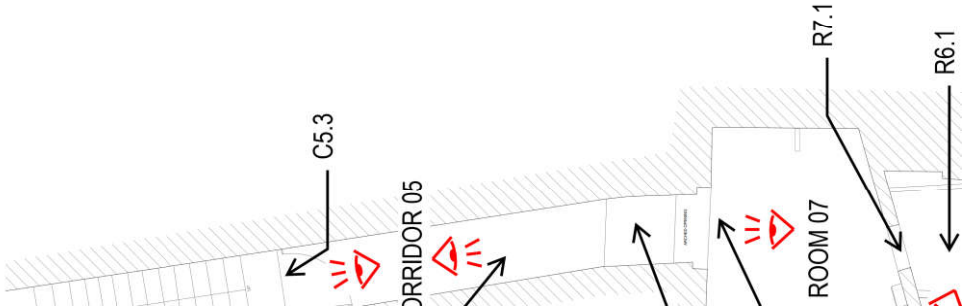
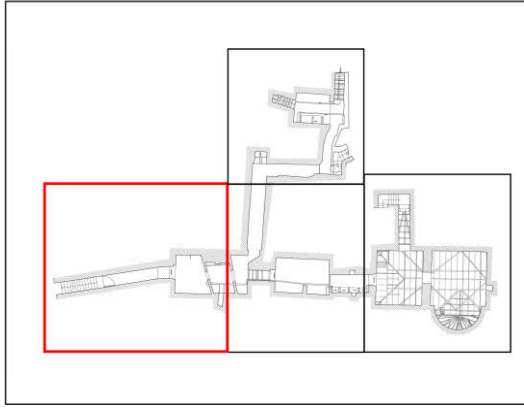
Appendix D - 2080-01-JUB-S-DR-SK004

- R6.1 - TIMBER JOISTS IDENTIFIED AT CEILING LEVEL. JOISTS APPEAR TO BE ROTTEN.
- R6.2 - EXPOSED PIPE THROUGH WALL.
- R6.3 - TUNNEL THROUGH WALL. BELIEVED TO BE FOR A CHIMNEY.
- R7.1 - SINGLE PRE-CAST CONCRETE LINTEL SUPPORTING OPENING.
- R7.2 - OPENING ABOVE ARCH.
- C5.1 - LINTELS SUPPORTING PART OF THE ROOF. OPENING ABOVE SECOND ARCH IN CORRIDOR 05.
