## Geoenvironmental Report

Site: Bakers DIY

**REPORT TITLE** : **Geoenvironmental Report: Proposed Development, Bakers DIY, Brytwn Road, Duffryn Rhondda**

**REPORT REFERENCE** : **170723-17782-ISSUE02**

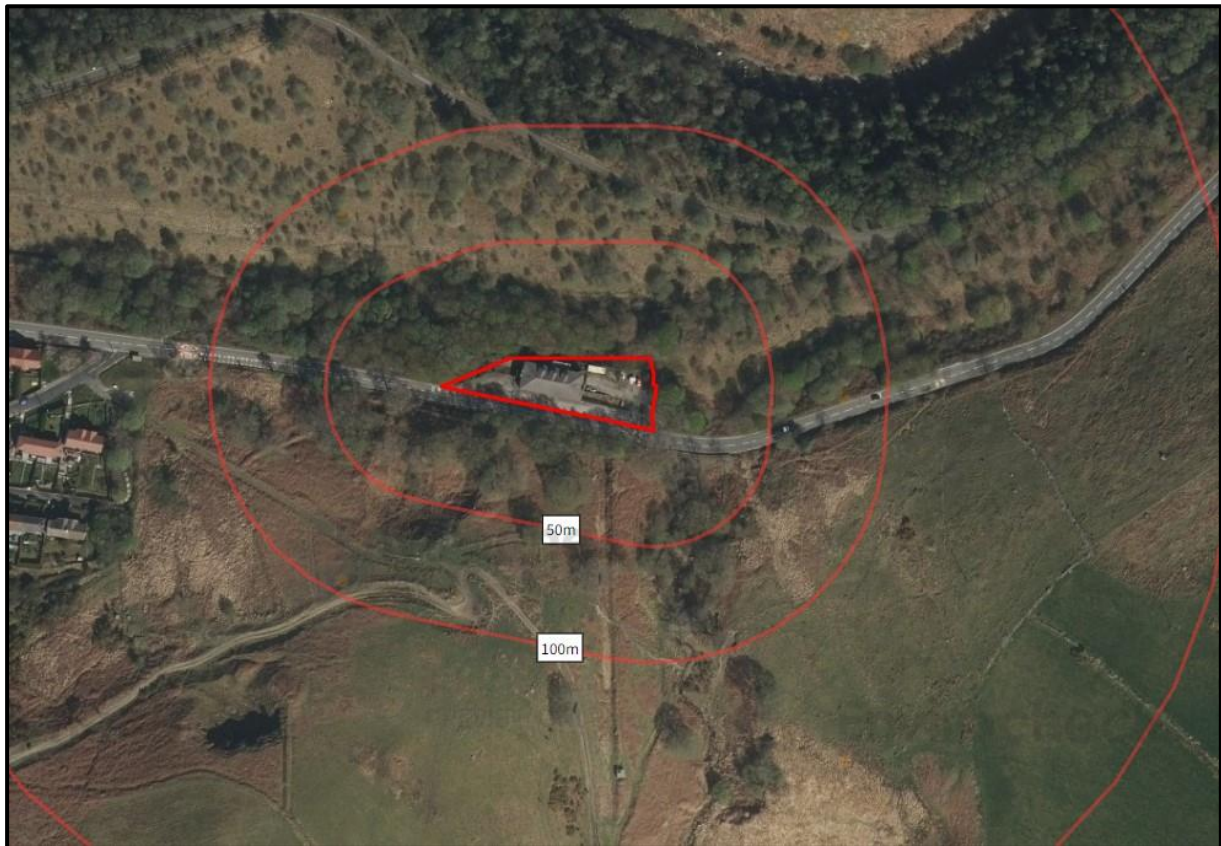
**Figure 2.1 Site Location**

The site location can be seen on **Figure 2.1** along with the exploratory hole locations on **Drawing 01**.

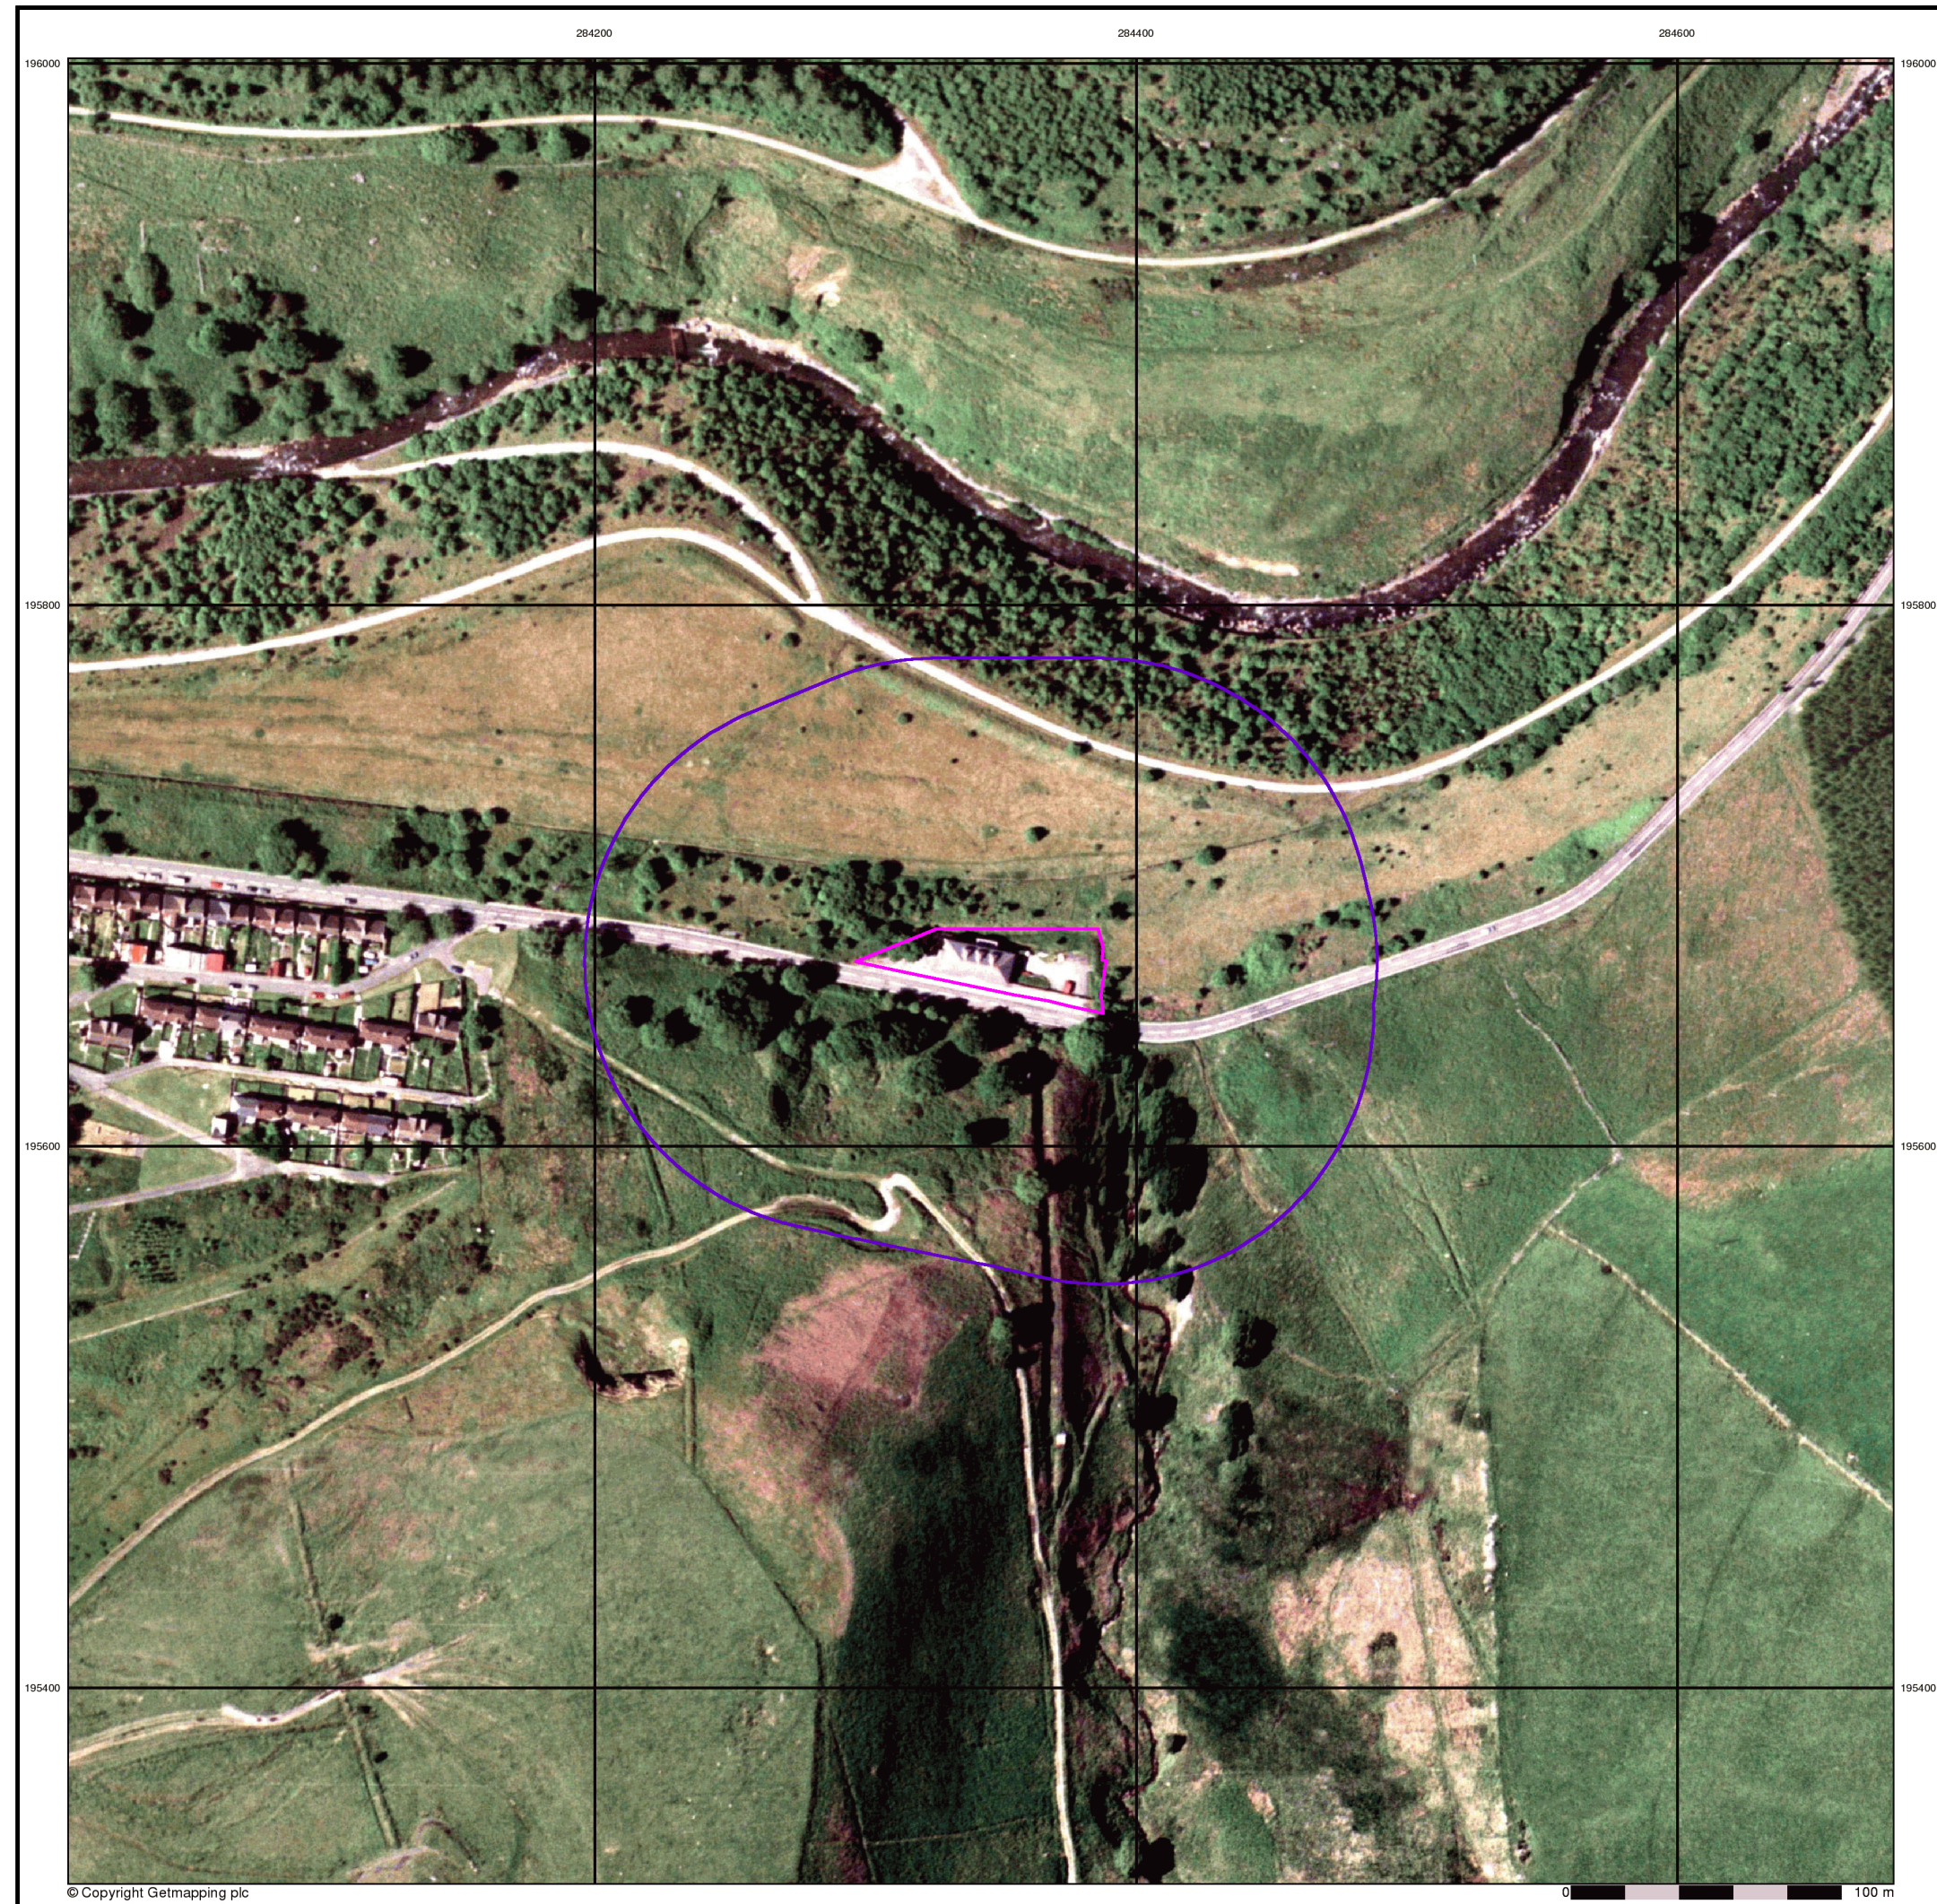
## Historical Aerial Photography

The Historical Aerial Photos were produced by the Ordnance Survey at a scale of 1:1,250 and 1:10,560 from Air Force photography. They were produced between 1944 and 1951 as an interim measure, pending preparation of conventional mapping, due to post war resource shortages. New security measures in the 1950's meant that every photograph was re-checked for potentially unsafe information with security sites replaced by fake fields or clouds. The original editions were withdrawn and only later made available after a period of fifty years although due to the accuracy of the editing, without viewing both revisions it is not easy to spot the edits. Where available Landmark have included both revisions.

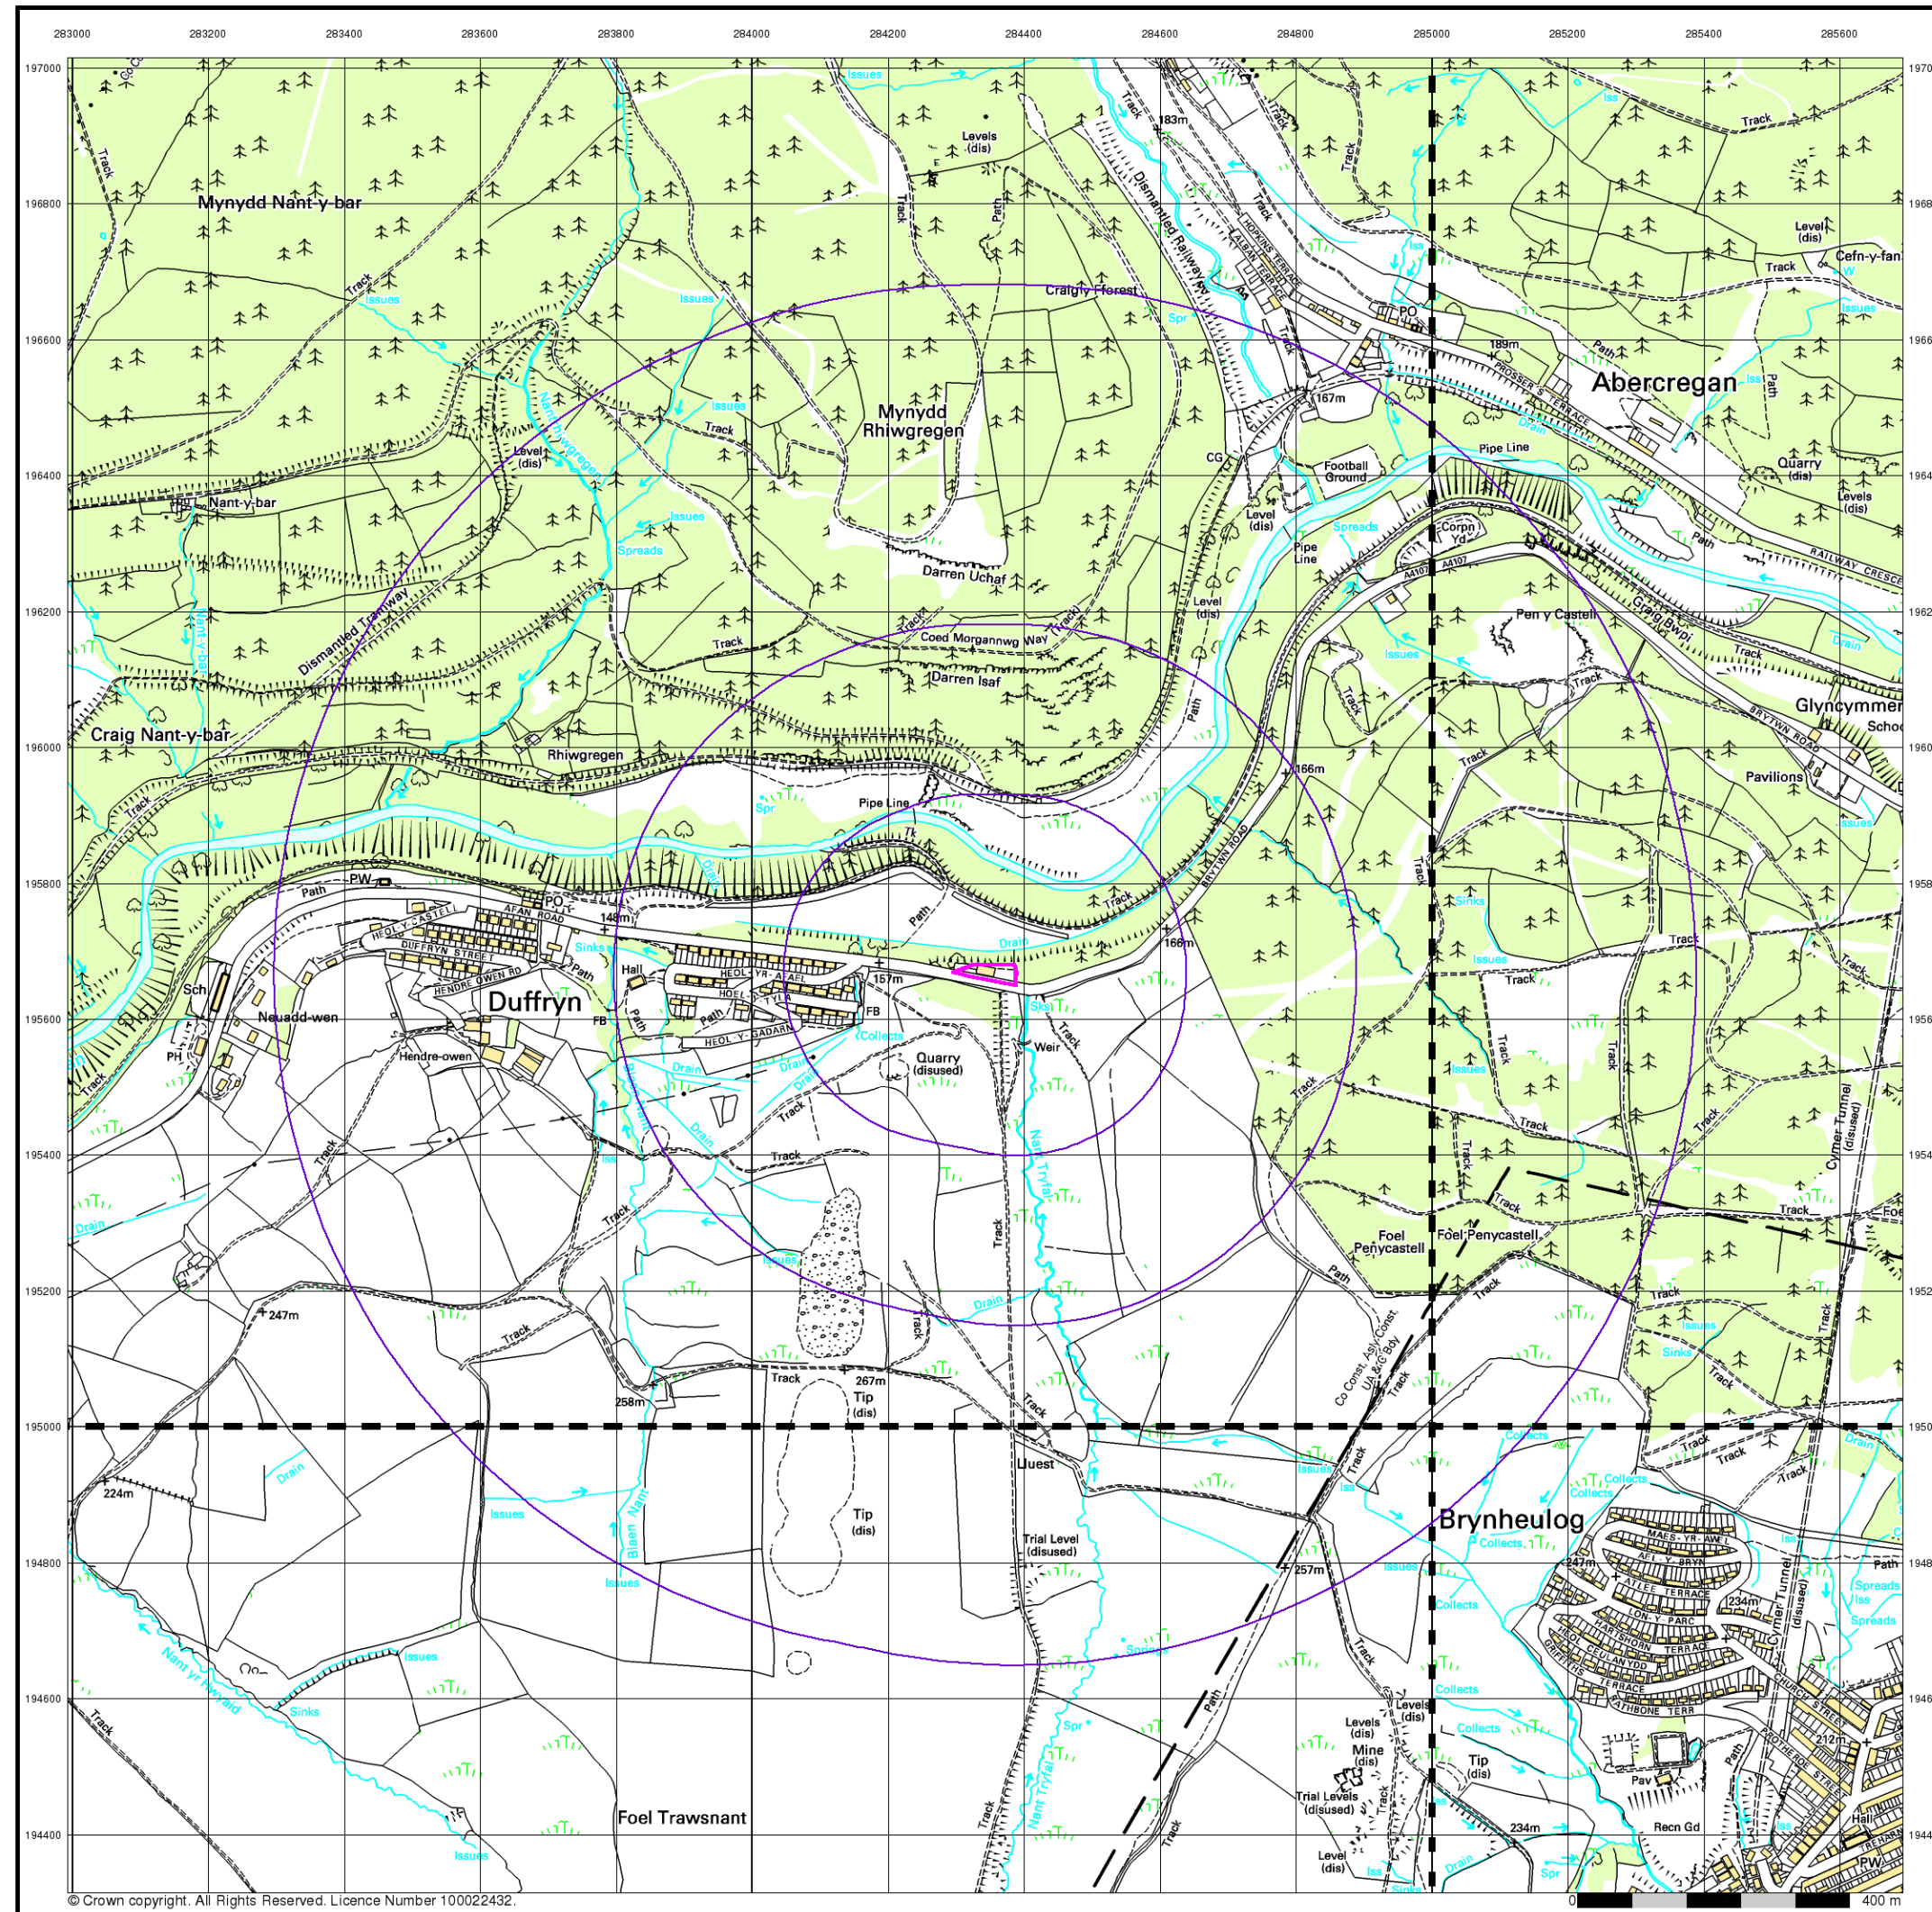
## 10k Raster Mapping

The historical maps shown were produced from the Ordnance Survey's 1:10,000 colour raster mapping. These maps are derived from Landplan which replaced the old 1:10,000 maps originally published in 1970. The data is highly detailed showing buildings, fences and field boundaries as well as all roads, tracks and paths. Road names are also included together with the relevant road number and classification. Boundary information depiction includes county, unitary authority, district, civil parish and constituency.
