Gnoll Kitchen Gardens &  
Service Yard  
Bat Survey Report &  
Preliminary Ecological  
Appraisal

by Date: October 2023

Lewis Badham & Megan Price  
Ecologist (Planning) / Ecologist  
(Planning and Consultancy)  
Countryside and Wildlife Team  
Neath Port Talbot CBC

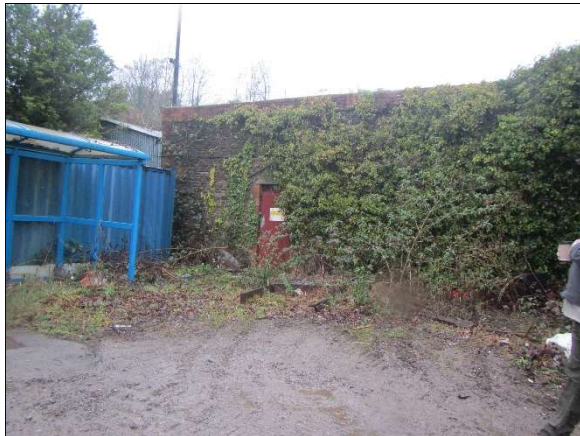
Southern elevation of main central building.

The areas of the roofline with gaps into the internal structures were considered to offer roosting potential. Most of the structures were open with free accessibility to potential roosting bats. Overall, the buildings were considered to be of Moderate potential to support roosting bats, given the features present and the environment in which the buildings are situated, namely parkland with immediately adjacent woodlands and a large waterbody.

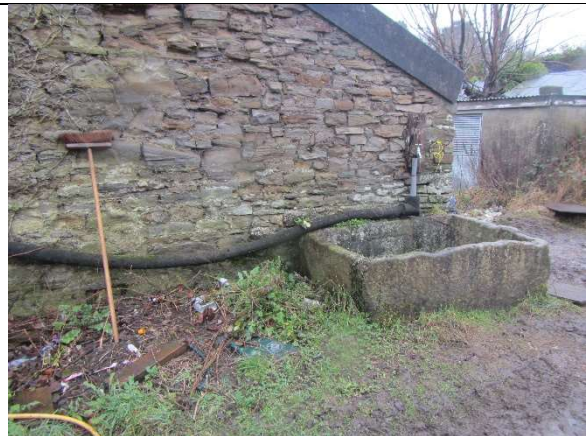
Eastern elevation of main central building.

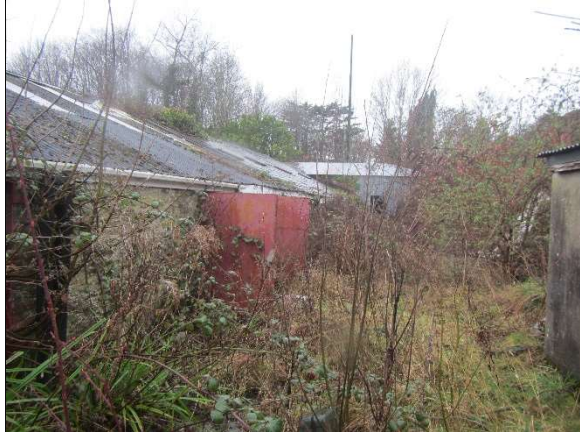
Northern elevation of main central building.

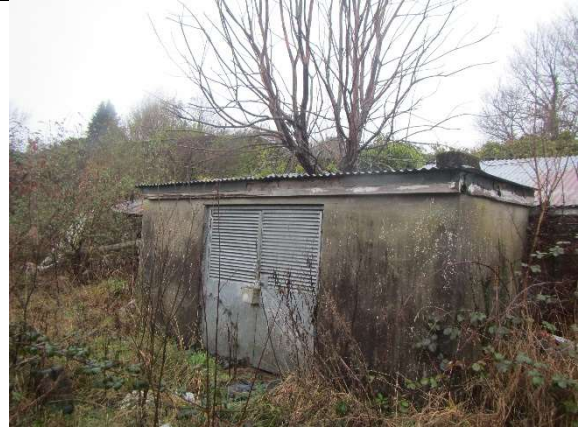
Southern elevation of small building

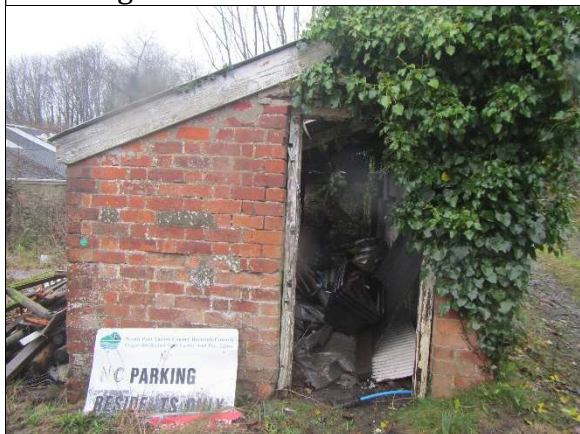
Eastern elevation of northern building

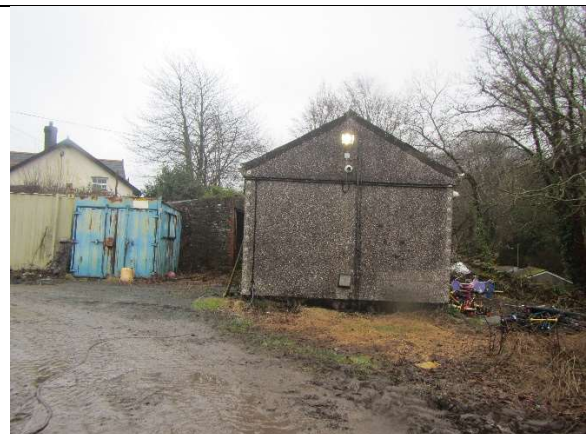
South-western elevation of building in south-east corner of site

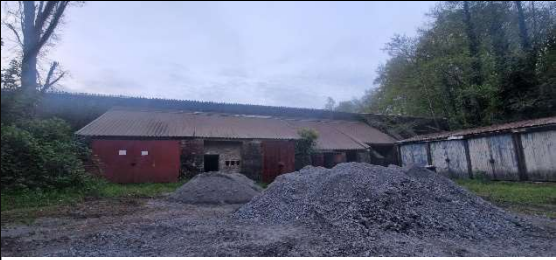
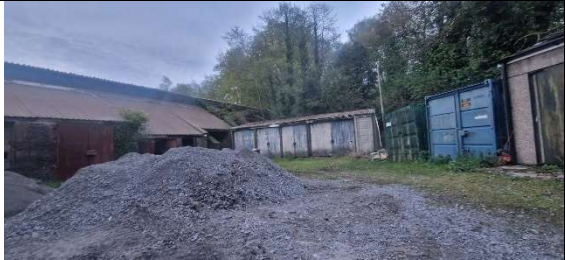
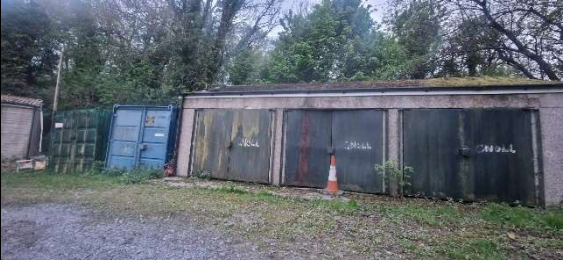
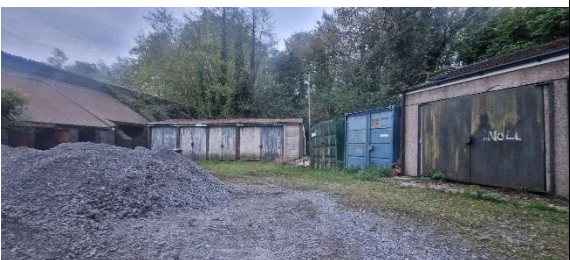
**Table 2. Photos highlighting roof structure of buildings**

| <p>Southern elevations of northern building</p> | <p>Overview of garages in east of the site</p> |
| <p>Garages in south-east of site</p> | <p>Overview of garages in east of the site</p> |

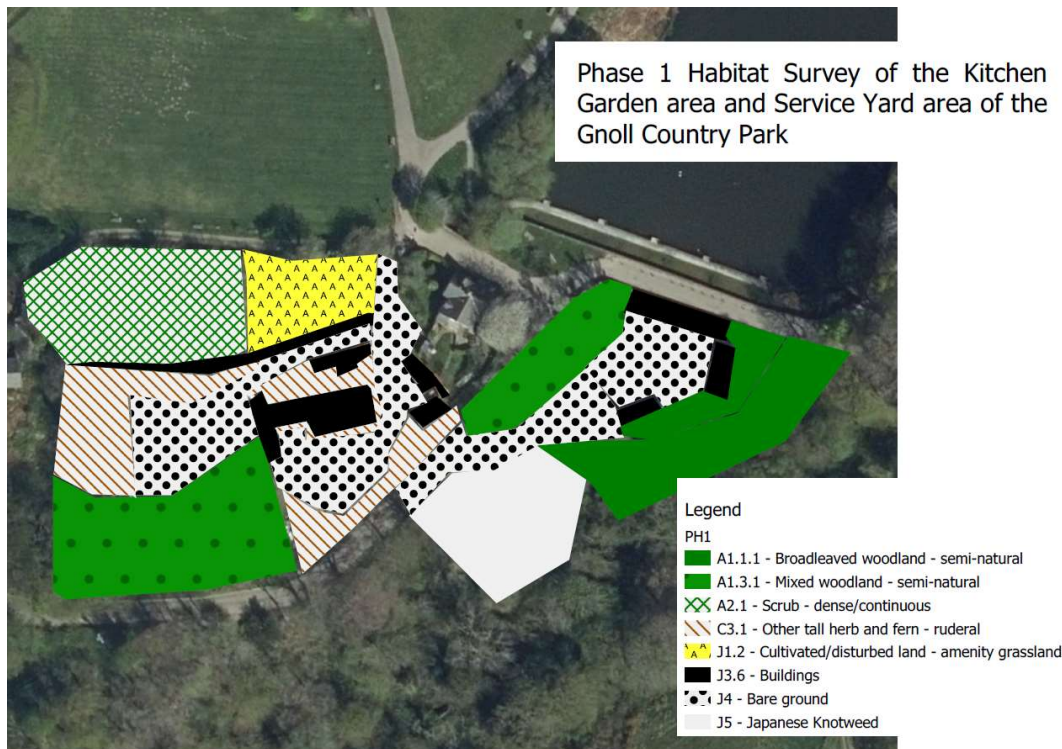
Figure 4 Phase 1 habitat plan

The results of the phase 1 habitat survey are presented on the plan below (Figure 4). The below sets out descriptions of each habitat type represented on the site.

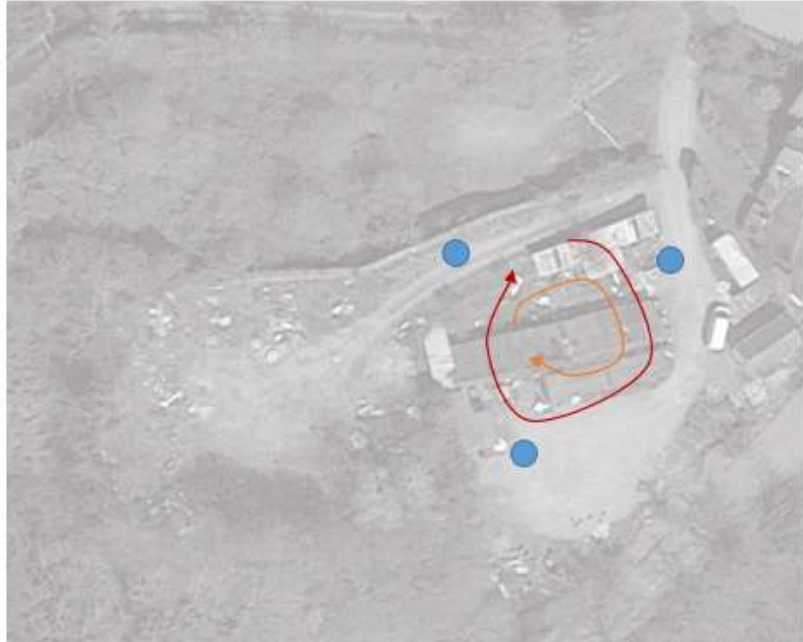
## APPENDIX C – 2023-06-07: FLIGHT LINES & SURVEYOR POSITIONS

Low levels of bat activity were recorded on site during the emergence survey. No bats were observed emerging from any of the buildings. Soprano Pipistrelle and Common Pipistrelle were observed foraging and commuting within the immediate vicinity of the buildings. A plan highlighting surveyor positions and bat activity over the course of the survey can be found at Appendix C. A summary table of the data collected over the course of the survey can be found at Appendix H.

### 2023/06/07 Emergence Survey: Kitchen Gardens
