# Gnoll Country Park, Neath

**Title** Ground Conditions Assessment Report

Andrew Scott Limited working on behalf of the local council is proposing infrastructure enhancements at specific sections of the Gnoll Estate Country Park in Neath, including the construction of a new visitor centre. To assist with the development of the site proposals, Jubb Consulting Engineers (Jubb) have been appointed to undertake a geotechnical and geo-environmental assessment of the ground conditions for the proposed site use.

This report constitutes a Ground Conditions Assessment (GCA) to support the planning application for the proposed development, with this issue relating to the different proposal areas of the site and provides advice for the geotechnical and geo-environmental design of the development and associated ground contamination or geotechnical hazards.

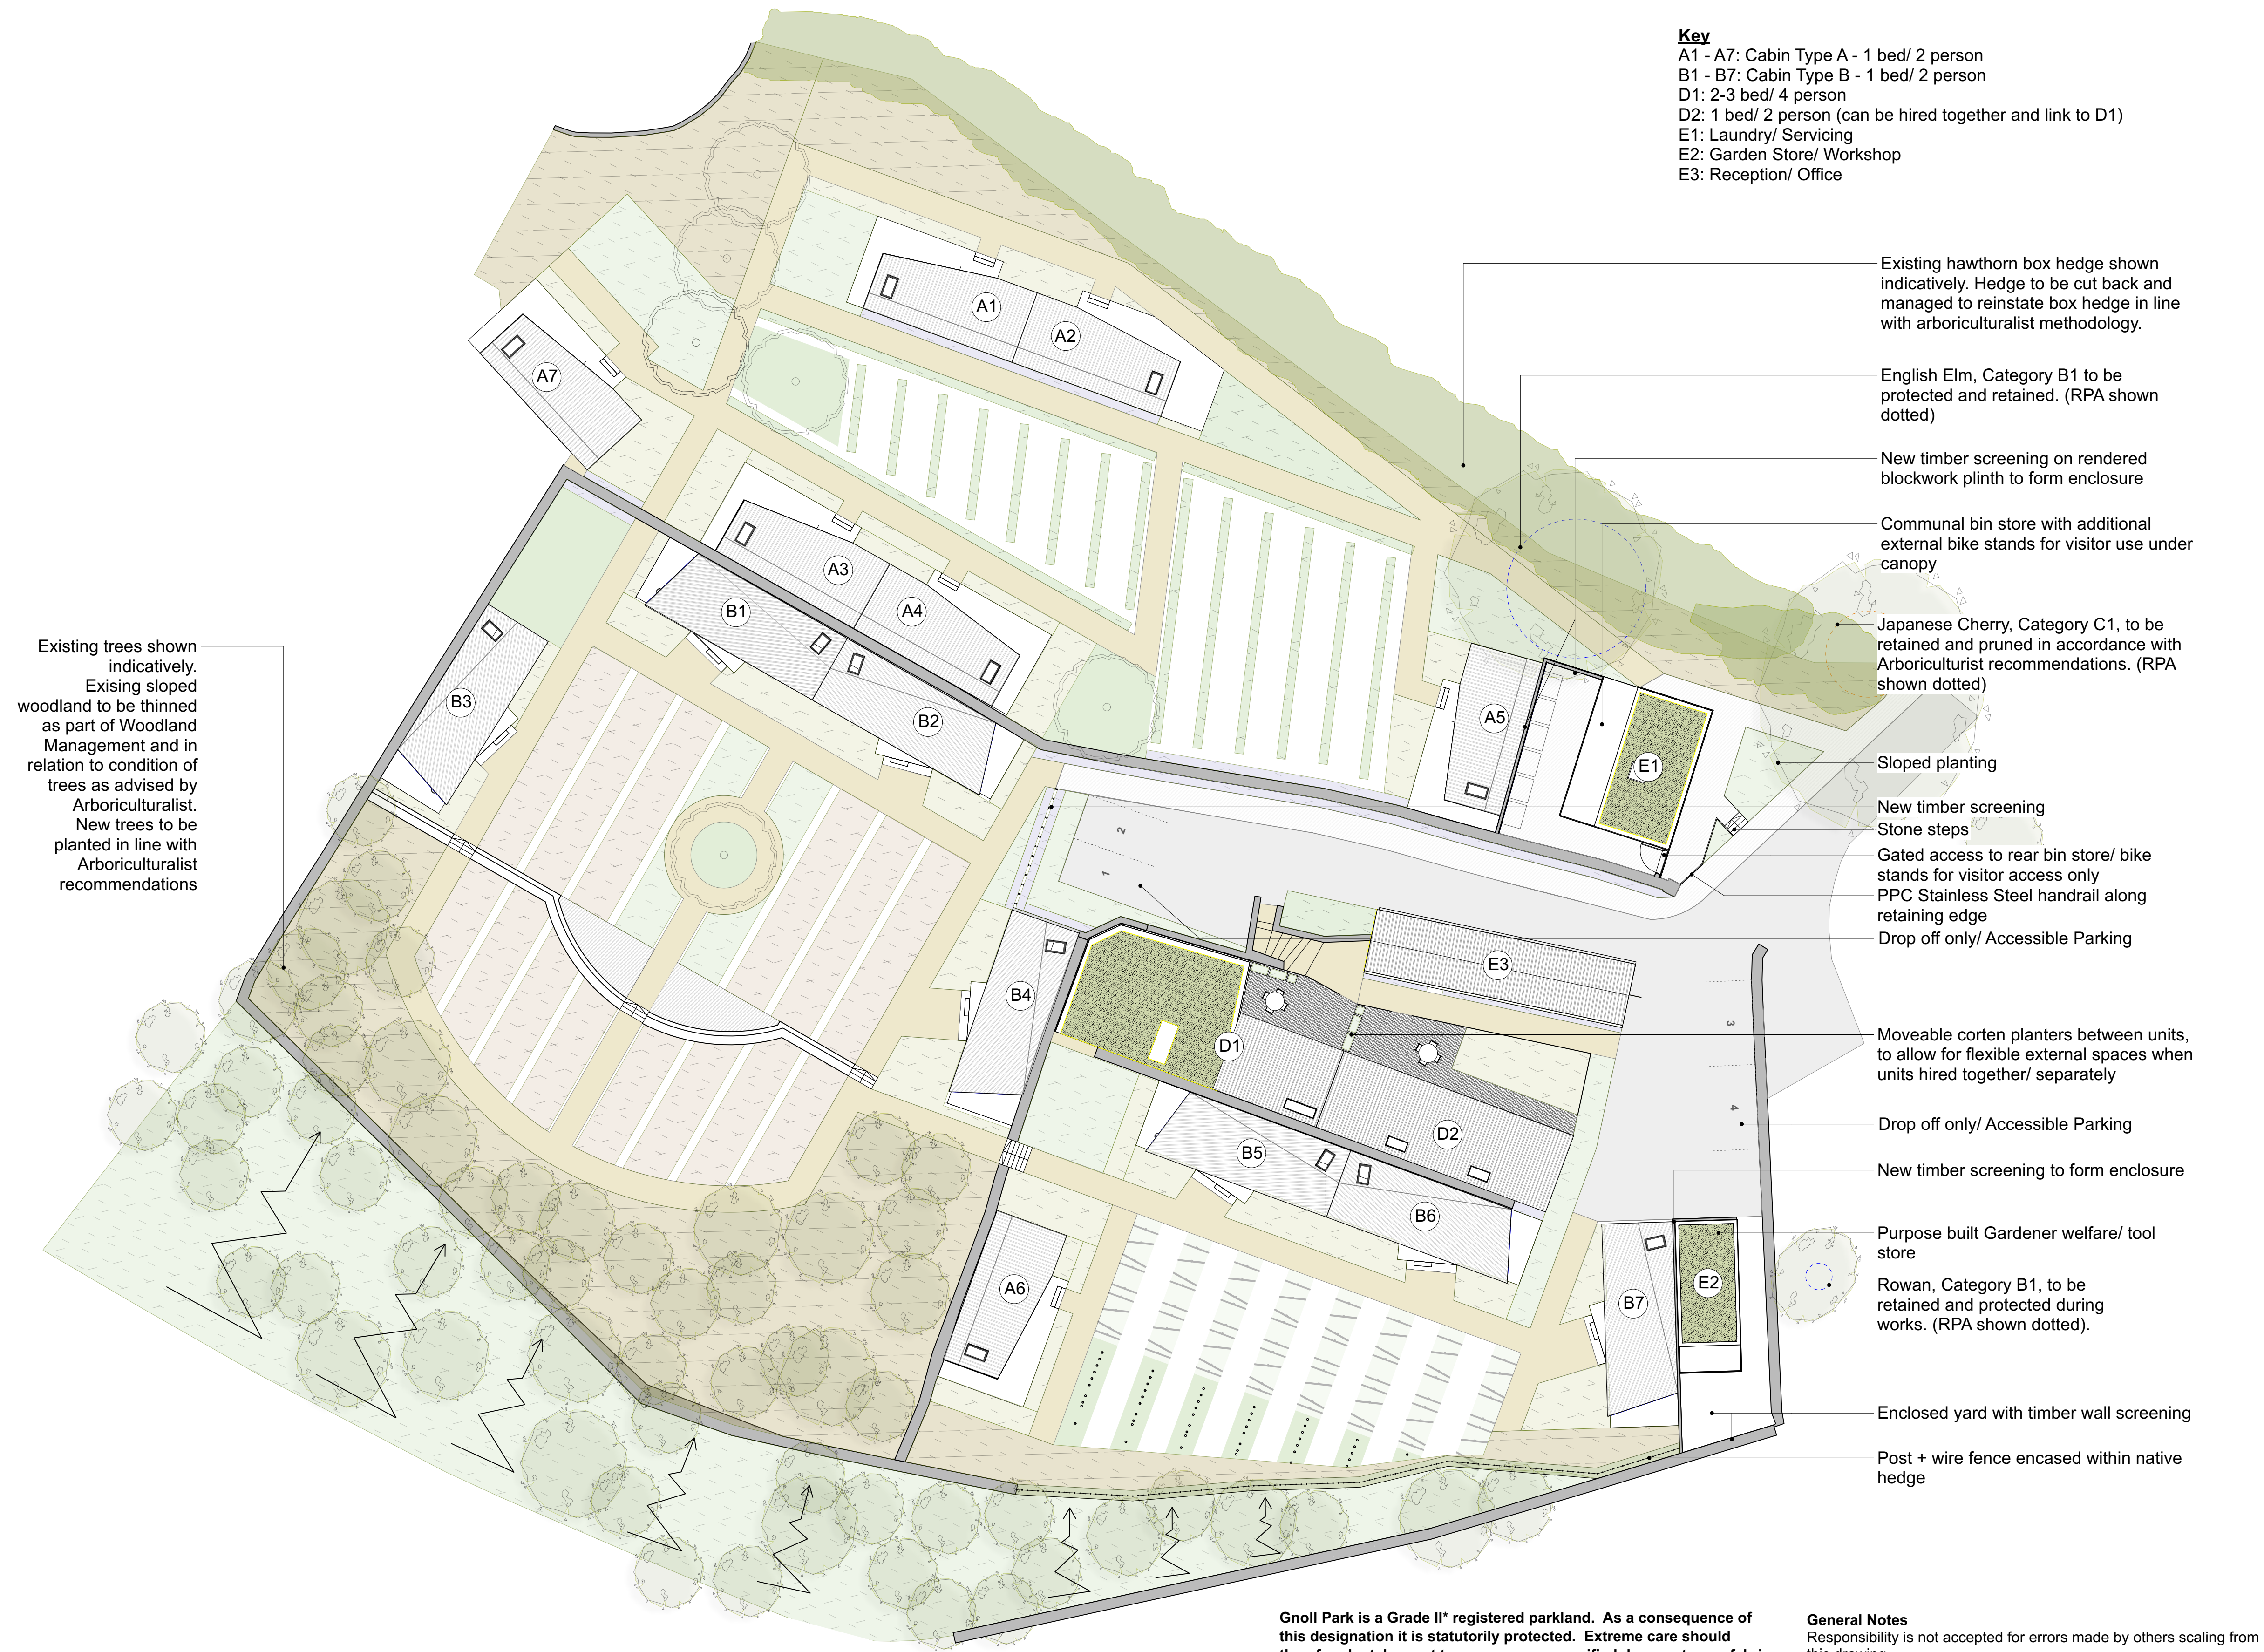
## **APPENDIX B: PROPOSED SITE DEVELOPMENT PLAN**

- Key**  
A1 - A7: Cabin Type A - 1 bed/ 2 person  
B1 - B7: Cabin Type B - 1 bed/ 2 person  
D1: 2-3 bed/ 4 person  
D2: 1 bed/ 2 person (can be hired together and link to D1)  
E1: Laundry/ Servicing  
E2: Garden Store/ Workshop  
E3: Reception/ Office

- A raised platform to be formed to create performance space/ outdoor cinema. Platform to be formed with a low blockwork wall on foundations. The wall to support beam and block floor with floor to be screeded and finished with pavers.
- A new hoggin surface to replace former paths of formal Garden to Gnoll House. The hoggin surface is to be laid within new natural stone edging strips set in concrete haunching.
- Former footprint of Gnoll House to be reinstated with a new flexible terrace area.

The existing visitor centre is proposed to be demolished and replaced with a 2-storey building with a podium and a first-floor timber frame building, with two cascade seating areas on the first floor and an external terrace.

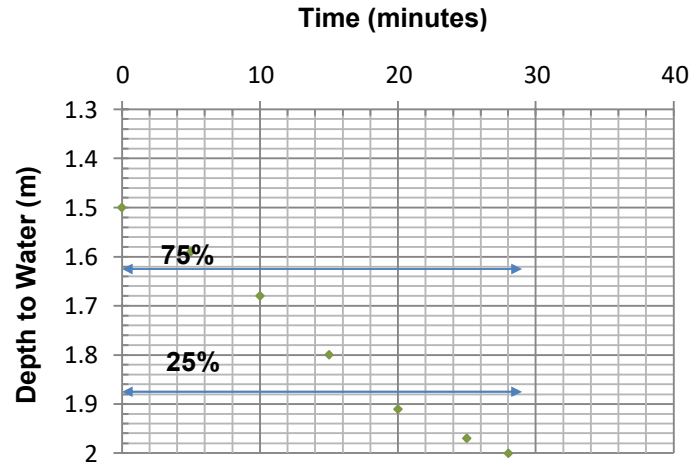
$V_{p75-25}$  0.225 m<sup>3</sup>  
 $a_{p50}$  1.95 m<sup>2</sup>  
 $t_{p75-25}$  9 minutes

Soil Infiltration Rate,  $f$  2.14E-04 ms<sup>-1</sup>

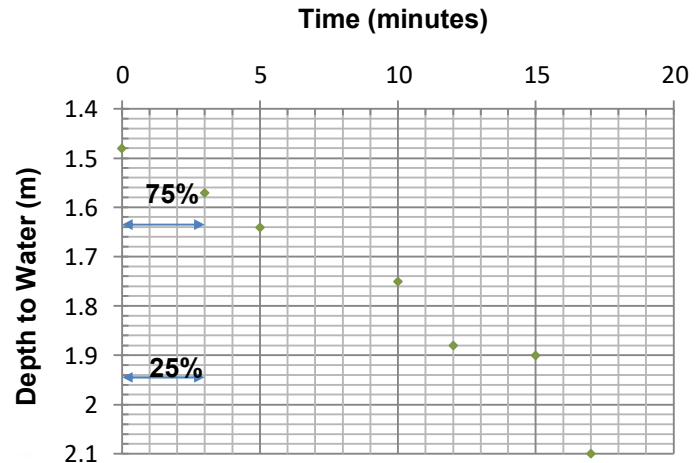
## TEST 2

Length 2.00 m  
 Width 0.60 m  
 Depth 2.10 m  
 Fill Level 1.48 m

$V_{p75-25}$  0.372 m<sup>3</sup>  
 $a_{p50}$  2.812 m<sup>2</sup>  
 $t_{p75-25}$  2 minutes

Soil Infiltration Rate,  $f$  1.10E-03 ms<sup>-1</sup>
