## **GNOLL HOUSE AND POND COTTAGE, THE GNOLL, NEATH PORT TALBOT HISTORIC BUILDING RECORDING**

REPORT NO. 2023-25  
EVENT RECORD No. E007491

September 2023

Philip Poucher MCIfA

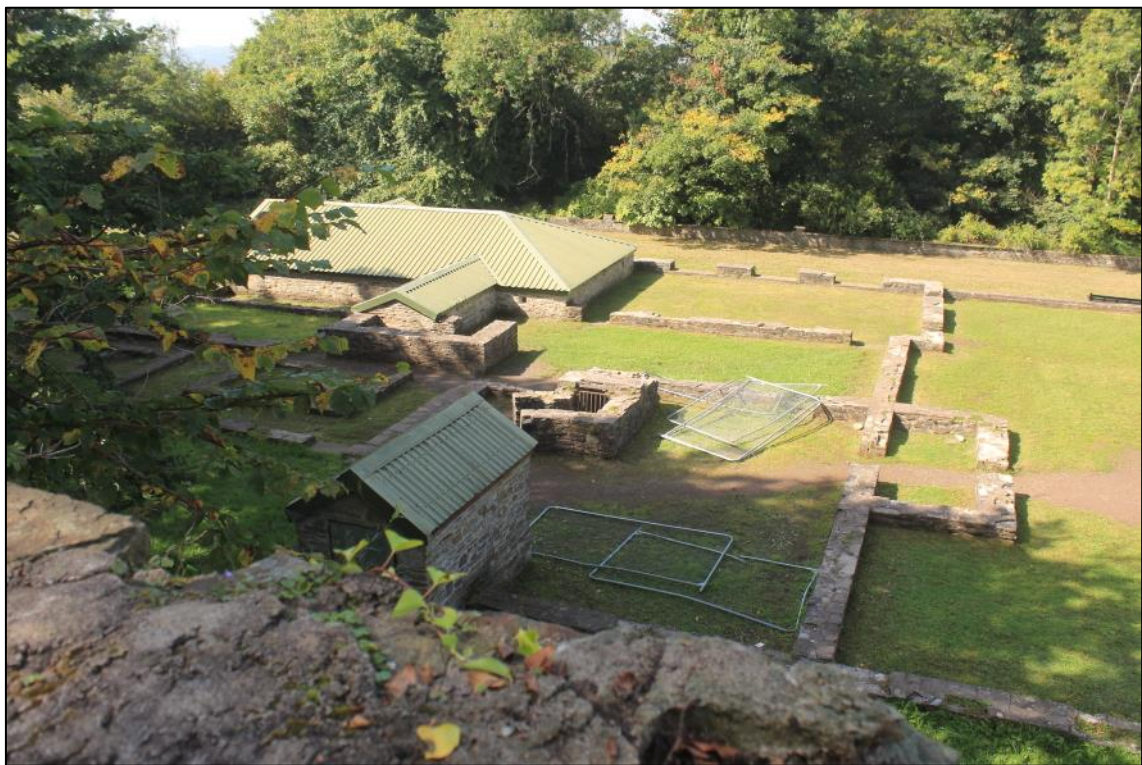
**Photo 1:** View west over the Gnoll House ruins. The roofed buildings cover cellars and their entrances.

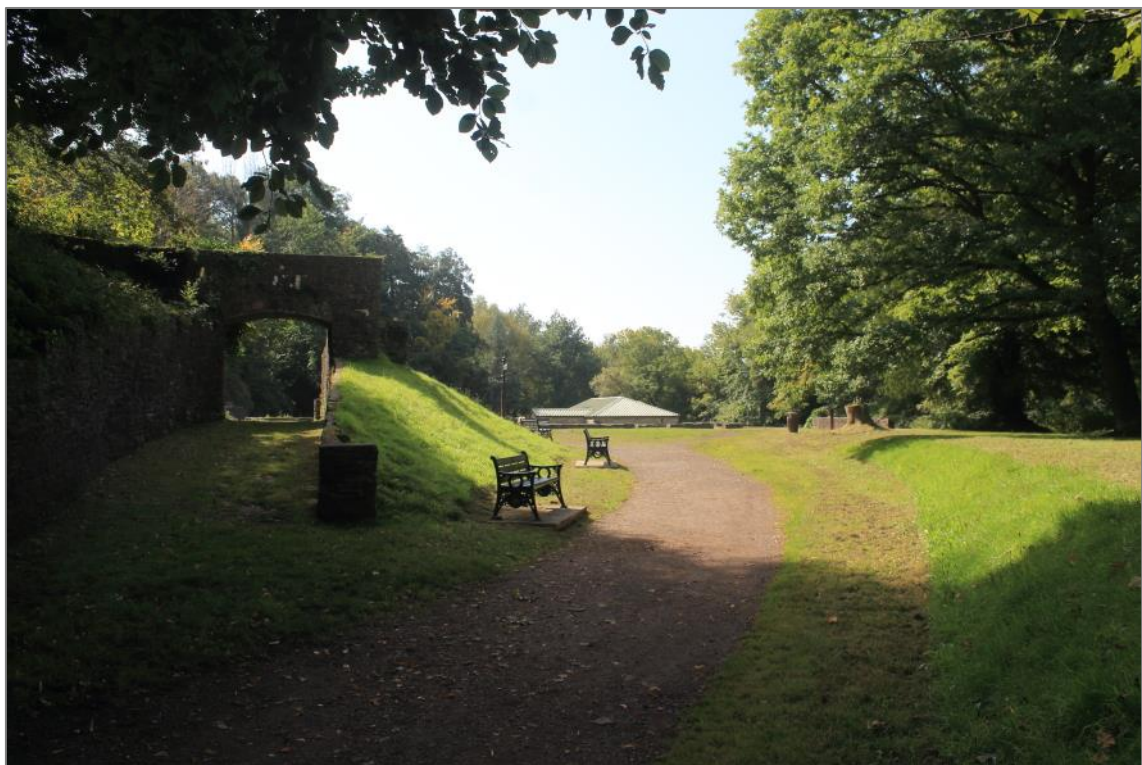
**Photo 2:** View south from the main drive approach to Gnoll House. The arched entrance to the left led to the rear service yard.

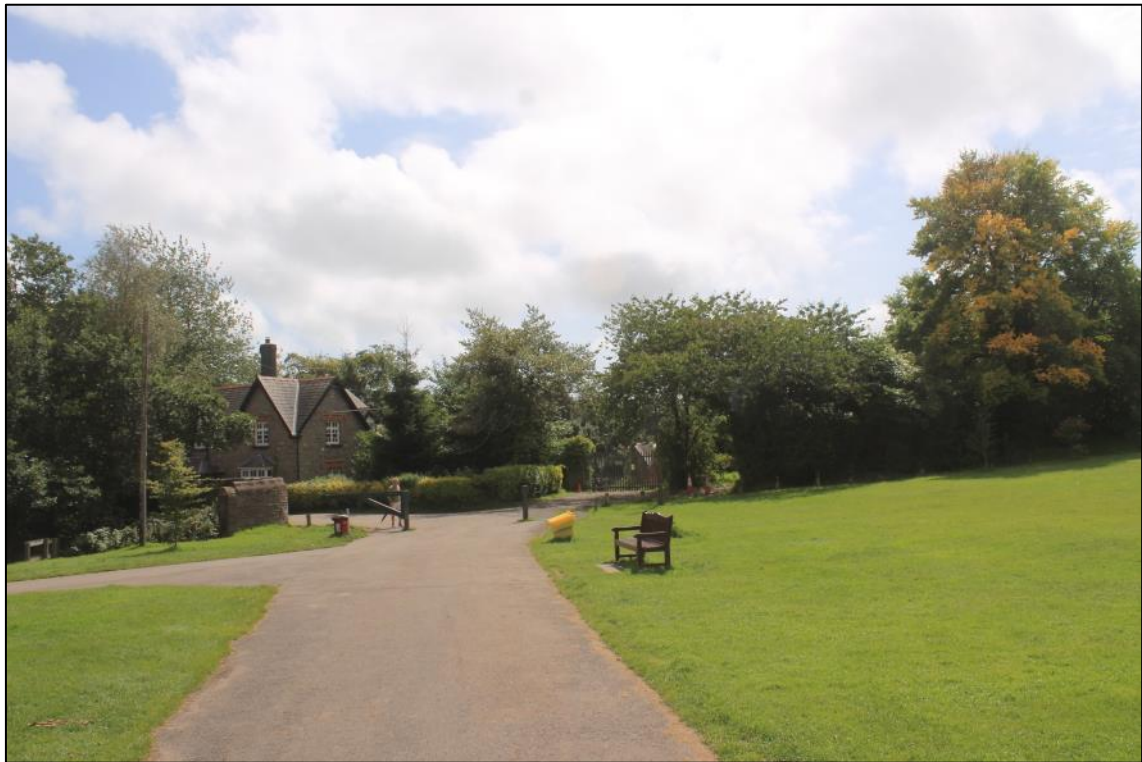
**Photo 3:** View south towards Pond Cottage (on the left) with the entrance to the walled gardens in the centre, the ground rising up to the gnoll on the right and the upper pond lying off to the left.

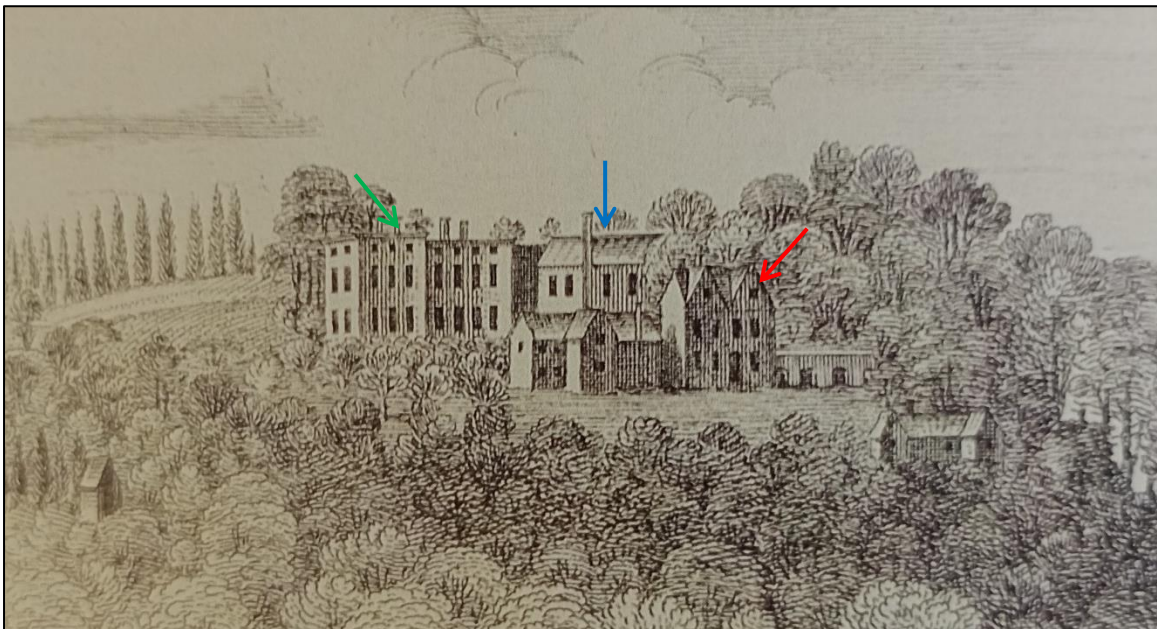
**Figure 3:** An extract from Samuel and Nathaniel Buck's engraving of Neath Castle looking northwest in 1741 which depicts Gnoll House. According to Green (1979) this shows an Elizabethan house (red arrow), a hall-house of 1666 (blue arrow) and Mackworth's house of the early 1700s (green arrow).

3.2.8 In the 1730s Herbert also extended the house but it is not clear what additions he made. The first recorded image of the house comes shortly afterward, in a print by Samuel and Nathaniel Buck from 1741. This image (Fig 3) shows a collection of buildings occupying the Gnoll. Green (1979) suggests it shows three main phases of building on the site, as described in section 3.2.3, including an early house (which Green suggests is Elizabethan), a mid-17<sup>th</sup> century structure and the Mackworth house of the earlier 18<sup>th</sup> century. The accuracy of the depiction can be questioned, and angles were often adjusted in order to show a more comprehensive illustration of buildings than would otherwise be visible from the given viewpoint. However, the buildings on the left of the image do resemble later images of the 18<sup>th</sup> century house, with an early Georgian square profile, suggesting these may well have been constructed by the Mackworths. The remaining structures are therefore presumably parts of the 17<sup>th</sup> century buildings, but exactly where these were located and how they were arranged remains open to interpretation.

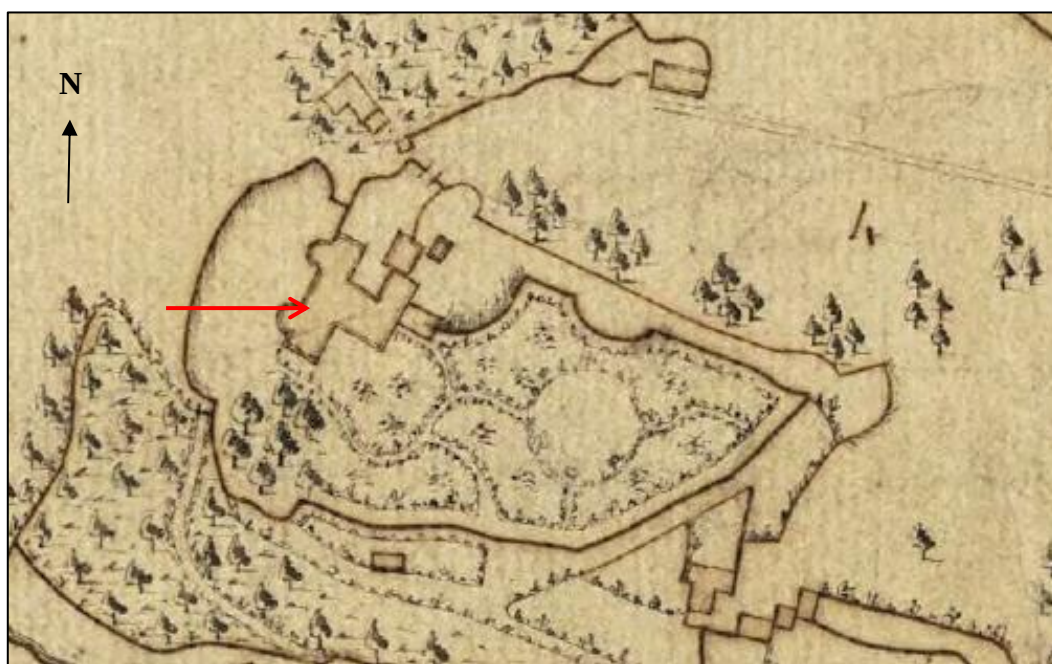
**Figure 4:** An extract from an estate map by B Jones, dated to sometime between 1741-68 although in plan form the house (red arrow) appears to match the layout as designed by John Johnson and Herbert Mackworth in the mid-1770s. West Glamorgan Archive Service Gn/E/1.

accommodate the attached conservatory. An L-shaped range extends to the east of the main range, the north-south element likely to include the mid-17<sup>th</sup> century house. A building is attached to the east of this which appears to roughly correspond to a building marked as a coach house on later maps. A further building is attached to the north, with a small detached building east of this. These two buildings do not appear to correspond to later annotated maps but may have been part of the service buildings to the rear of the house. The attached building however may also front the main entrance to the house from the north, suggested by the main driveway approach to the house, entering through a gateway in an enclosure on the northern side. Curvilinear boundaries around the service area on the east side appear to become part of the formal vista that extends from the house to a ha-ha to the east, with views of the ponds and cascades. The plan suggests the house has developed into a largely single structure, changing the appearance from the collection of structures visible on the Buck print of 1741. Presumably the possible Elizabethan structures had been cleared in the 1760-70 developments, with the 17<sup>th</sup> century house subsumed and largely hidden by the Mackworth/Johnson house.

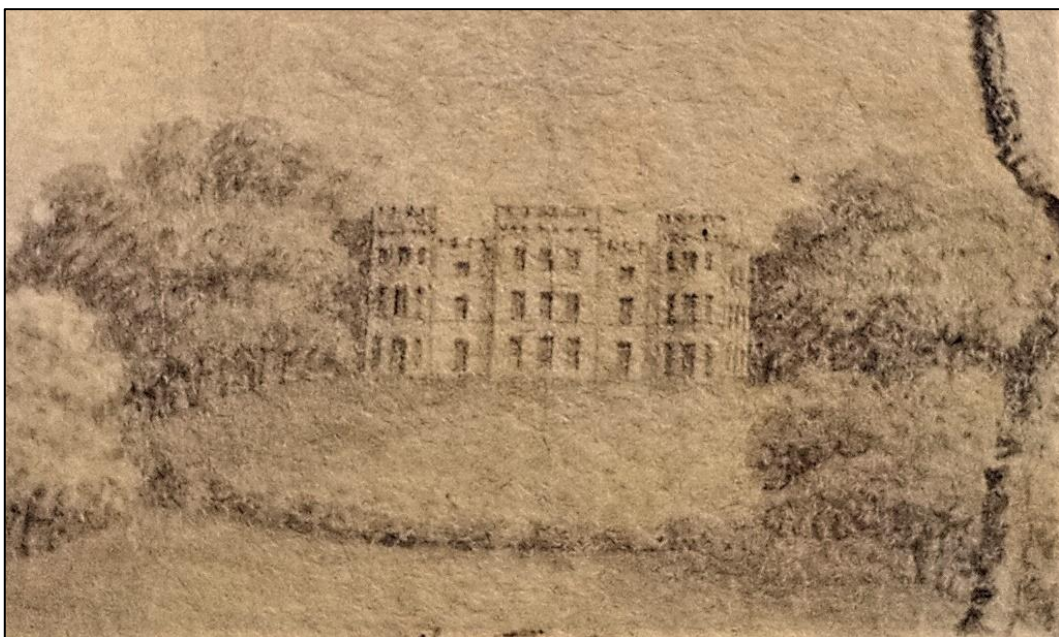
**Figure 5:** An image of Gnoll House taken from an estate map of 1801 by P Padley showing the appearance of the Herbert Mackworth/John Johnson adapted house of the 1770s. West Glamorgan Archive Service Gn/E/5/1.

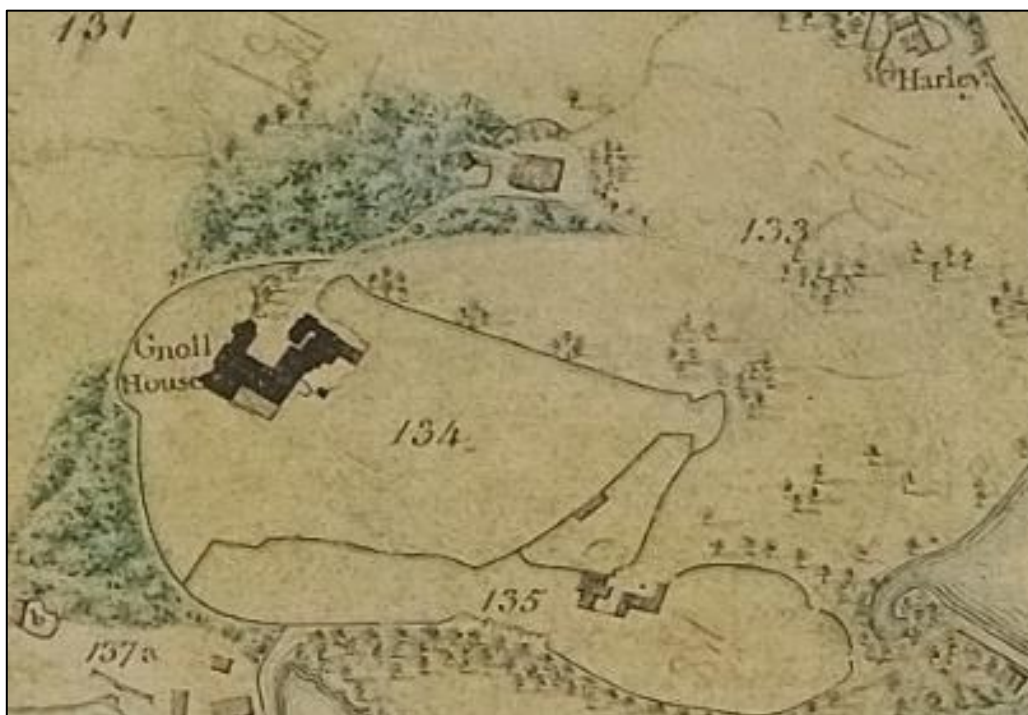
**Figure 6:** Extract from Padley estate map of 1801 showing Gnoll House in plan form. West Glamorgan Archive Service Gn/E/5/1.

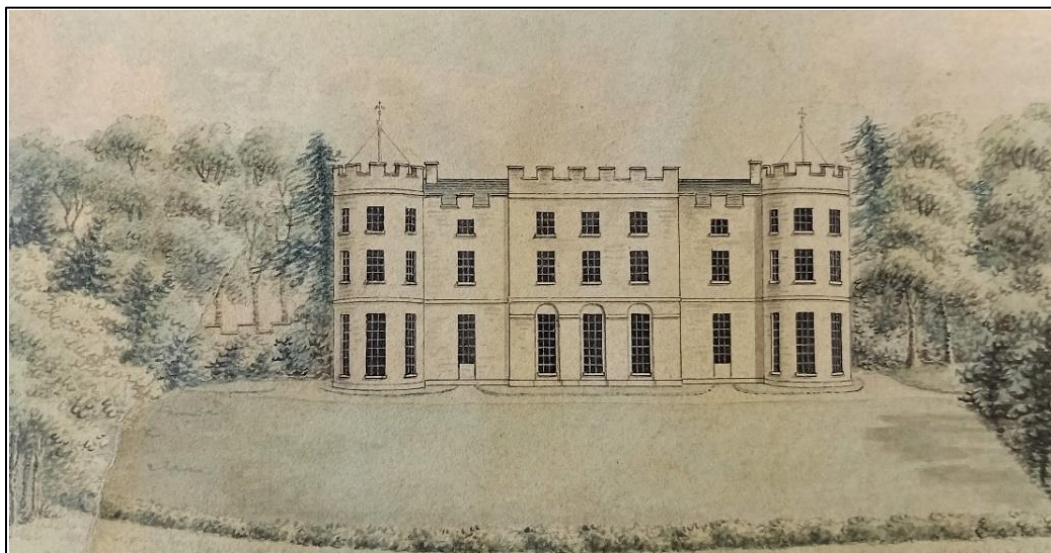
**Figure 7:** The west face of Gnoll House depicted on the estate map of 1812. West Glamorgan Archive Service Gn/E/5/2.

- 3.2.13 Henry Grant lived at the Gnoll until his death in 1832, appearing to have invested in it, with the house being referred to in 1822 as a "delightful mansion" and "one of the finest in the principality" (Neale 1822). An estate map produced during his tenure in 1812, includes a clearer depiction of the house (Figs 7 and 8). As with the 1801 map, the image shows the west face of the house with the protruding central square bay and the two rounded corner towers, and the typical Georgian detailing of the windows. The stepped surround in front of the windows is also apparent, with the lawn and treeless area to the west allowing clear views to and from Neath. The plan of the building shows little change in the outline of the house, suggesting any improvements made by Henry Grant are likely to have been largely internal.

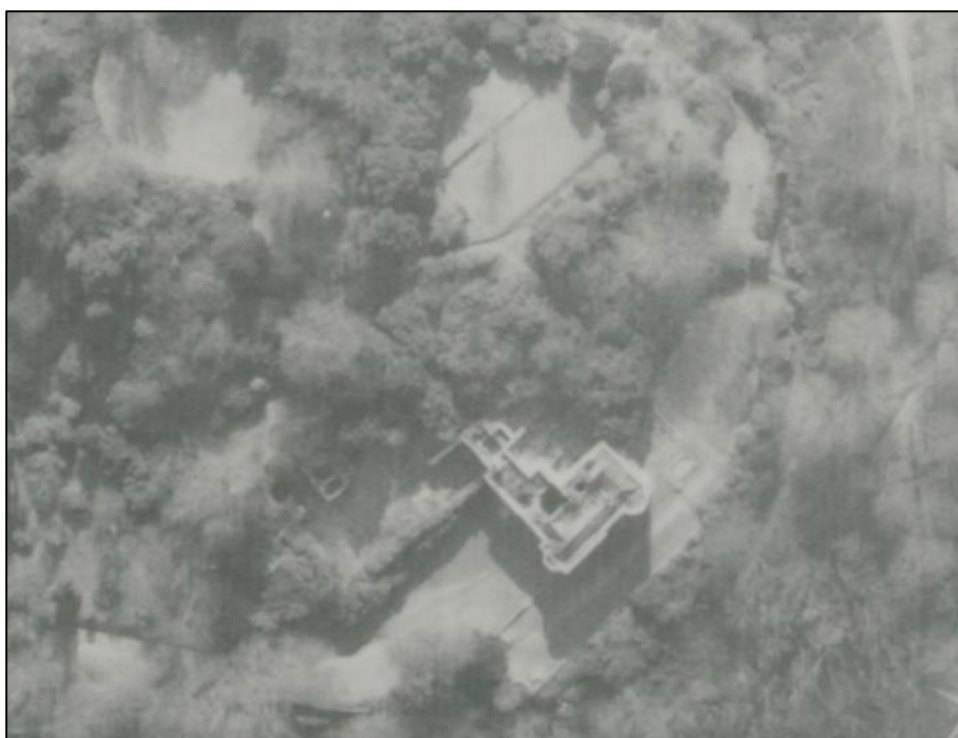
**Photo 5:** Vertical aerial photograph taken by the RAF in 1944 showing Gnoll House, with the open croquet lawn and tennis pitch above.

- 3.2.20 In the early 1920s the house and grounds were purchased by the Neath Corporation, who erected the war memorial gates at one of the estate entrances in 1921. A health clinic was established at the house in 1925. During the Second World War, the house was turned over for use by ARP personnel for exercises and training, which presumably included some of the surrounding grounds as well. Generally the mid-20<sup>th</sup> century appears to be a period of general neglect for the house and grounds. The house is visible on aerial photographs taken during the 1940s (Photo 5), which show the main block of the house as intact but with the southern conservatory removed. The service

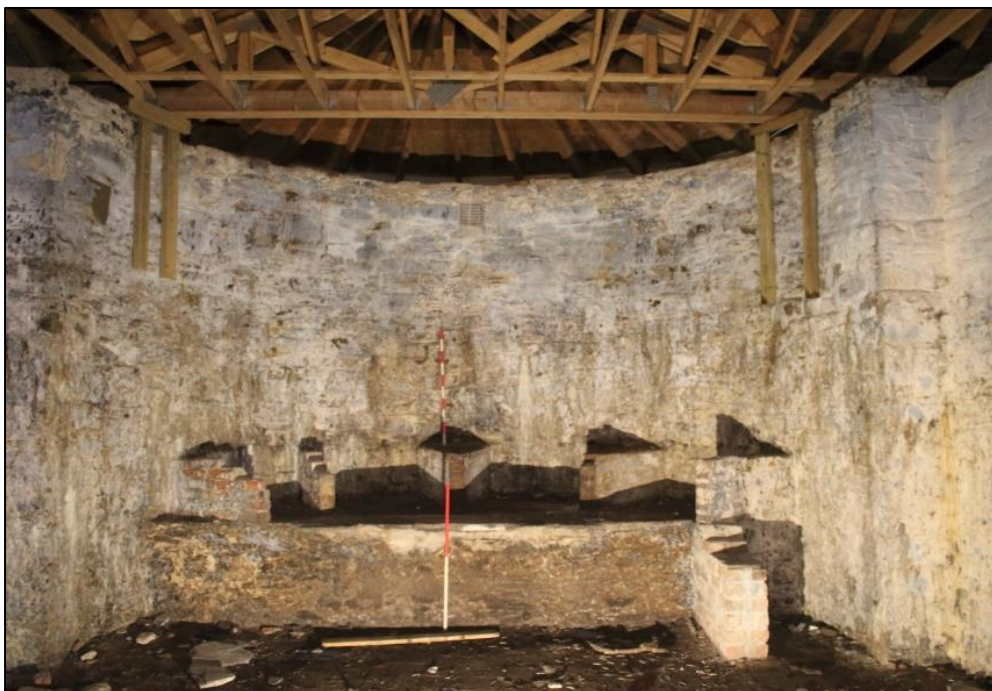
4.1.2 Room 1 lies at the southern end of the main range. It comprises a squarish room (5.7m north-south by 8.2m) with a curved western frontage (Photo 6). A flagstone floor is surrounded by faced random-rubble masonry walls 3.8m high, internally whitewashed. The upper circa 1.3m comprises a later rebuild of smaller masonry including a series of brick ventilation points below the modern timber roof covered in metal sheeting. A masonry shelf topped by stone slabs sits within the bay, itself topped by a series of brick supports for a removed shelf. A rectangular opening (0.7m by 0.5m) lies in the south wall, part brick lined and internally whitewashed with a stone lintel but otherwise open above. The shaft is built of unfaced random rubble. The northern wall is featureless apart from a central squared doorway (1.2m by 1.95m) with a modern electric light fixed to the upper heightening above it. The door accesses Room 2 (Photo 7).

**Photo 6:** View west of bay front of Room 1. 1m scales.

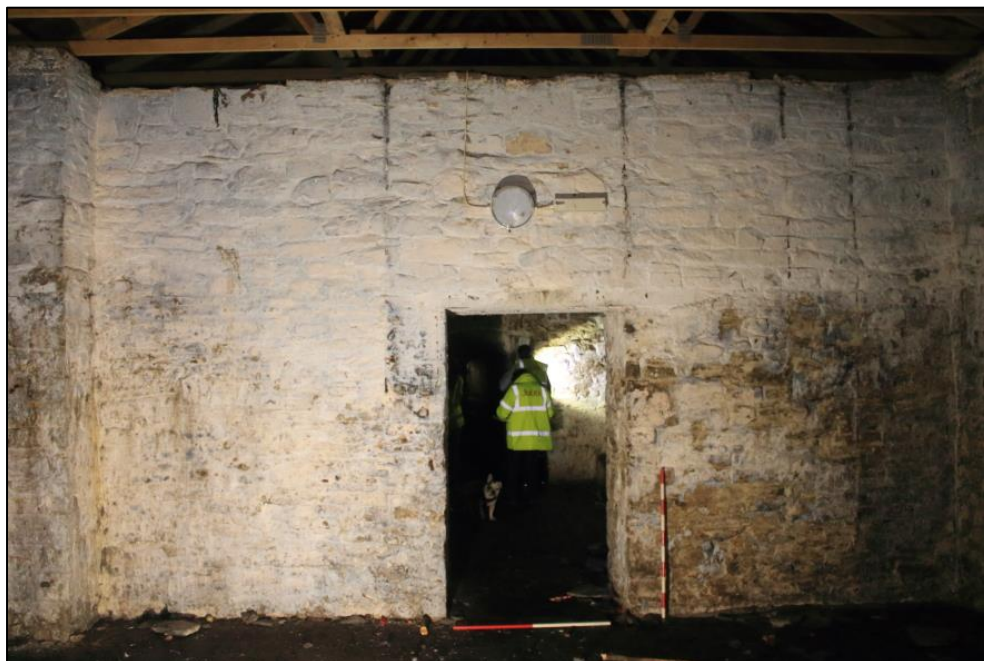
**Photo 7:** View north of north wall and doorway in Cellar Room 1. 1m scales.

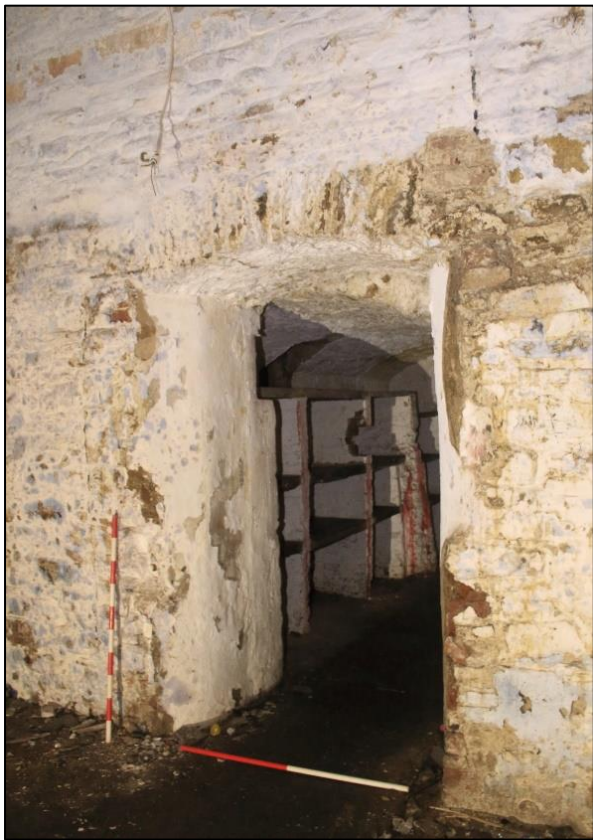
**Photo 9:** View northwest of the doorway between Room 2 and Corridor 1.  
1m scales.

- 4.1.3 Room 2 measures 4.8m north-south by 5.6m and has a modern brick floor and whitewashed walling as in Room 1, topped by modern roofing. The western wall is featureless with the central squared doorway to Room 1 in the southern wall. The eastern wall contains a squared opening (1.1m by 2.1m) to Cellar Entrance 1 (Photo 8), offset slightly to the north. Brick repairs to the top of the opening support a concrete lintel. A masonry stand (1.2m by 1.3m, circa 0.9m high) stands in the northeast corner, with brick inclusions. A centrally placed doorway (1.2m by 2m) lies in the north wall, accessing Corridor 1 (Photo 9). The entrance has a splayed opening into Room 2, with a low arched head of stone voussoirs.

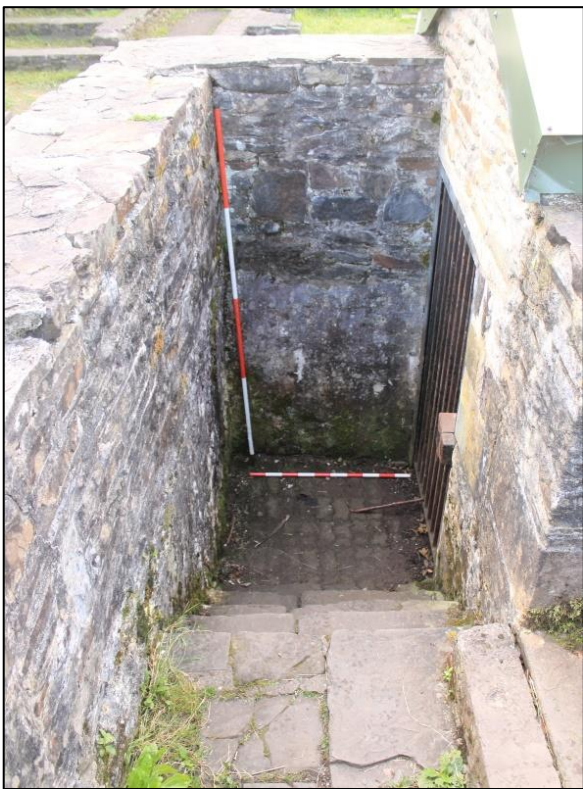
4.1.4 Entrance 1 (Photo 10) comprises an L-shaped set of stone stairs, bounded by mortared random rubble walling, to a metal bar gate. Beyond this a modern brick tile floor slopes gradually down to Room 2, with whitewashed masonry walls.

**Photo 10:** View south of Entrance 1 to cellars.  
2m and 1m scales.

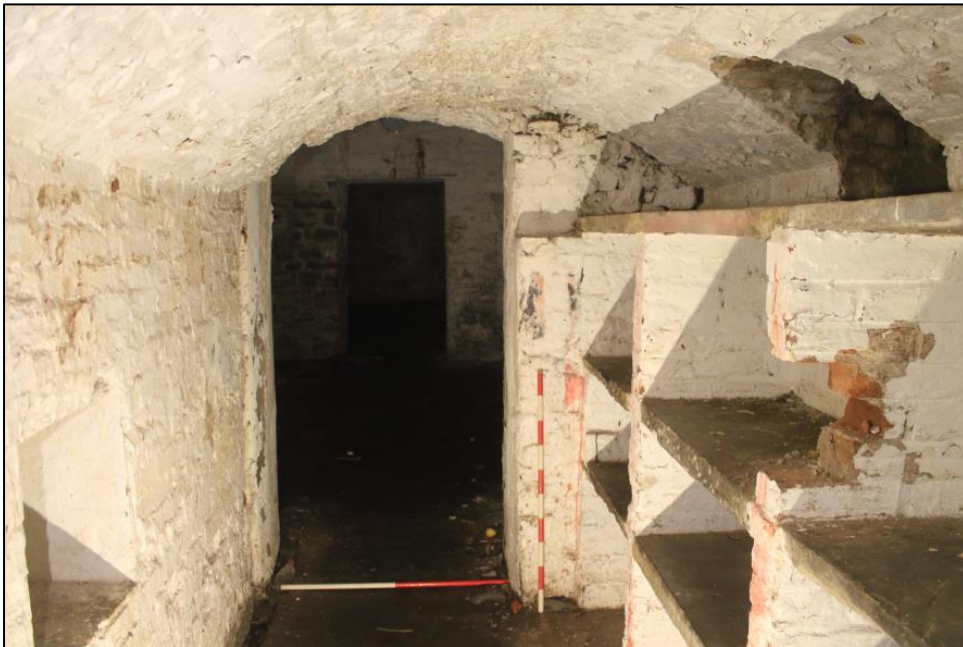
- 4.1.5 The entrance from Room 2 to Corridor 1 (5m north-south by 1.8m) is cement rendered and whitewashed (Photos 11 and 13). There is a butt joint between the room and corridor, which is set at a slight westward offset from the room. Corridor 1 has a floor of brick, partly covered by stone slabs, and whitewashed walls of roughly coursed masonry and brick, 2m high to a low arched masonry roof. 1.1m of the roof at the western end, where it butts against Room 3, has been replaced by brickwork (Photo 12), and at the southern end the roof partly blocks the top of the door arch. A 0.1m wide vertical groove at the doorway possibly marks a doorframe to Room 2 (Photo 14). In the west wall lies a squared opening (0.45m by 0.75m) with an arched head, built into the wall and roof. This is fronted by stone slab shelving on brick supports which line the west wall. A small, squared recess lies in the east wall and is internally rendered (Photo 15).

**Photo 11:** View south down Corridor 1, looking into Room 2. 1m scales.

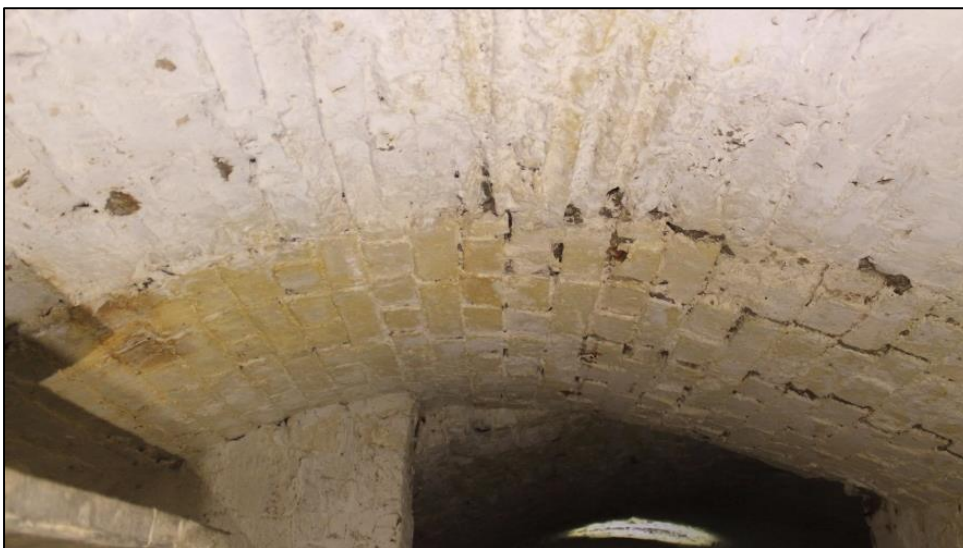
**Photo 12:** View north, replaced section of roofing in Corridor 1 as it enters Room 3.

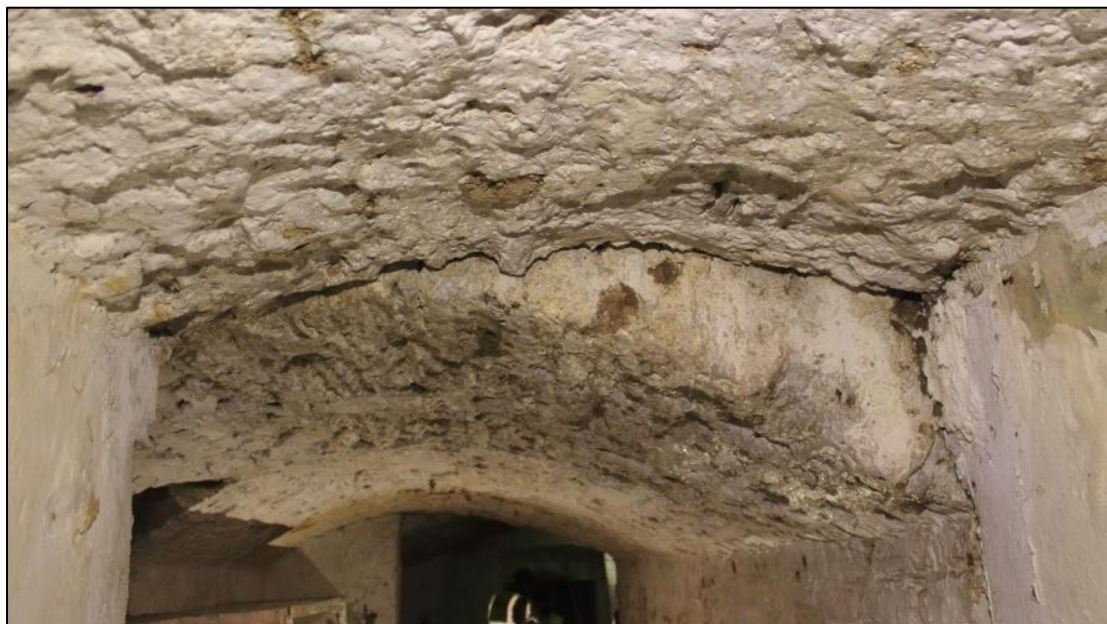
**Photo 13:** View north, detail of roof alignments at the entranceway between Room 2 and Corridor 1.

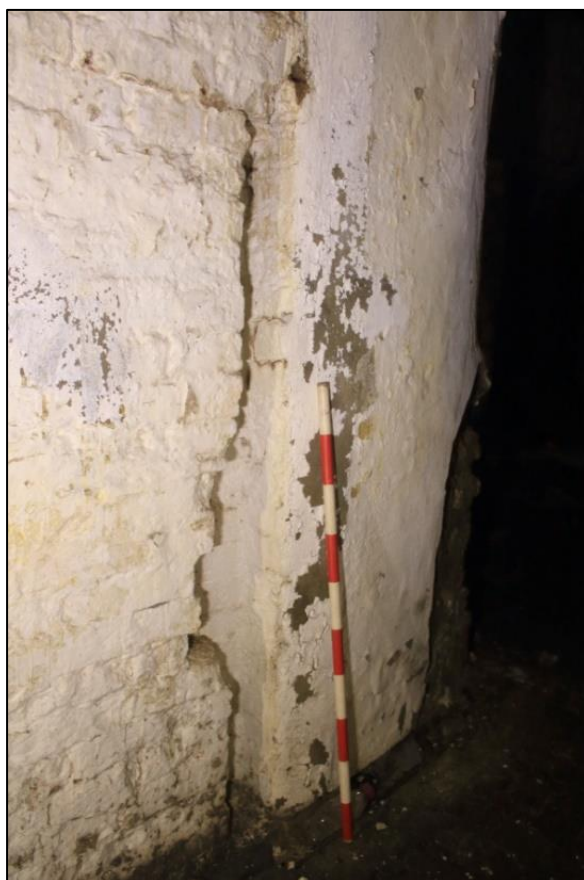
**Photo 14:** View southeast. Detail of former door jamb between Corridor 1 and Room 2. 1m scale.

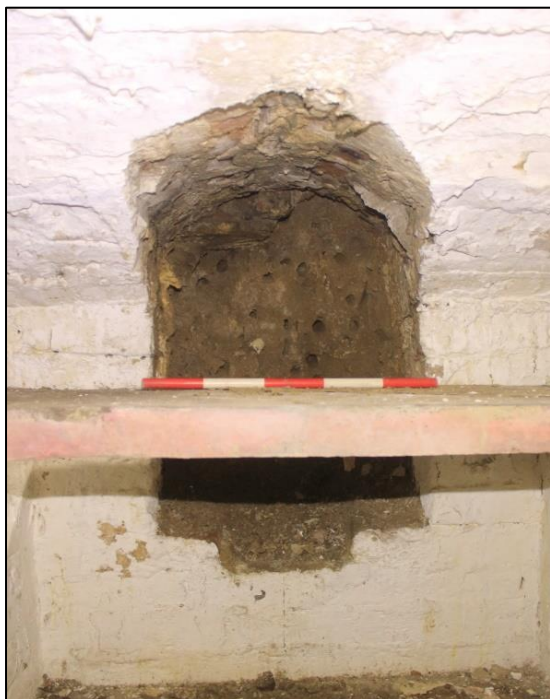
**Photo 15:** View west of the recess in the west wall of Corridor 1.  
0.5m scale.

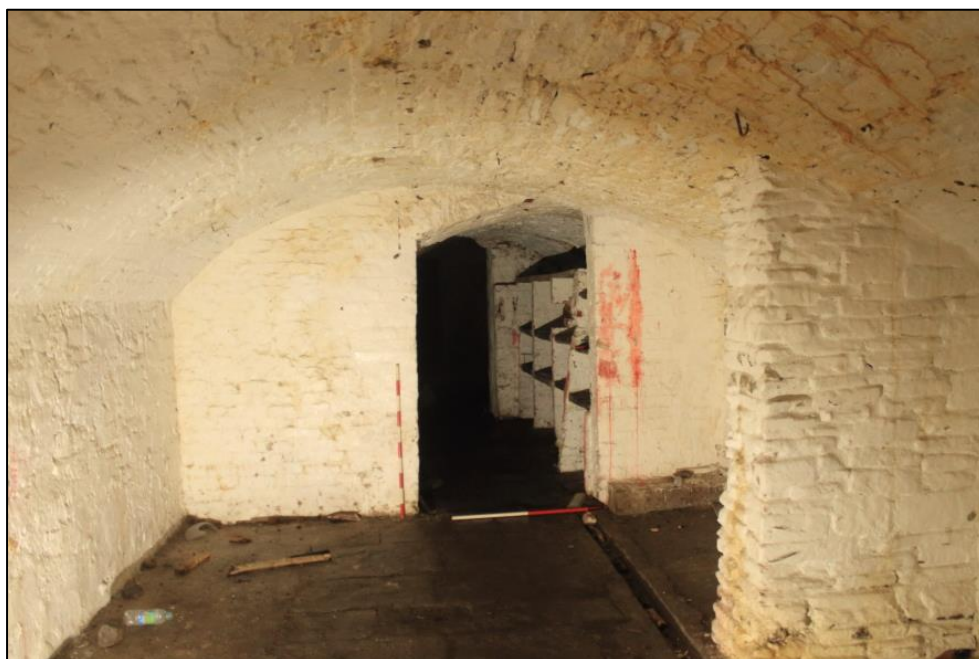
4.1.6 Room 3 is a rectangular space (5.5m north-south by 3.6m) with a slight eastward offset to Corridor 1 (Photo 16). It has a stone slab floor with a central passageway circa 1.3m wide, rougher to the east and delineated by a drainage groove to the west. The northern half of the floor slopes downward slightly. The faced random rubble walls are whitewashed and meet arched masonry vaulting. A supporting wall protrudes 0.8m from the west wall. There is a butt joint in the ceiling 1m from the northern end against a slightly narrower vaulted masonry ceiling. This in turn butts against the low arch of masonry voussoirs that frame the entrance to Corridor 2, placed centrally in the north wall (Photo 17). The walls and ceiling are otherwise featureless.

**Photo 16:** View south of Room 3 looking into Corridor 1. 1m scales.

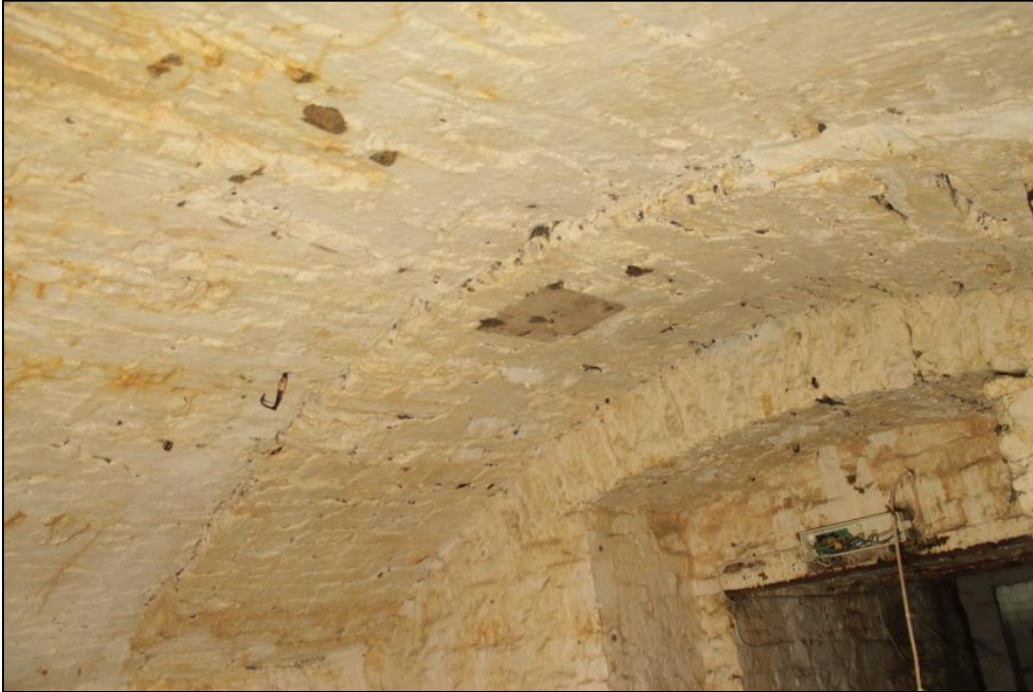
**Photo 17:** View northwest of changing roof structures at the northern end of Room 3 and entrance to Corridor 2.

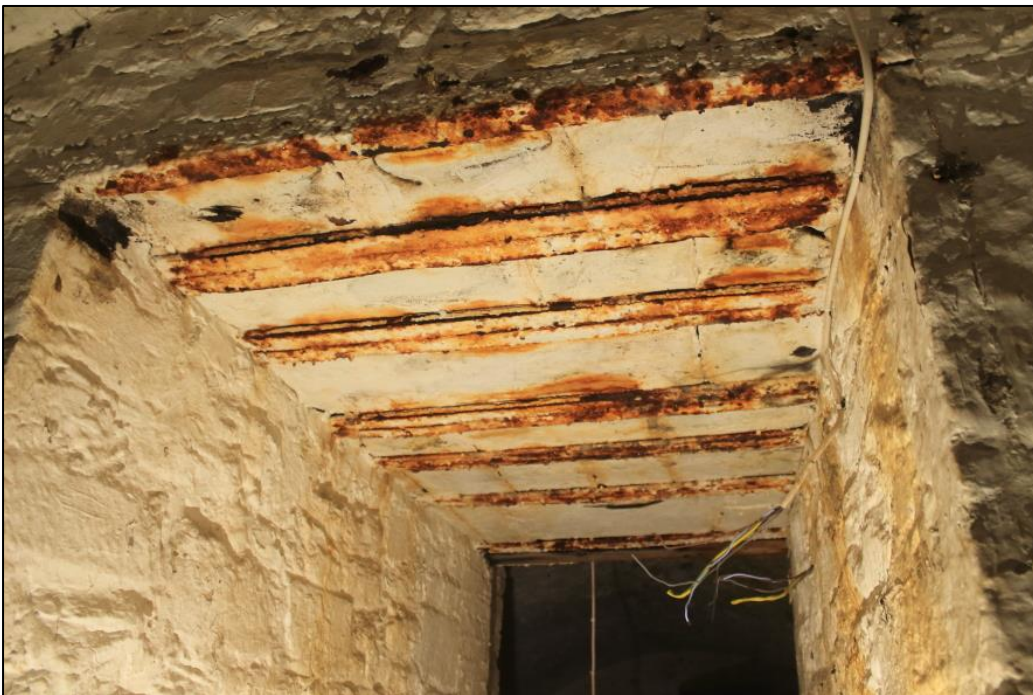
- 4.1.7 Corridor 2 is rectangular, measuring 1m wide, 2.8m long and 1.8m high with a stone slab floor, whitewashed random rubble walls and a flat concrete ceiling held on rusting steel/iron beams (Photos 18 and 19). The floor has a central north-south groove, and a threshold stone at the north end into Room 4.

**Photo 18:** View north of the roof structure in Corridor 2.

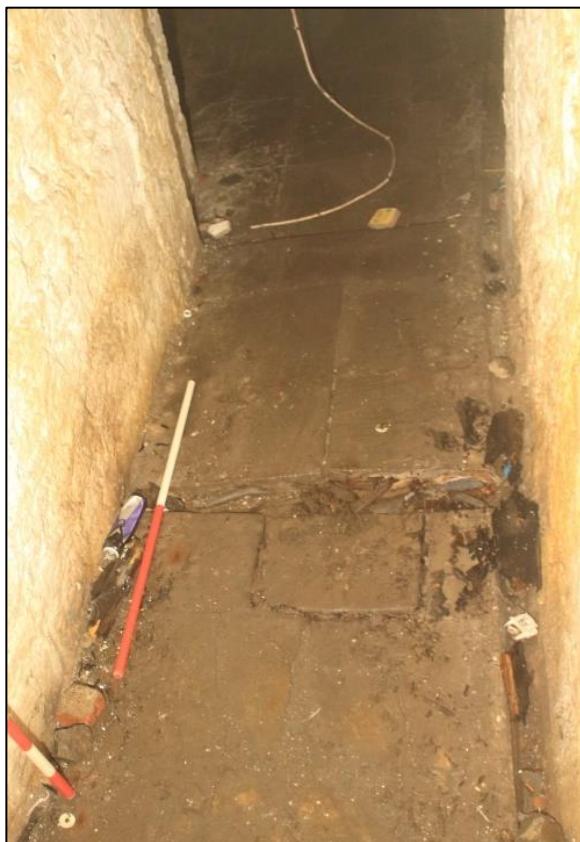
**Photo 19:** View north of the stone slab floor through Corridor 2.

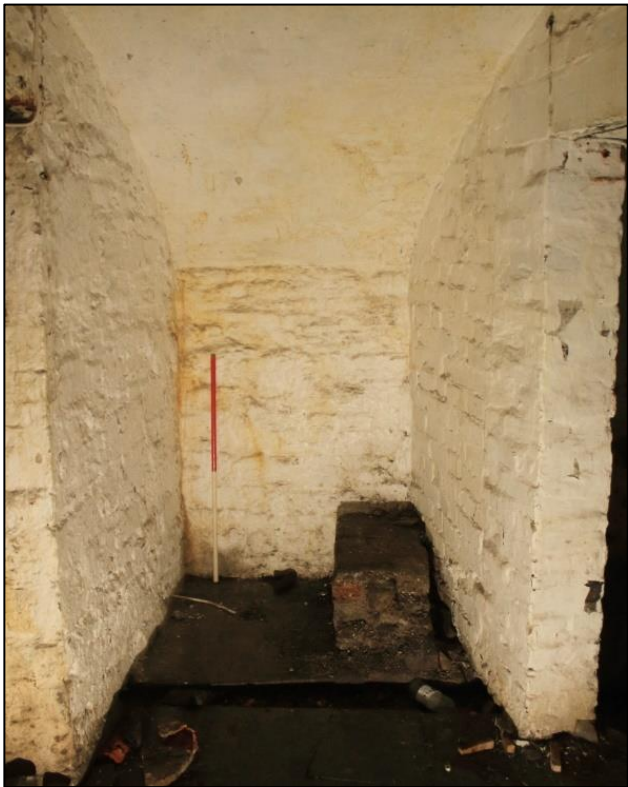
**Photo 20:** View west of Room 4 (Compartment A). 1m scale.

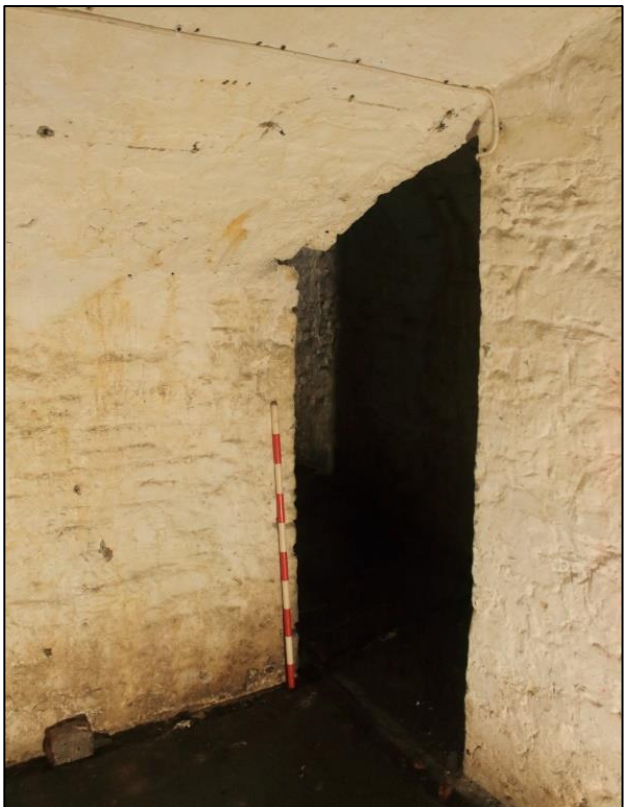
**Photo 21:** View southeast of the doorway leading from Room 4 (Compartment A) to Corridor 3. 1m scale.

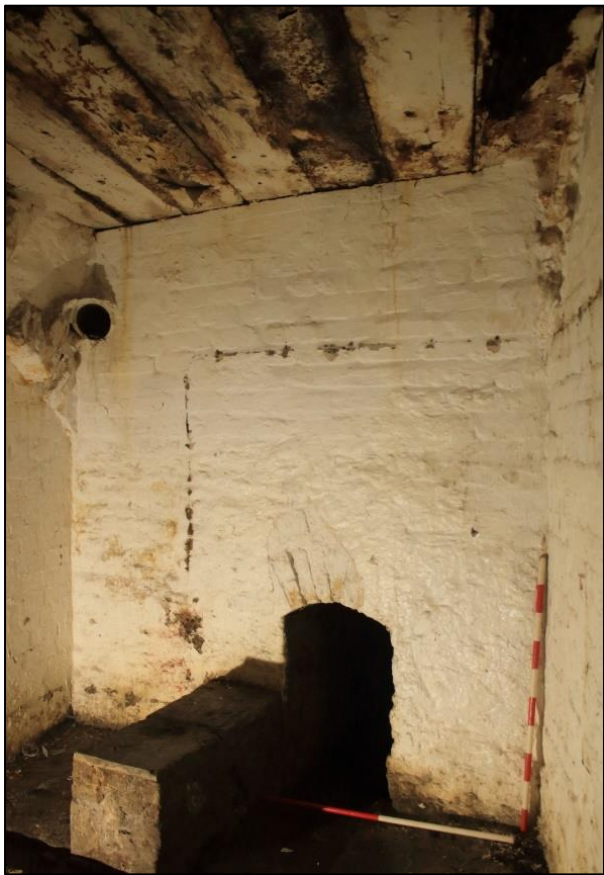
**Photo 22:** View west of the opening in the west wall of Room 4 (Compartment B).  
1m scales.

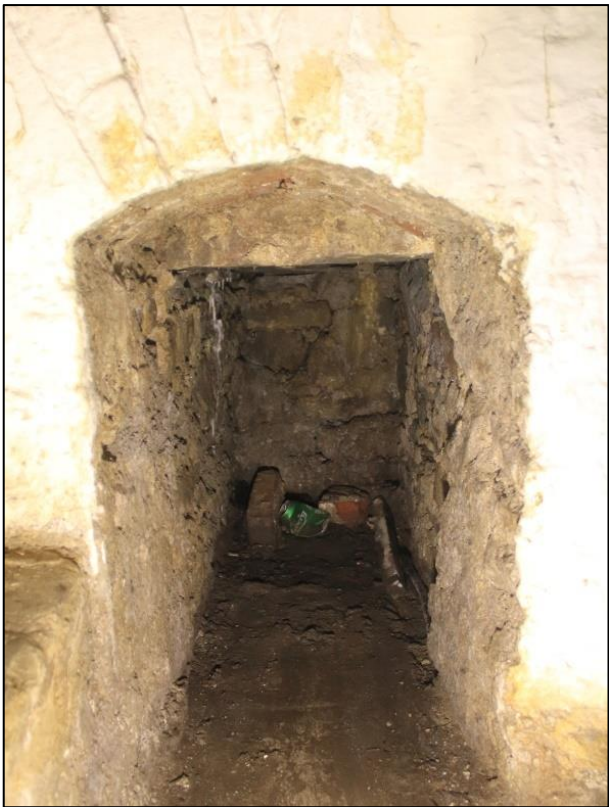
**Photo 23:** View west of the interior of the opening in the west wall of Room 4 (Compartment B).

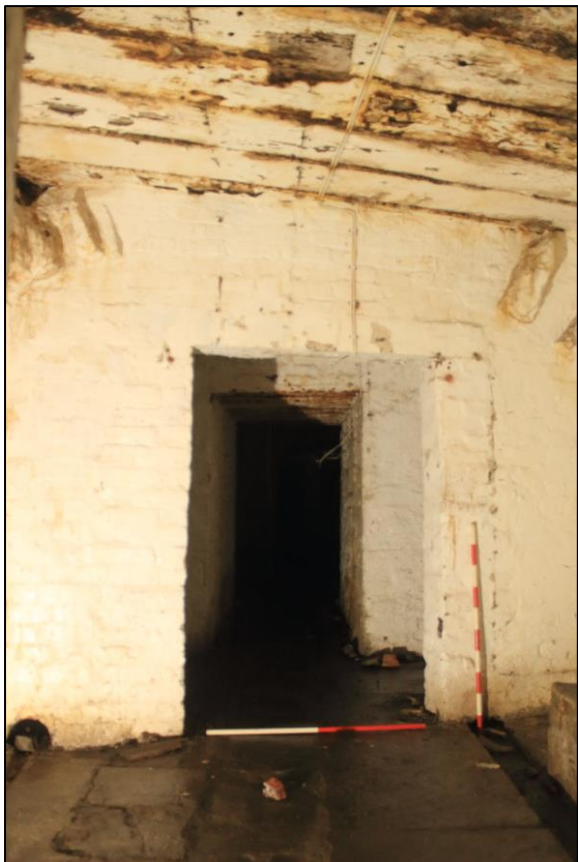
**Photo 24:** View south from Room 4, looking from Compartment B, through Compartment A and into Corridor 2, showing the timber ceiling and remnants of the masonry arched ceiling in the inserted brick wall.  
1m scales.

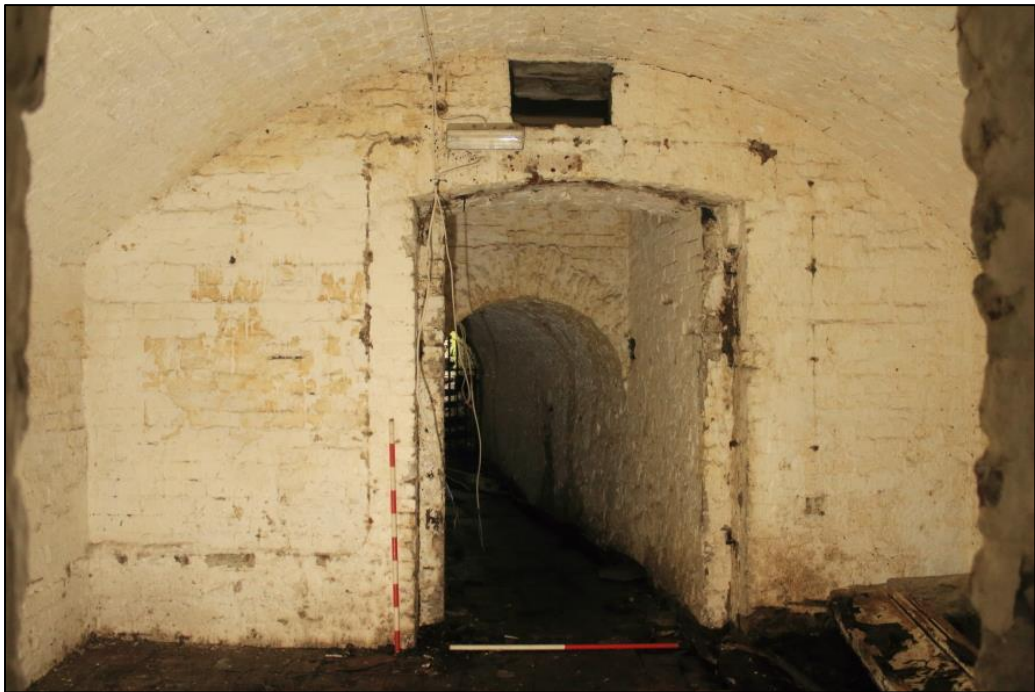
**Photo 25:** View north from Room 4 (Compartment C) looking into Entrance 2. 1m scales.

pipework/wiring, lie in the west wall. A slightly offset opening lies in the north wall, accessing Entrance 2 (Photo 25). The opening is 1.3m wide, 2m high, with squared grooves for a door frame and a low arched head.

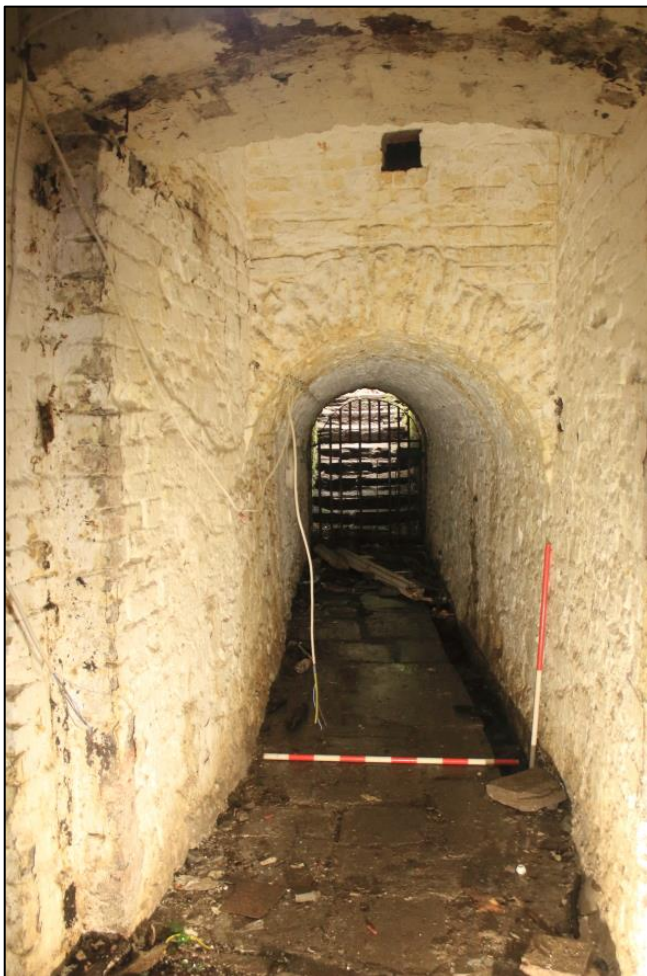
- 4.1.9 Entrance 2 comprises a linear set of stone steps down to a 7.6m long corridor. The corridor (Photo 26) is 1.1m wide and 1.7m high, with a stone flag floor and drainage channel along the eastern edge. Whitewashed random rubble walls rise to a curved continuous brick vaulted ceiling. At the eastern end is a 1.8m long section where it adjoins Room 4, set at a slightly offset angle to the rest of the entrance corridor. The vaulted ceiling ends with brick walling rising to a concrete rafter ceiling with stone slabs above.

**Photo 26:** View north looking down the corridor to Entrance 2.  
1m scales.

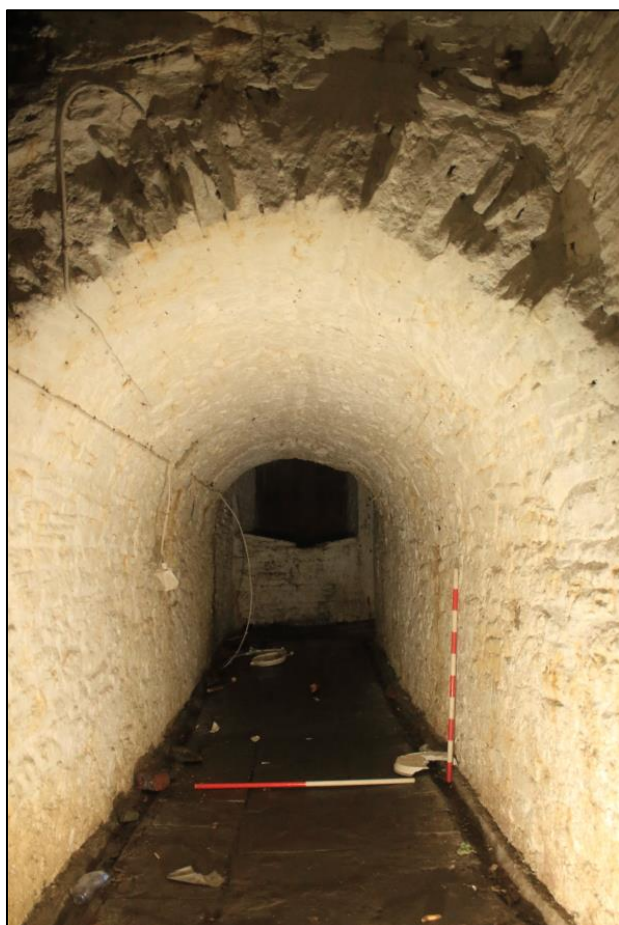
**Photo 28:**

View east, looking down Corridor 3, with the blocked opening at the turn.

- 4.1.10 Corridor 3 runs east-west for 9.6m, with an angled access to the southeast corner of Room 4 (Photo 27) and abutting archways of differing widths. A stone slab floor with drainage grooves to either side rises gradually to the east. Whitewashed random rubble walls rise to an arched vaulted masonry ceiling, 1.9m high (Photo 28). At the western end of the corridor the vaulting stops short of Room 4, with masonry and brickwork rising to a squared opening above, covered by a concrete capping or floor (Photo 29). Pipework (drainage) runs off to the north along an opening formed under the eastern end of a brick vaulted ceiling, presumably a continuation of the ceiling of Room 4 (Photo 30). The eastern end of the corridor turns a right angle to the south into Corridor 4. At the junction the ceiling rises to an unsupported brick arch 2.3m high running into an opening occupying the upper half of an eastward extension for 1.3m. The lower part of the opening is formed by masonry, the northern wall with inserted brickwork. A large stone slab blocks the rear (east) of the opening (Photos 28 and 31).
