## **GNOLL HOUSE AND POND COTTAGE, THE GNOLL, NEATH PORT TALBOT HISTORIC BUILDING RECORDING**

REPORT NO. 2023-25  
EVENT RECORD No. E007491

September 2023

Philip Poucher MCIfA

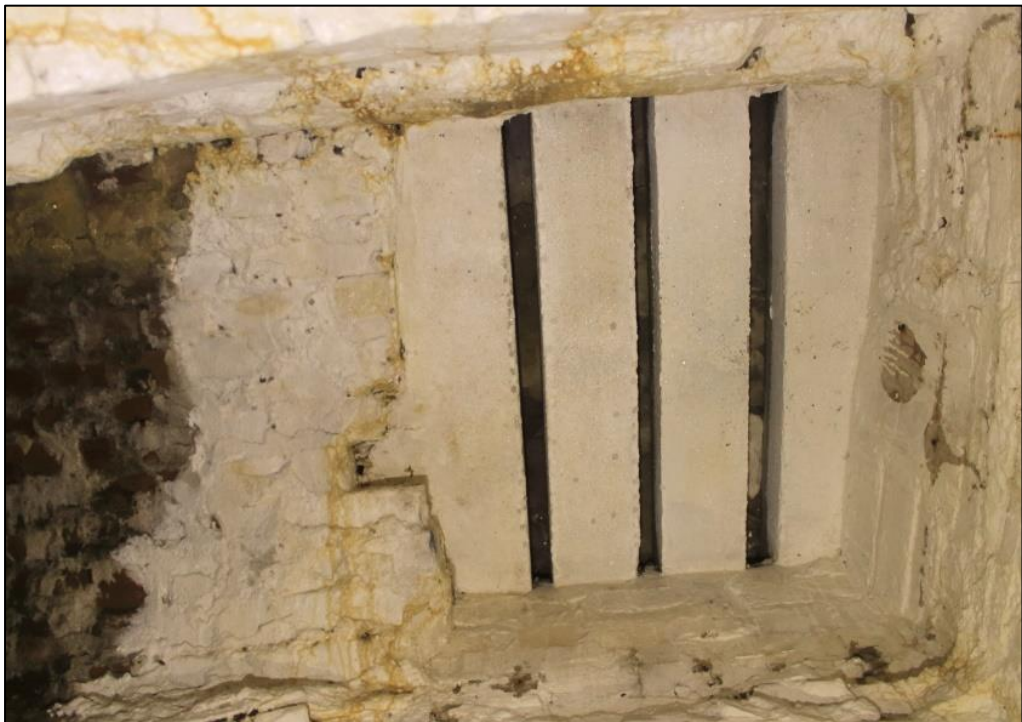
**Photo 29:** The ceiling at the western end of Corridor 3, showing a blocked vertical shaft.

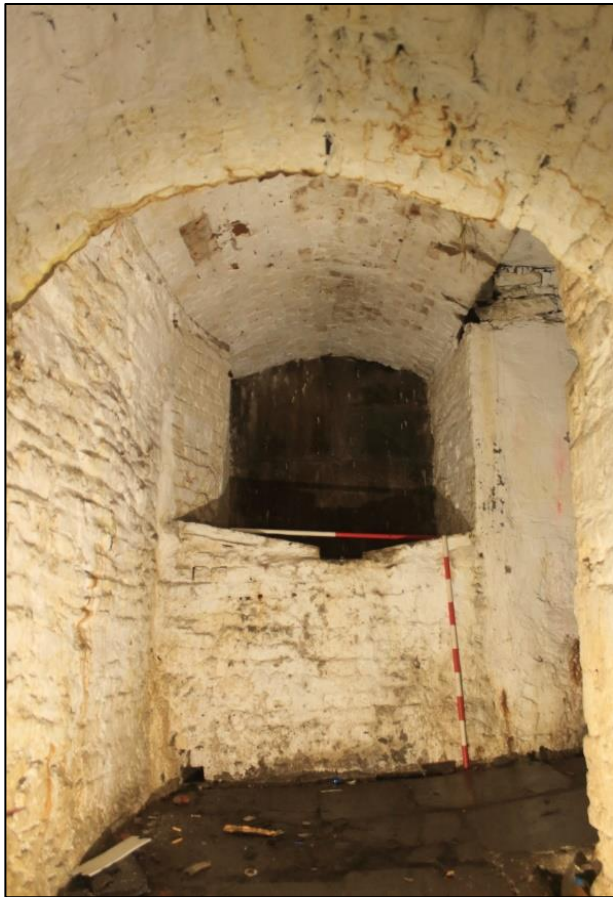
**Photo 31:** View east of the blocked opening at the eastern end of Corridor 3.  
1m scales.

- 4.1.10 Corridor 3 runs east-west for 9.6m, with an angled access to the southeast corner of Room 4 (Photo 27) and abutting archways of differing widths. A stone slab floor with drainage grooves to either side rises gradually to the east. Whitewashed random rubble walls rise to an arched vaulted masonry ceiling, 1.9m high (Photo 28). At the western end of the corridor the vaulting stops short of Room 4, with masonry and brickwork rising to a squared opening above, covered by a concrete capping or floor (Photo 29). Pipework (drainage) runs off to the north along an opening formed under the eastern end of a brick vaulted ceiling, presumably a continuation of the ceiling of Room 4 (Photo 30). The eastern end of the corridor turns a right angle to the south into Corridor 4. At the junction the ceiling rises to an unsupported brick arch 2.3m high running into an opening occupying the upper half of an eastward extension for 1.3m. The lower part of the opening is formed by masonry, the northern wall with inserted brickwork. A large stone slab blocks the rear (east) of the opening (Photos 28 and 31).

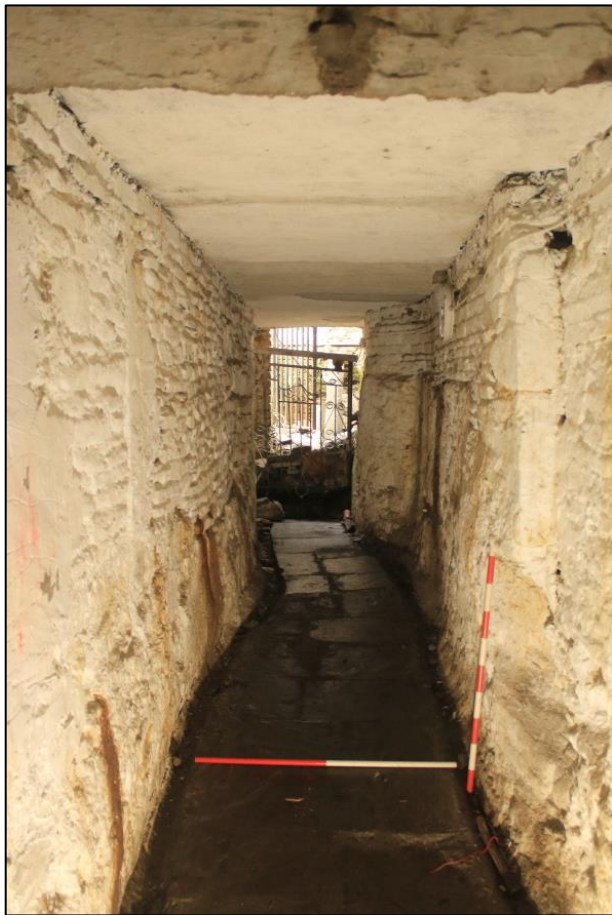
**Photo 32:** View south, looking down Corridor 4 towards Entrance 3.  
1m scales.

4.1.11 Corridor 4 forms a continuous corridor with Corridors 3 and 5, but running at a right angle (Photos 32 and 33). The stone slab floor continues but the lower part of the walls are rock-cut, with white-washed roughly coursed masonry above, topped by a flat concrete ceiling. A roughly vertical butt joint is visible on the west wall, approximately 1.2m from the northern end, with a rendered vertical repair in the eastern wall opposite. The floor continues to rise gradually to Entrance 3 at the southern end and a right-angled turn to Corridor 5.

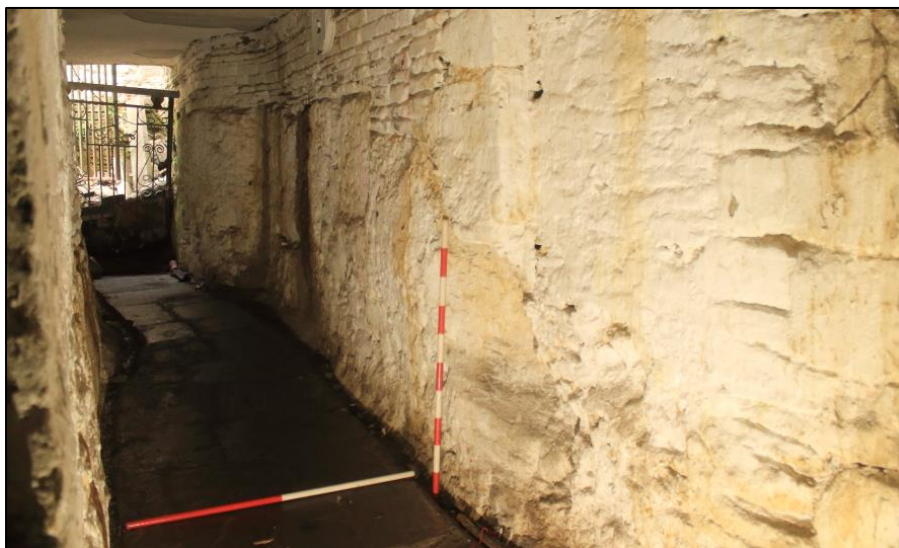
**Photo 33:** View southeast of the western wall of Corridor 4 showing the vertical butt joint and rock-cut walling. 1m scales.

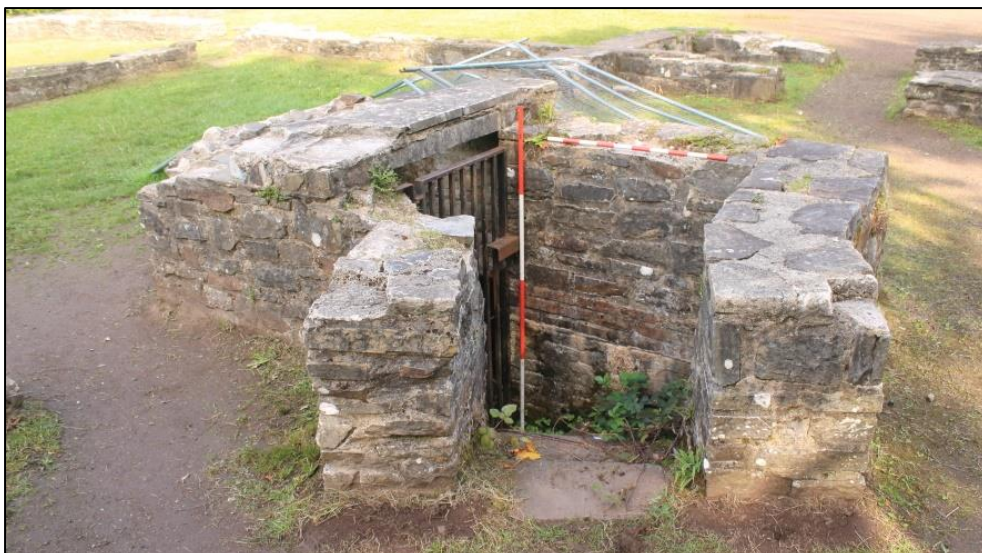
4.1.12 Entrance 3 (Photo 34) is an off-set L-shaped stone stairwell accessing the southern end of Corridor 4. The stairwell is surrounded by whitewashed rock-cut walling at its base with roughly coursed mortared masonry as it rises, then a band of brickwork just below current ground level and mortared random-rubble walling at surface level and above. The stairs are enclosed by a modern metal bar gate and partly roofed by damaged concrete slabs.

**Photo 34:** View northwest of Entrance 3 at surface level. 2m scale.

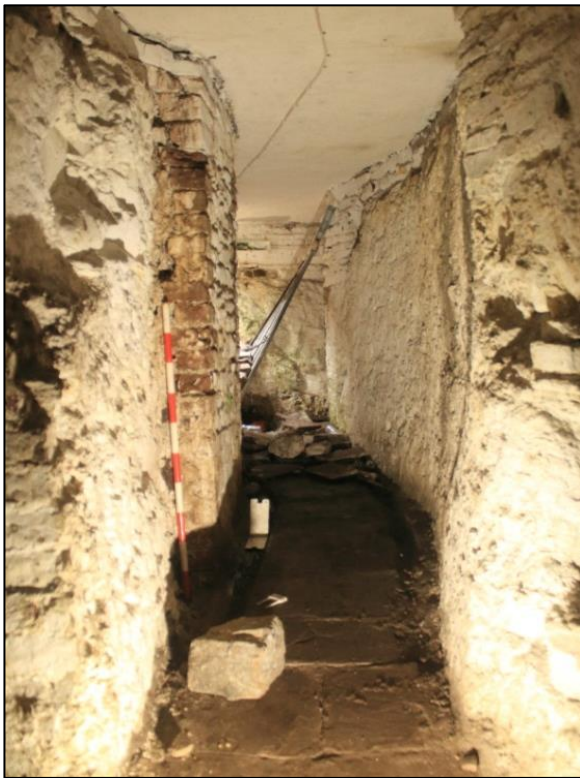
4.1.13 Corridor 5 runs continuously from Corridor 4 in a easterly direction for 7.8m with a gradual curve to the south (Photo 35). The walls are rock-cut along the northern side and built of roughly-coursed masonry along the southern side for 3m before doglegging slightly back to the south onto rock-cut walling. The corridor is topped by a flat concrete ceiling and accesses Entrance 4 at its eastern end. On the north side at the eastern end it opens into Room 5. A doorway infilled with roughly coursed masonry lies in the south wall opposite, 1m wide with rock-cut edges lined in brickwork and stone steps at the base.

**Photo 35:** View west along Corridor 5 to the right-hand turn into Corridor 4, with Entrance 3 on the left. 1m scale resting against blocked doorway.

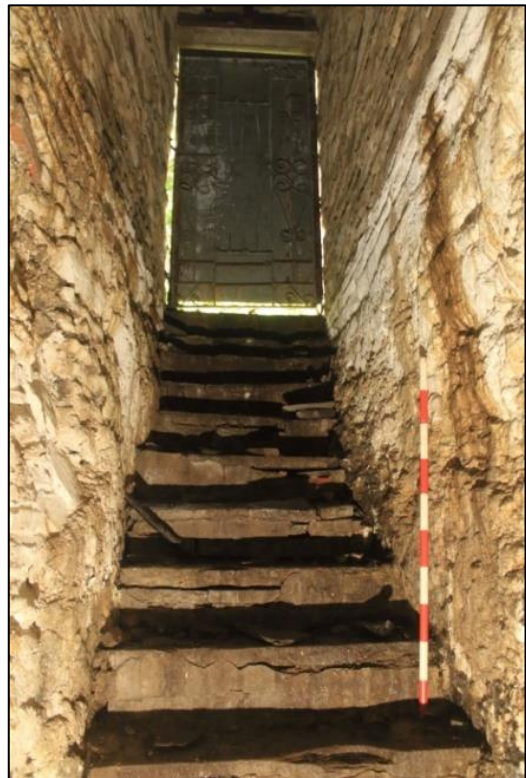
**Photo 36:** View east of the stairway of Entrance 4. 1m scale.

4.1.14 Entrance 4 comprises a linear series of concrete and brick steps with rock cut edging (Photo 36). A rectangular structure in random rubble masonry has been built at ground level to enclose a doorway access to the steps.

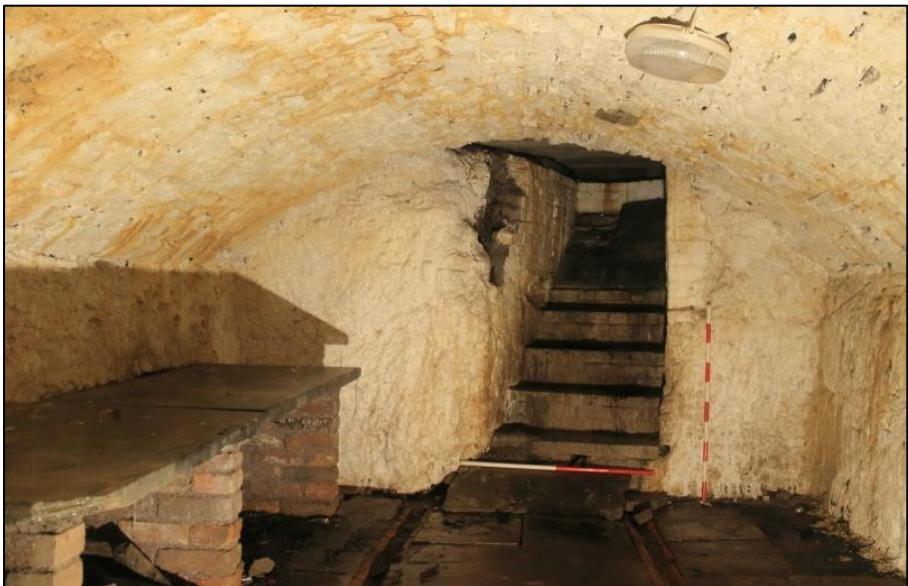
**Photo 37:**  
View north  
from Room 5  
towards the  
blocked stair  
access.

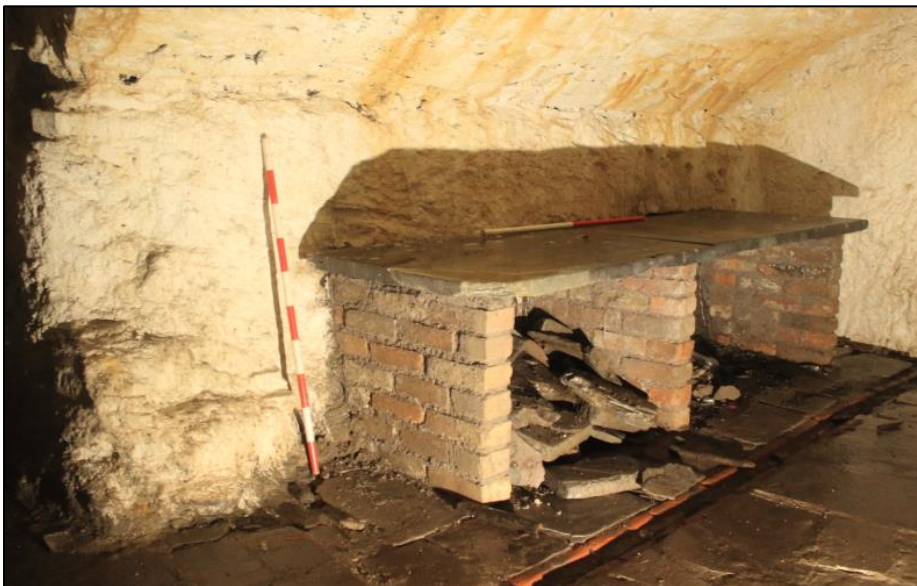
**Photo 38:**  
View  
northwest of  
shelving  
within Room  
5.

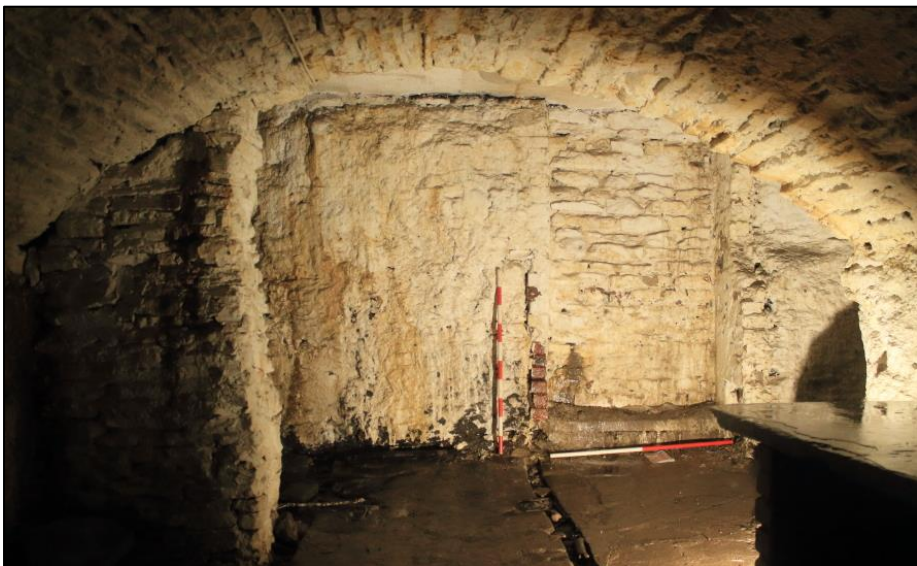
**Photo 39:**  
View south out  
of Room 5 and  
across  
Corridor 5,  
with the  
blocked  
doorway  
visible on the  
right.

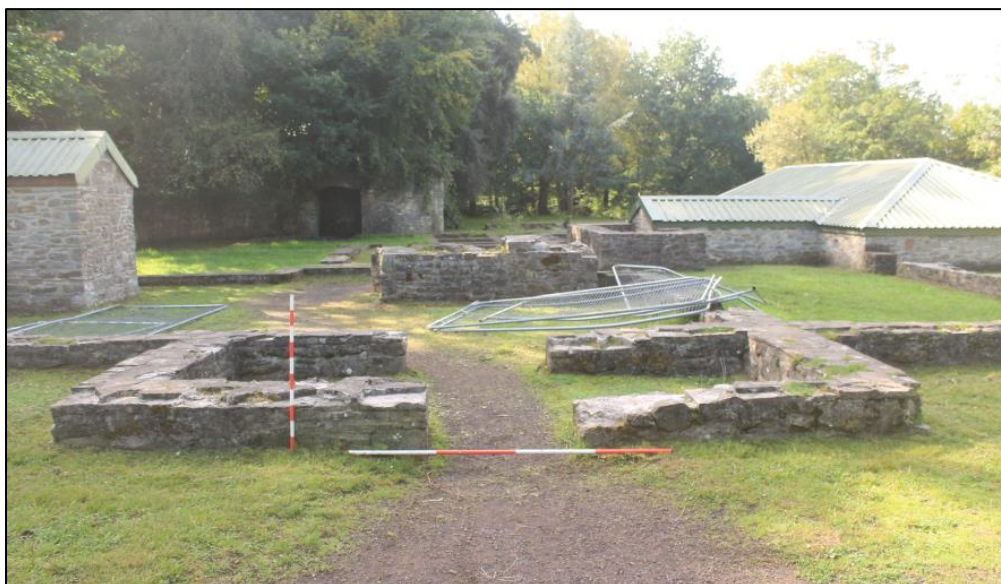
- 4.2.2 The walls form the outline of a central porch in the north face (Photo 42), with central openings through into a large room (7.5m north-south by 16.3m), partially sub-divided by the walling around Cellar Entranceway 3. This room comprises the former entrance hall and smoking room to the north of the cellar entranceway wall and former inner hall to the south.

**Photo 42:** View south. The entrance porch to the house. 2m and 1m scales.

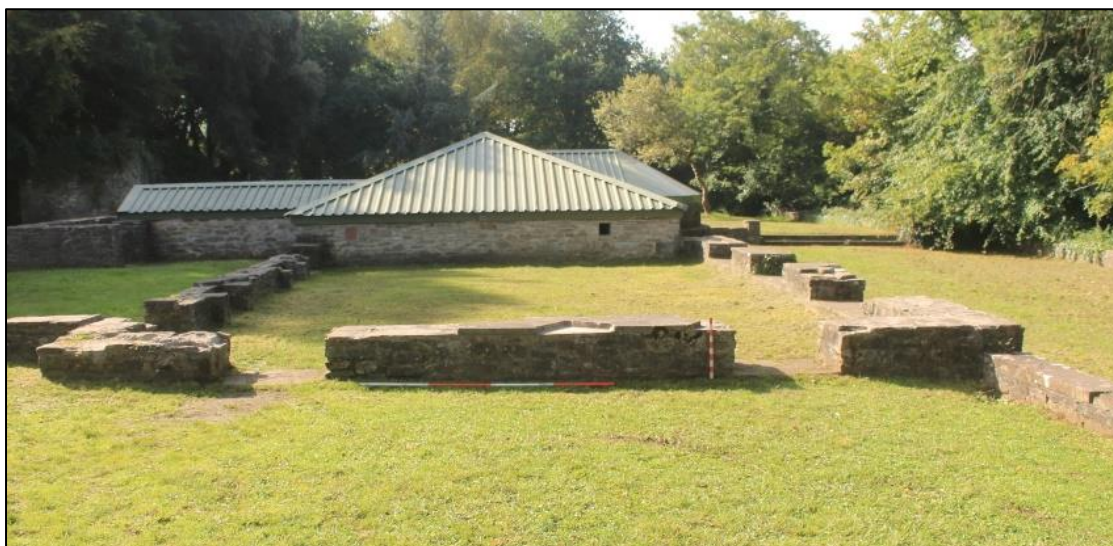
- 4.2.3 To the west, two 1m wide openings at either end of the west wall access a western room (the former dining room), 10m north-south by 7m (Photo 43). Three openings along the western wall represent former window openings, large dressed stone blocks lie along the lower face of this wall, with each opening fronted (to the west) by dressed stone steps (Photo 44). Along the eastern wall two rectangular recesses, each 0.85m wide, are cut back into the wall.

**Photo 43:** View south. Looking at the former dining room, with the roofed cellar area behind. 2m and 0.5m scales.

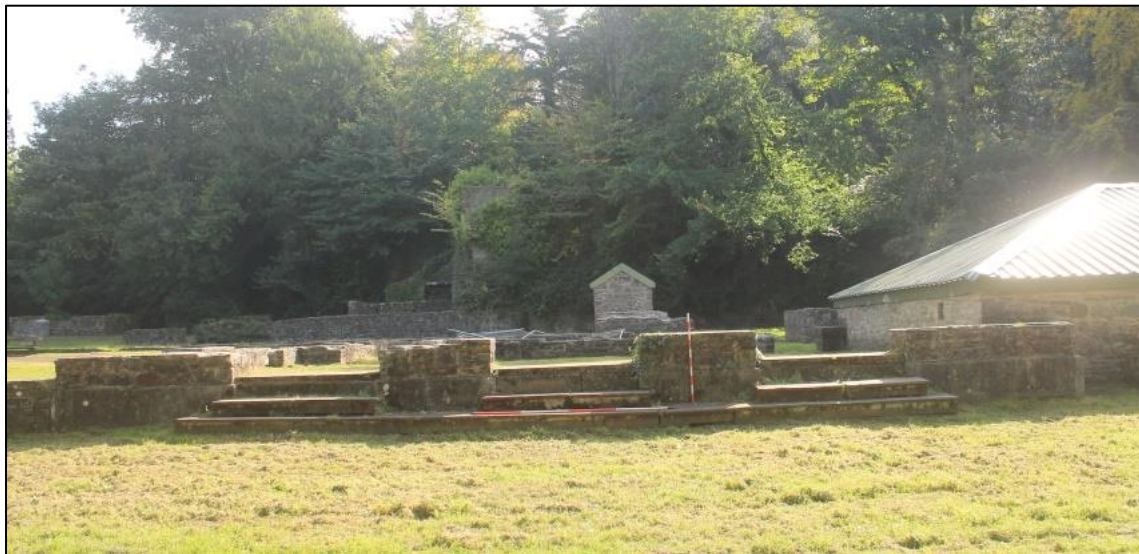
**Photo 44:** View east. The stone steps fronting the former dining room windows. 2m and 1m scales.

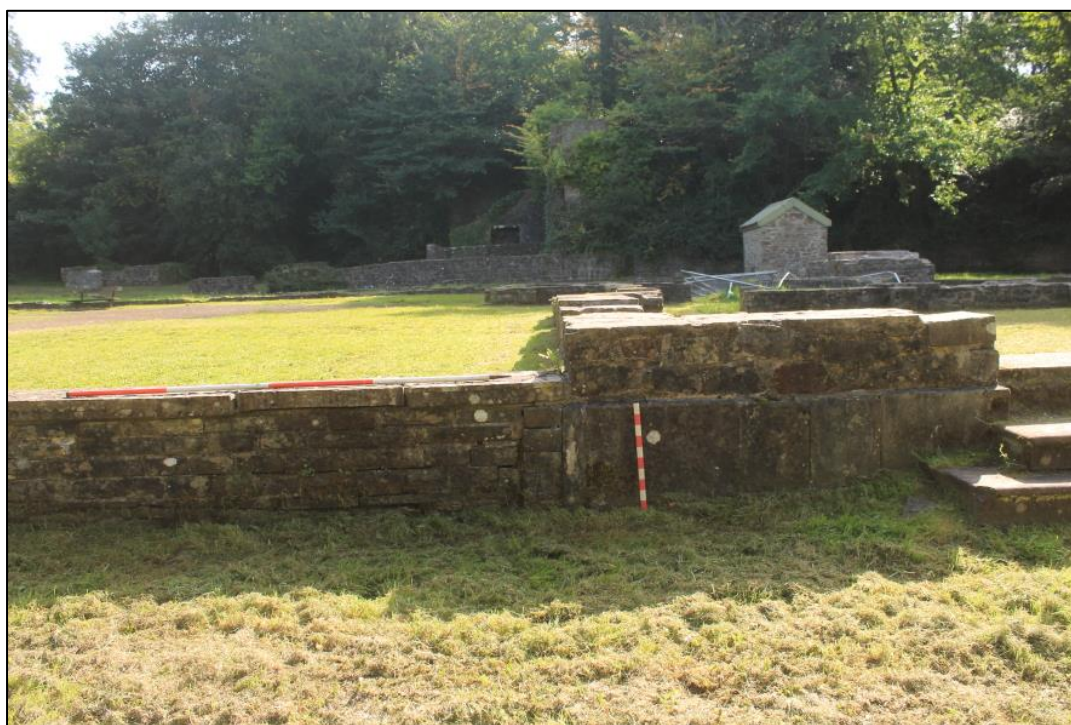
4.2.4 To the north of the former dining room a 0.6m high, coursed masonry wall butts against the dining room wall, continuing its line northward for 24m (Photo 45). Only the northernmost section follows the original line of the Gnoll House building, the section that abuts the dining room is on a new alignment. A set of stone steps have been built into the original line of walling to the west; two 0.25m deep steps of stone slabs set on mortared masonry (Photo 46).

**Photo 45:** View east of the wall abutting the former dining room. 2m and 0.5m scales.

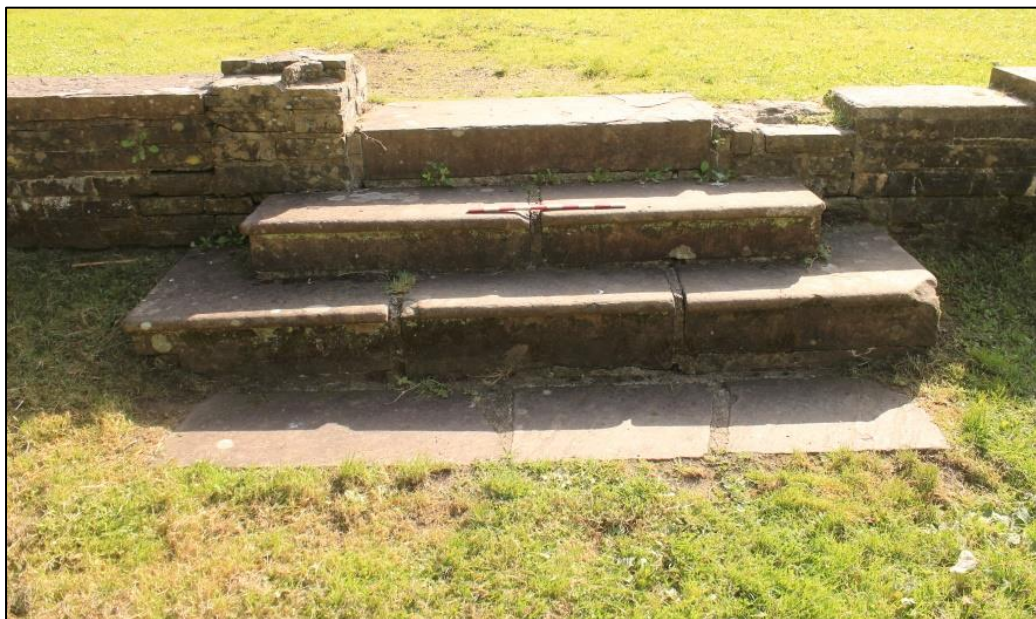
**Photo 46:** View east of stone steps leading down to the lower terrace. 0.5m scale.

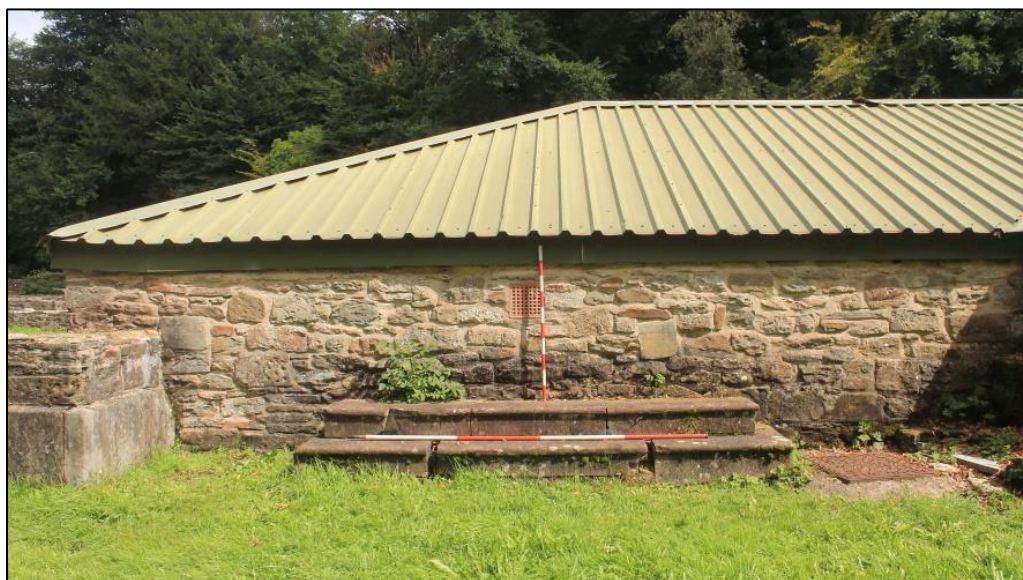
**Photo 47:** View east of dressed stone steps marking the site of a former window in the library. 2m and 1m scales.

4.2.5 To the south of the former dining room lies the modern roofed structure enclosing Cellar Rooms 1 and 2. These rooms demarcate the former library (northernmost) and drawing room (southernmost), with mortared random rubble masonry walling, 0.95m high, topped by a pitched roof of corrugated steel. The library is fronted to the west by dressed stone steps with protruding rounded tread marking the site of a window (Photo 47). The western wall of the drawing room curves outward in a bay/tower base (Photo 48), also fronted by two stone steps. The lower step comprises squared stone slabs topping coursed masonry, the upper step comprises dress stone treads with a rounded protruding edge, over a cement-rendered step. The south wall of the drawing room includes a lower course of finely dressed grey stone (Photo 49).

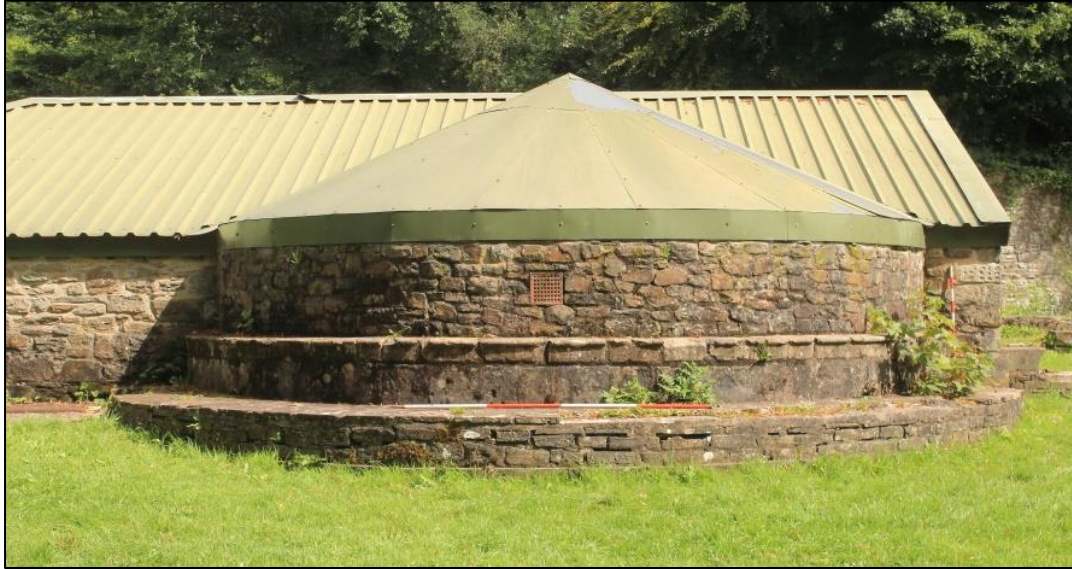
**Photo 48:** View east of the curved bay/tower base of the former drawing room. 2m scale.

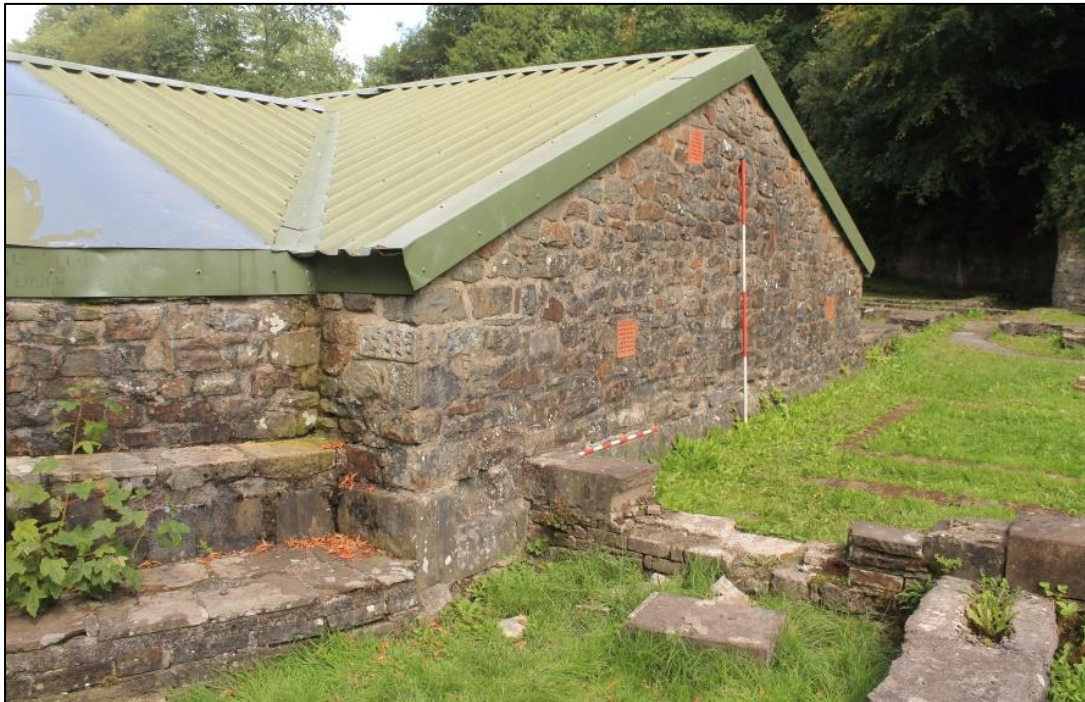
**Photo 49:** View northeast of the south wall of the former drawing room, showing the lower course of dressed stone. 2m and 1m scales.

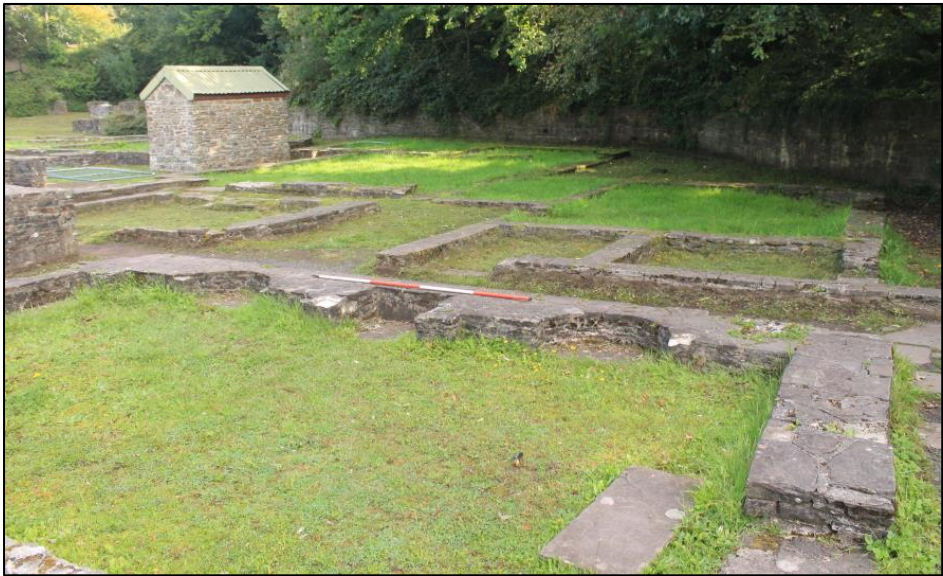
**Photo 50:**  
View  
northeast  
across the  
southern  
rooms of the  
east-west  
range of  
Gnoll House,  
with a hall in  
the  
foreground.  
2m scales.

4.2.7 To the east of the cellar stairs lies a small room (3.7m north-south by 2m) with an eastern wall incorporating two irregular rectangular recesses and partially open to the west, surrounded by pathways. This represents a former butler’s pantry, the northernmost recess in the east wall marking the location of a fireplace. A path, along an original passageway, runs north-south to the east of the butler’s pantry, east of which lies a large 6.5m square room with entrances in the west wall, the western end of the south wall and the southern end of the east wall. Small stubs of walling protrude westward from the east wall. This represents the former kitchen, incorporating the site of a set of stairs to the north. The wall protrusions to the east mark the site of a kitchen fireplace. The entrance to the south accessed a former larder, the current wall marking out a larger area (1.5m north-south by 3.5m) than the original room. The entrance to the east accessed a former scullery, marked out by a room (3.5m north-south by 2.5m) with an entrance to the north. To the north the walls mark out three sides of a similarly sized room (4.5m wide), open to the east, marking the site of a former dairy (Photos 50, 51 and 52).

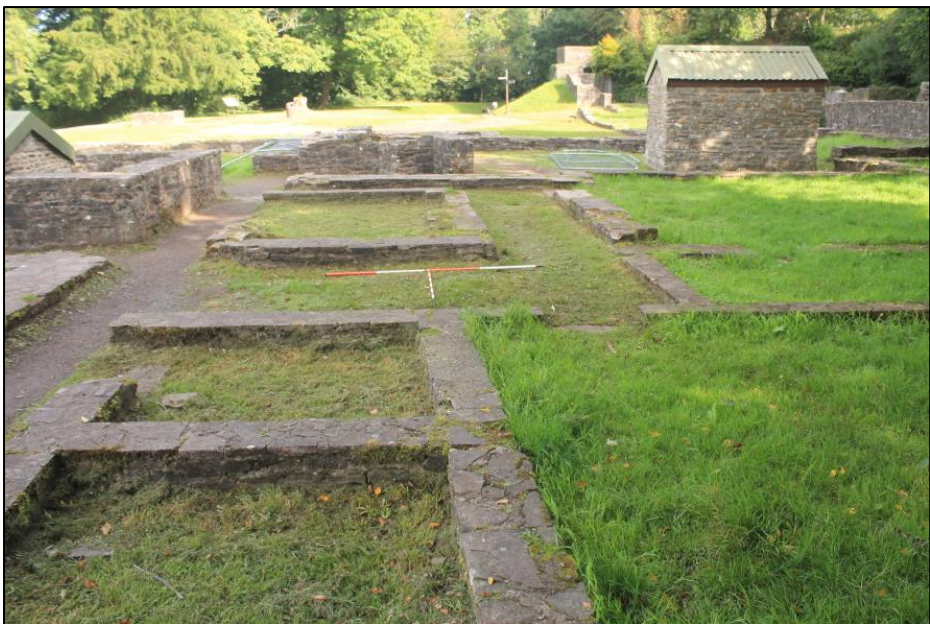
**Photo 51:**  
View north.  
Looking  
across the  
rooms on the  
east side of  
the former  
drawing room  
and library.  
2m and 1m  
scales.

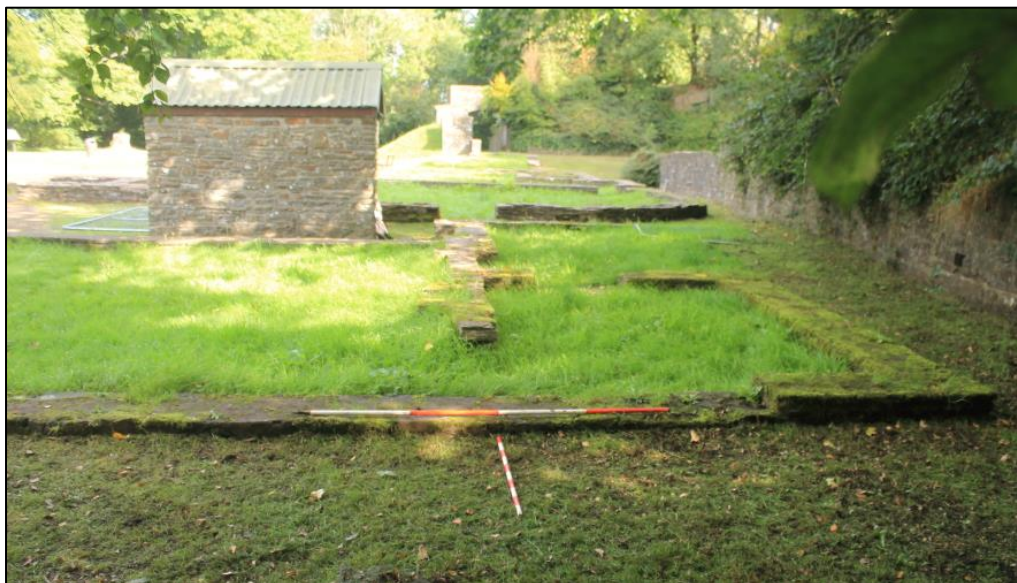
**Photo 52:** View north over rooms at the east end of Gnoll House, including a former scullery and dairy. 2m and 1m scales.

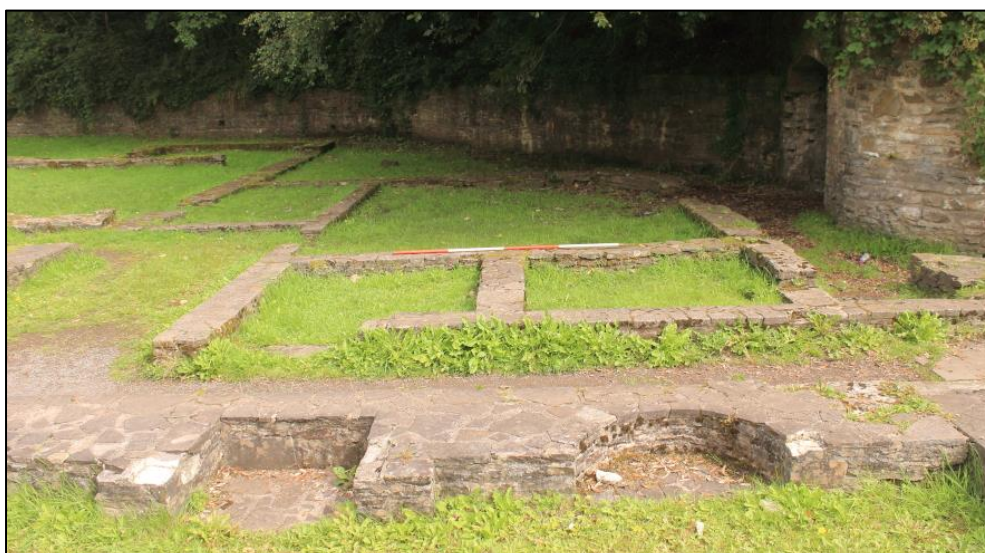
**Photo 53:** View east from a former hall towards the servant's hall to the rear. 2m scale.

4.2.8 To the east of the former hall the walls demarcate two small square rooms (1.75m<sup>2</sup> and 1.8m by 2m), partially representing a former boot room and cupboard, with a passage to the north, a new path inserted and a new entrance on the south side. East of this lies a room (4m north-south by 5.5m) with a chamfered southeast corner and an entrance to the north. This represents a former servant's hall, originally with a matching chamfered corner to the northeast (Photo 53). The southern entrance is a new addition and adjoins the former larder described above.

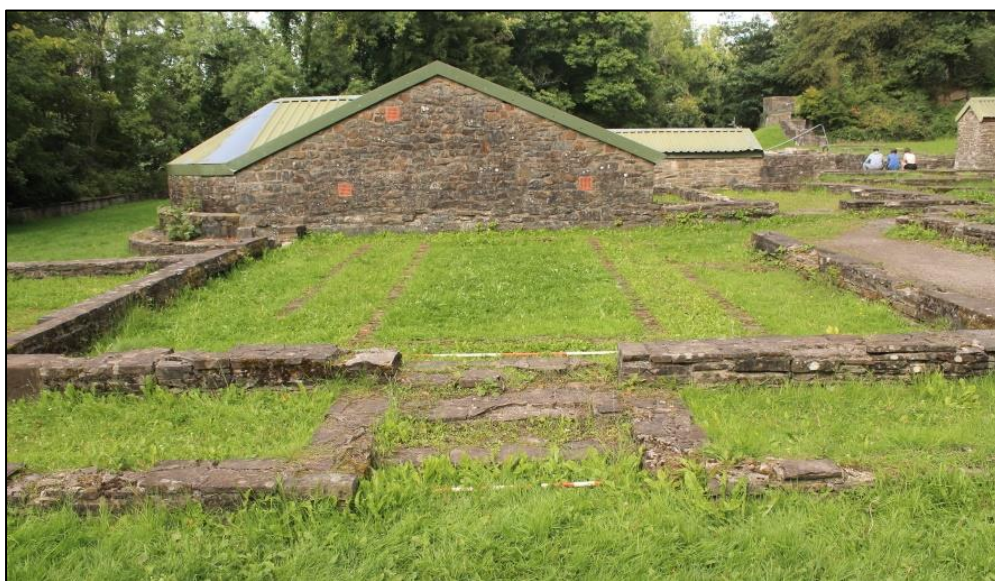
**Photo 54:** View north of the outline of the former conservatory. 2m and 1m scales.

the northern end of the east wall and a central entrance in the south wall, fronted by a set of very shallow steps built of flat slabs of mortared masonry. Internally the area is subdivided into rectangular compartments by lines of brickwork laid at ground surface level. The steps to the south are flanked by two low rectangular compartments (2.5m by 1m) of mortared masonry which represent the site of the former conservatory (Photo 54).

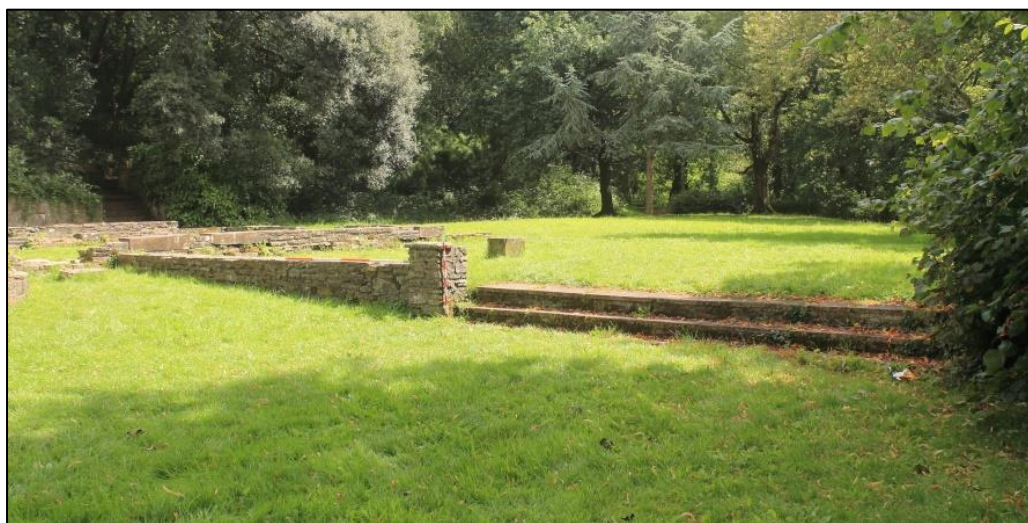
**Photo 55:** View southeast showing the retaining wall and steps to the west of the former conservatory. 2m and 1m scale.

4.2.10 To the west, a 6.7m long stretch of wall runs east-west. Up to 0.6m high, it is built of mortared random rubble and is concrete capped. Acting as a retaining wall as ground falls slightly from south to north, it has a set of wide concrete-slab steps to the south accessing the terrace to the west of the building (Photo 55). An area of turf-covered concrete, 2.9m wide, lines the west side of the former conservatory wall, in the angle with the retaining wall. A square (0.5m<sup>2</sup>) stone plinth lies a short distance to the west of this.

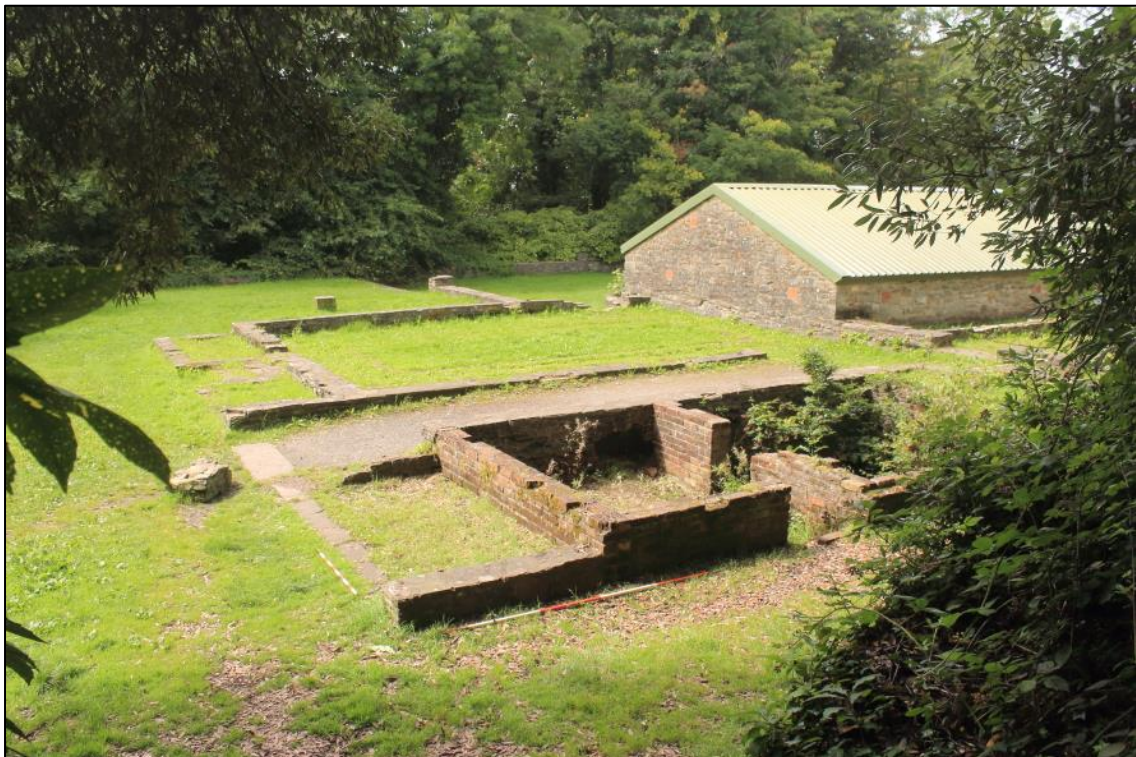
**Photo 56:** View west across the brick structure at the southeast end of Gnoll House. 2m and 1m scales.

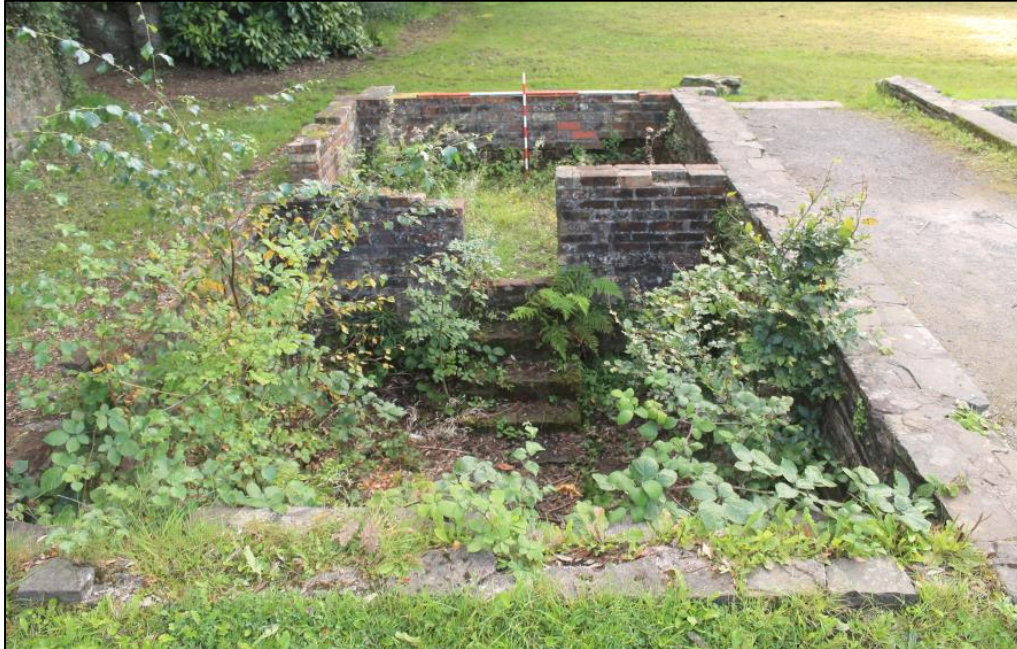
**Photo 57:** View south across the brick structure at the southeast end of Gnoll House. 2m and 1m scales.

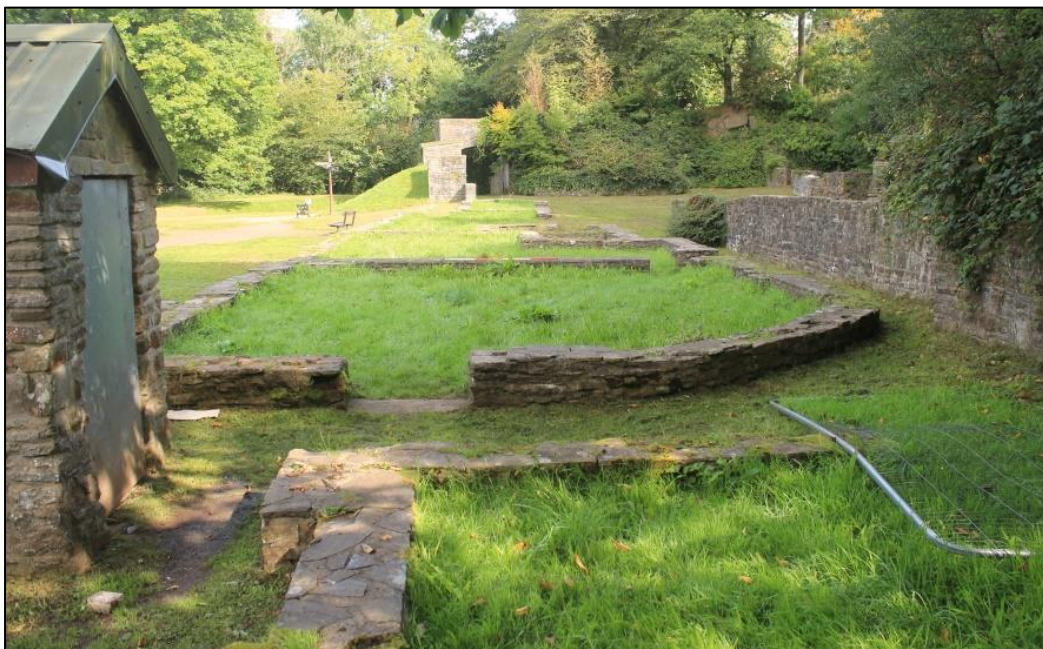
**Photo 58:** View north across the site of a former kitchen and mid-17<sup>th</sup> century building. 2m scales.

4.2.12 A north-south range of rooms are laid out to the east of the main house as part of the continuous outline of the building. Adjoining the former smoking room and dairy is a large room (8.6m north-south by 7.5m) with a rounded southeast corner and entrance through the south wall. There is a butt joint midway along the east wall with the latter increasing in thickness to the north. This marks the site of a former kitchen, shown on late 19<sup>th</sup> century plans with substantially thicker east and south walling, identified as part of a mid-17<sup>th</sup> century building (Green 1979) (Photo 58).

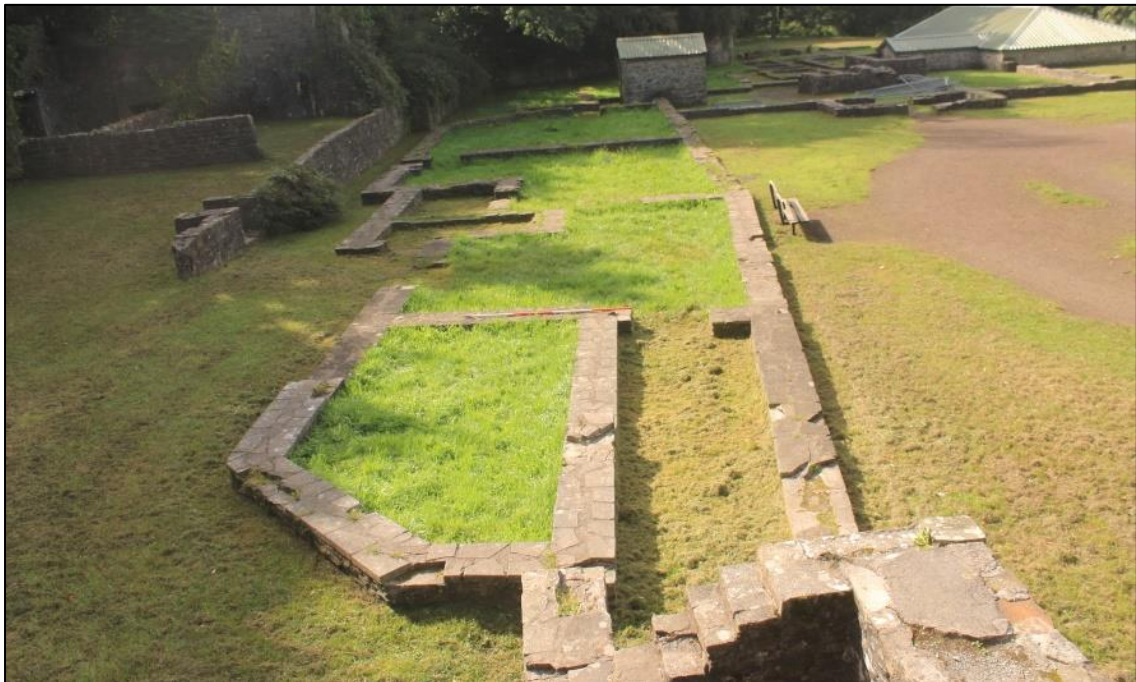
**Photo 59:** View south across the eastern service wing of Gnoll House. 2m scale.

- 4.2.13 To the north lies an adjoining room (7.9m north-south by 7.4m) accessed via a doorway at the eastern end of the dividing wall. There is a dog-leg in the east wall, and a smaller room (3m by 1.8m) has been inserted into the northeast corner, with an entrance to the west (Photo 59). This area formerly comprised a larder and scullery, and was part of the mid-17<sup>th</sup> century building.

- 4.2.14 To the north the wing gets narrower, dog-legging in from the east. The adjacent room (7.4 north-south by 4.8m) is L-shaped and accessed via a doorway to the east. To the southeast lies a small room (2.9m by 1.5m) built within the recess and accessed from the north. These rooms would appear to represent a modern re-arrangement of the former coach house. At the west end of the north wall is an access to a long narrow room (6.8m north-south by 1.4m), representing the former harness room. East of this is a small room (5.5m north-south by 2.5m) with a chamfered northeast edge and no entranceway marked (Photo 59).

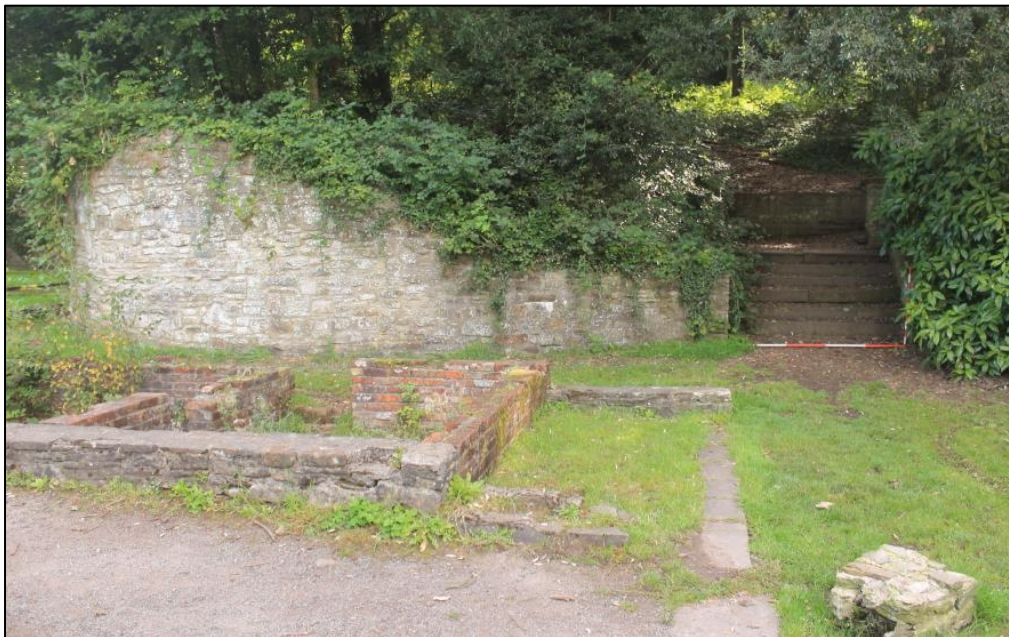
**Photo 60:** View east showing the stairs and retaining wall to the southeast of the house. 2m scale.

- 4.2.16 Starting at the southern end, a set of seven stone steps approximately 2m wide ascend the hillside to the rear before narrowing and continuing to climb off to the south to access the grounds around the gnoll (Photo 60). The initial steps are built of square dressed large stone blocks and the upper step has a protruding rounded tread. The steps are set between low walls of mortared random rubble, roughly faced, with squared pillars (0.9m high) flanking the entrance. To the south the area is covered in vegetation but it is assumed some form of retaining wall runs in that direction. To the north lies a wall of roughly faced mortared random rubble which rises steadily to 2.8m in height. This wall runs to the east of the brick-built former boiler/oil tank house, before curving around to the east, acting as a retaining wall/frontage to the rapidly rising ground behind.

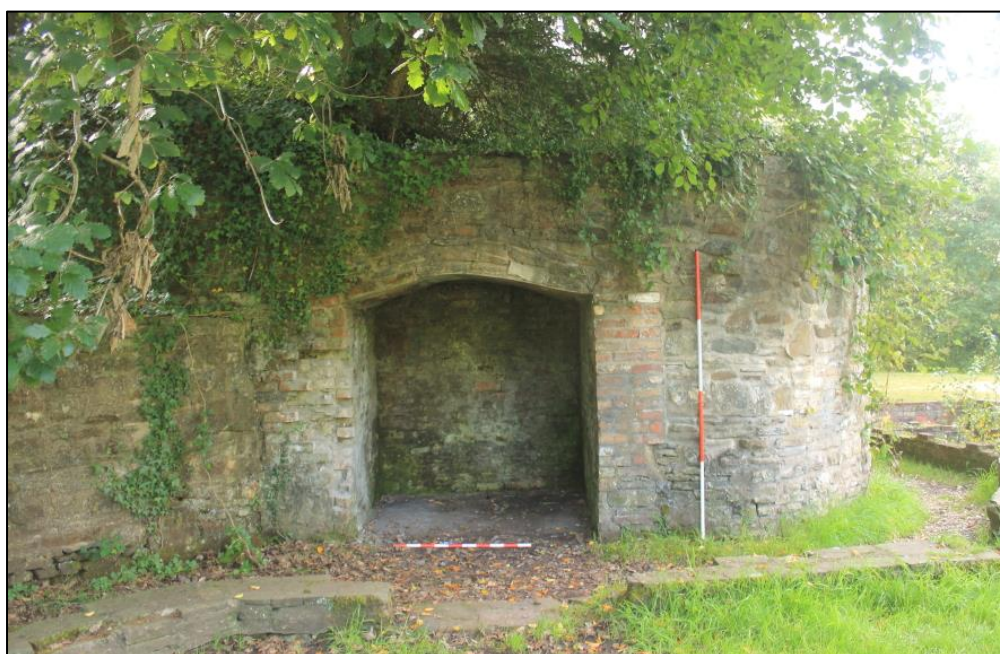
**Photo 61:** View south of a small room within the retaining wall adjacent to the house. 2m and 1m scales.

4.2.17 As the wall curves around to run west-east it is seen to contain a recessed room (1.7m<sup>2</sup> and 1.8m high) with a low arched ceiling and open to the north, facing the former servant's hall (Photo 61). The side walls of the room are largely brick-built with masonry inclusions and the rear wall is largely masonry with the occasional brick inclusion. There is a butt joint on the west side of the room between the brick and the curving masonry of the corner section of wall. The ceiling is partially cement rendered over brick, the facing masonry carried over the gentle curve with no lintel or voussoirs visible.

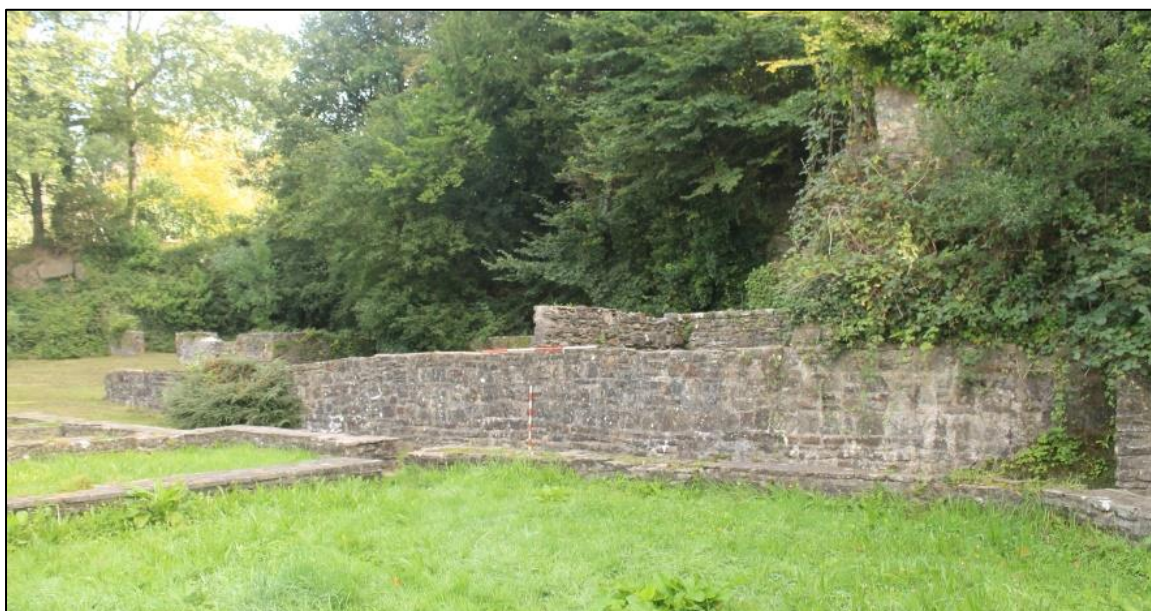
**Photo 62:** View northeast of retaining wall along the eastern side of Gnoll House.  
2m and 1m scales.
