## **GNOLL HOUSE AND POND COTTAGE, THE GNOLL, NEATH PORT TALBOT HISTORIC BUILDING RECORDING**

REPORT NO. 2023-25  
EVENT RECORD No. E007491

September 2023

Philip Poucher MCIfA

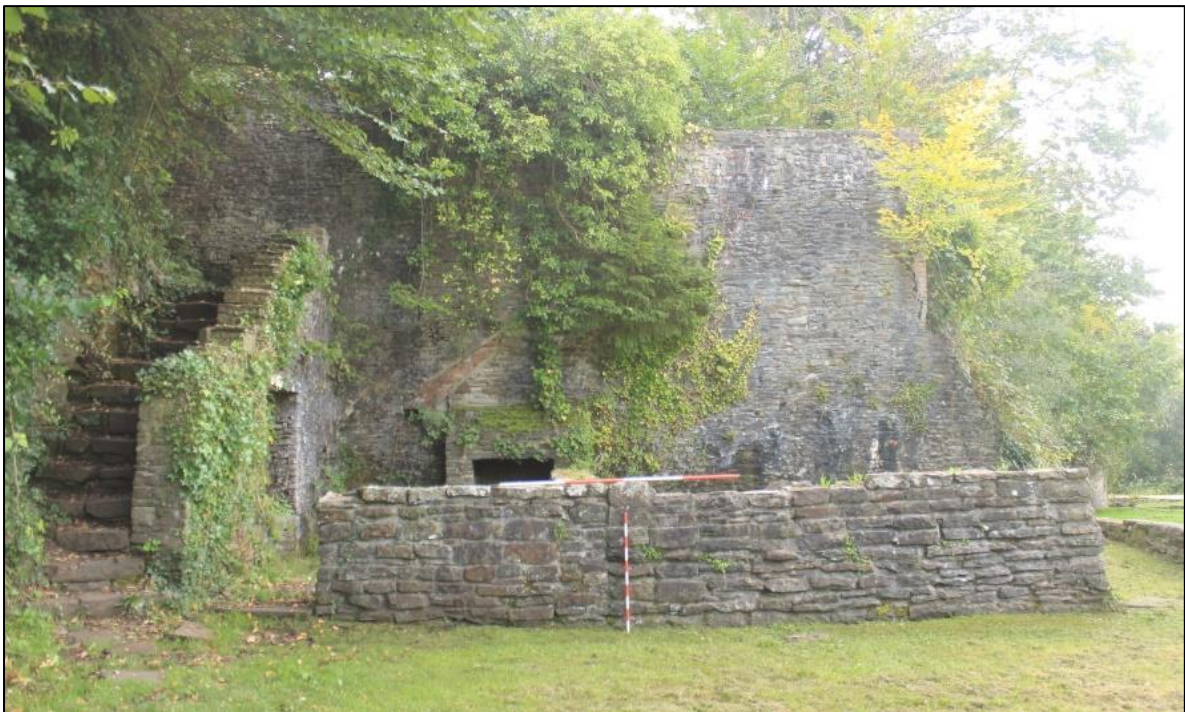
**Photo 63:** View south of the north and south walls of a former coach house and washhouse, with steps to a viewing platform above. 2m and 1m scales.

- 4.2.21 The eastern room (5.4m north-south by 3m), which contains the fireplace, is enclosed to the east by a wall of mortared random rubble with an angled top to provide the edging to a rising stone staircase on the east side (Photo 63). Placed centrally within the wall is a square recess (1.4m<sup>2</sup>) with brick edging to one side (Photo 65). It has a concrete lintel and an opening to the bedrock face behind. A 1m wide opening at the top of the wall, where it joins (the join obscured by mortar) against the south wall, may represent a former access point to an upper storey. This is now enclosed by metal bars as the rising stairs run past this opening. The west wall of the room, dividing the two rooms, is built against the west side of the fireplace structure, is 1.1m high and built of mortared random rubble. The north wall butts against this dividing wall and is built of roughly coursed mortared rubble with an entrance at the east end. The floor of this room is paved with squared stone slabs.

- 4.2.22 The western room (5.4m north-south by 6.5m) is formed by the high southern wall, the western boundary wall, the eastern dividing wall and a north wall that butts against the dividing wall. These walls are largely featureless although the northern wall stops approximately 1.8m from the west wall with an internal concrete floor the width of this opening and may indicate the site of a removed stairway. These rooms would appear to represent a former coach house and washhouse.

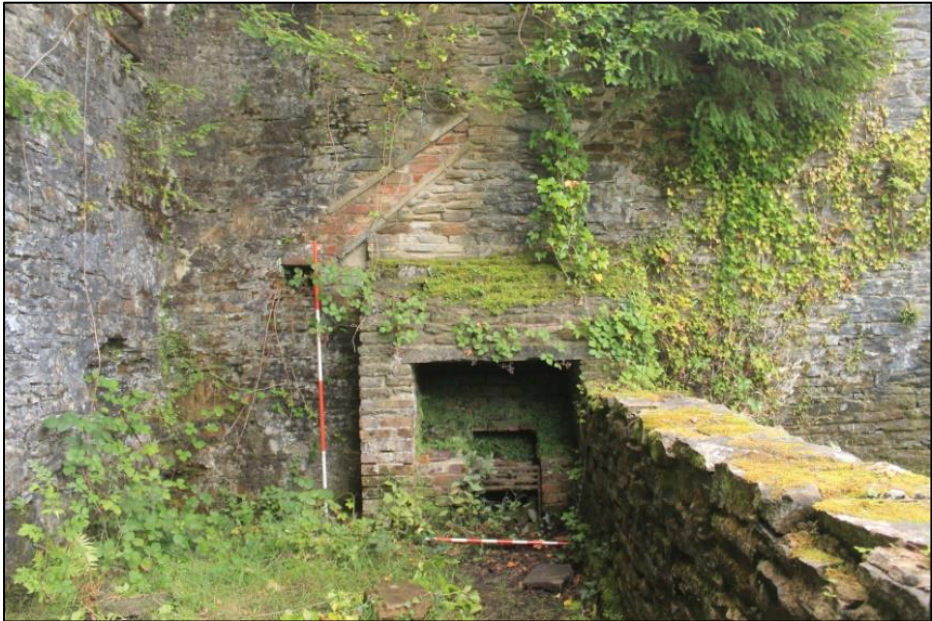
**Photo 64:**  
View south of  
the fireplace  
within the  
former  
washhouse.  
2m and 1m  
scales.

4.2.20 The wall appears continuous between the two rooms, although vegetation obscures this. Within the confines of the eastern room a small brick-built fireplace is built into the wall at ground level, fronted by an iron grill, with a protruding brick-built surround supporting a mortared masonry hood over a stone lintel (Photo 64). The whole structure measures 1.9m wide and 1.75m high. Just to the east of the fireplace is a beam slot (0.3m by 0.2m), level with the top of the fireplace hood. Two angled lines of stone slabs set into the wall and infilled with brickwork mark a possible roofline above the fireplace, although this stops abruptly midway over the fireplace hood. Further angled roof flashing is suggested to the west but largely obscured by vegetation. Towards the top of the wall a vertical butt joint just beyond the northern wall may mark an original end to the wall which was therefore topped and extended

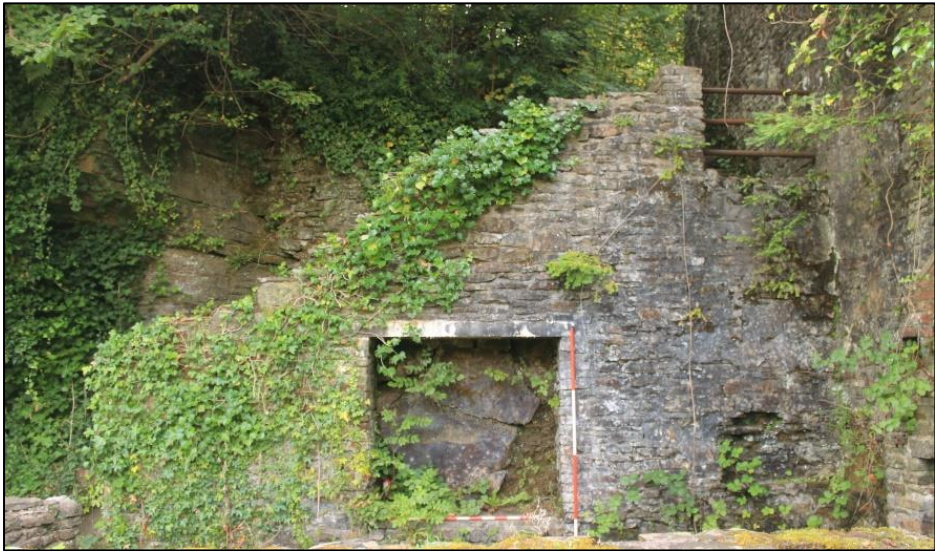
**Photo 65:**  
View east of  
the squared  
recess in the  
eastern wall  
of the former  
washhouse.  
2m and 1m  
scales.

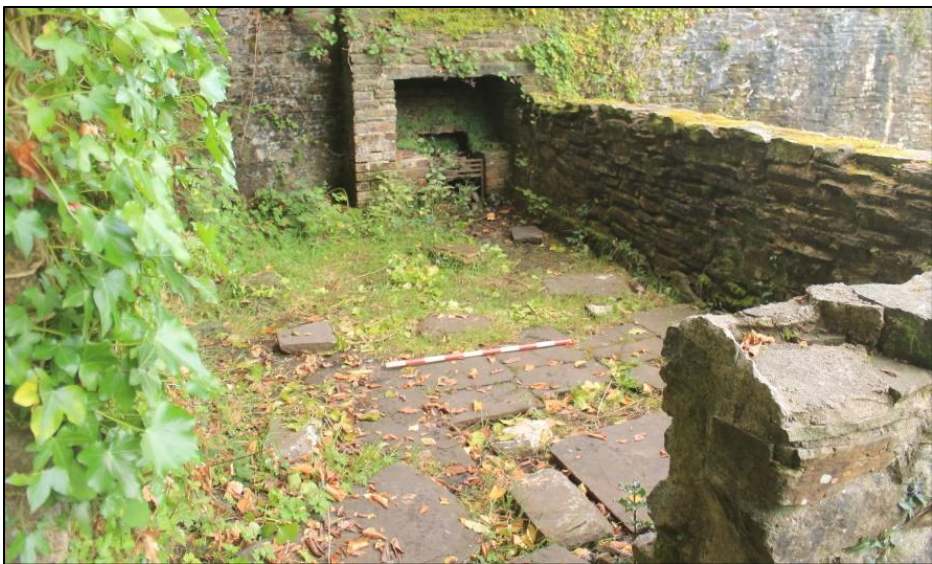
**Photo 66:**  
View  
southwest  
showing the  
paved floor  
of the former  
washhouse.  
1m scale.

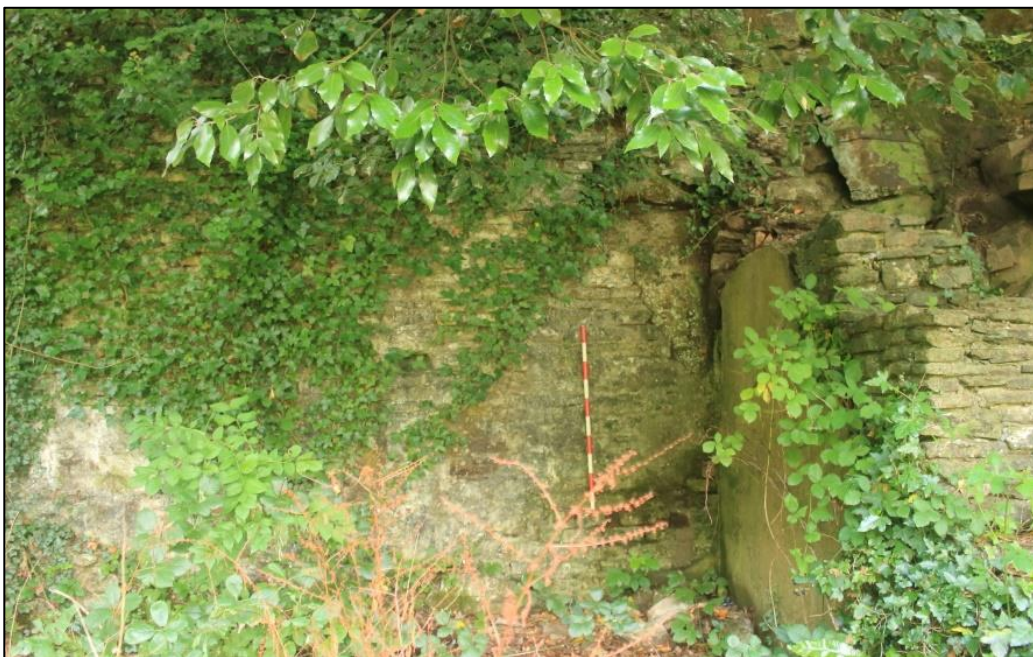
**Photo 67:** View east of the eastern wall of a detached room built against the quarried rock face. 1m scale.

- 4.2.23 To the north, two rooms have been built against a partly quarried rock face on the east side, currently vegetation covered (Photos 67 and 70). The larger room (4.5m north-south by 9m) is built against the bedrock on the eastern side which has been faced with a wall of mortared brick and masonry, approximately 2.5m high and internally covered in a lime render. The northern wall is 0.9m high and built of mortared random rubble with two doorway openings in the western half (Photo 68). The relationship with the east wall is obscured. The south wall is built of mortared random rubble with a cement rendered internal face. This extends for 3m, before being stepped down and ending in a doorway opening. The wall then continues as a 0.9m high wall of mortared random rubble, partially cement rendered to the interior. The wall appears to return to form the west wall, which has largely been rebuilt in sections, with a block of random rubble butting against the return (Photo 69). The northern end of this west wall is built of rough brickwork and butted against the north wall, leaving a 1.6m gap between the two sections of wall which has subsequently been infilled in rough random rubble with an additional heightening and capping of masonry and cement mortar. Internally a partial concrete floor is visible, with remnants of a north-south cross wall roughly midway between the two door openings visible in the north wall.

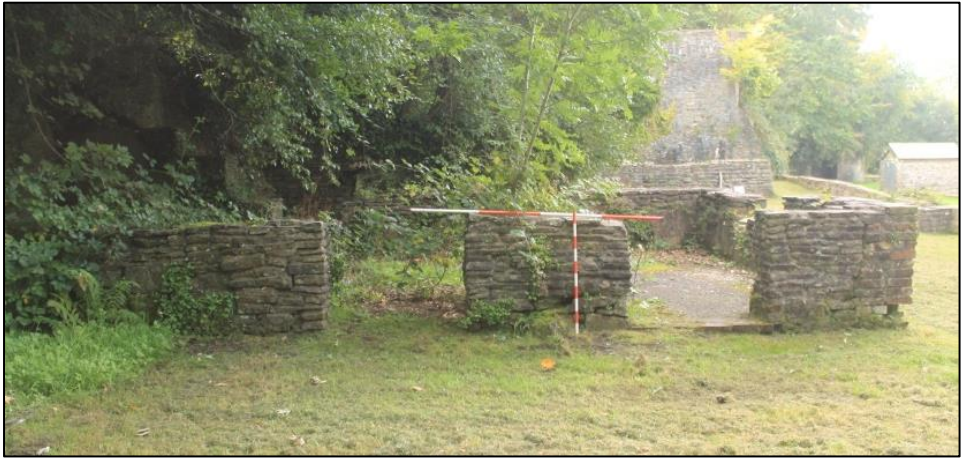
**Photo 68:**  
View south  
of the  
northern  
wall of the  
detached  
room.

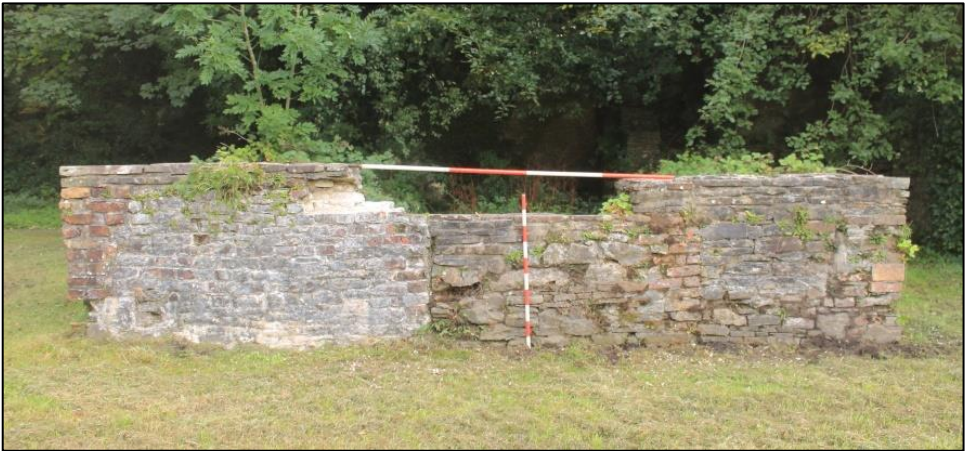
**Photo 69:**  
View east  
of the  
heavily-  
patched  
west wall  
of the  
detached  
room.

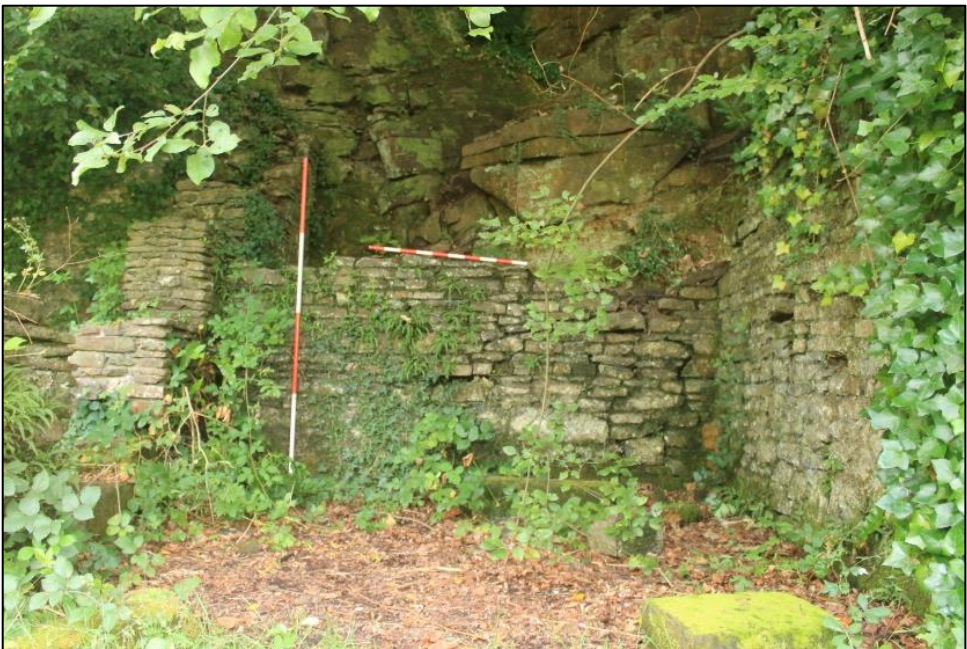
**Photo 70:**  
View east  
of the  
smaller of  
the two  
detached  
rooms  
against the  
rock face  
to the east  
of Gnoll  
House.

- 4.2.24 A room (3.1m north-south by 5m) lies on the south side, formed by an L-shaped abutting wall, up to 2.2m high, of roughly coursed mortared rubble. This room is open to the west, with surface level stonework of a possible threshold in line with the western end of the wall. Squared stones on the ground surface suggests possible stone slab flooring in front.

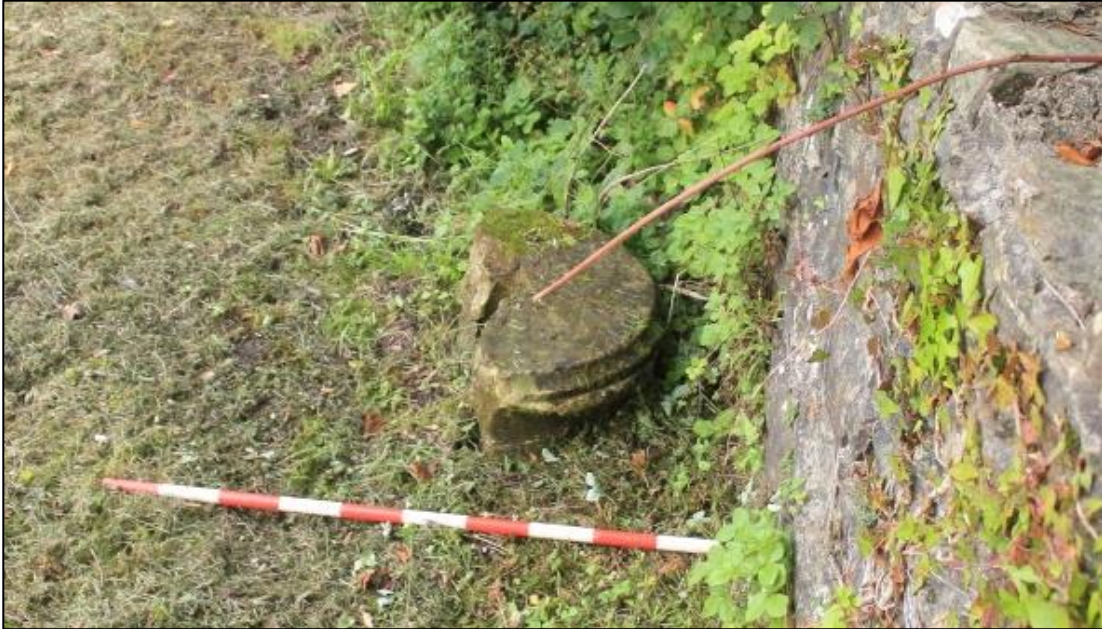
- 4.2.25 Extending south from the southern room is a retaining or boundary wall of mortared random rubble, 5m long, 1.1m high, 0.35m wide and otherwise featureless. On the south side of the wall lie the partial remains of a carved stone circular plinth (0.6m in diameter), set 0.15m in front of the wall. The plinth is carved in a yellow sandstone with a central hole, from which it has broken radially (Photo 71).

**Photo 71:** View north showing the plinth set in front of an eastern retaining/boundary wall. 1m scale.

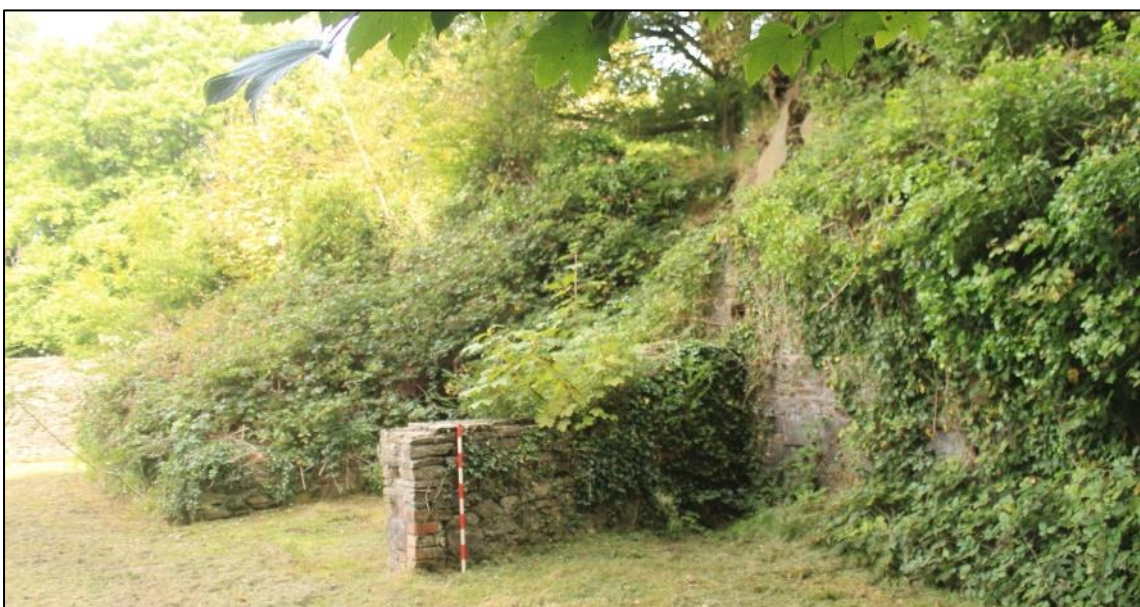
**Photo 72:** View northwest of walls against the northern side of the service yard area. 1m scale.

4.2.26 To the north lies a further set of vegetation-covered walling built into or against the rising ground (Photo 72). An east-west wall built against the face is up to 2.5m high and built of mortared random rubble. Only small sections of this wall are visible amongst the vegetation cover. A 1.1m high wall of random rubble and with a brick-edged terminus extends 3m south from the east-west wall. A line of bricks is placed at ground level to define an eastward return, extending 4.1m to the east. To the west the northern wall doglegs back to the north slightly, before returning at a right angle southward to enclose an area of roughly 3m by 4.8m. Positioned centrally within this area, close to the north wall, is another carved sandstone circular plinth (Photo 73).

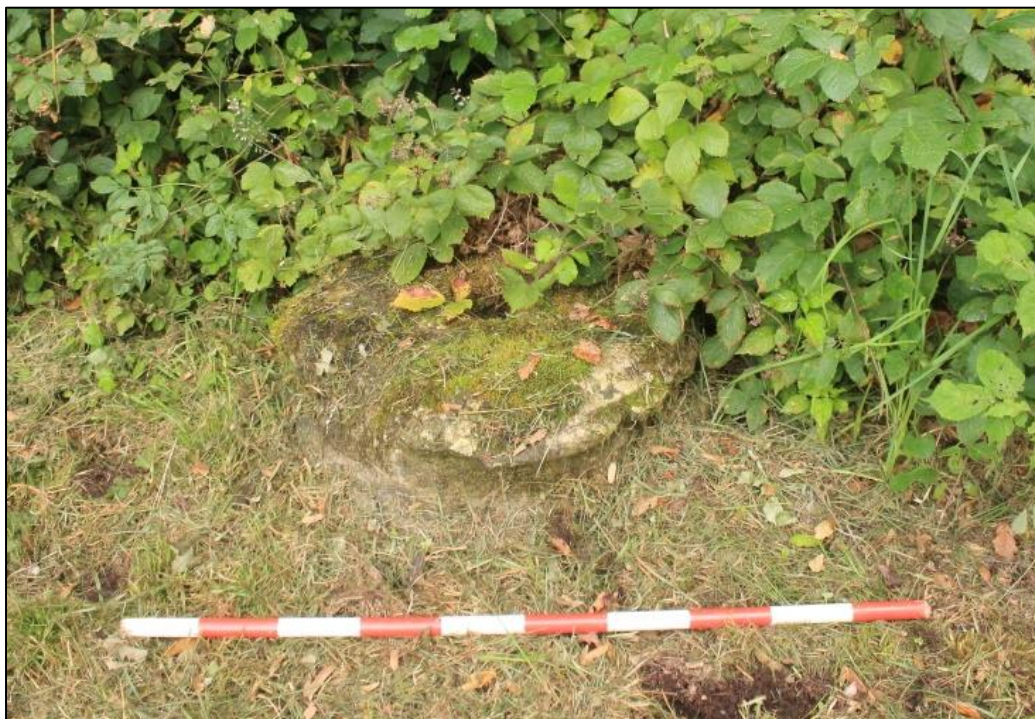
**Photo 73:** View north of a stone plinth close to the northern edge of the service yards area. 1m scale.

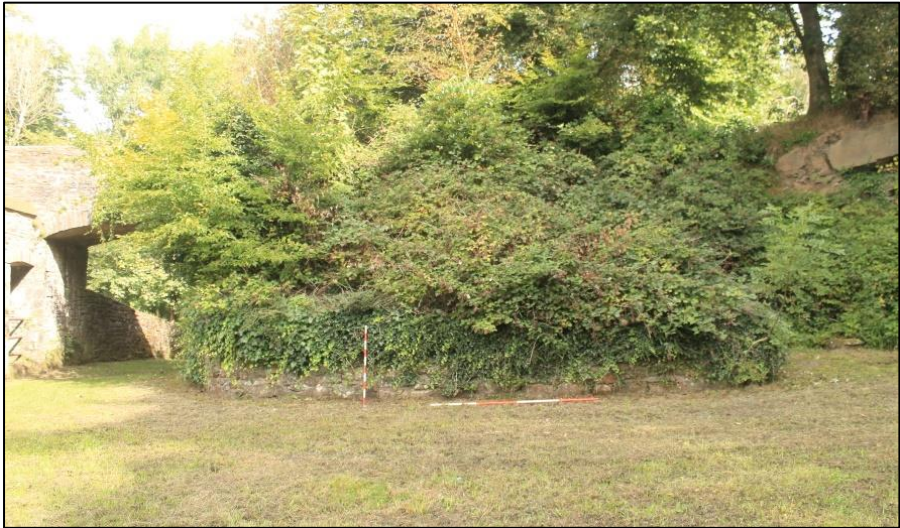
**Photo 74:** View north showing the retaining wall running up the entrance structure on the left.  
2m and 1m scales.

- 4.2.27 The north wall returns west to form a curving retaining wall that then forms the east edge of the entranceway structures to the rear service yard of the house (Photo 74). The wall butts against a 2.1m wide arched gateway structure. Squared blocks of faced mortared random rubble form either side of the entrance, with a central opening 2.5m wide (Photo 75). Central vertical grooves to either side suggest a door structure in the middle (Photo 77). Dressed quoins are visible along the northern edge on the east side of the entrance, in the lower courses on the north edge of the west side, and almost to full height on the southern edge. These blocks carry a low arch of mortared masonry above, with dressed stone voussoirs to either side. The arch forms an opening approximately 2.4m high, with an additional 1.4m of masonry above, enclosing a viewing platform.

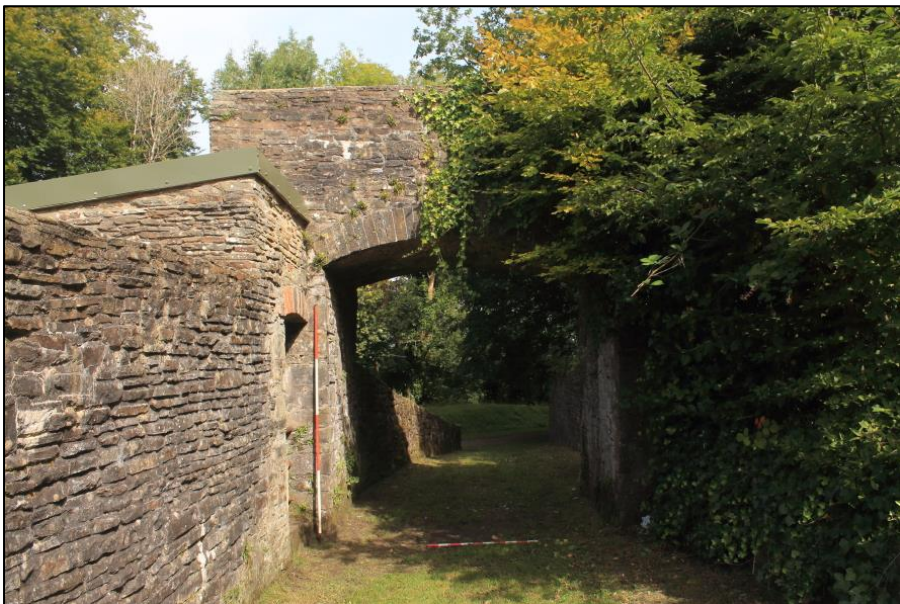
**Photo 75:** View north of the archway entrance to the rear service yard.  
2m and 1m scales.

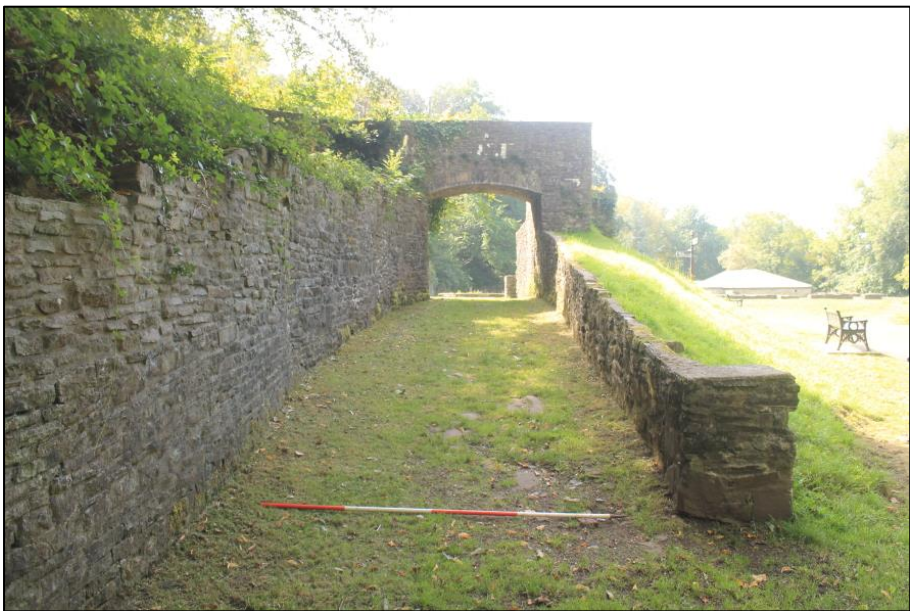
**Photo 76:** View south of the entrance drive to the rear service yard area.  
2m scale.

- 4.2.28 On the east side a high boundary wall butts against the north side of the entranceway structure, and forms a gently curving boundary to a sloping approach. This is mirrored by a lower wall on the west side (Photo 76).

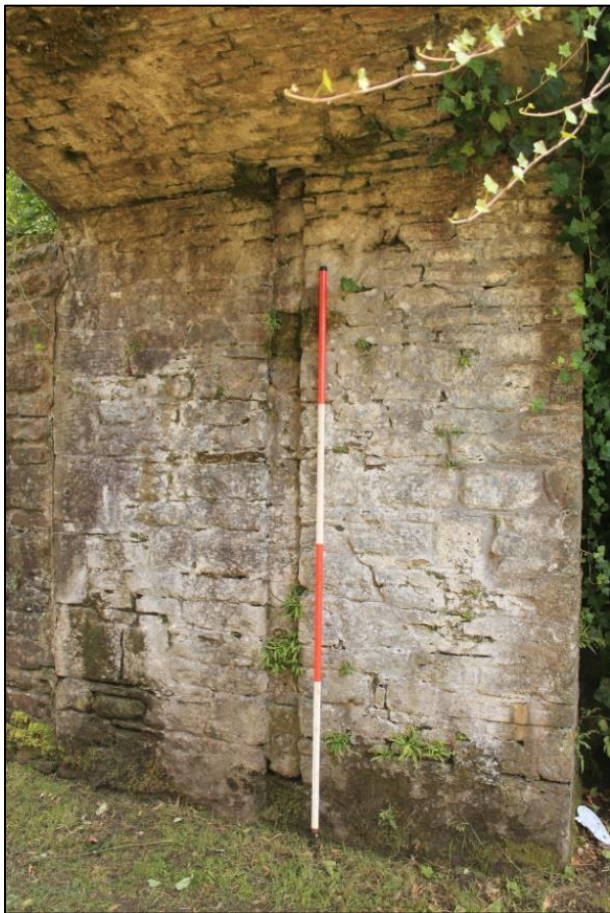
**Photo 77:** View east of the door jamb groove in the entranceway structure to the service yard.  
2m scale.

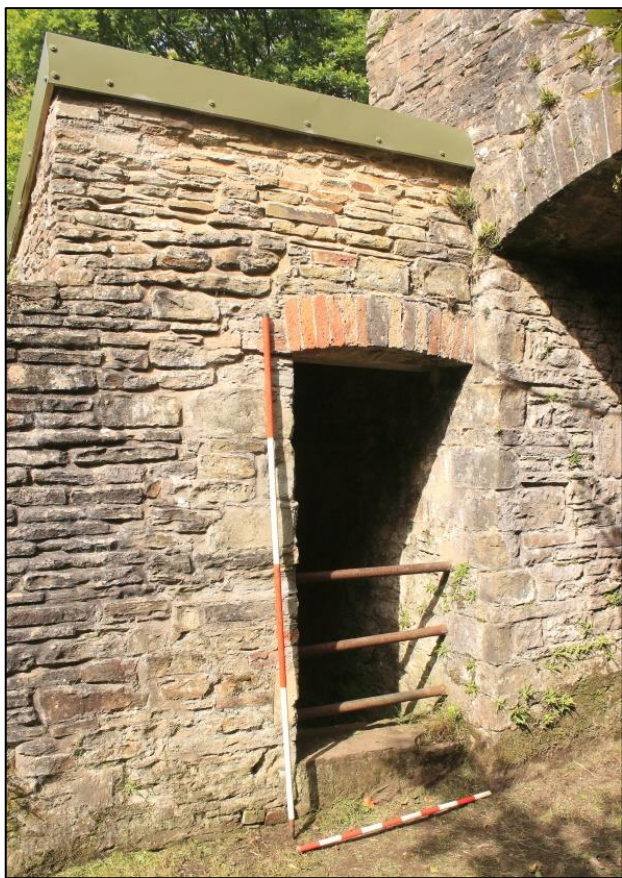
**Photo 78:** View west of the doorway and entrance to a former w.c. on the internal side of the entranceway structure.  
2m and 1m scales.

- 4.2.29 On the internal (east) side to the south lies an open doorway (1m by 1.9), topped by a low brick arch but otherwise in a structure of mortared random rubble. This opens into a small room (1.2m by 1.5m) that drops 1.5m below the external ground level, although protruding stonework and beam slots indicate a raised floor within. This structure has been topped by a modern metal roof. Annotated late 19<sup>th</sup> century plans suggest this was a w.c. (Photos 78 and 79). The internal face of the wall continues for 3.3m to a western return, with large roughly dressed corner stones. The upper part of the wall falls gradually to the south but has been levelled off with later infill. The wall returns once more to the south and then dog-legs to the east, forming a possible room (3m by 1.4m). A small section of walling has then been butted against the southern edge (Photo 80).

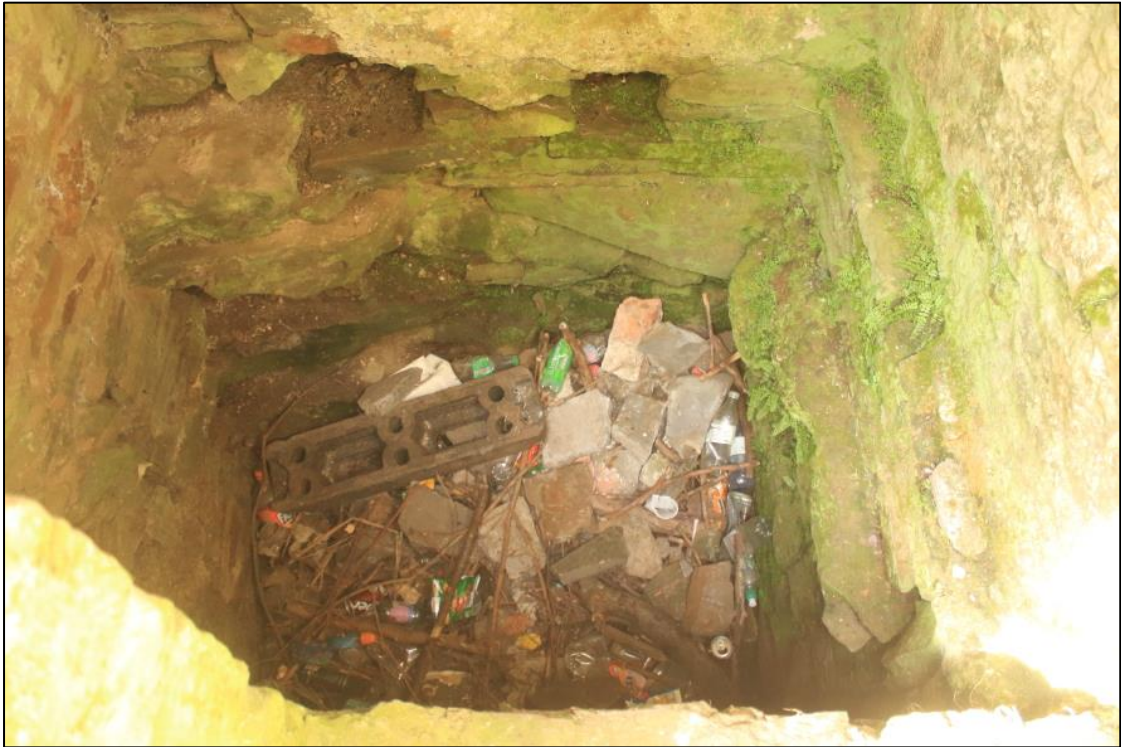
**Photo 79:** View west of the interior of the former w.c.

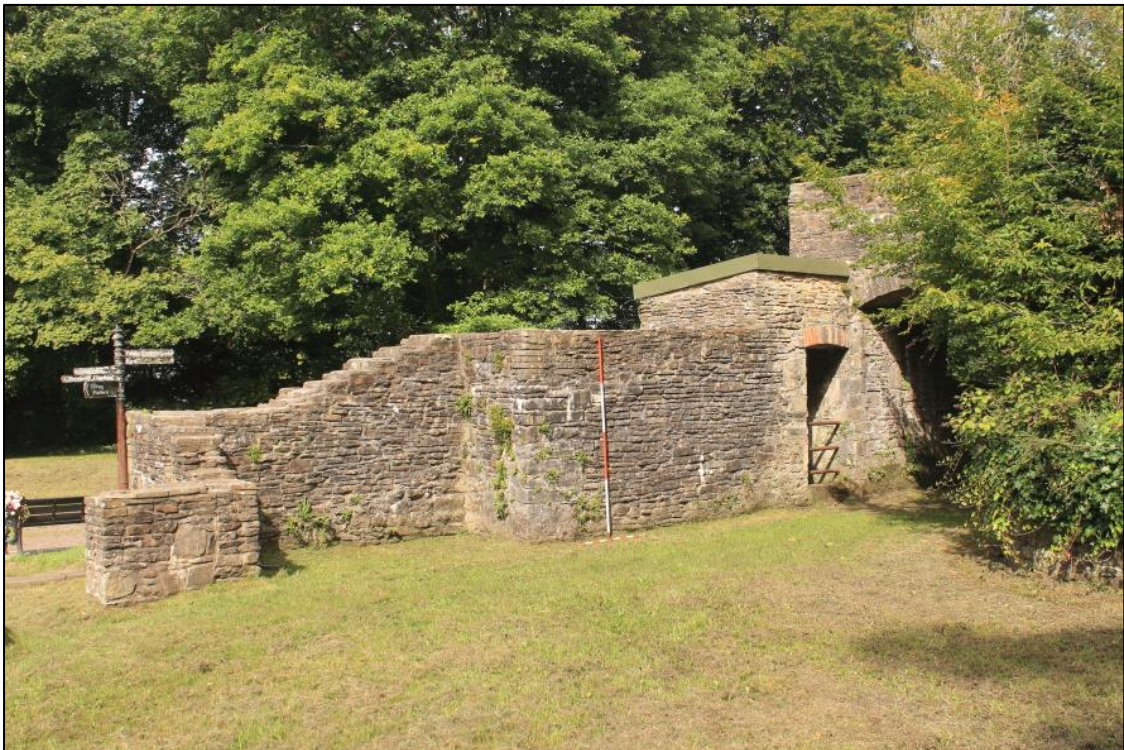
**Photo 80:** View west showing the wall on the south side of the entranceway structure. 2m scale.

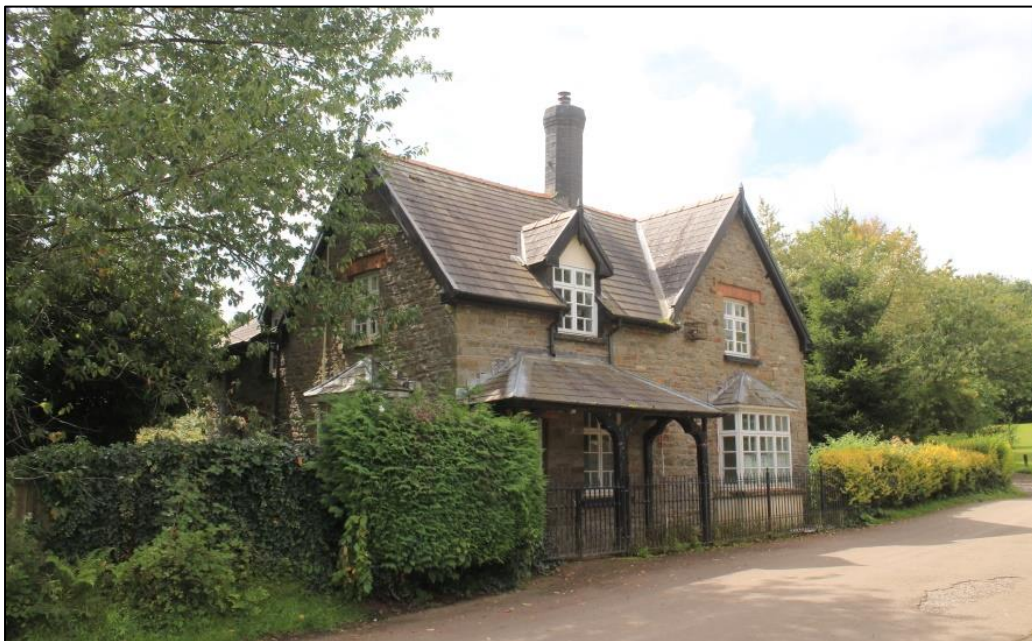
**Photo 81:** View southwest showing the front elevation of Pond Cottage.

- 4.3.1 Pond Cottage (Photo 81) is a two-storey dwelling, 9.8m east-west by 9.5m north-south, built of mortared random rubble, roughly faced and squared, and rendered to the rear (south). The building is 4m high to the apex, with a cross-gabled roof of slate with clay-ridge tile and a centrally placed octagonal chimney stack in black brick (Photo 82).

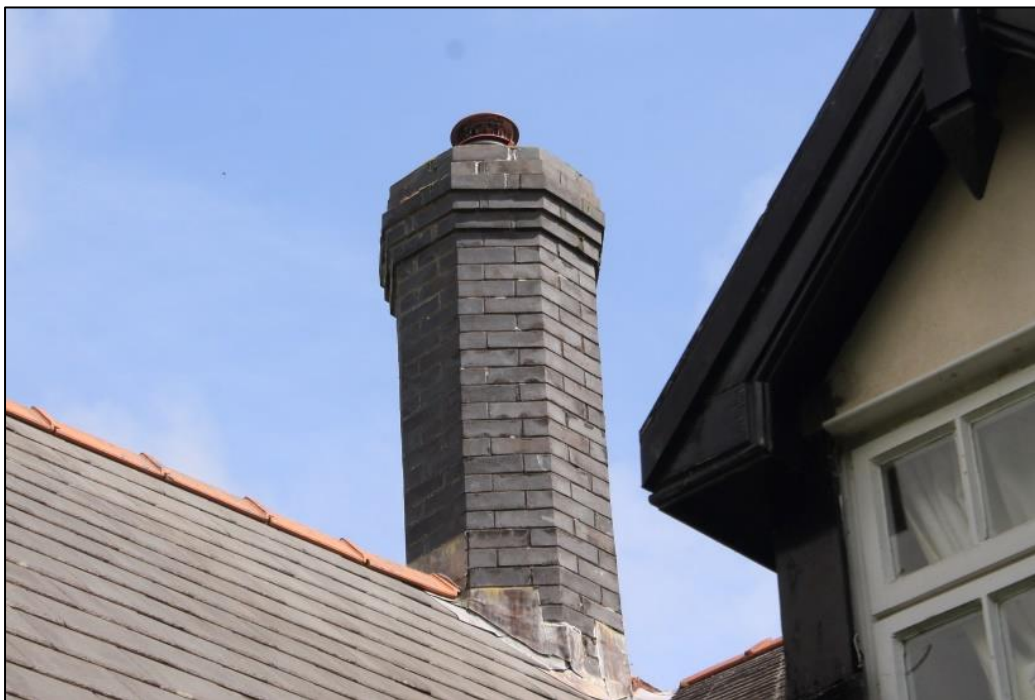
**Photo 82:** View northeast of the octagonal chimney.

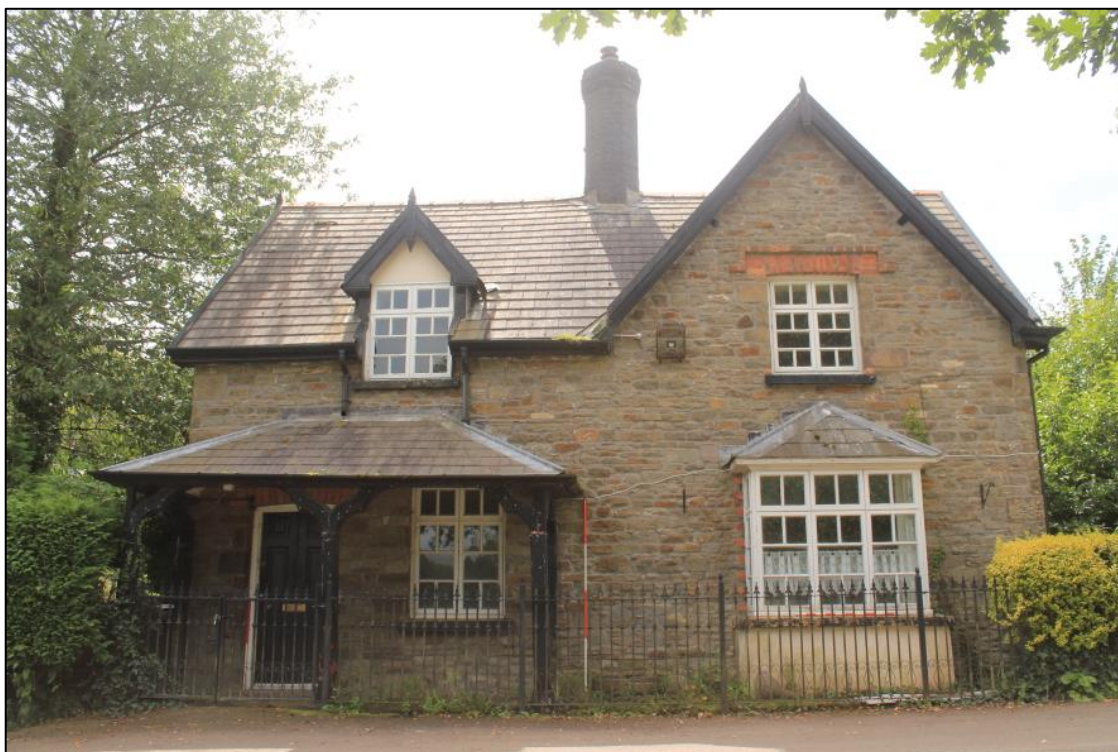
**Photo 83:** View south of the front elevation of Pond Cottage. 2m scale.

- 4.3.2 The front elevation of the building (Photo 83) faces north-northeast and the front door sits towards the east end; a black-painted timber panel door within a wooden frame, flanked by large squared masonry with a low arched header in red brick (Photo 84). Adjacent, to the west, sits a casement window in a white-painted timber frame above a projecting painted cast stone sill. The single-glazed windows have a rectangular central panel, topped by a smaller pair of glazed panels above and below. These smaller panels are replicated in the upper openings and this window design is repeated throughout the building. Both door and window sit beneath a projecting porch canopy of a hipped slate roof with rolled lead joints, held on an open frame of black-painted squared timber posts with chamfered corners, split into angular m-shaped braces at the top.

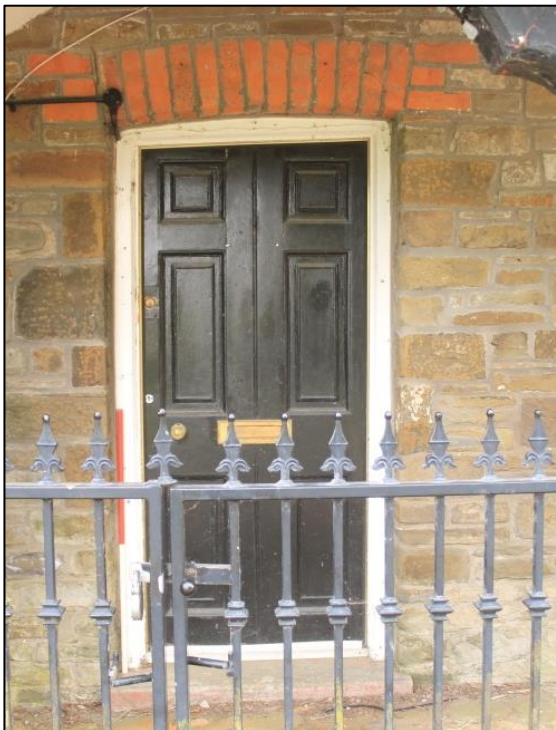
**Photo 84:** View south of the front door.  
1m scale.

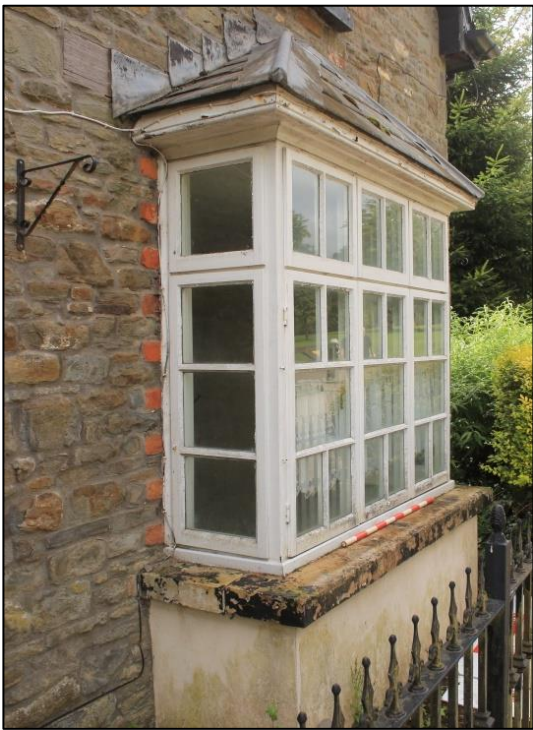
**Photo 85:** View southwest of the front facing bay window.  
1m scale.

- 4.3.3 To the west at ground floor level sits a projecting squared bay (Photo 85) with a continuous line of windows below a hipped slate roof, and above a projecting cast stone sill with smooth cement-rendered facing below. Brickwork frames the join between the bay and the main wall.

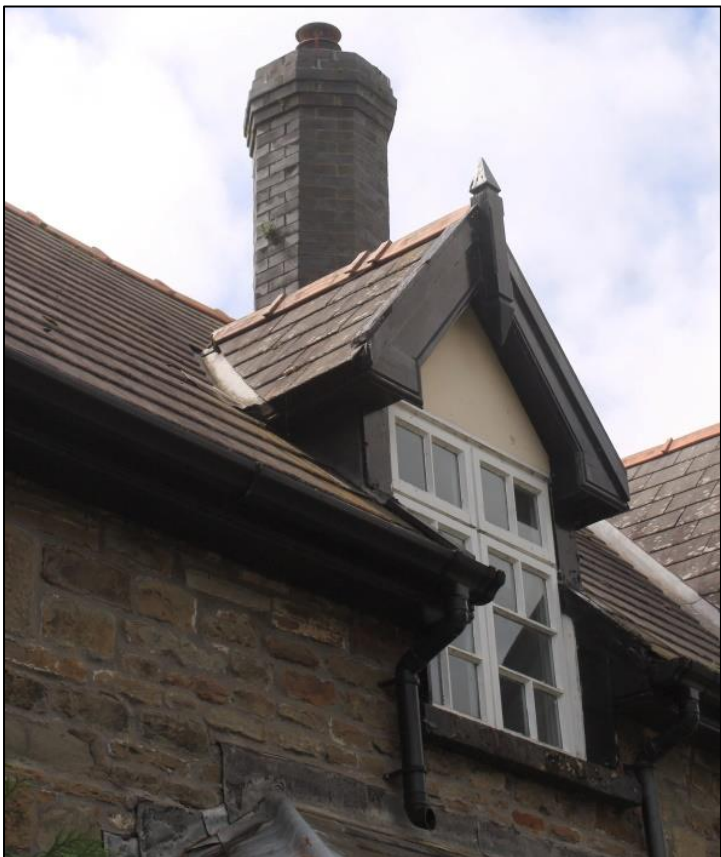
**Photo 86:** View southwest.  
First floor dormer window  
and roofing detail.

- 4.3.4 At first floor level above the bay window sits another window within the cross-gable, flush to the rest of the building face. The brick window header is topped by a projecting line of brickwork in a mock-Tudor style. To the east lies a dormer window (Photo 86). The roof is lined by black-painted timber fascias and barge boards, with finials at each roof apex.

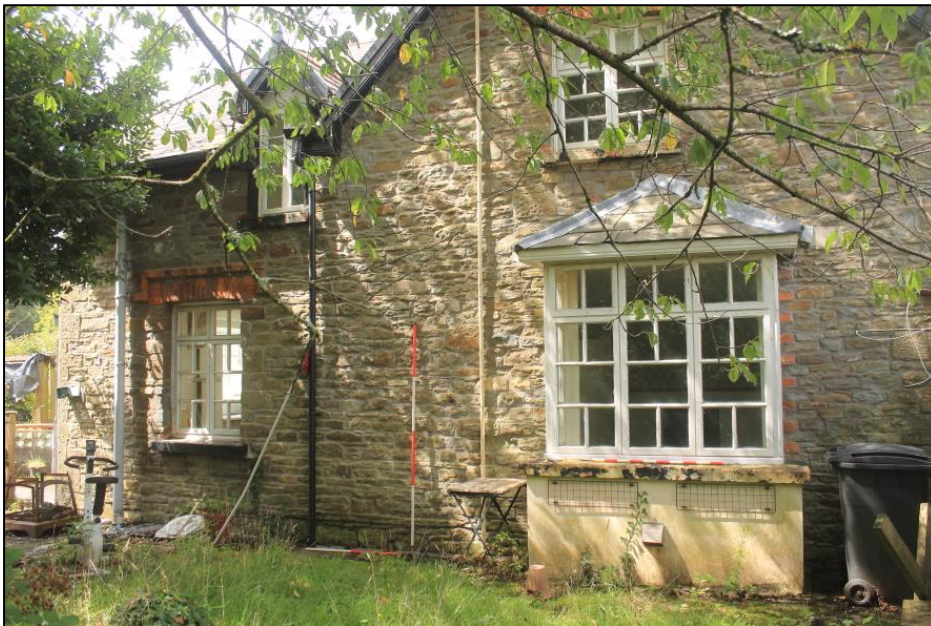
**Photo 87:** View west of the east elevation of Pond Cottage. 2m and 1m scales.

- 4.3.5 The east elevation includes an end gable wall and side wall of the rear cross gable, presenting a continuous face of exposed masonry with stippled quoin stones to the front and rear (Photo 87). At ground floor level there is a projecting squared bay in the gable end, mirroring the style of the front wall. To the south lies a casement window with brick mock-Tudor header.
- 4.3.6 At first floor level a casement window sits centrally in the gable end (Photo 88). To the south a smaller dormer window sits at the angle in the roof at a slightly lower level, giving light to an internal staircase (Photo 89). Black-painted timber fascias, barge boards and finials are continued across this elevation.

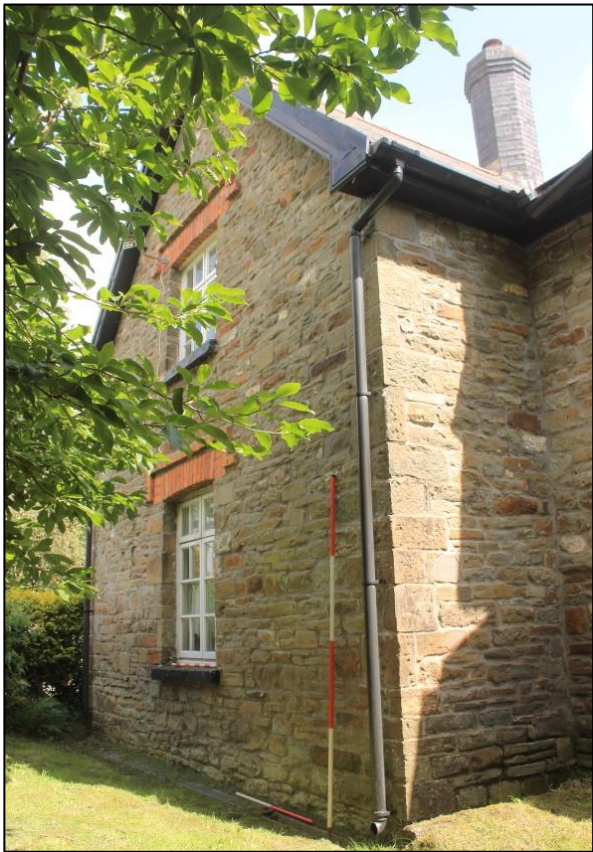
**Photo 90:** View northeast of the west elevation of Pond Cottage.  
2m and 1m scales.

4.3.7 The west elevation (Photo 90) has a projecting gable end in exposed masonry with corner quoins. A ground floor casement window with a brick mock-Tudor head is mirrored by a slightly shorter window at first floor level above. The cross gable is set back slightly and includes a centrally placed three-panelled casement window at ground level, with a two-panelled dormer window above. An integral lean-to with single pitched roof extends the line of the wall to the south. A gas meter box is attached to this section of wall (Photo 91).

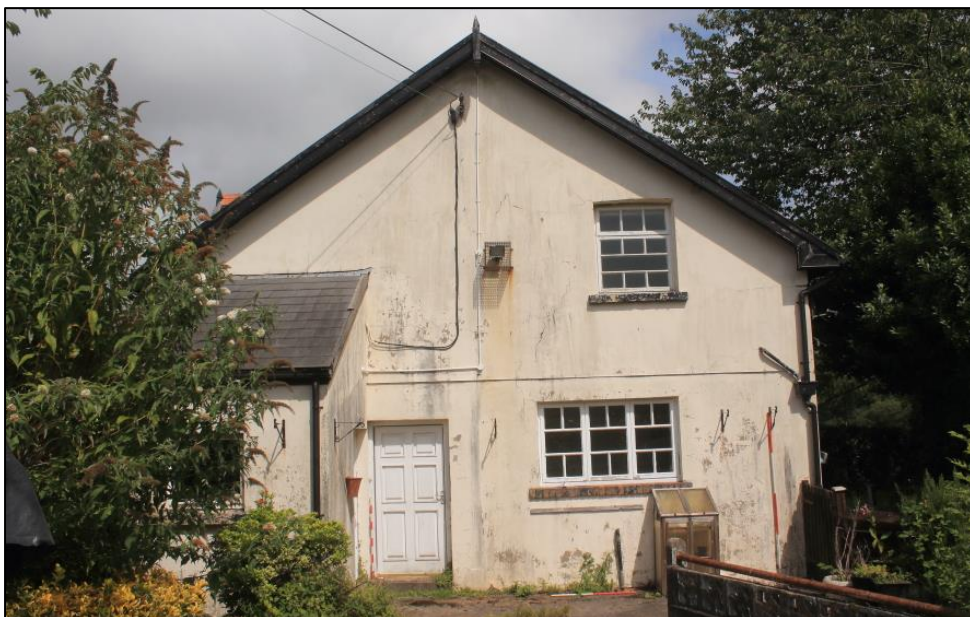
**Photo 92:** View north of the rear, south elevation of Pond Cottage. 2m and 1m scales.

- 4.3.8 The south (rear) elevation is covered in smooth cement render (Photo 92), painted white. The rear door is a white-painted panelled timber door within a plain squared surround, sitting off-centre to the west. A three-panelled casement window with a protruding brick sill but no brick header lies to the east. A wide single-panel fixed first floor window with awning lies above, also lacking the brick header, but with a typical painted cast stone sill.
- 4.3.9 At the western end of the elevation lies an integral ground-floor lean-to with slate pitched roof and cement rendered walls (Photo 93). A white-painted timber shed door accesses from the east and a plain fixed single-glaze window in a timber frame sits centrally in the south wall.

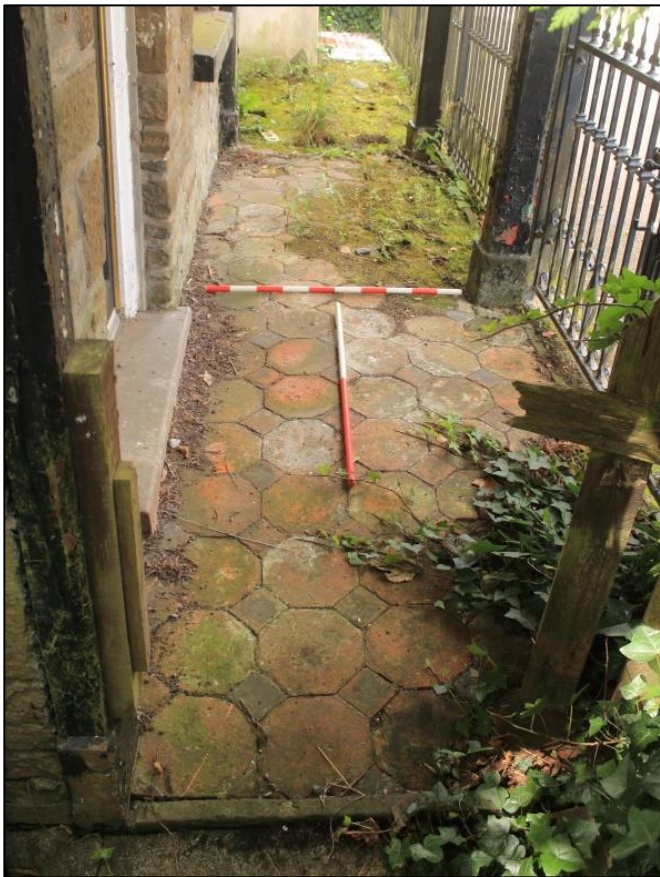
**Photo 94:** View north of tiled patio fronting the building.  
1m scales.

4.3.10 Externally the front north elevation is fronted by a tiled patio 1.4m wide and laid with red-clay octagonal tiles with small black diamond clay-tile infill. A decorative iron rail fronts this area with a gateway in front of the main door, dividing it from the drive in front (Photo 94).

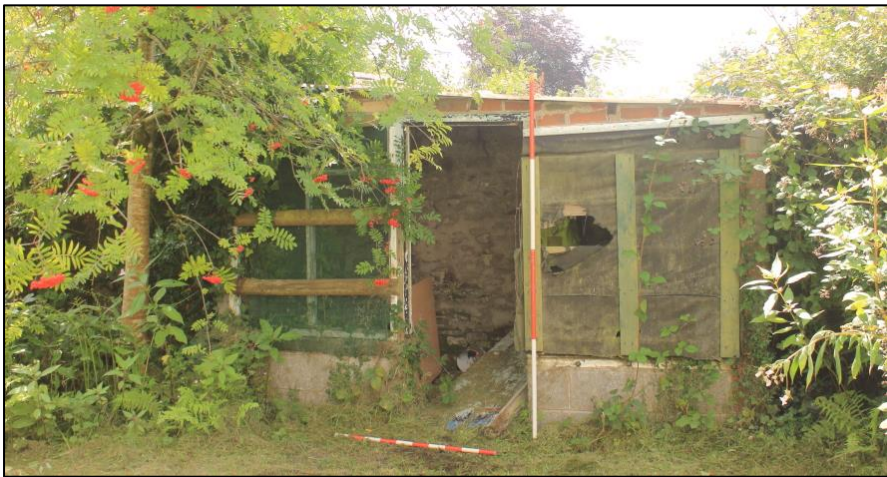
**Photo 97:** View south of garden shed in the southeast corner of the rear garden.

- 4.3.13 Built against the angle of the south and east masonry boundary walls is a shed structure (Photo 97). A low wall of concrete breeze blocks supports large timber-framed windows, with gable end walls of red brick. Red brick also tops the windows to support gently sloping corrugated sheet roofing. Internally, an external doorway is visible in the east boundary wall as it meets the south wall. The doorway has a timber lintel and is blocked in concrete breeze block and red brick (Photo 98).

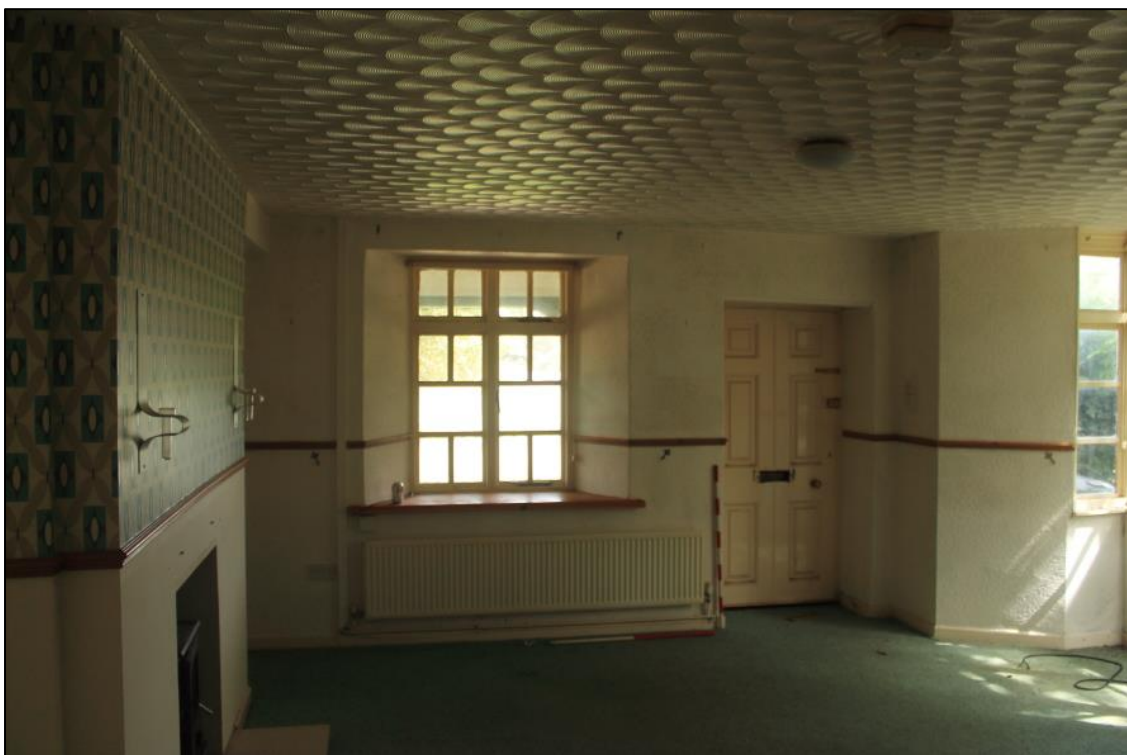
**Photo 101:** View north of living room. 1m scales.

- 4.4.2 The main entry to the building is via the front door in the north elevation, directly into the living room (5.8m north-south by 4.3m) (Photo 101). The floor is carpeted, with low plain skirting to papered walls with a mid-level plain timber dado and an artex ceiling in a repeating fan pattern. The front door sits in a plain squared surround. The room is lit by a window in the north wall and a squared bay window in the east wall, both within splayed openings.
