## **GNOLL HOUSE AND POND COTTAGE, THE GNOLL, NEATH PORT TALBOT HISTORIC BUILDING RECORDING**

REPORT NO. 2023-25  
EVENT RECORD No. E007491

September 2023

Philip Poucher MCIfA

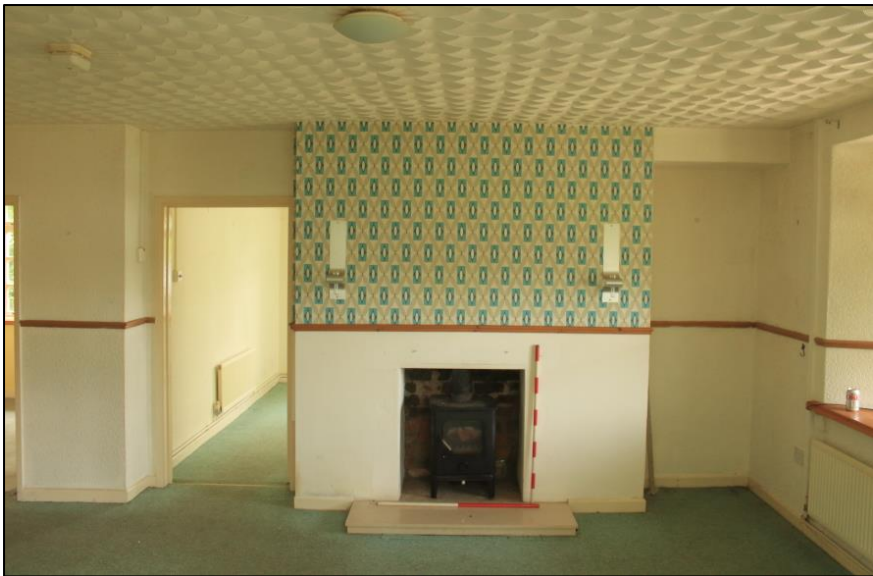
**Photo 102:** View west of living room fireplace.  
1m scales.

- 4.4.3 A fireplace sits centrally within the chimney block on the west side (Photo 102). A plain squared opening with coursed squared masonry visible behind contains a modern free-standing log burner on a concrete base fronted by a modern marble-effect hearth.

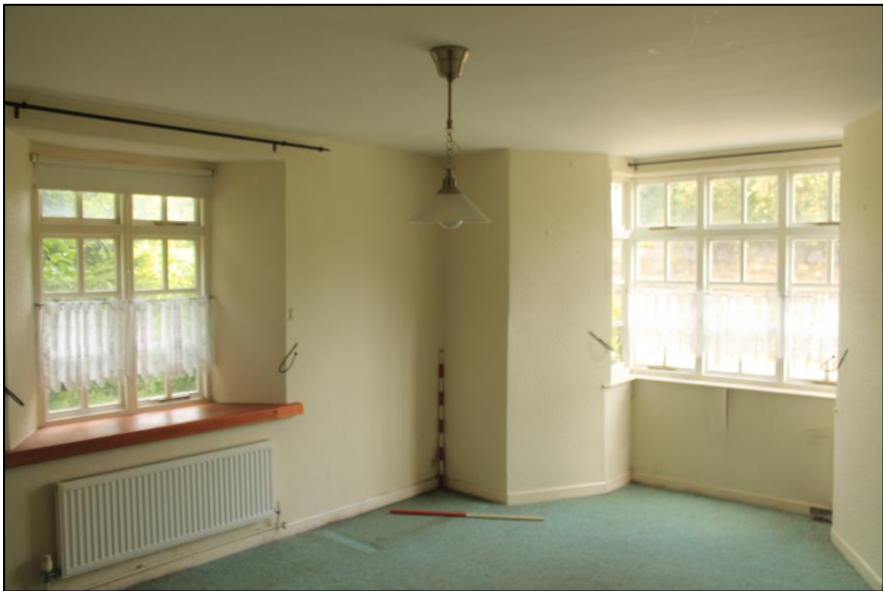
**Photo 104:** View northwest. Ground floor parlour/bedroom.  
1m scales.

- 4.4.6 To the west lies a parlour/bedroom (4.2m north-south by 4m) (Photo 104). The floor is carpeted, with a low plain skirting to plain papered walls and plain plastered ceiling with a central modern light fitting. The room is lit by a window in the west wall and a squared bay window in the north wall, both in splayed openings.
- 4.4.7 A plastic vent cover on the east wall marks the site of a blocked fireplace which has been papered over (Photo 105). The door access lies on the south side of this chimney block and the recess on the north side of the chimney block has an arched head with beaded edging. A modern radiator lies on the west wall and all fixtures are modern.

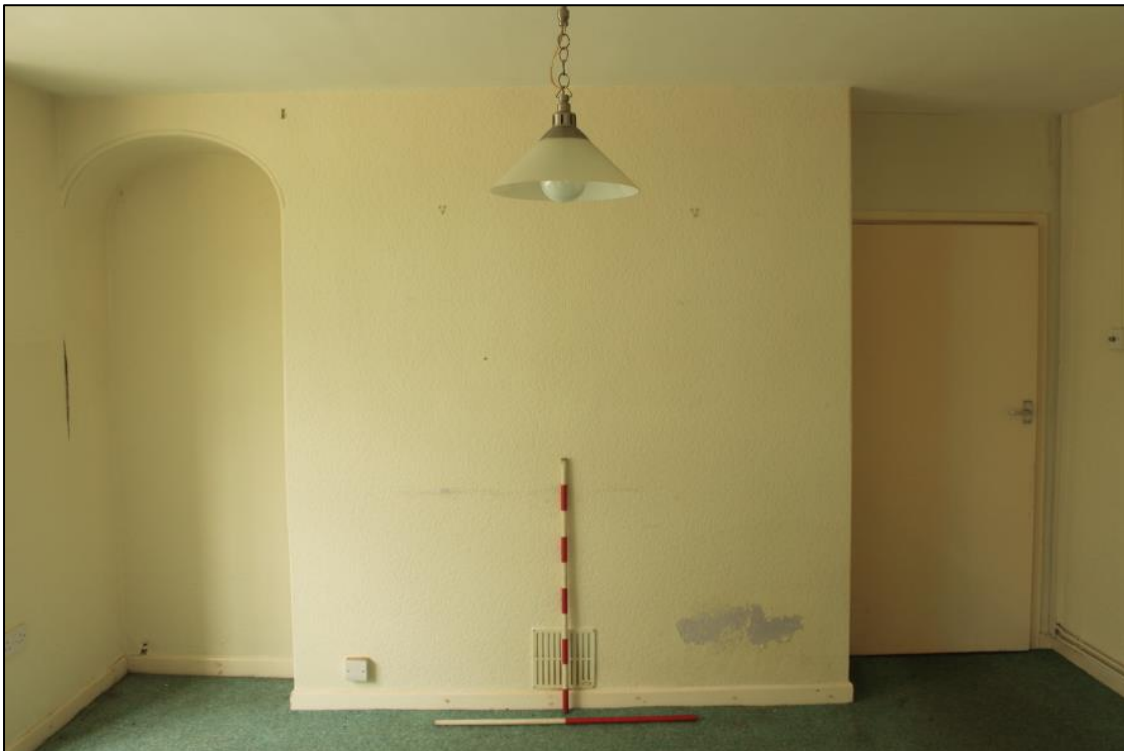
**Photo 105:** View east of ground floor parlour/bedroom, showing blocked fireplace. 1m scales.

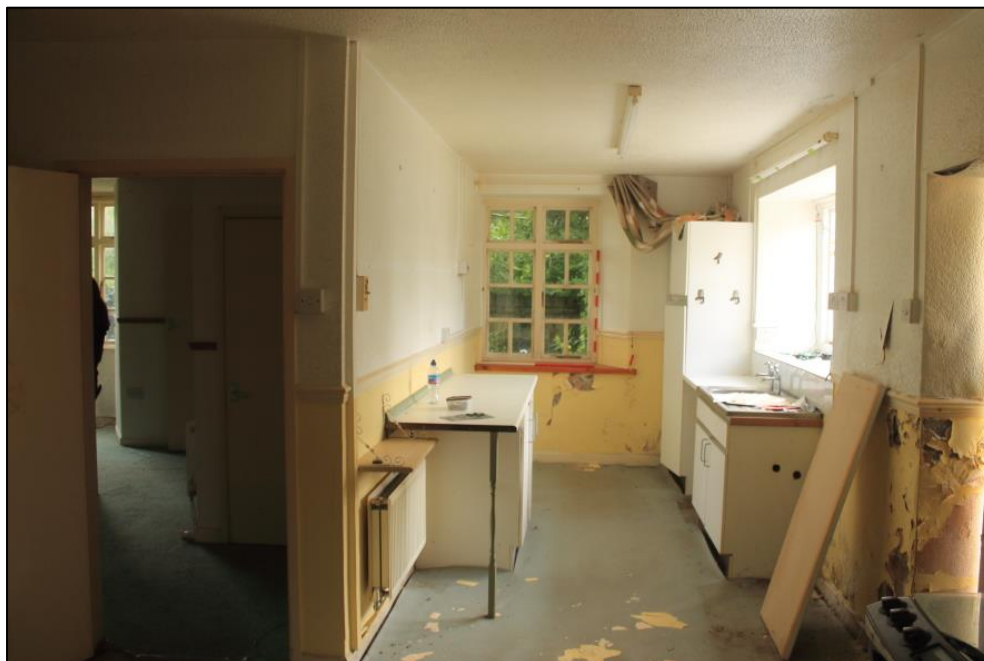
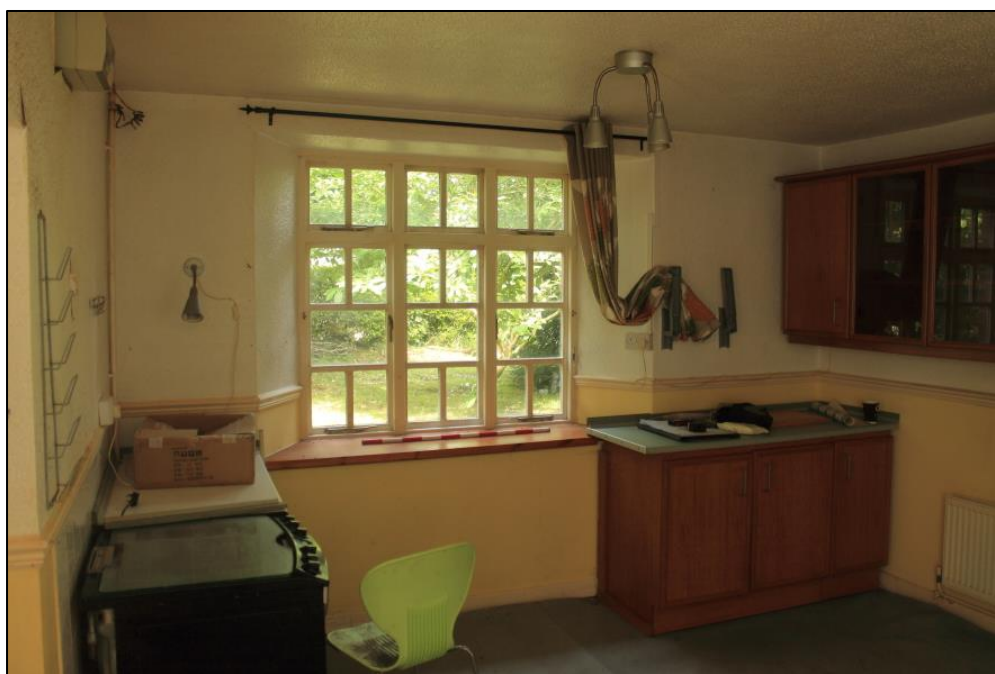
- 4.4.8 On the south side of the building lies a combined kitchen diner (Photos 106 and 107) occupying an L-shaped space (3.7m north-south by 7m) with access to the living room to the north and an external rear door to the south. The floor is covered with linoleum, with low plain skirting to a plain painted plaster wall, mid-level moulded timber dado and papered walls above to a stippled artex ceiling.

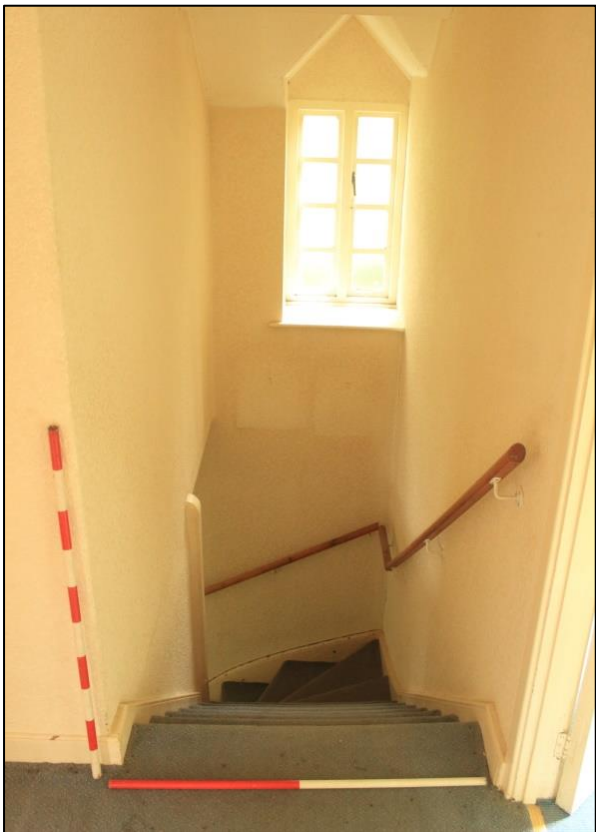
**Photo 108:** View east, looking down the stairway.  
1m scales.

4.4.10 The stairway is accessed via the living room. A half-turned staircase rises to the first floor landing (Photo 108). The steps are carpeted with low ridge-topped skirting to either side. A plain wooden handrail lies on the east and south walls. The staircase is lit by a narrow casement window in square opening with pointed dormer head. The staircase opens onto a small L-shaped landing with plain painted timber doors accessing three bedrooms and a bathroom. The landing is carpeted over floorboards, with low beaded skirting, plain papered walls and a plain plastered ceiling with loft access above.

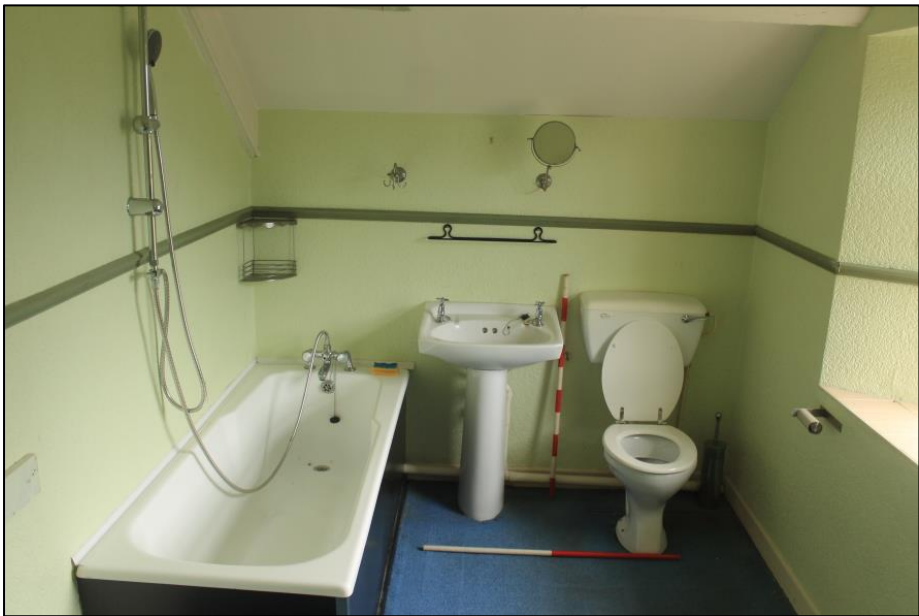
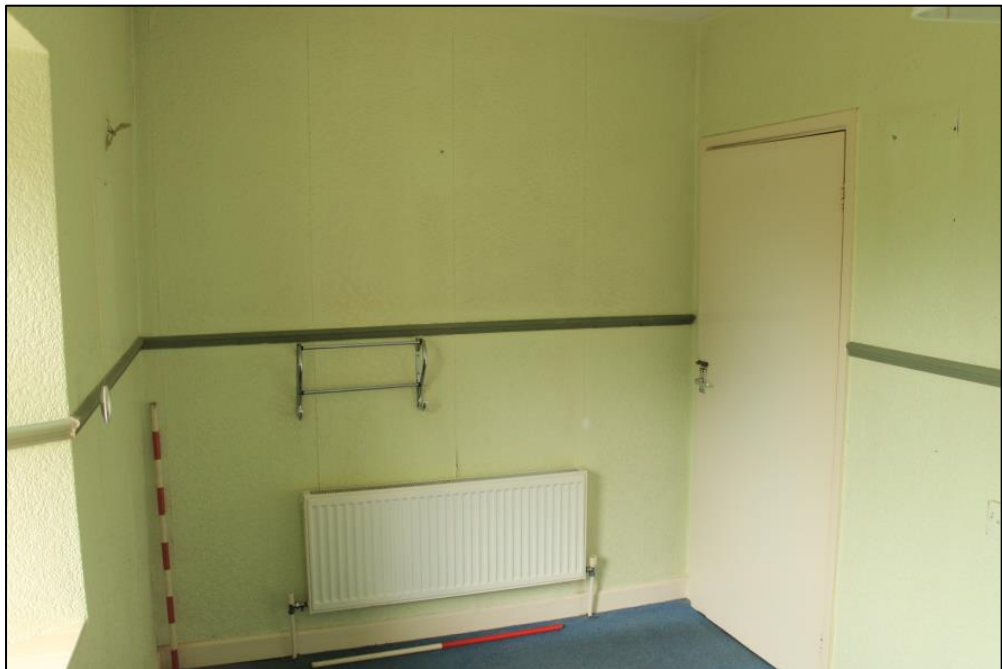
4.4.11 The bathroom (2.1m north-south by 3.6m) occupies the southeast corner (Photos 109 and 110). The floor is carpeted over floorboards, with low plain skirting to papered walls with mid-level plain timber dado, and a plain plastered ceiling with plastered roof beams visible. The room is lit by a window in the south wall, within a splayed opening with tiled sill. A modern bath, sink and toilet suite occupy the east end of the room. A modern radiator lies on the west wall and all fixtures are modern.

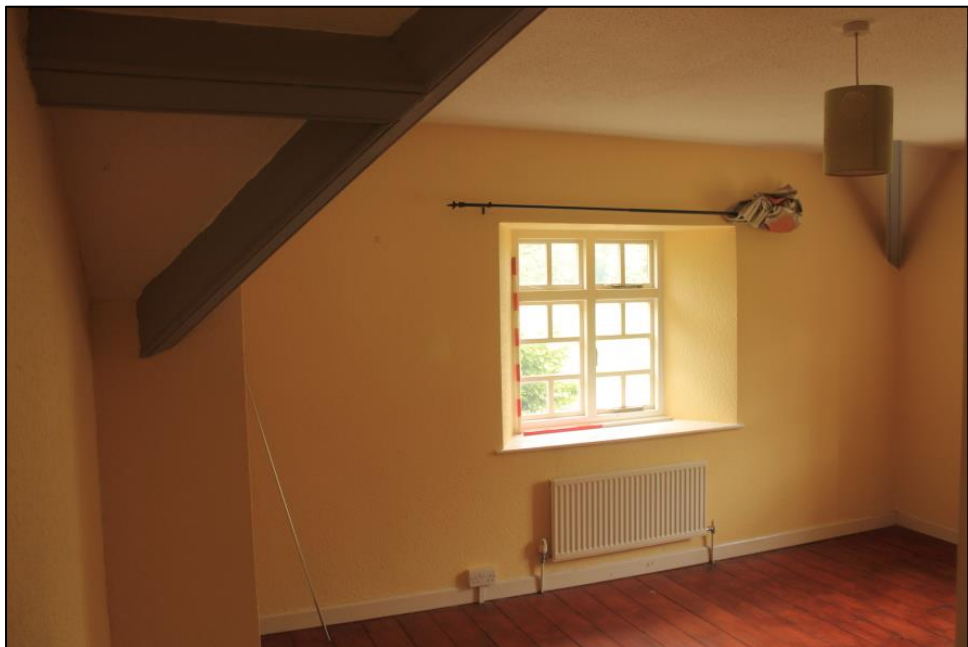
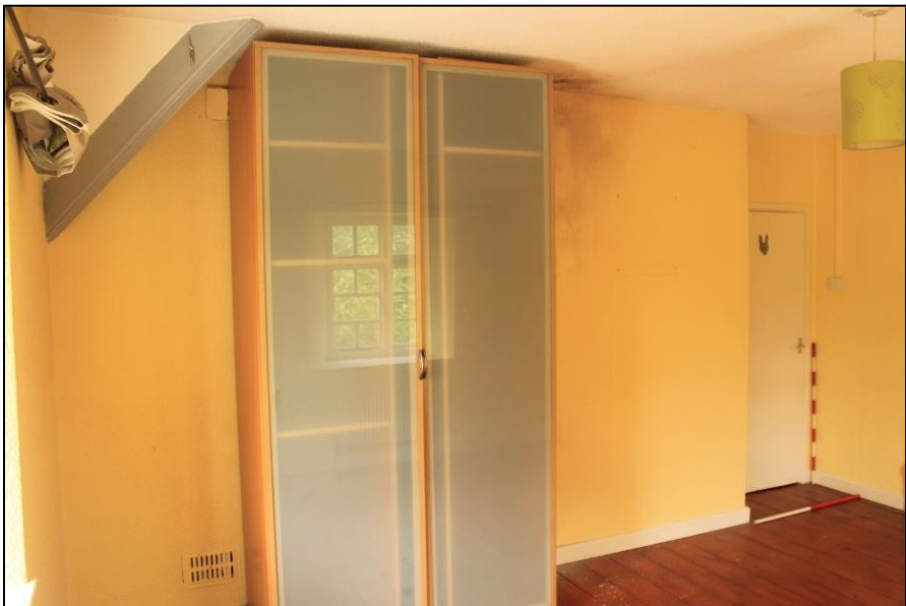
4.4.12 Bedroom 1 (4.6m north-south by 3.6m) occupies the northwest corner (Photos 111 and 112). The varnished floorboards are topped by low plain skirting, plain papered walls and a textured artex ceiling. Plastered roof timbers are visible in each corner, with loft access just in front of the north wall. The room is lit by two matching windows, one in the west wall, one in the north wall and both set in splayed openings. A modern cupboard is set centrally on the east chimney block wall. A small vent towards the northern end of this wall suggests a possible former offset fireplace, now blocked. A modern radiator lies on the west wall and all fixtures are modern.

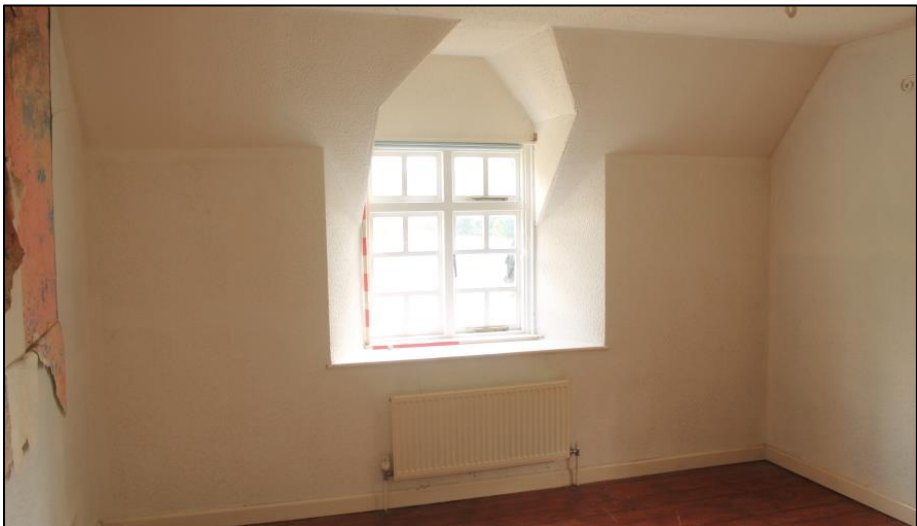
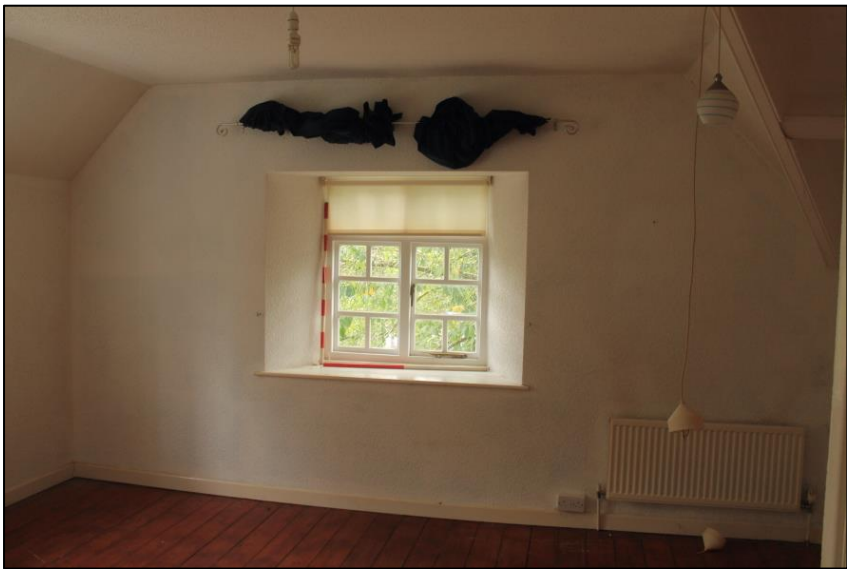
4.4.13 Bedroom 2 (4.6m north-south by 3.8m) occupies the northeast corner (Photos 113 and 114). The floor, wall and ceiling decorations are consistent with Bedroom 1. Plastered roof timbers are visible in the southeast and southwest corners and the northern part of the ceiling is sloping to accommodate the roof line. The room is lit by two windows, one in the north wall in a splayed opening with a dormer head, the second in the east wall in a splayed opening. On the west (chimney block) wall a small vent towards the northern end may mark the site of a blocked fireplace. An airing cupboard with modern boiler is inserted into the recess on the south side of the chimney block. Modern radiators lie on the north and east walls, all fixtures are modern.

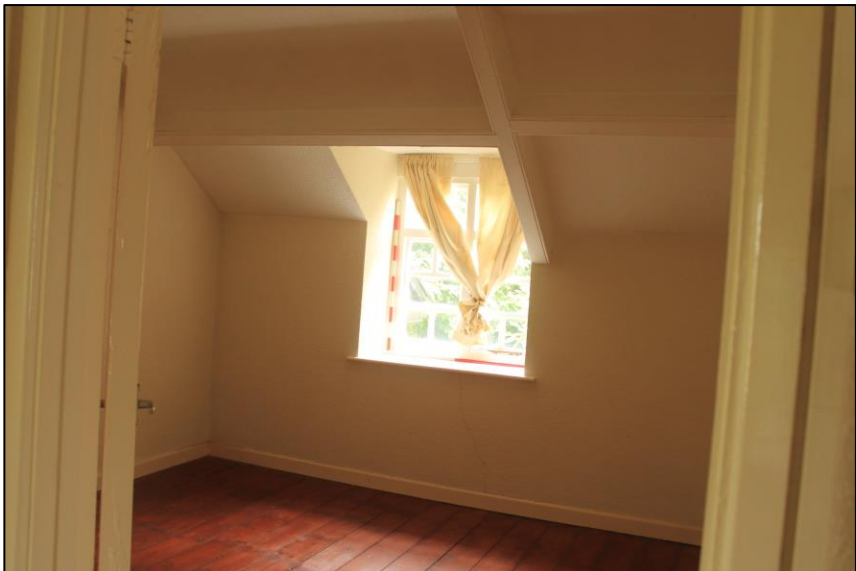
**Photo 116:** View west. Bedroom 3.  
1m scales.

4.4.14 Bedroom 3 (3.3m<sup>2</sup>) occupies the southwest corner. The floor, wall and ceiling decorations are consistent with the other bedrooms. The west part of the ceiling slopes to accommodate the roof, with plastered roof timbers visible. The room is lit by a window in the west wall, in a squared opening. A modern radiator lies on the north wall, all fixtures are modern.
