## **GNOLL HOUSE AND POND COTTAGE, THE GNOLL, NEATH PORT TALBOT HISTORIC BUILDING RECORDING**

REPORT NO. 2023-25  
EVENT RECORD No. E007491

## **GNOLL HOUSE AND POND COTTAGE, THE GNOLL, NEATH PORT TALBOT: HISTORIC BUILDING RECORDING**

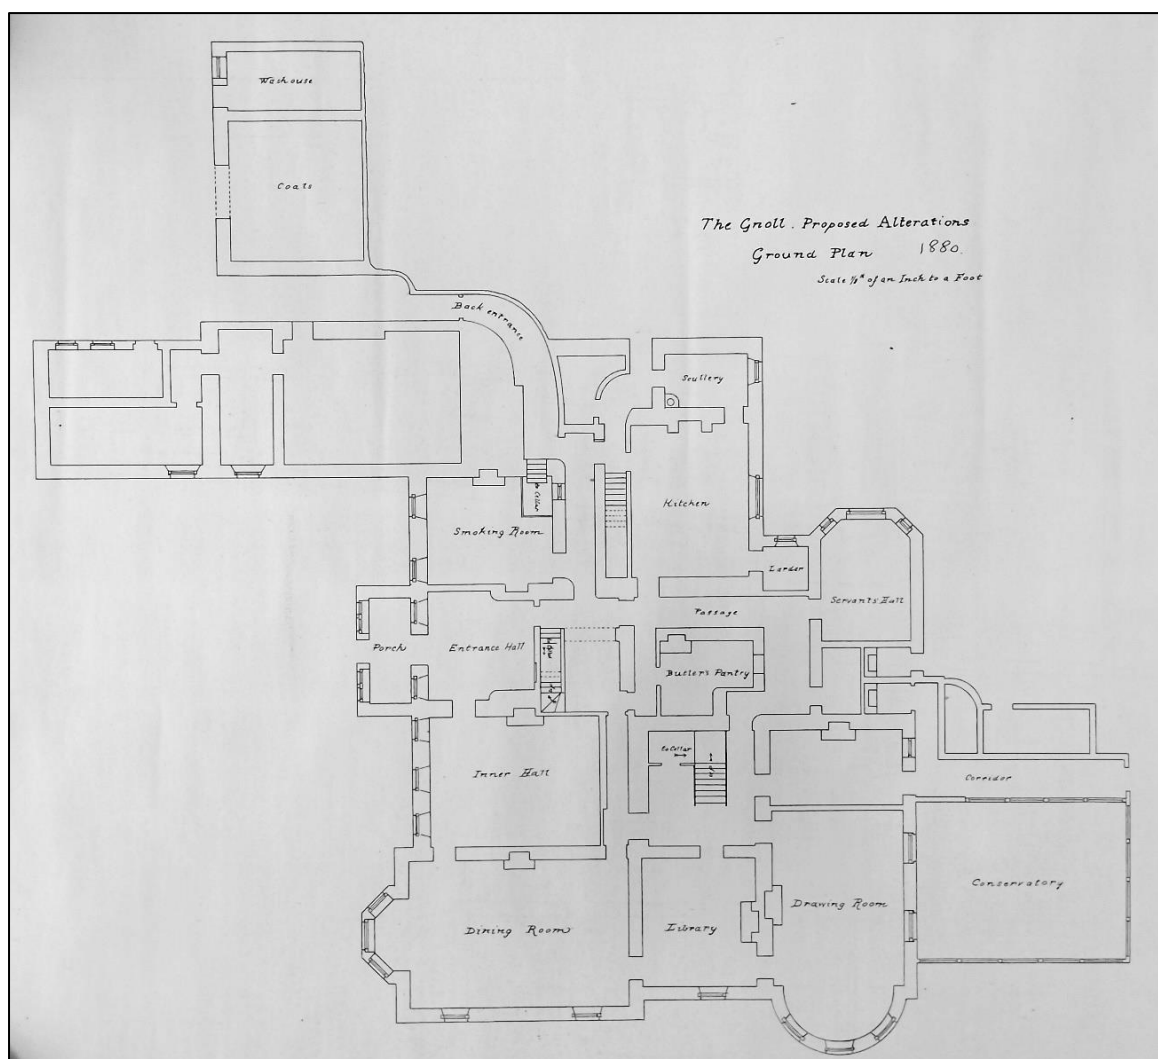
- 3.2.16 The subsequent plans of the reduced building (Fig 10) show the loss of the north wing and main entrance. The west range now contains an amalgamated dining room with a northern bay window, the library and drawing room to the south remaining the same. To the east a new entrance porch has been added to the north face of the east-west range, opening into a hall and replacing the school room. A further galleried hall replaced the saloon to the west, and a smoking room replaced the store room to the east. The staircase from the saloon also appears to have been removed to accommodate the galleried hall. To the south the rooms appear largely unchanged, although the servant's hall has acquired an angular eastern bay. To the northwest the windows of the kitchen in the former 17<sup>th</sup> century building are shown as blocked, although windows are clearly visible in a later postcard so these plans may have been adapted. The first floor plan shows the building rising over the main west range, the adjoining east-west range (including over the southern part of the former 17<sup>th</sup> century building) and the rooms to the south (excluding the conservatory). This included at least four bedrooms, a housekeeper's room and the hall gallery. The second floor rose over the main north-south and east-west range but excluded most of the southern rooms. This floor included a further five bedrooms, a smoking room, and a garden entrance on the eastern side which would have accessed the current viewing platform at its western side.

**Figure 10:** A ground floor plan showing the initial proposals for the reduced house of 1881. West Glamorgan Archive Service B/N/115/1.

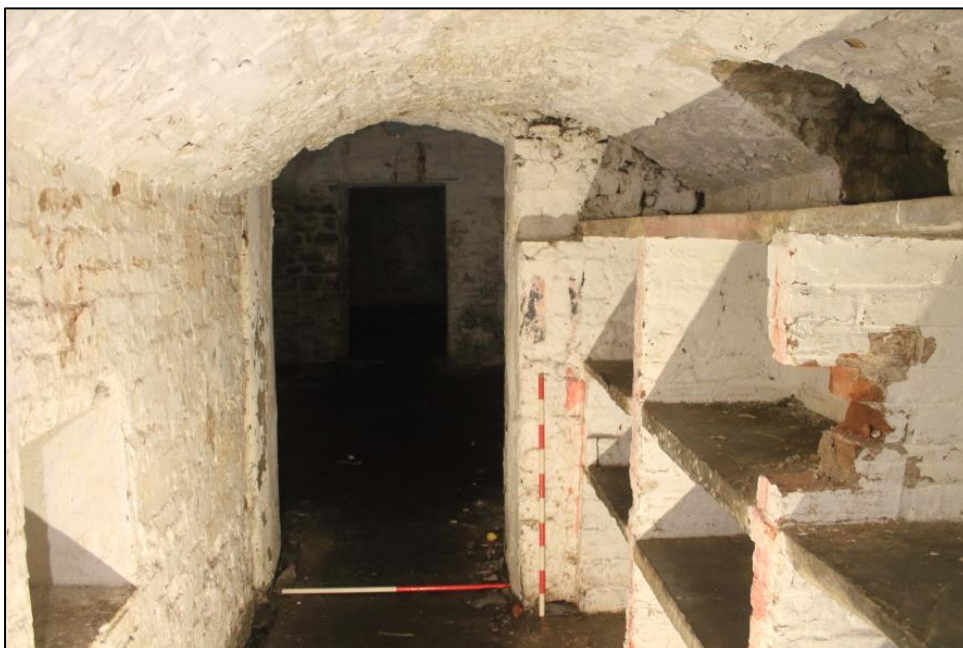
- 4.1.5 The entrance from Room 2 to Corridor 1 (5m north-south by 1.8m) is cement rendered and whitewashed (Photos 11 and 13). There is a butt joint between the room and corridor, which is set at a slight westward offset from the room. Corridor 1 has a floor of brick, partly covered by stone slabs, and whitewashed walls of roughly coursed masonry and brick, 2m high to a low arched masonry roof. 1.1m of the roof at the western end, where it butts against Room 3, has been replaced by brickwork (Photo 12), and at the southern end the roof partly blocks the top of the door arch. A 0.1m wide vertical groove at the doorway possibly marks a doorframe to Room 2 (Photo 14). In the west wall lies a squared opening (0.45m by 0.75m) with an arched head, built into the wall and roof. This is fronted by stone slab shelving on brick supports which line the west wall. A small, squared recess lies in the east wall and is internally rendered (Photo 15).

**Photo 11:** View south down Corridor 1, looking into Room 2. 1m scales.

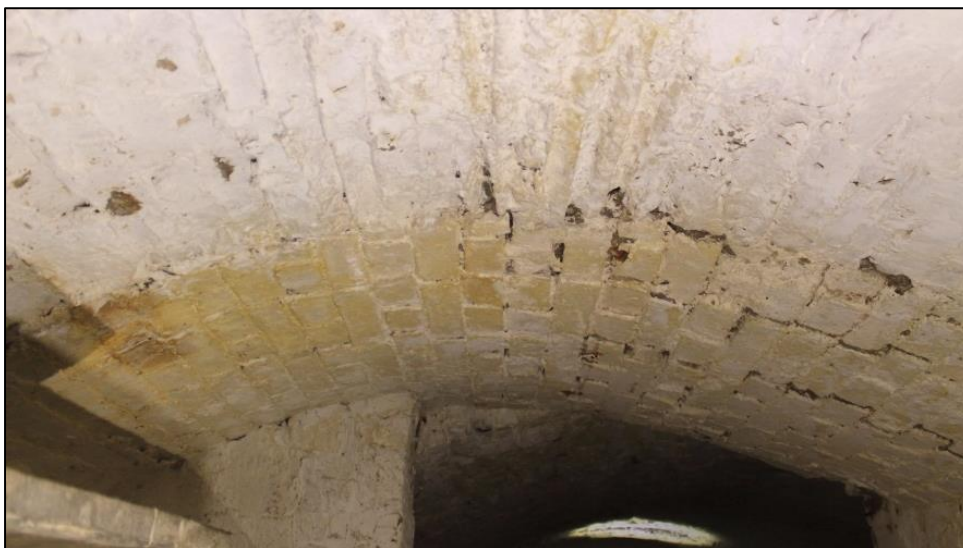
**Photo 12:** View north, replaced section of roofing in Corridor 1 as it enters Room 3.

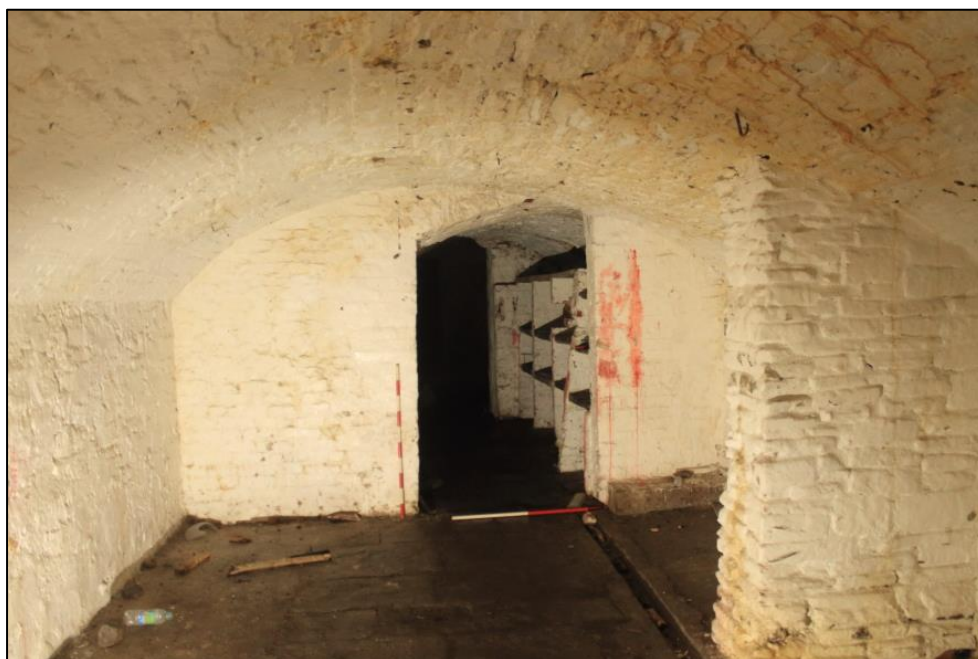
4.1.6 Room 3 is a rectangular space (5.5m north-south by 3.6m) with a slight eastward offset to Corridor 1 (Photo 16). It has a stone slab floor with a central passageway circa 1.3m wide, rougher to the east and delineated by a drainage groove to the west. The northern half of the floor slopes downward slightly. The faced random rubble walls are whitewashed and meet arched masonry vaulting. A supporting wall protrudes 0.8m from the west wall. There is a butt joint in the ceiling 1m from the northern end against a slightly narrower vaulted masonry ceiling. This in turn butts against the low arch of masonry voussoirs that frame the entrance to Corridor 2, placed centrally in the north wall (Photo 17). The walls and ceiling are otherwise featureless.

**Photo 16:** View south of Room 3 looking into Corridor 1. 1m scales.

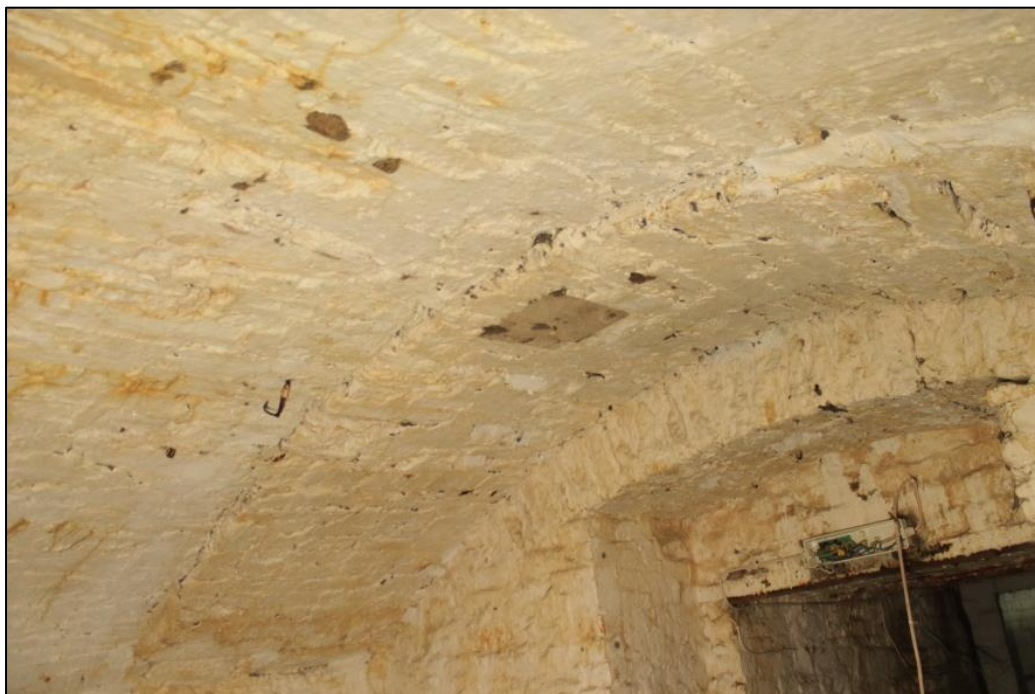
**Photo 17:** View northwest of changing roof structures at the northern end of Room 3 and entrance to Corridor 2.

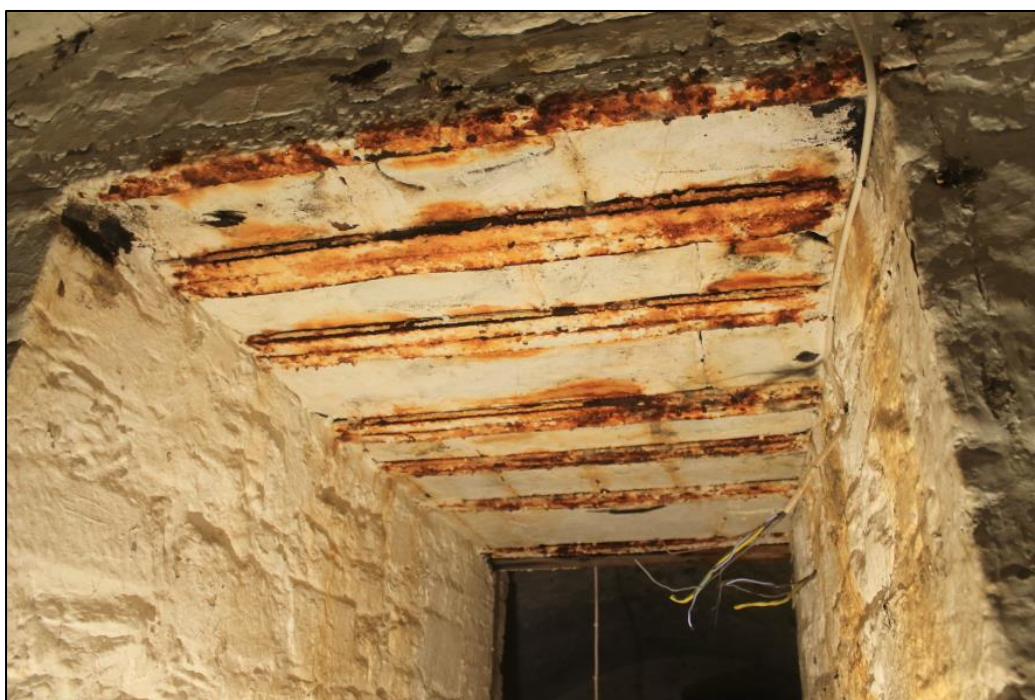
- 4.1.7 Corridor 2 is rectangular, measuring 1m wide, 2.8m long and 1.8m high with a stone slab floor, whitewashed random rubble walls and a flat concrete ceiling held on rusting steel/iron beams (Photos 18 and 19). The floor has a central north-south groove, and a threshold stone at the north end into Room 4.

**Photo 18:** View north of the roof structure in Corridor 2.

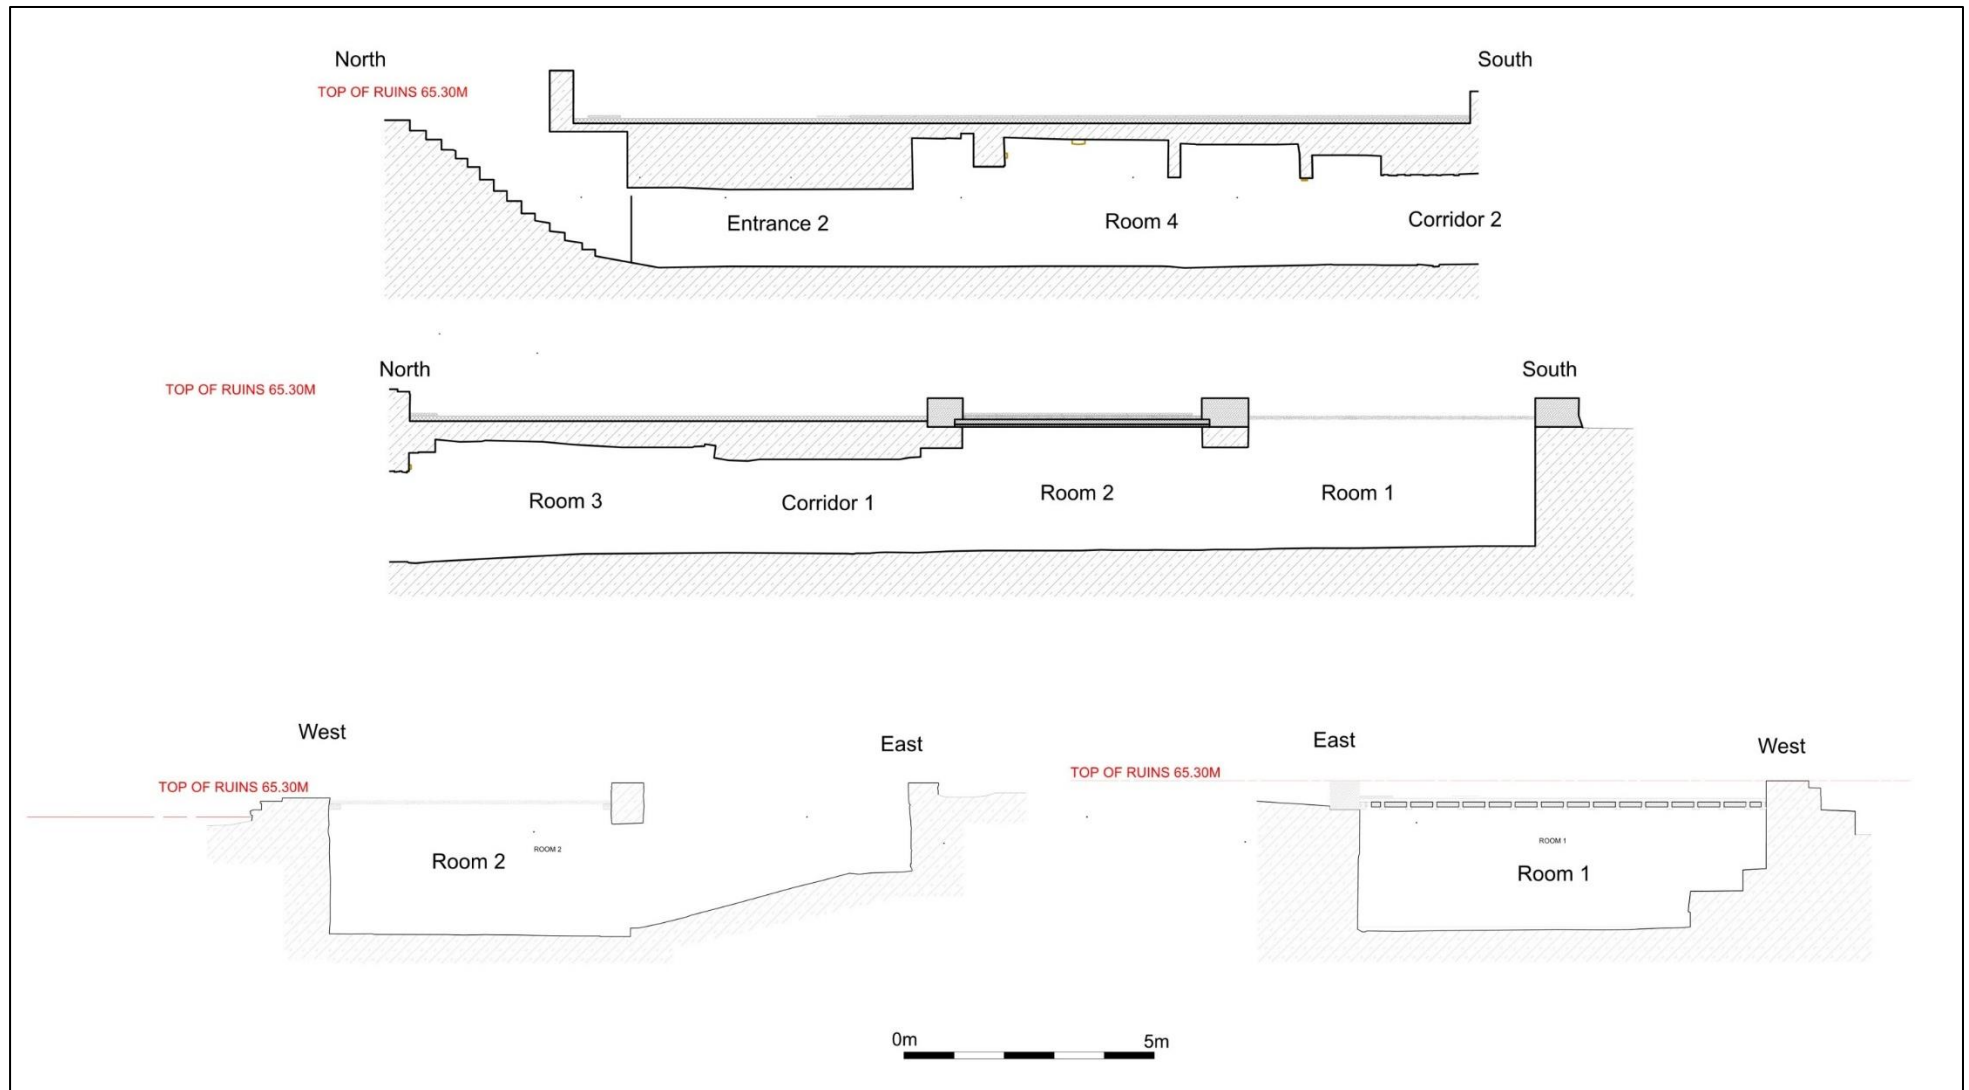
**Figure 13:** Section through Gnoll House cellars. Based on drawings produced by Hiraeth for Andrew Scott Ltd (drawing 03501/S2/P1 and 03502/S2/P1) with annotations by DAT-AS.

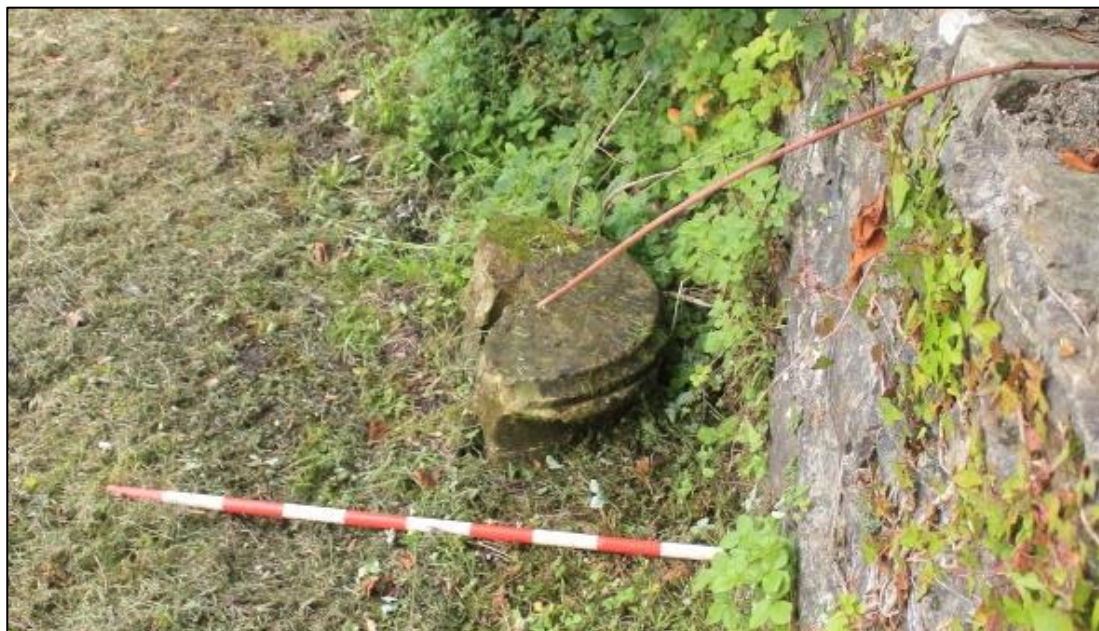
- 4.2.25 Extending south from the southern room is a retaining or boundary wall of mortared random rubble, 5m long, 1.1m high, 0.35m wide and otherwise featureless. On the south side of the wall lie the partial remains of a carved stone circular plinth (0.6m in diameter), set 0.15m in front of the wall. The plinth is carved in a yellow sandstone with a central hole, from which it has broken radially (Photo 71).

**Photo 71:** View north showing the plinth set in front of an eastern retaining/boundary wall. 1m scale.

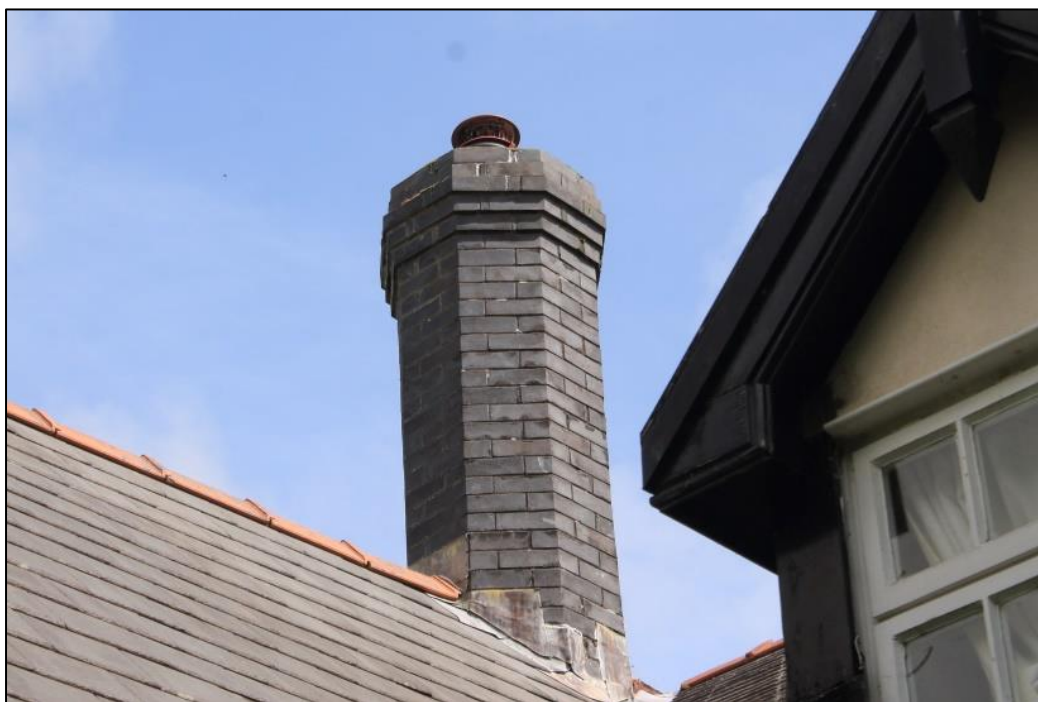
**Photo 82:** View northeast of the octagonal chimney.

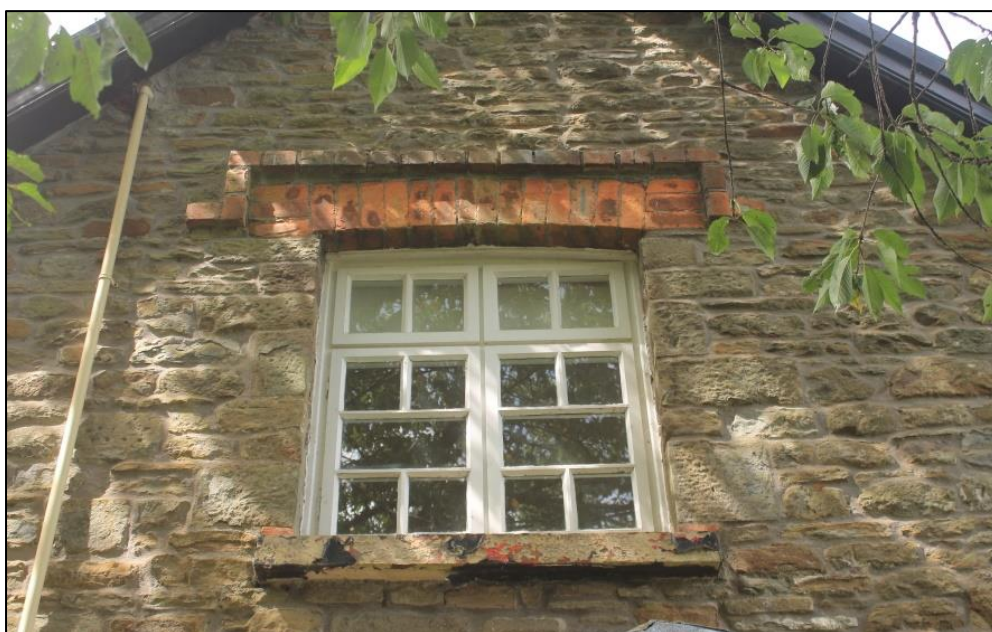
**Photo 88:** View west showing the detail of first floor window on east elevation.

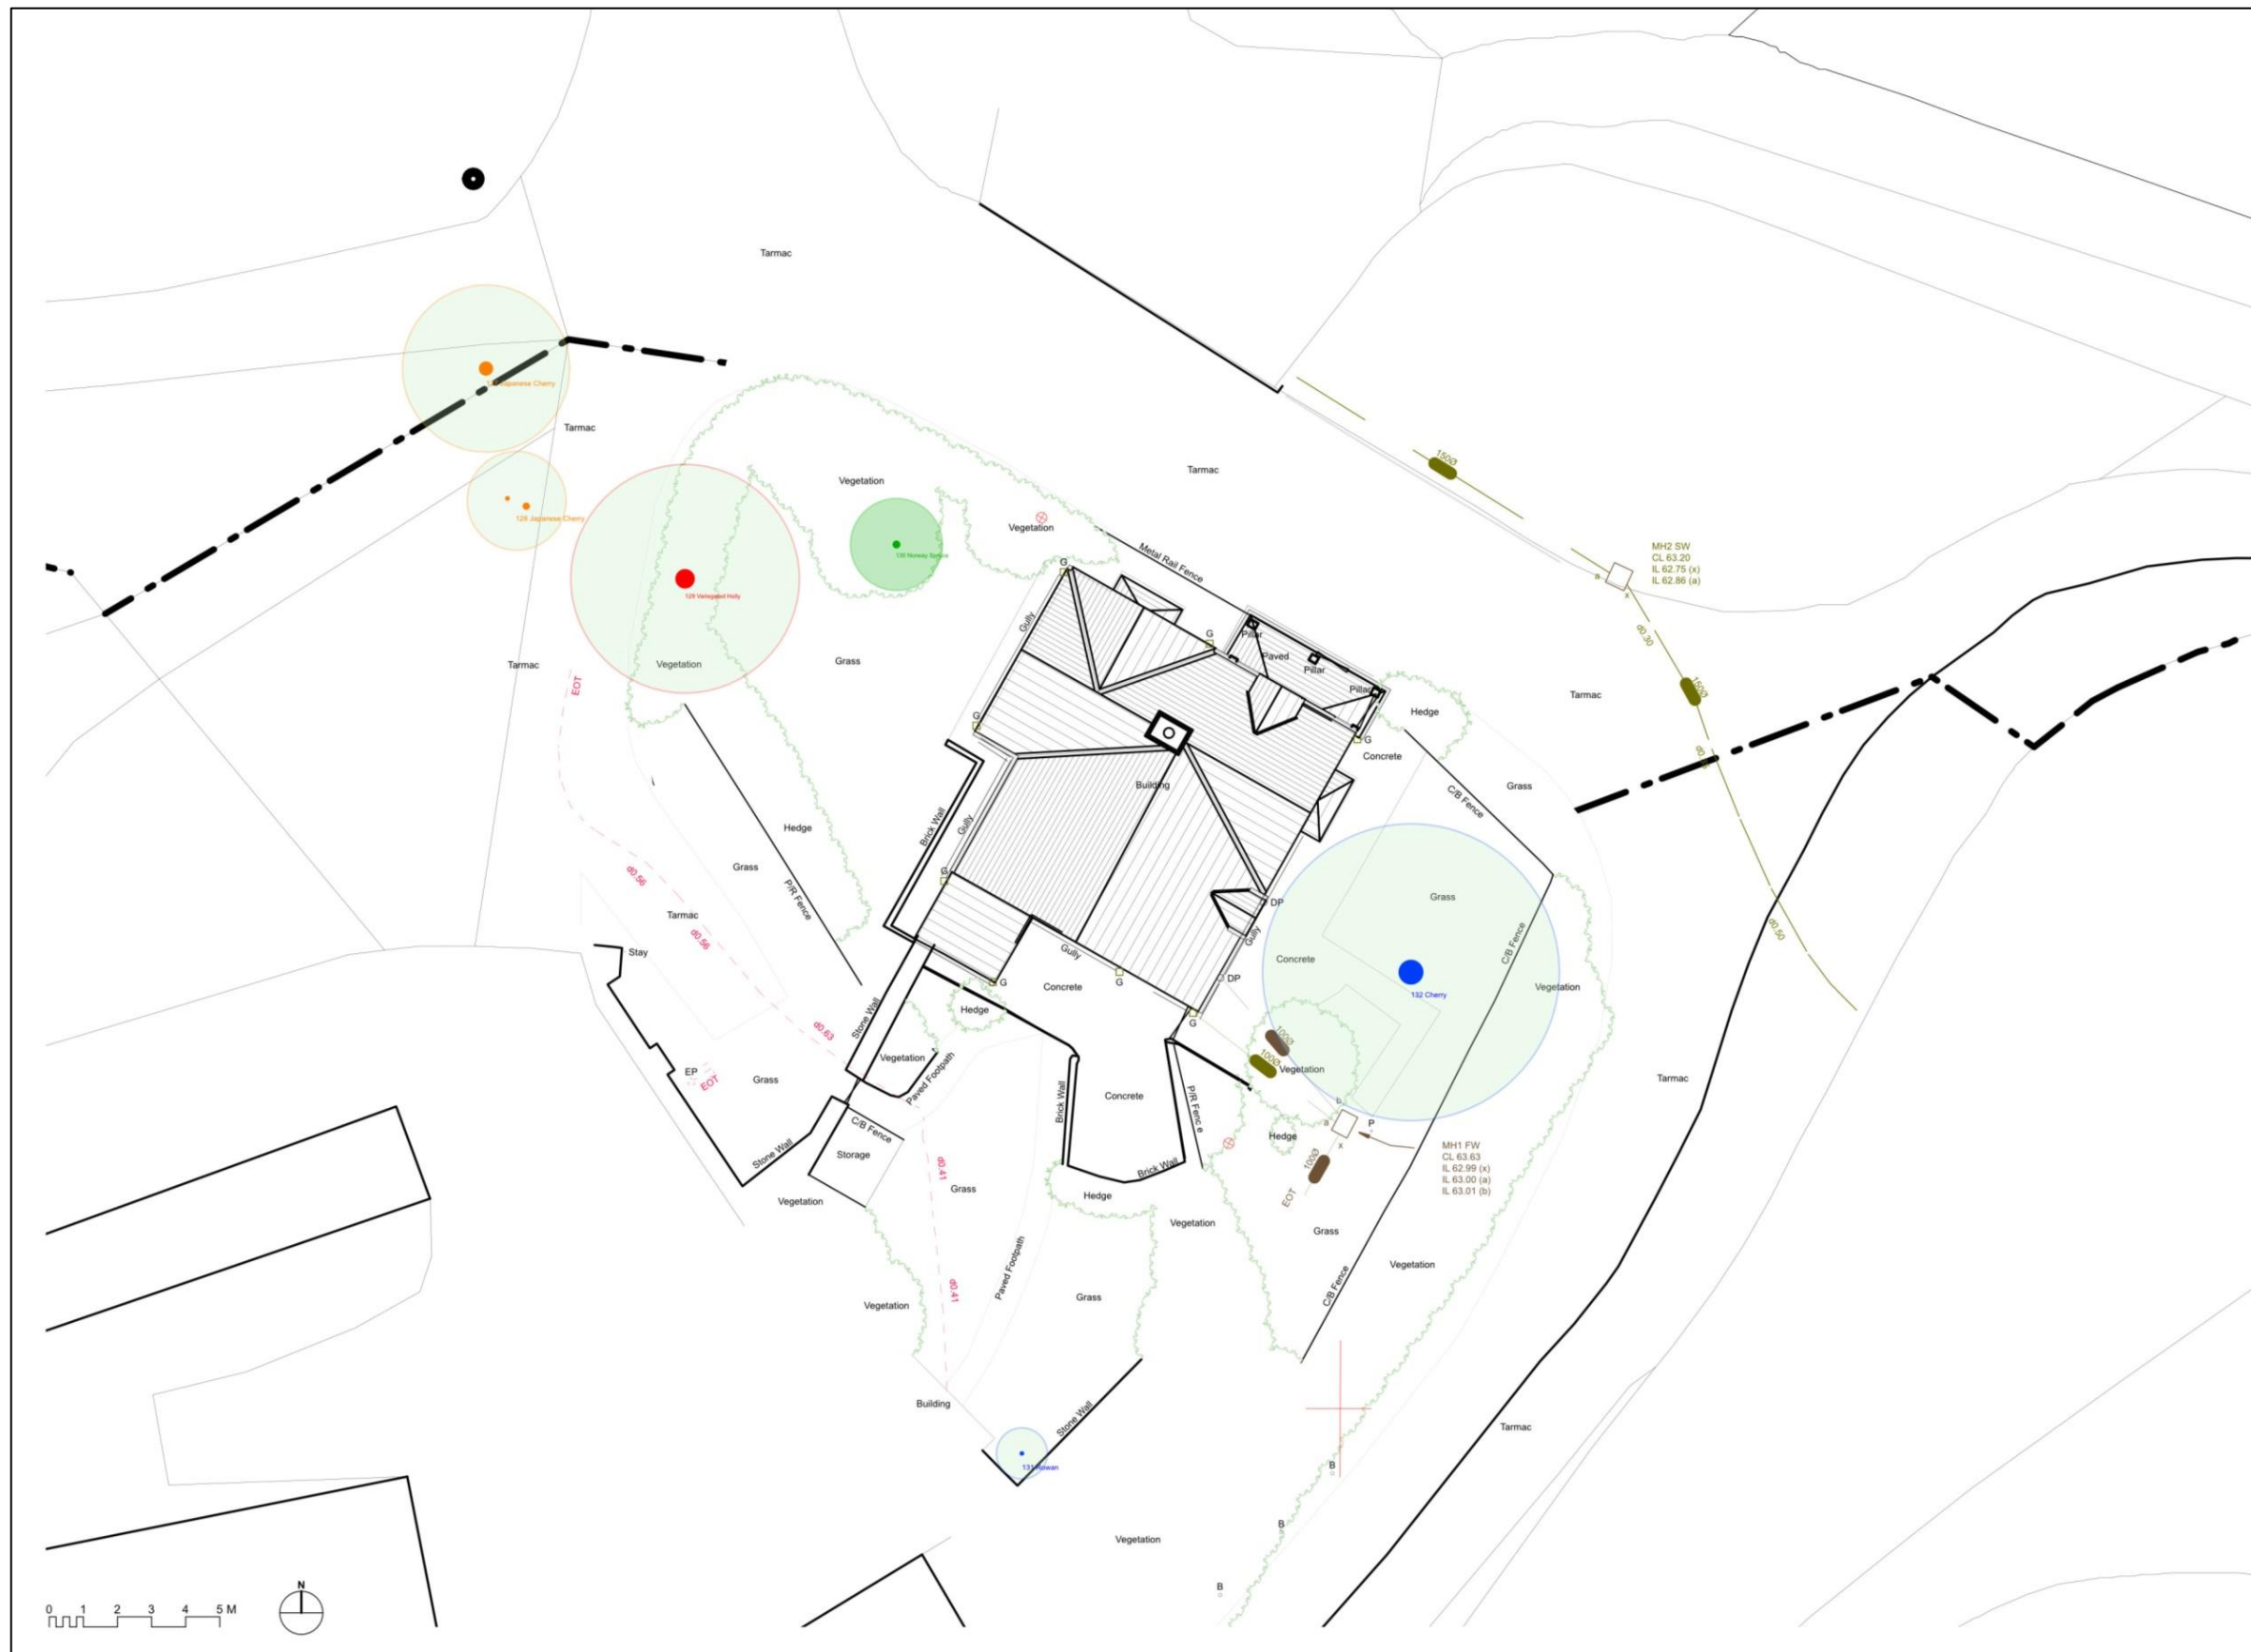
**Figure 15:** Plan of Pond Cottage and its surrounds. Based on drawings produced by Hiraeth for Andrew Scott Ltd (drawing 00020/S2/P2) with annotations by DAT-AS.

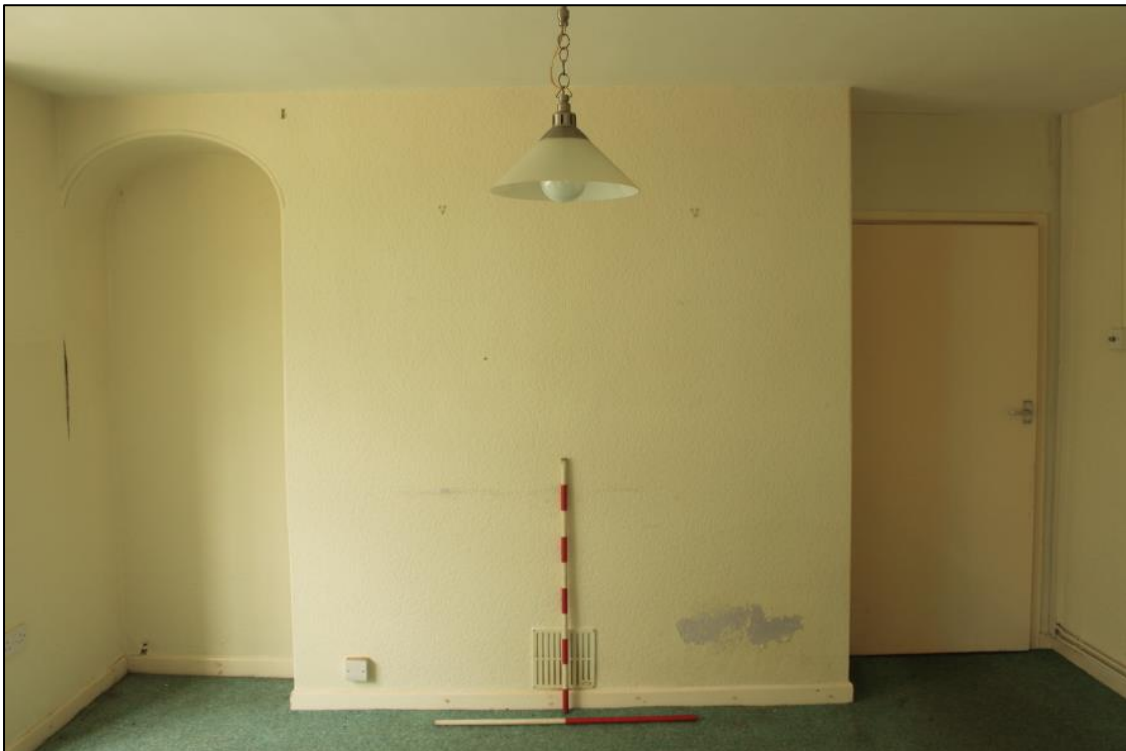
**Photo 105:** View east of ground floor parlour/bedroom, showing blocked fireplace. 1m scales.

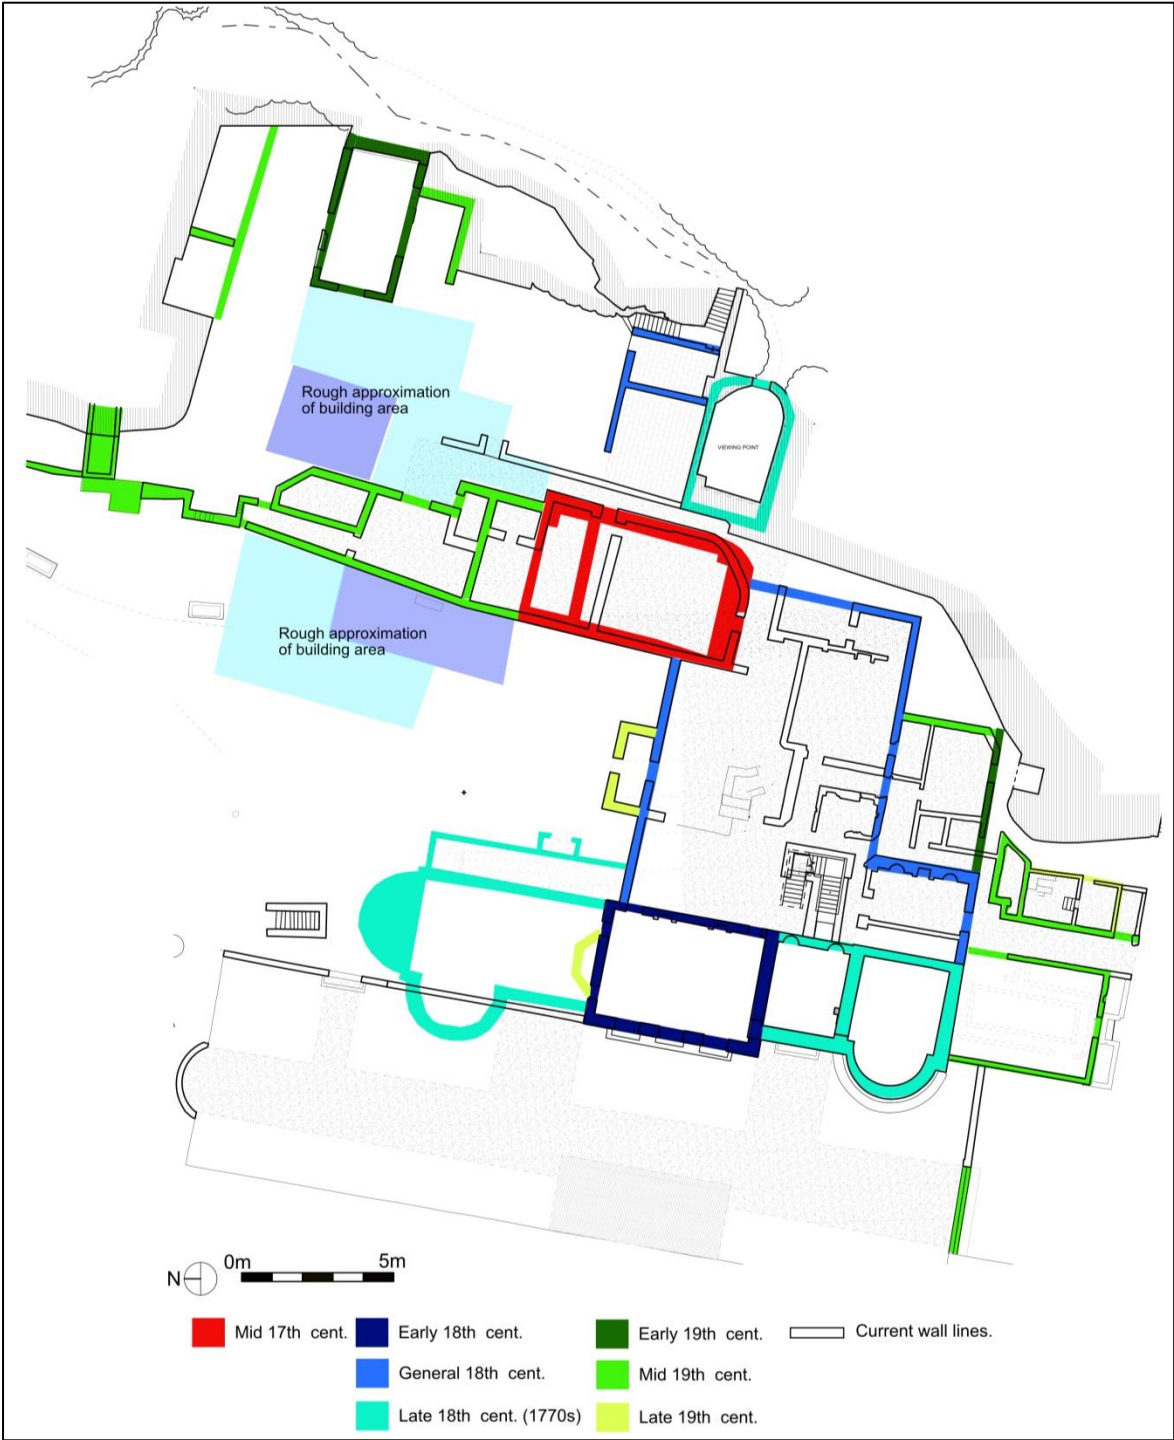
**Figure 18:** A broad phase plan showing the development of Gnoll House from the mid-17<sup>th</sup> century to late 19<sup>th</sup> century, overlaid with current wall lines.
