**Metal Box  
Bat Survey Report  
Date: September 2023**

**Lewis Badham  
Planning Ecologist  
Countryside and Wildlife Team  
Neath Port Talbot CBC**

**Metal Box, an office and factory building complex, on the south-western outskirts of Neath, is proposed for roofing works.**

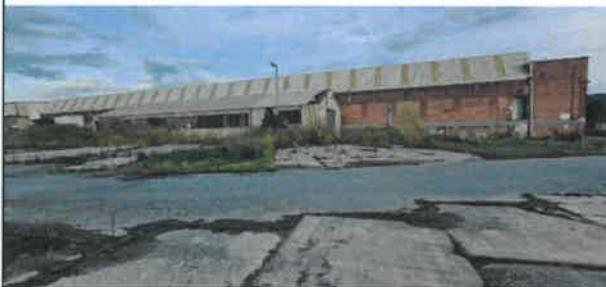
| Overview of south-western elevations. | Overview of roof structure – facing north |

The building is an office / factory building complex with corrugated metal roofing, of brick construction and three storeys in height.

Potential access points for roosting bats were observed during the preliminary roosting assessment: gaps were observed between the brick walls and the metal fascia of the building; the overall roofline structure is very complex and extensive, rendering thorough inspection difficult. Overall, the building was considered to be of Low - Moderate potential to support roosting bats, given the features present and the environment in which the building is situated.

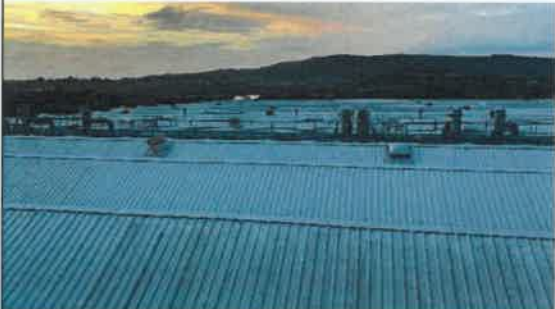
| Overview of roof structure – facing north-west | Overview of roof structure – facing west. |
