## GWRHYD QUARRY, PONTARDAWE

### APPENDIX 4.0

#### REVISED WORKING AND RESTORATION PROGRAMME

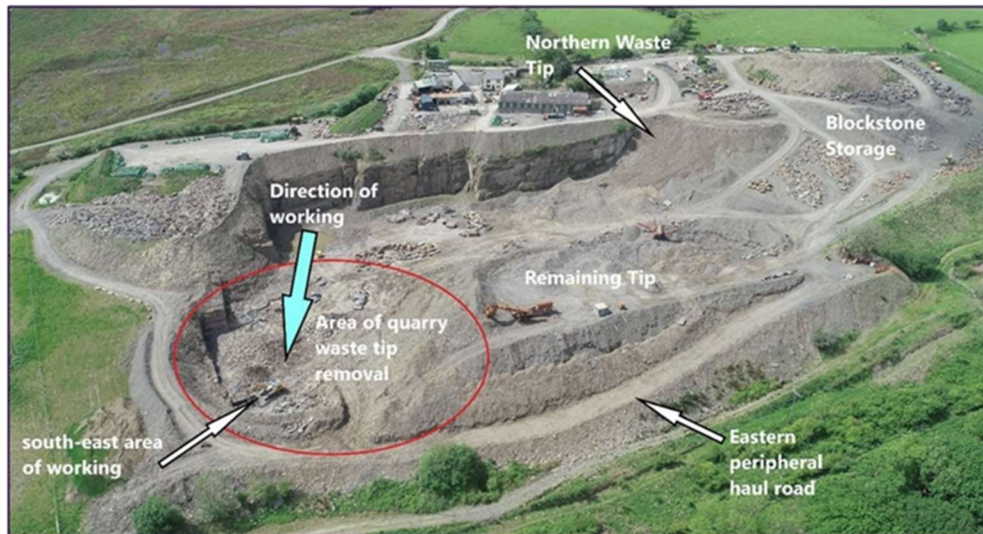
22. Quarry operations have continued to be undertaken in accordance with Phase 1 of the 2018 approved Working Programme as illustrated on the annotated aerial photograph below.

23. Access to the quarry remains from the north, along the eastern side of the site, to enable the consented limit of stone extraction to be achieved at the southern end. The general lateral direction of working remains the same, from south to north. The 'direction of working' shown on the above image reflects the deepening of the quarry to the approved depth.

24. Extracted blockstone continues to be transported from the southern end of the quarry to the block storage area to the north of the processing area, while quarry generated waste continues to be tipped at the northern end of the quarry.

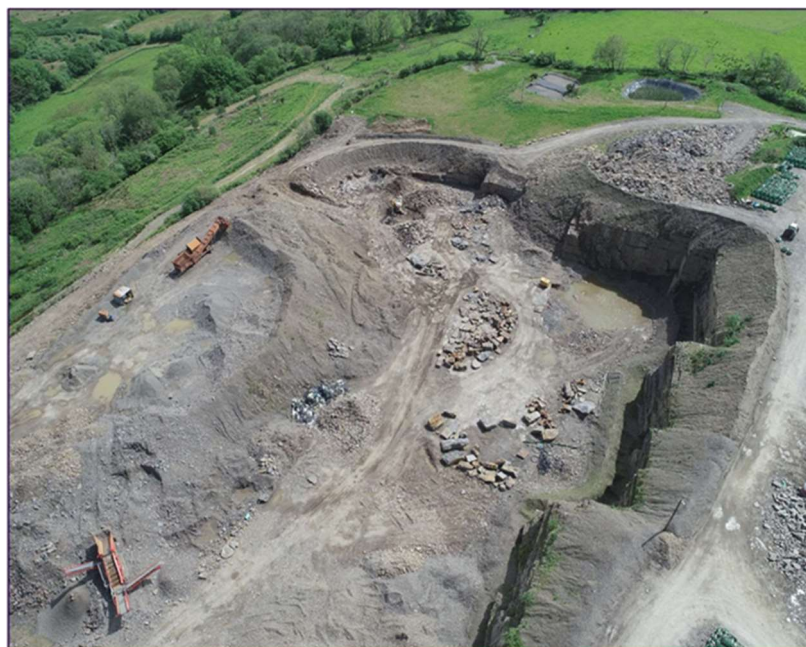
July 2022 – Drone Photo looking south – courtesy of DLG Survey

59. The July 2022 image illustrates the restored grassed area between the southern limit of excavation and the lagoon area which was previously overlain by quarry waste tipped material. Furthermore, additional boundary hedgerow planting has been undertaken at the south-eastern

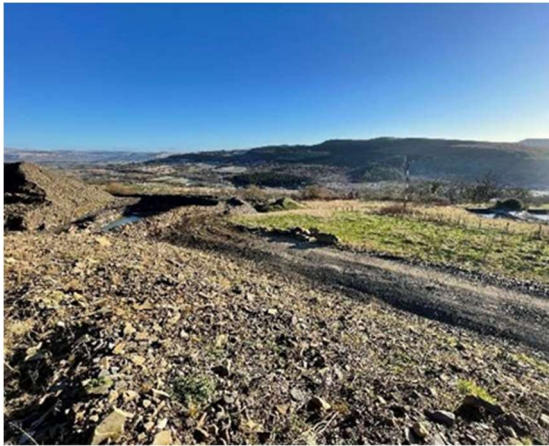
View of southern restored area looking east, from haul road.

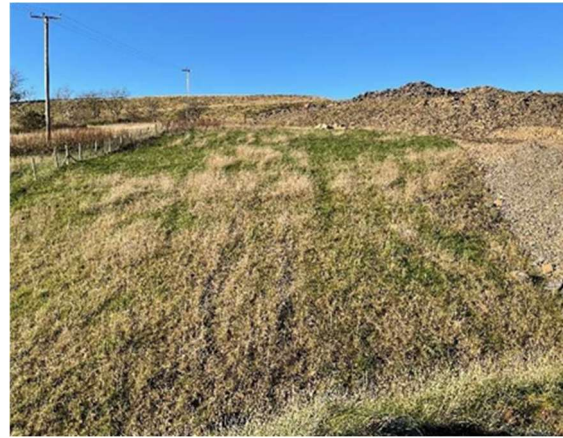
View of southern restored area looking west towards stock yard.

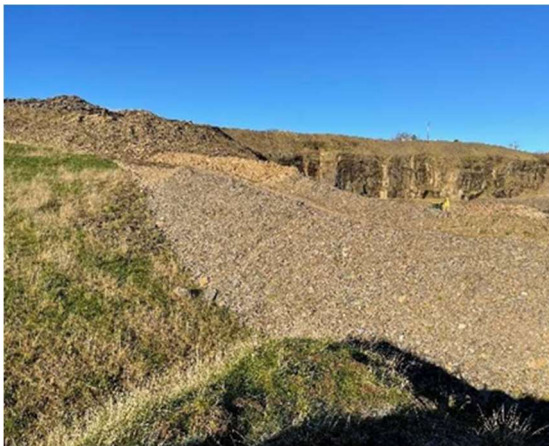
Boundary between haul road and restored area at southern end of quarry.

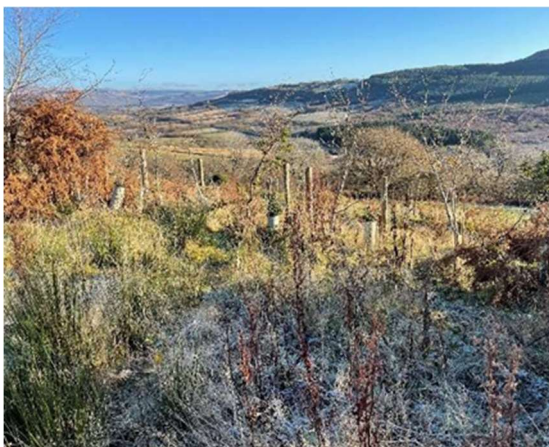
Tree planting along south-eastern boundary.

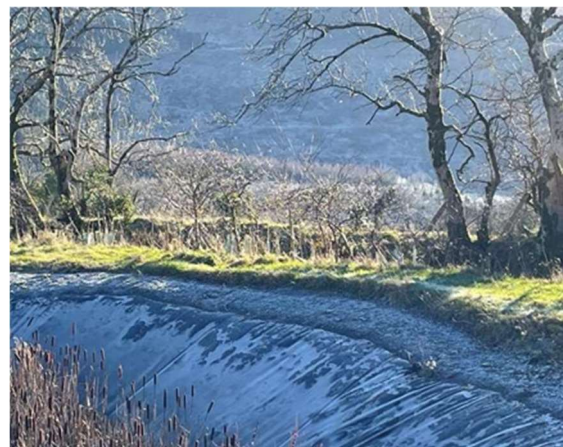
Tree planting along southern boundary (adjacent to lagoons)

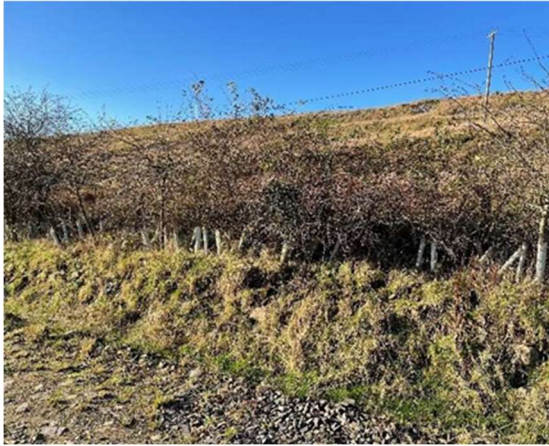
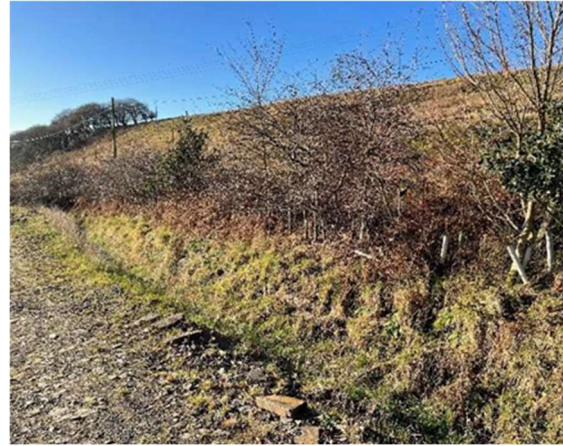
Tree planting along western boundary (adjacent to stockyard).

Tree planting along western boundary (adjacent to stockyard)
