**Former Ebenezer Chapel, Neath Road, Rhos,  
Pontardawe, Neath Port Talbot, SA8 3HB**

**Bat Survey Report for Mr R. Steadman**

| <b>Report type</b> | Bat Survey Report |

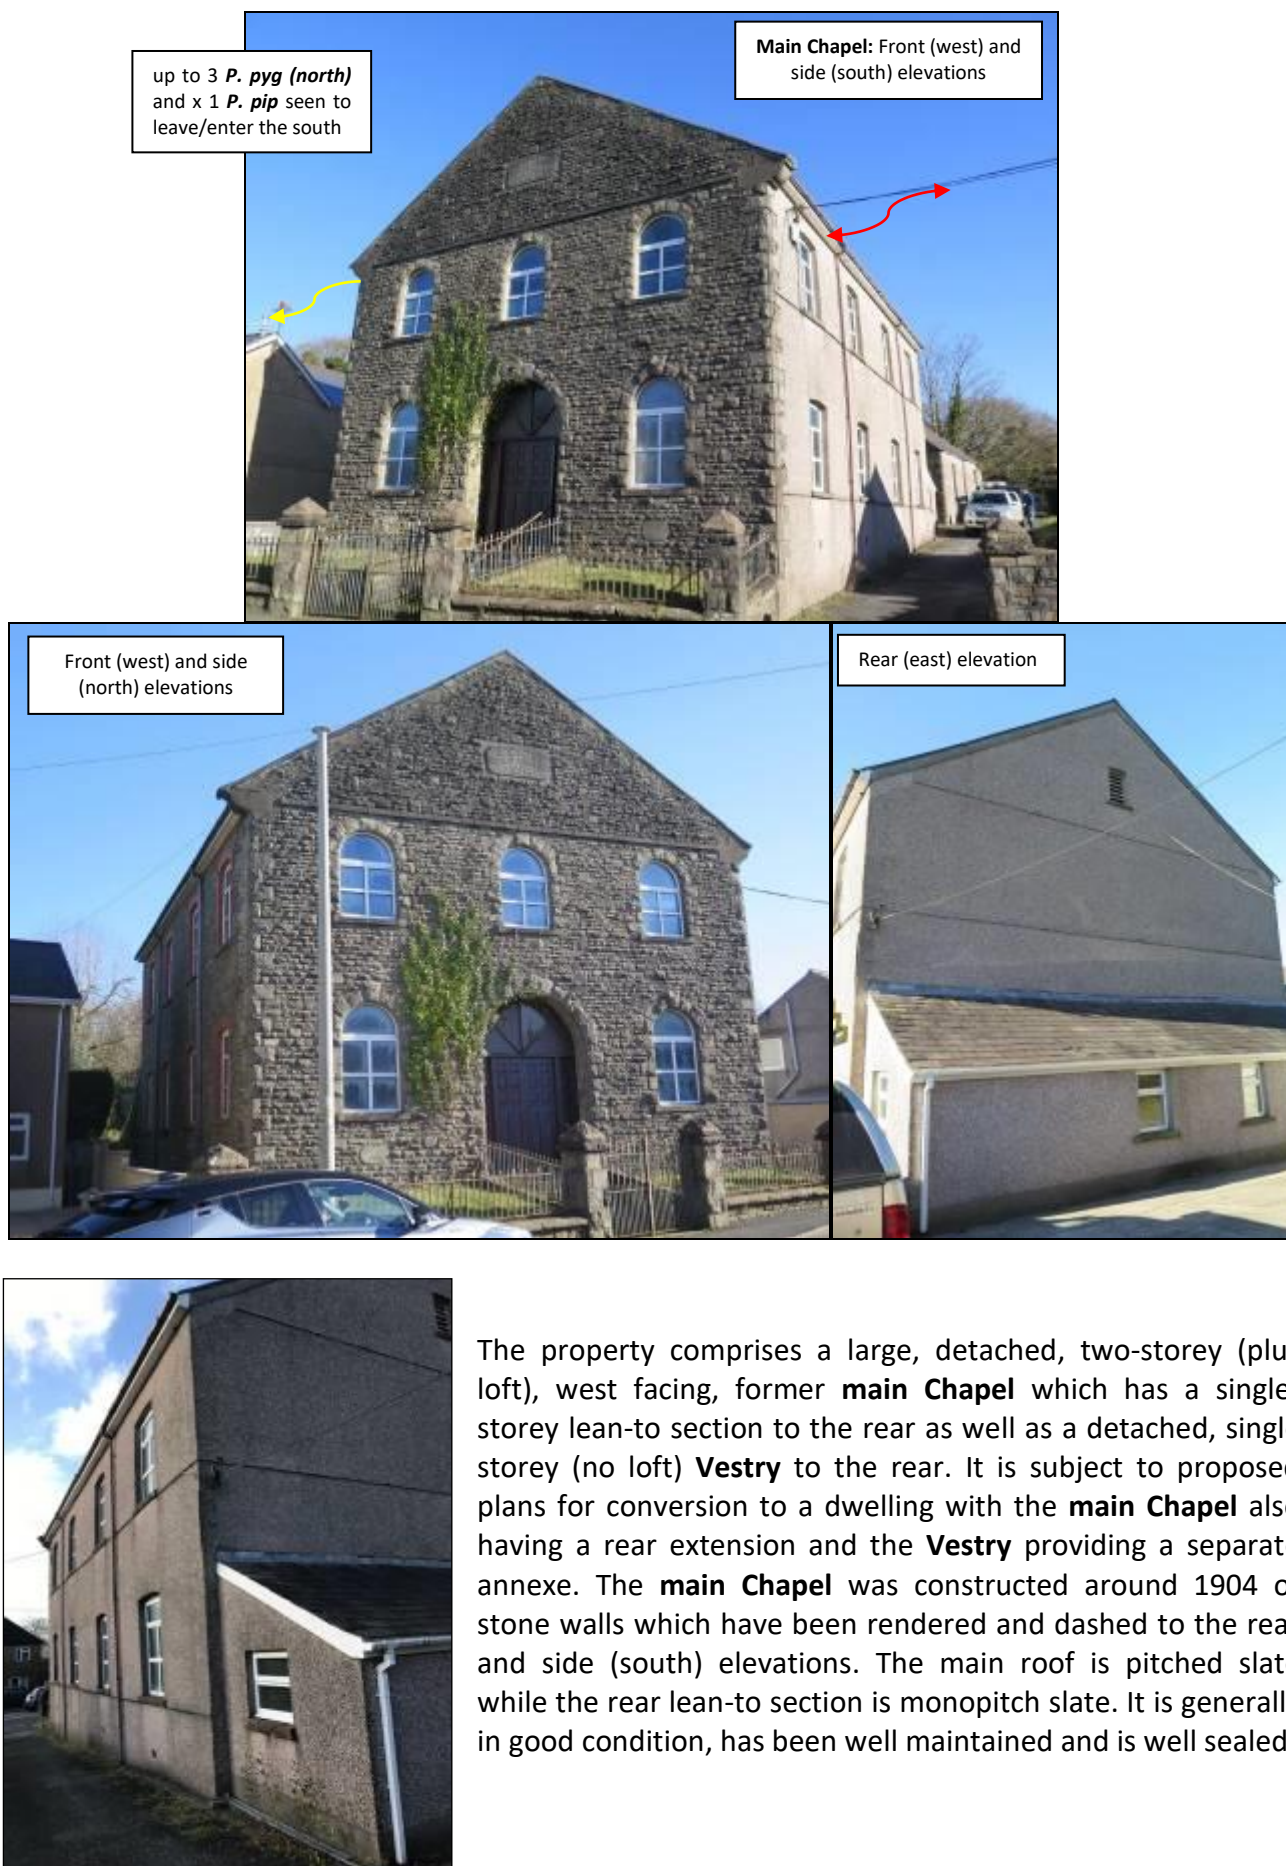
## Appendix 6: Site survey images

The walls are intact and the timber/uPVC framed windows and doors have no potentially exploitable gaps either in or around them. However, there are numerous wall top gaps on all elevations except the rear – especially under the flashing along the verges to the front and while the lean-to roof has only minor damage with only one or two slightly raised slates, it was not possible to fully view the main roof from outside.

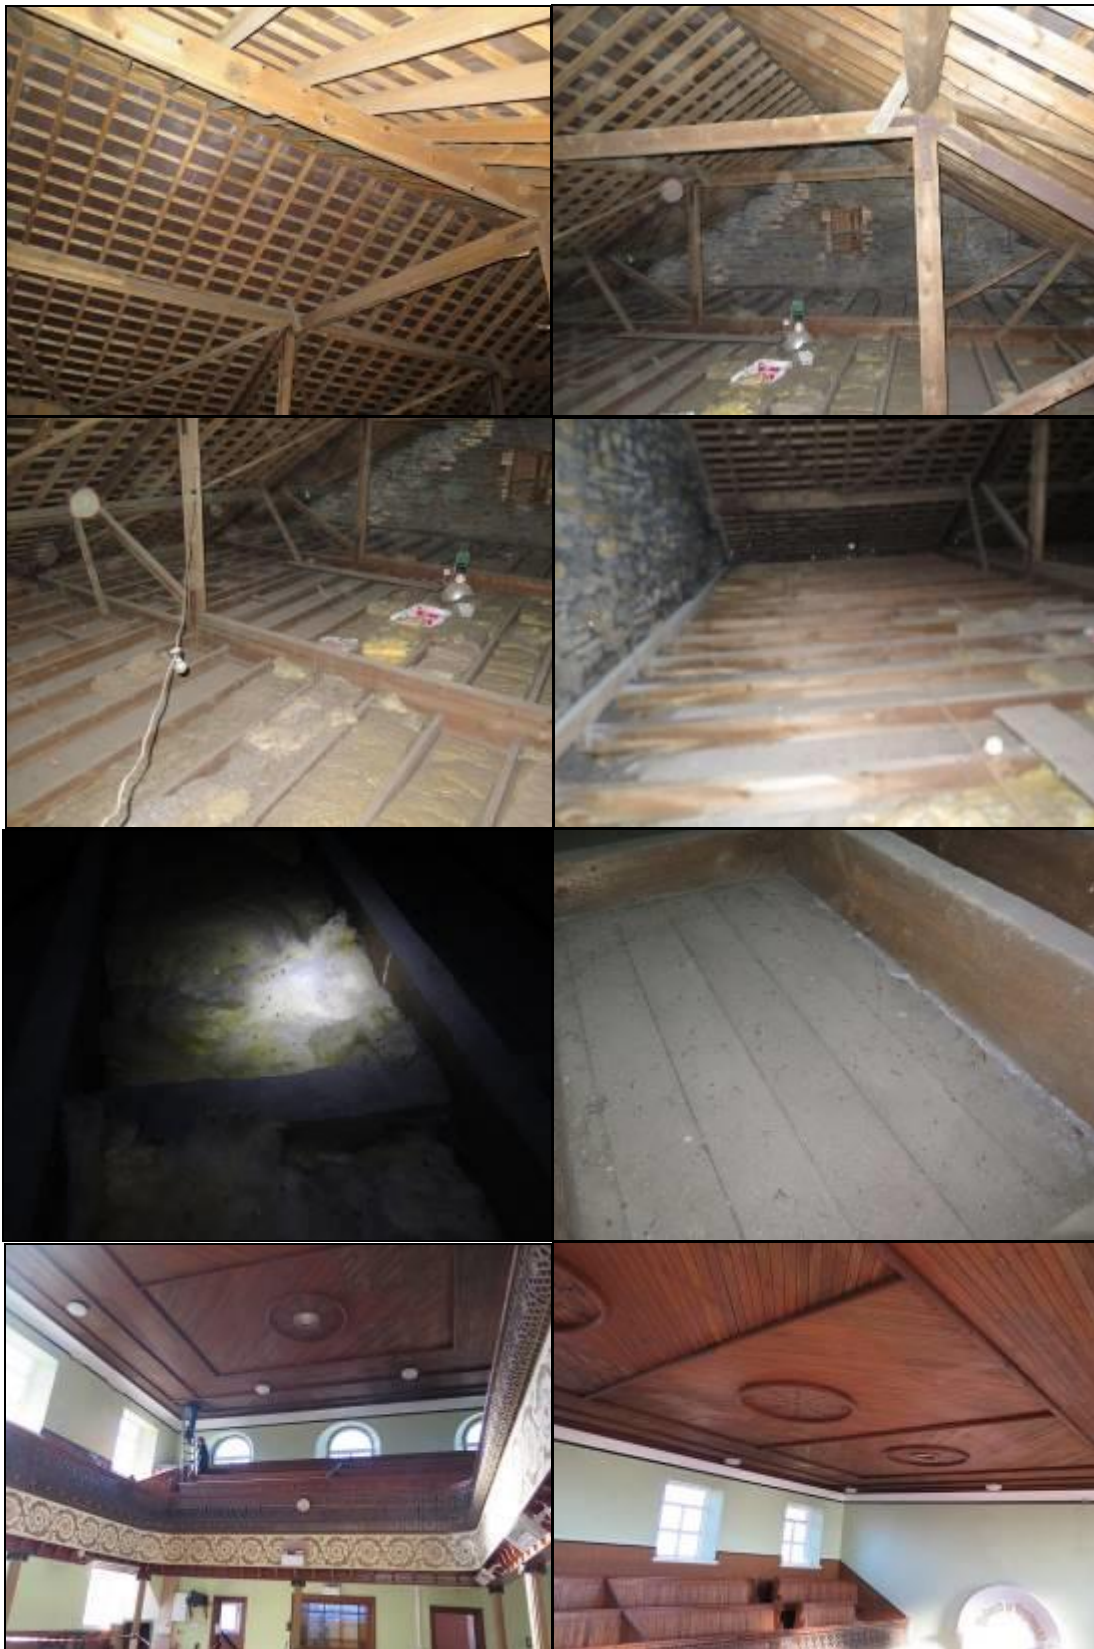
Internally, within the loft of the **main Chapel** there were no obvious gaps within either the roofs or at wall tops which could facilitate access into the loft space. In addition, the vent on the rear elevation is boarded up internally. However, there are dark, sheltered areas with crevices that could offer roosting opportunities as well as timber frames which could offer opportunities for free hanging bats and careful inspection of all items and surfaces found a small number of scattered and friable droppings on the floor. These were older and grey and DNA analysis was inconclusive. The

roof was in excellent condition, as were the timbers suggesting they may have been replaced within last few years.

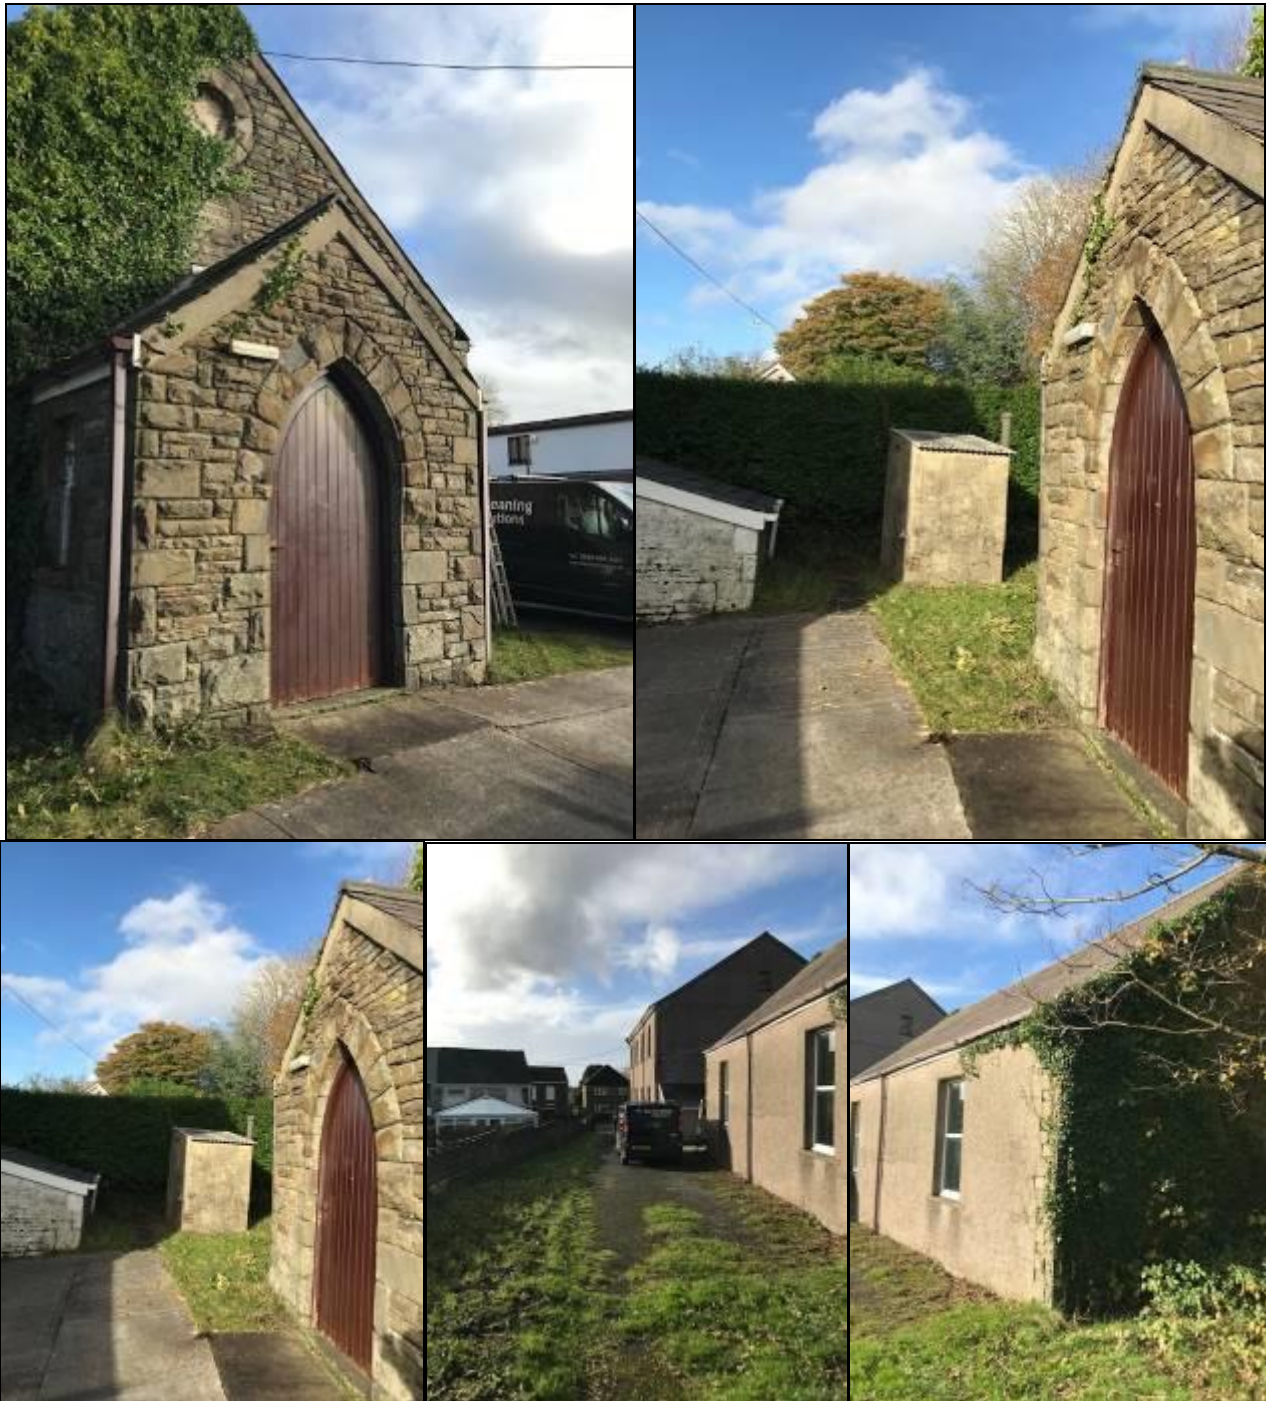
The **Vestry** was constructed around 1883 (and is believed to be the original chapel) of stone walls which have been part rendered and dashed and has pitched slate roofs. It is generally in good condition, has been well maintained and is well sealed. The walls are intact and the timber/uPVC framed windows and doors have no potentially exploitable gaps either in or around them. However, there are some wall top gaps as well as one or two slightly raised slates. Internally, there is no loft space and there were no signs of the presence of bats (e.g. live or dead bats, urine stains, smell, droppings) anywhere internally or externally.

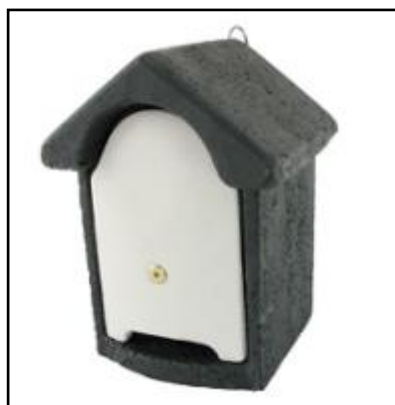
**Left:** The Harlech WoodStone bat box offers excellent insulation with a minimum of condensation for roosting bats. WoodStone® is a mixture of sawdust from FSC wood sources and concrete, and it is designed to last for years. It is breathable so there will be no problems with condensation and Woodstone maintains a consistent temperature inside, providing excellent insulation for roosting bats. Height 24cm x width 19cm x depth 18cm; Weight 4.4kg; Colour: Black with White front panel; Hook for hanging; Removable front panel for inspection/cleaning; and 10 Year Manufacturers Guarantee.

which is very durable so this product has a lifetime warranty. The attractive design is suitable for crevice roosting bats and has a rough interior to provide lots of grip. Bats need to increase their body temperature before flight so prefer warm roosting spots, which is why many of our bat boxes have a black exterior to absorb heat from the sun. WoodStone isn't just strong, it also has good thermal insulation, reducing temperature fluctuations inside the box and helping to make this an ideal roost site.

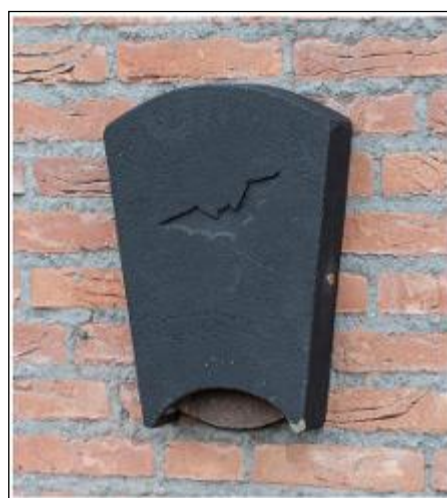
**Right:** The Beaumaris Bat Box is made from 100% WoodStone

Lack of sunlight can cause bat box/house failure, and structures for summer roosting should be positioned where they are unshaded for most of the day. Summer maternity roosts (in the northern hemisphere) should have a southerly or westerly aspect.

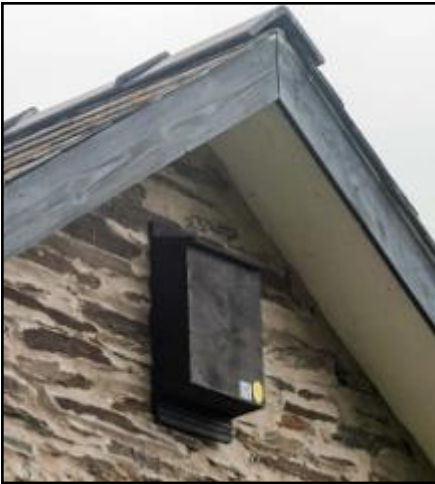
**Left:** The Improved Roost-Maternity Bat box is a large 3 crevice box suitable for larger roosts or maternity groups of the small British crevice-dwelling bats such as Pipistrelles. See [Improved Roost-Maternity Bat Box | NHBS Practical Conservation Equipment](#).

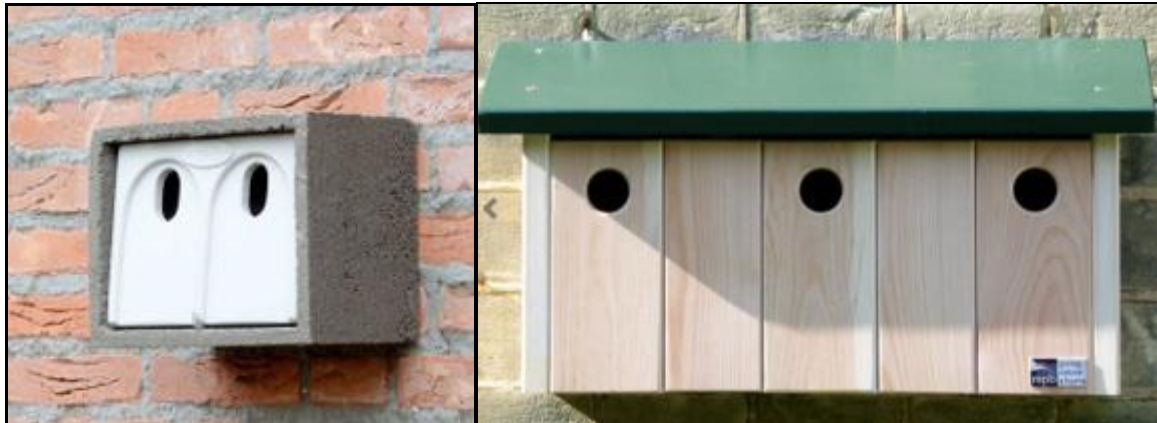
Examples of Sparrow terraces (top), House martin nest cups (middle), and Jackdaw (also suitable for Tawny owl when the hole is 12cm) nest boxes. Siting advice can be found at [Where To Put A Bird Box | Nestboxes - The RSPB](#)
